Appendix B

Landfill Inspection Forms and Survey Data

ORIGINAL LANDFILL – MONITORING AND MAINTENANCE PLAN INSPECTION FORM

Original Landfill January 2011 Monthly Inspection – Attachment 1

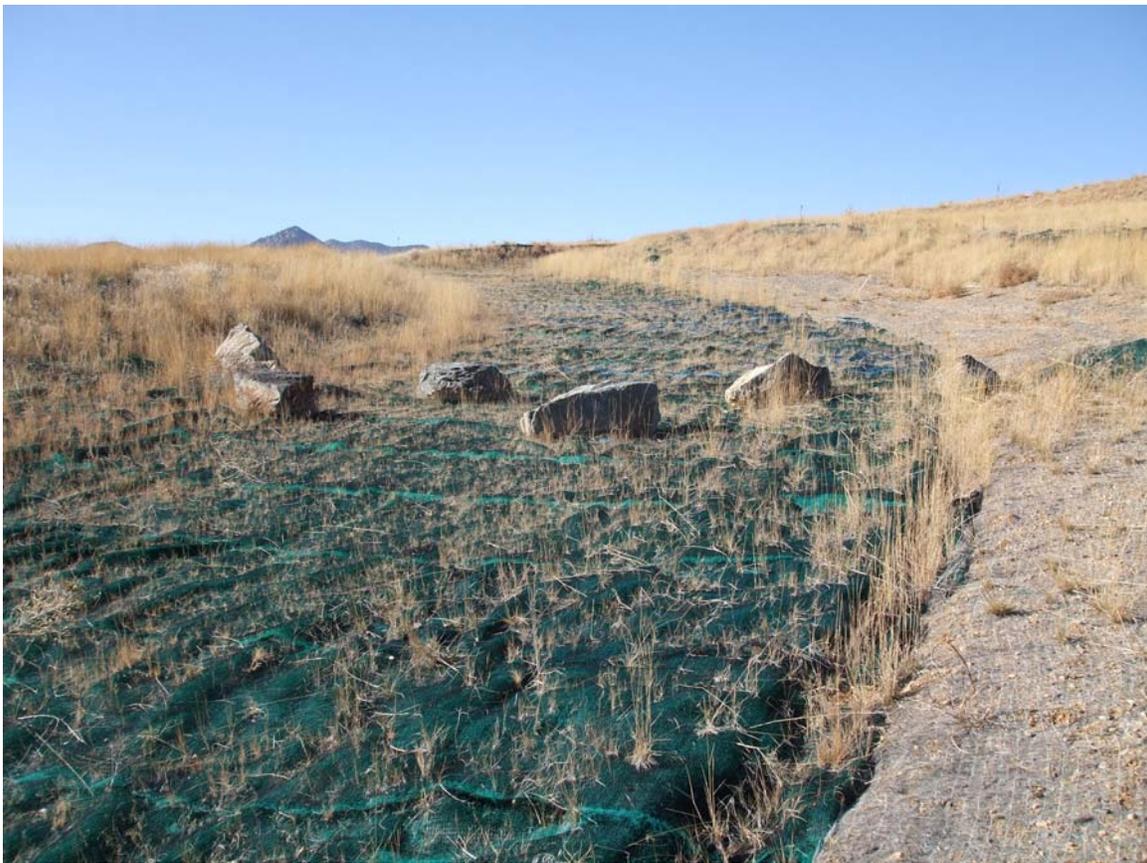
The Western Perimeter Channel is still in good shape. The vegetation is dormant this time of year, but will be coming back in the next few months.
