***Report of Steps Taken Regarding Monitoring Results at Surface Water  
Point of Evaluation (POE) SW027 and Contact Record 2010-06***

# **Report of Steps Taken Regarding Monitoring Results at Surface Water Point of Evaluation (POE) SW027**

## **August 31, 2010**

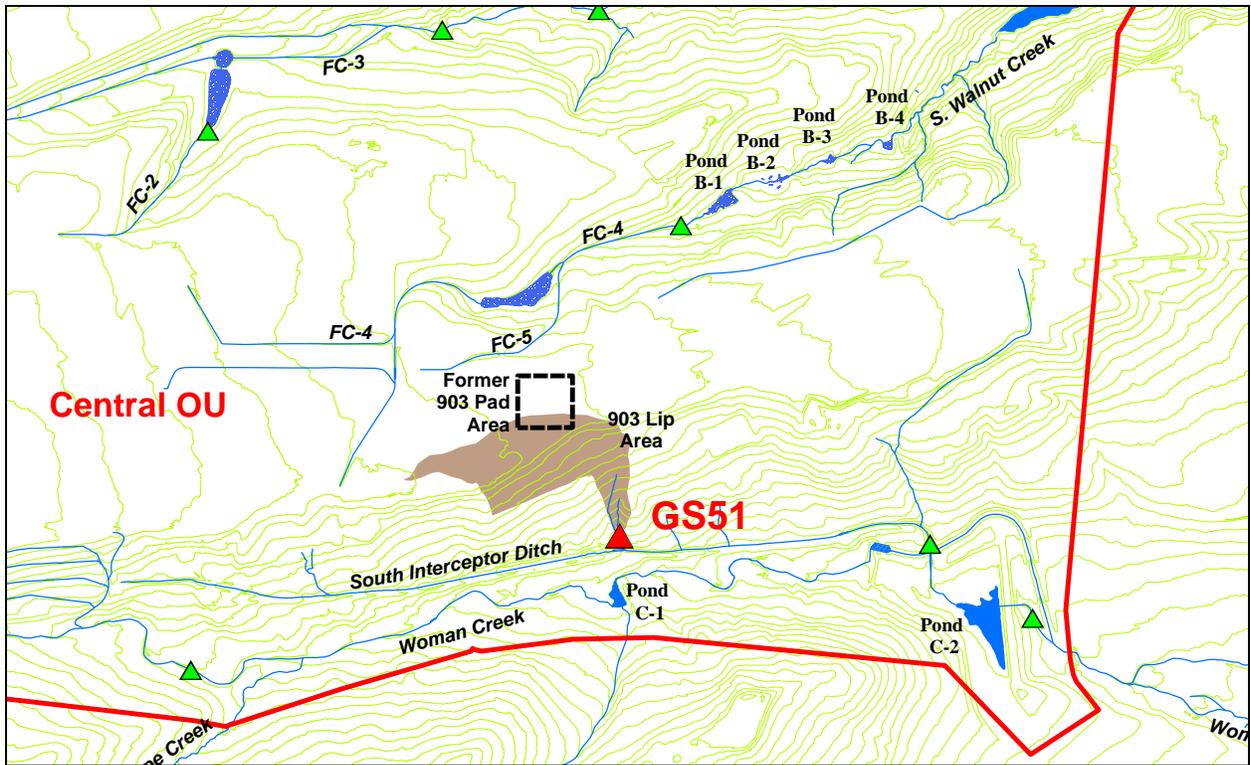
Figure 1. GS51 Drainage Area

Figures 1 and 2 show the drainage area for SW027 and the subdrainage within this area for GS51. This drainage area includes the former 903 Pad Lip Area, designated Individual Hazardous Substance Site (HSS) 900-155, which lies directly north of the SID. Large volumes of surface soil with residual Pu were removed from the surface of the 903 Lip Area in 2004, and the resulting surface was contoured and revegetated. Cleanup goals were met, but measurable concentrations of Pu in surface soil remained.

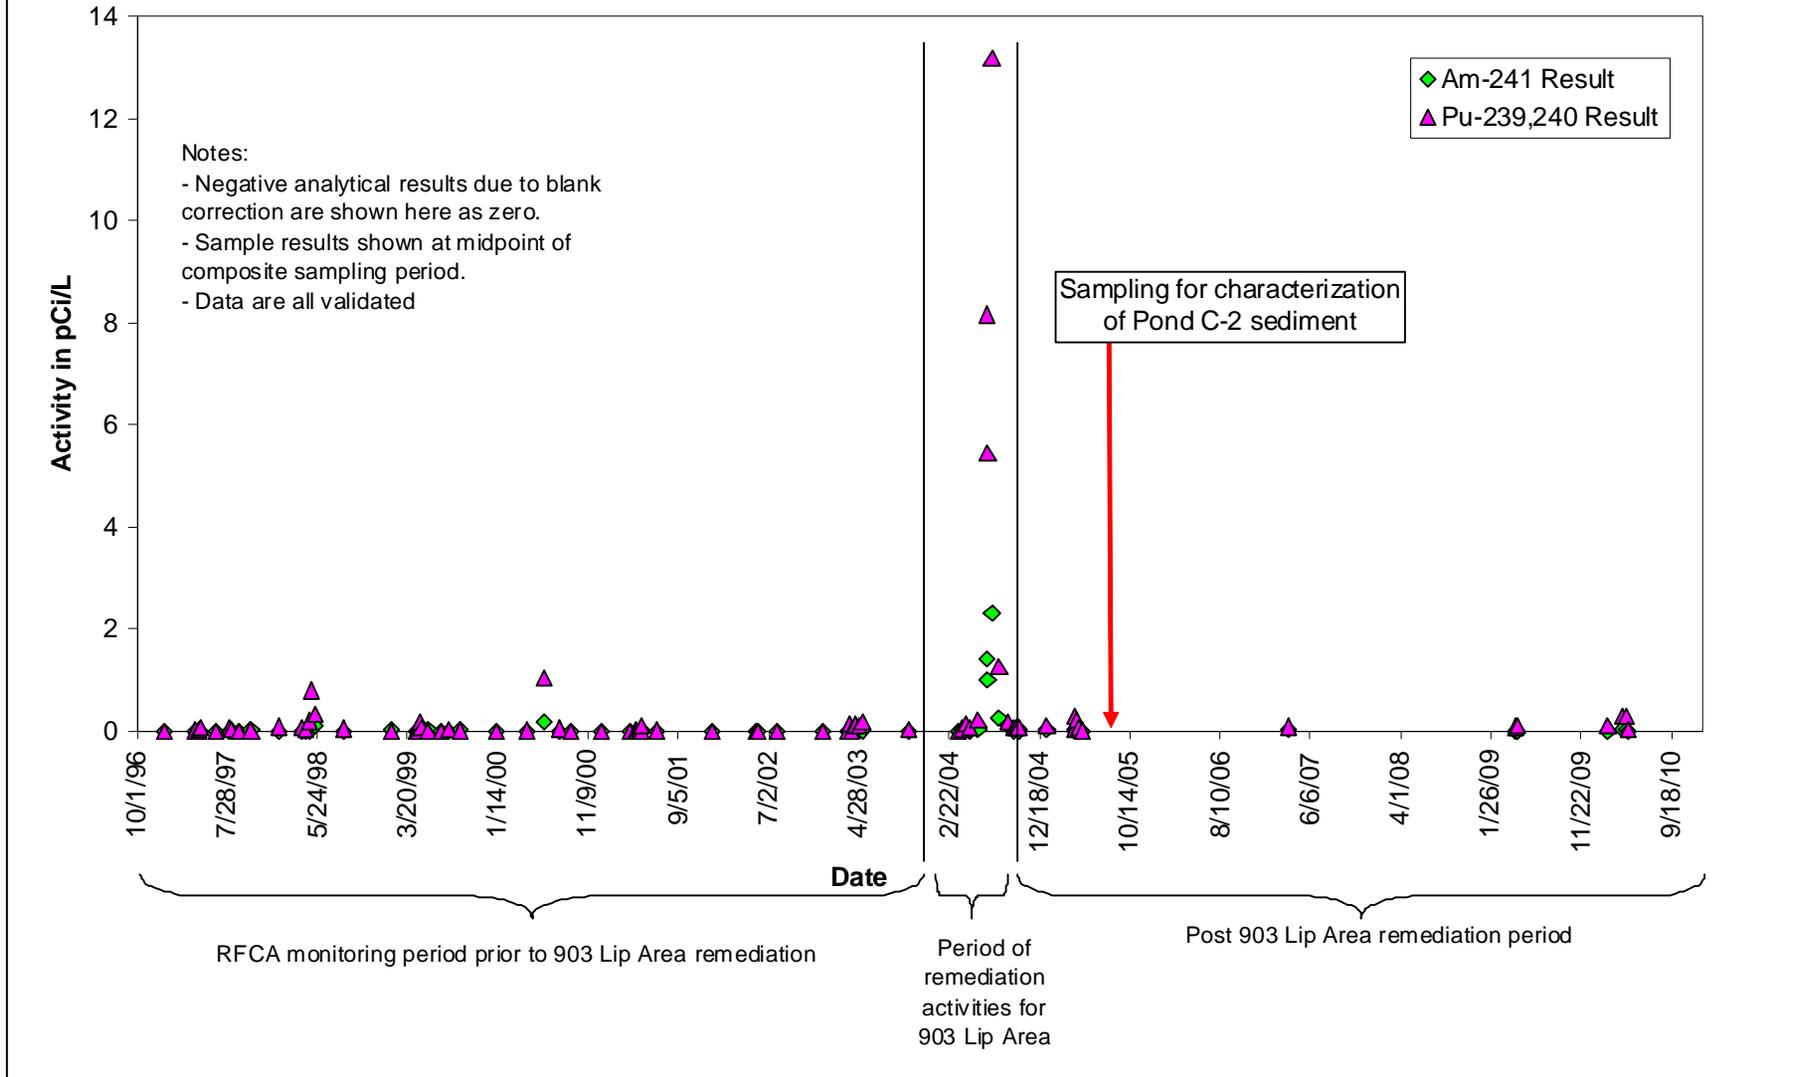
Figure 13. SW027 Data

### Monitoring Location SW027 (S. Interceptor Ditch upstream of Pond C-2): Plutonium and Americium Results for Continuous Flow-Paced Composite Samples
