Appendix A

Landfill Inspection Forms and Survey Data

Original Landfill April 2011 Monthly Inspection – Attachment 1

Original Landfill May 2011 Monthly Inspection – Attachment 1

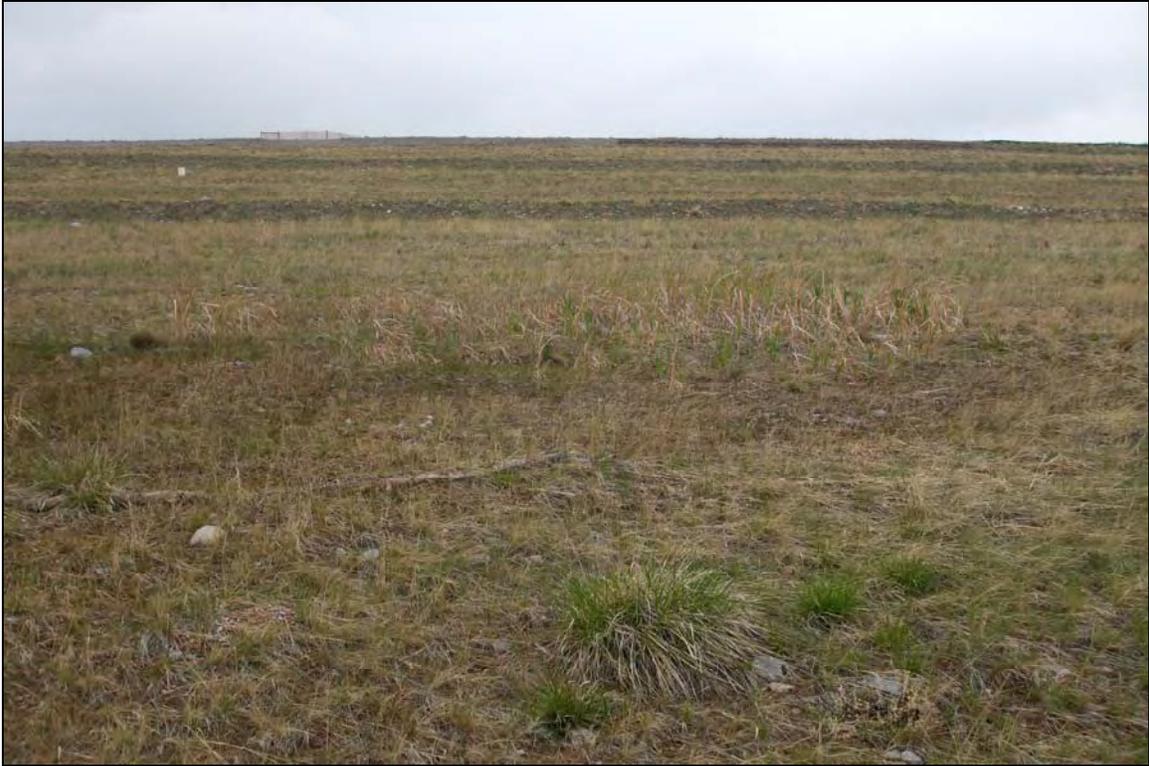
Seep 6 Area

The Seep 1 area was dry as usual. The Seep 2 and 3 areas were wet, but had no surface expression. The Seep 4 and 5 areas had some surface expression, but it was draining through the Berm 3 drain as designed. The Seep 6 area has three locations located above berm #7 that showed some wetness, but had no surface expression. The soil in the Seep7 area is moist, but there was no surface expression. Surface flow at Seep 8 continues to flow at a rate of approximately 2-3 gpm. Pictures of the main seep locations are included below.

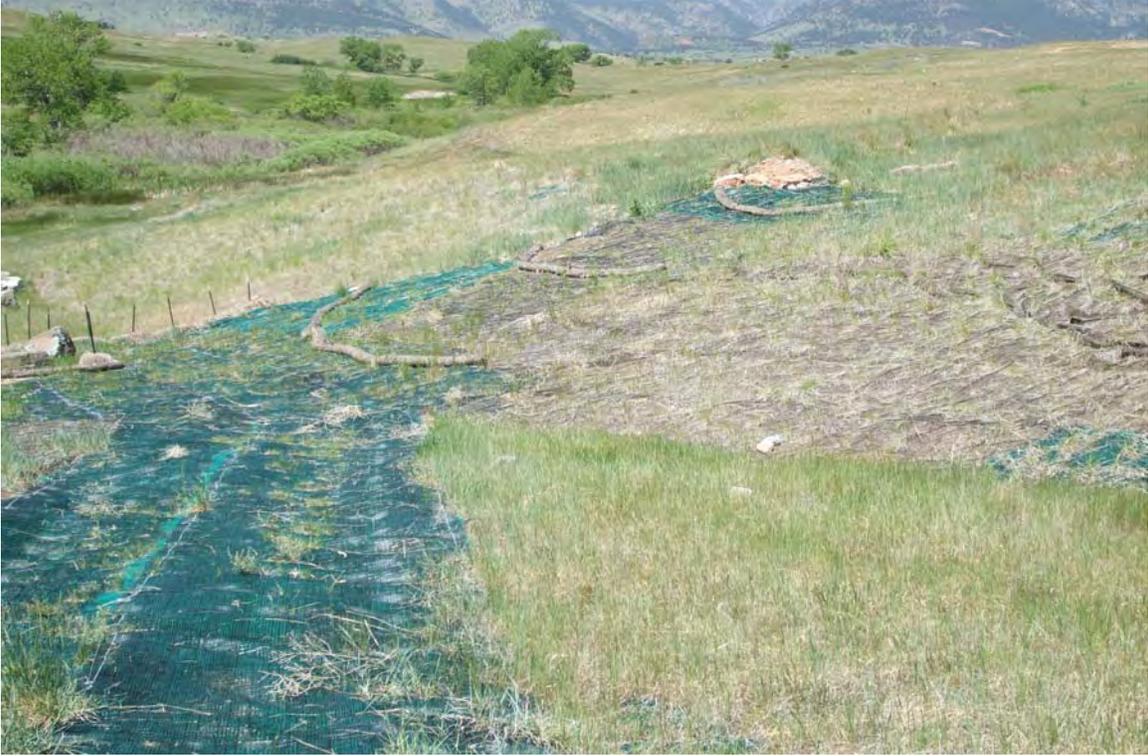
End of Berm 7

Berm 1 and 7 continue to look good with no new slumping or cracking present.
