Appendix B

Landfill Inspection Forms and Survey Data

Original Landfill January 2012 Monthly Inspection—Attachment 1

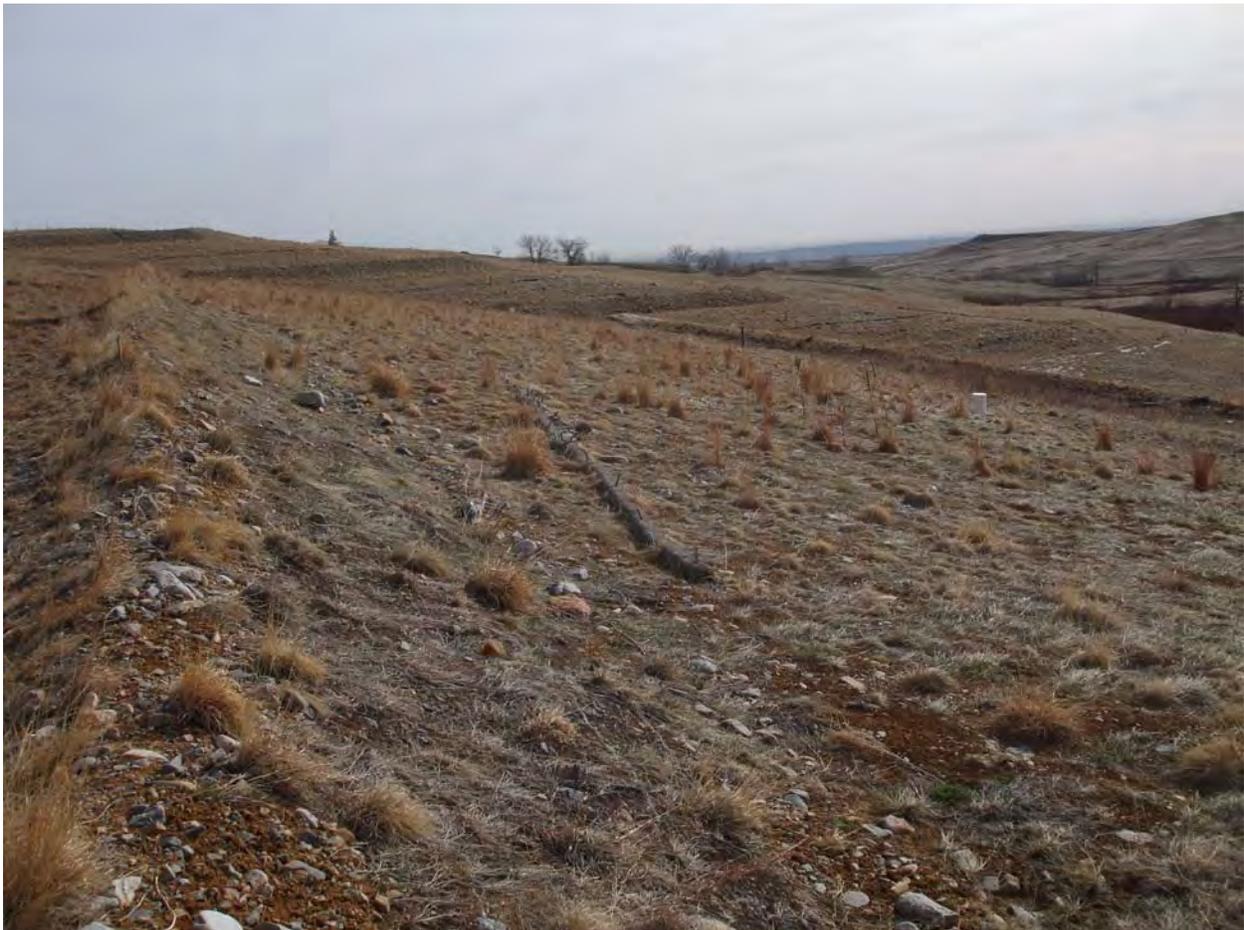
OLF Cover Facing East

Berm locations that were re-graded during the OLF Maintenance 2011 Project remained in good condition. Vegetation on the landfill cover is beginning to come out of dormancy.

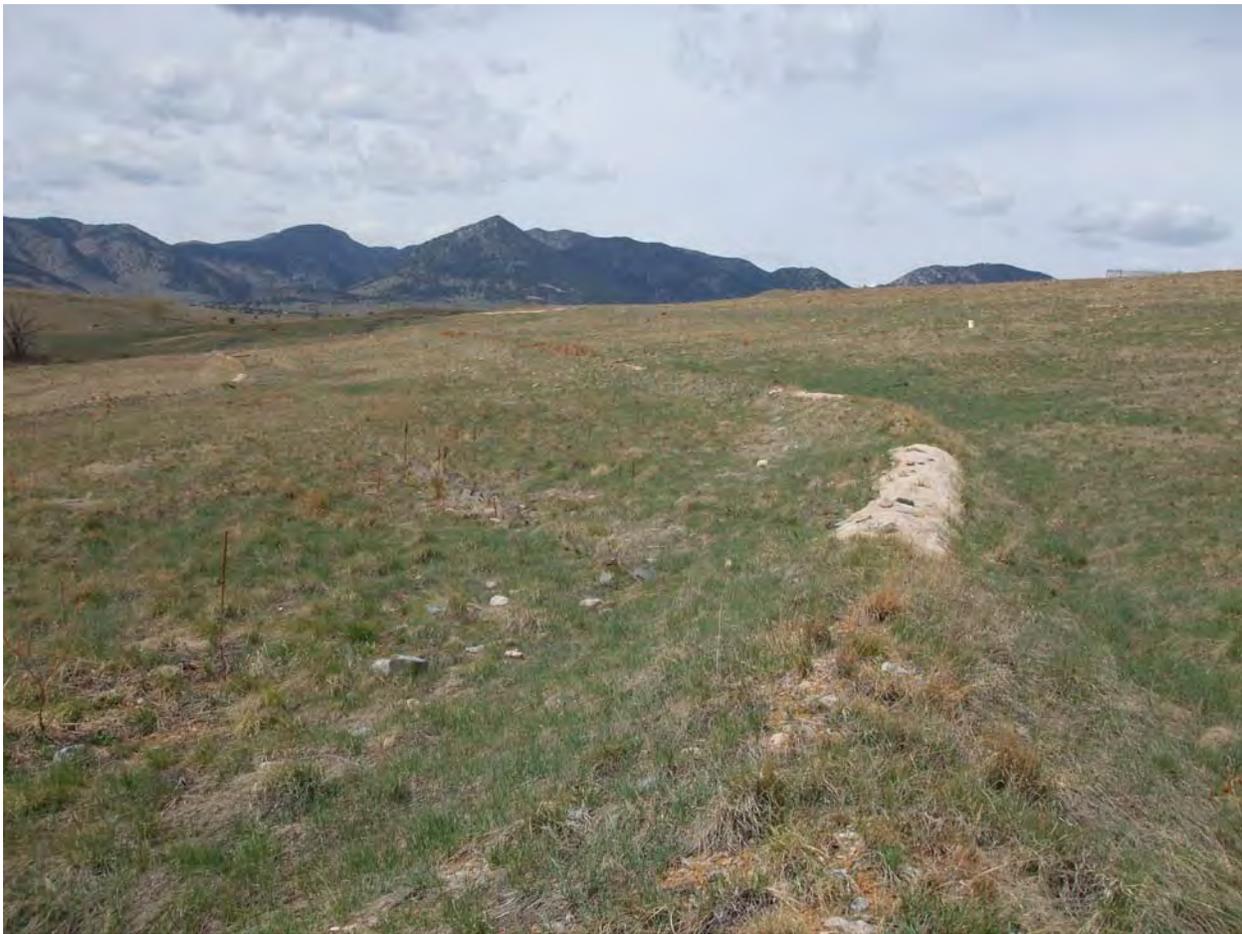
OLF Cover Facing East

Berms and channels remain in good condition. Vegetation on the landfill cover is coming out of dormancy and is green in most locations. No new cracks, depressions, or slumps were noted on the landfill cover during the March inspection. There were no locations that required any maintenance or repairs.
