Amchitka Annual Site Inspection 2018 Trip Report Amchitka, Alaska, Site

January 2019

Amchitka Site 2018 Annual Mud Pit Caps Inspection

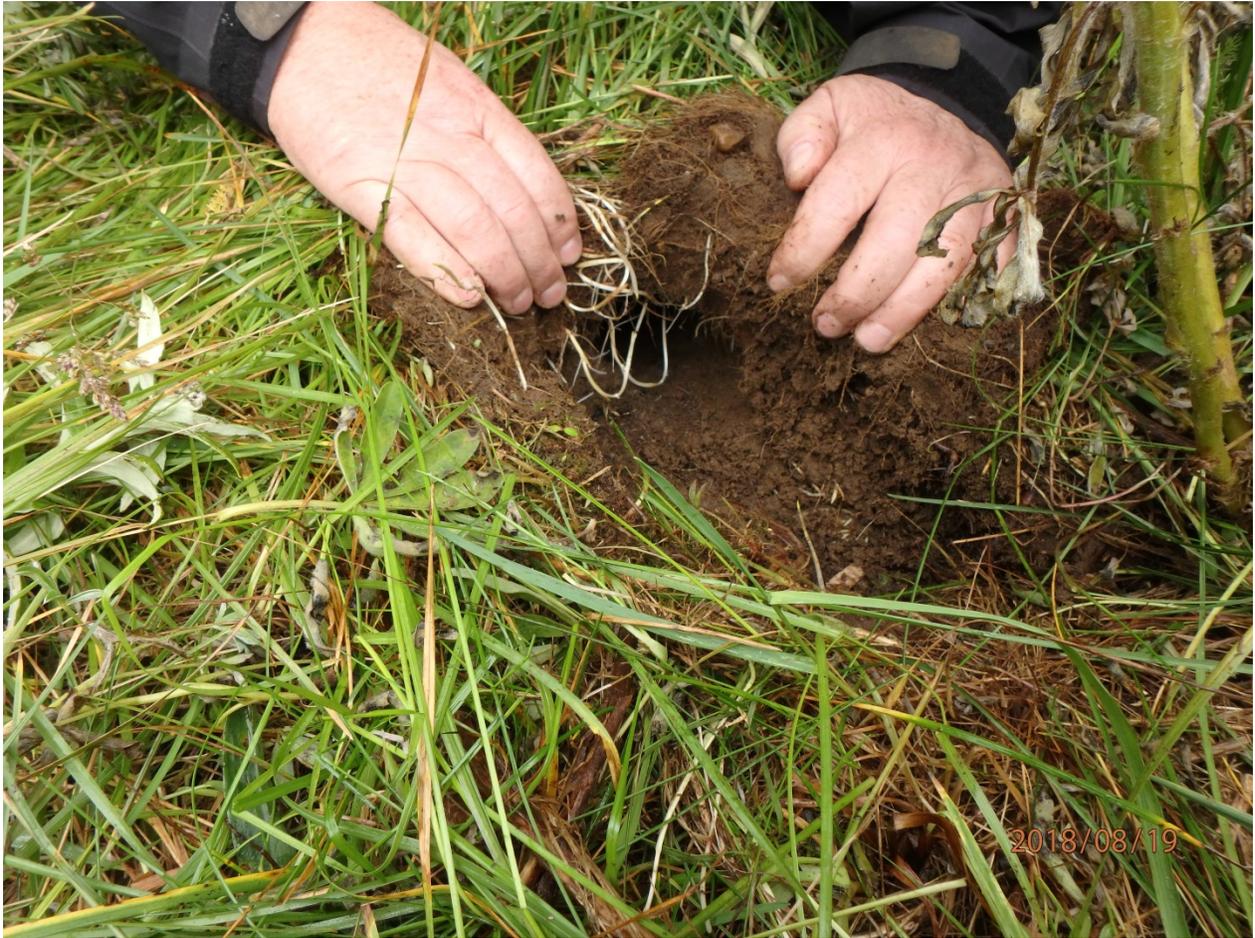
Photo RR04: Investigating animal burrow at the Rifle Range mud pit site

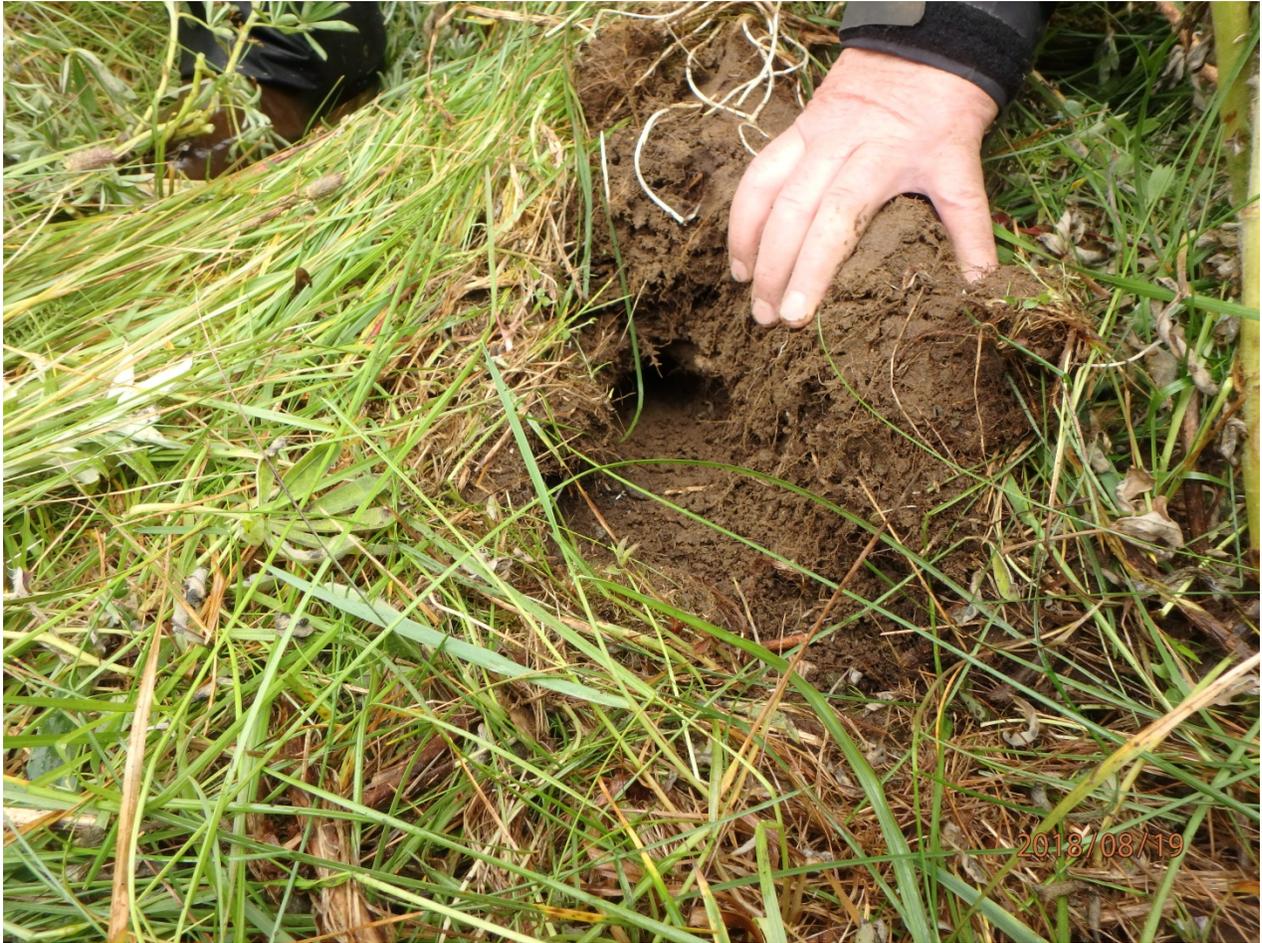
Photo RR05: Revealing animal burrow at the Rifle Range mud pit site

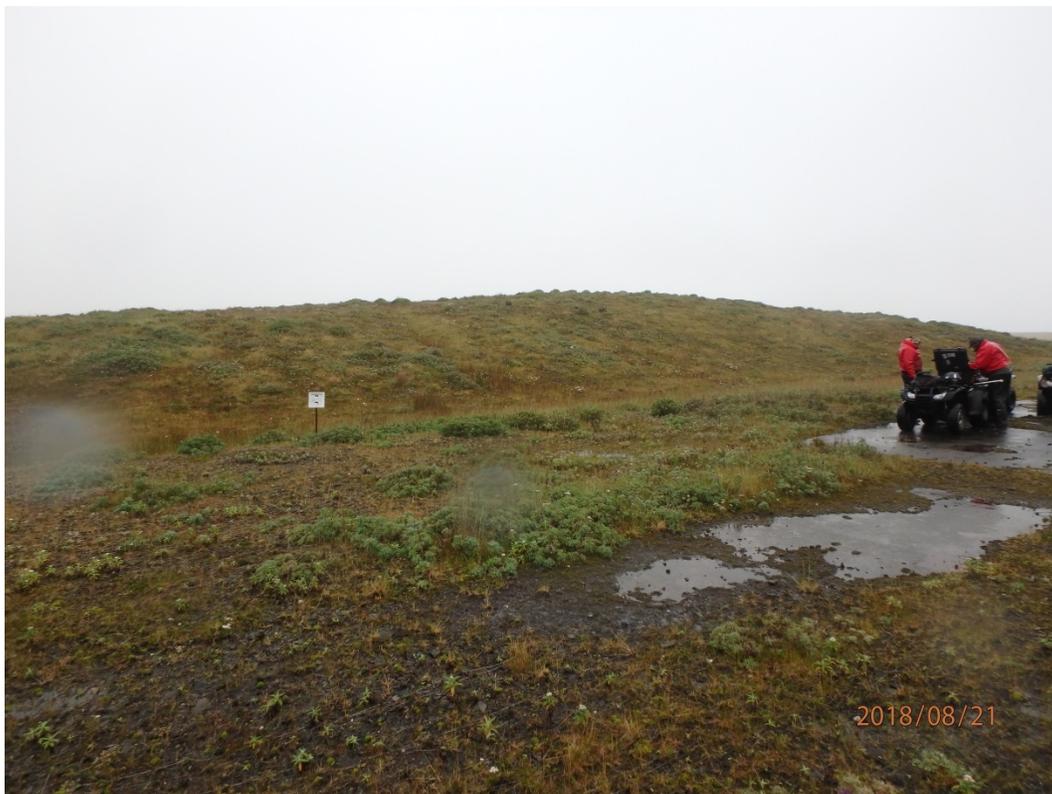
Photo LS02: Long Shot mud pit cap

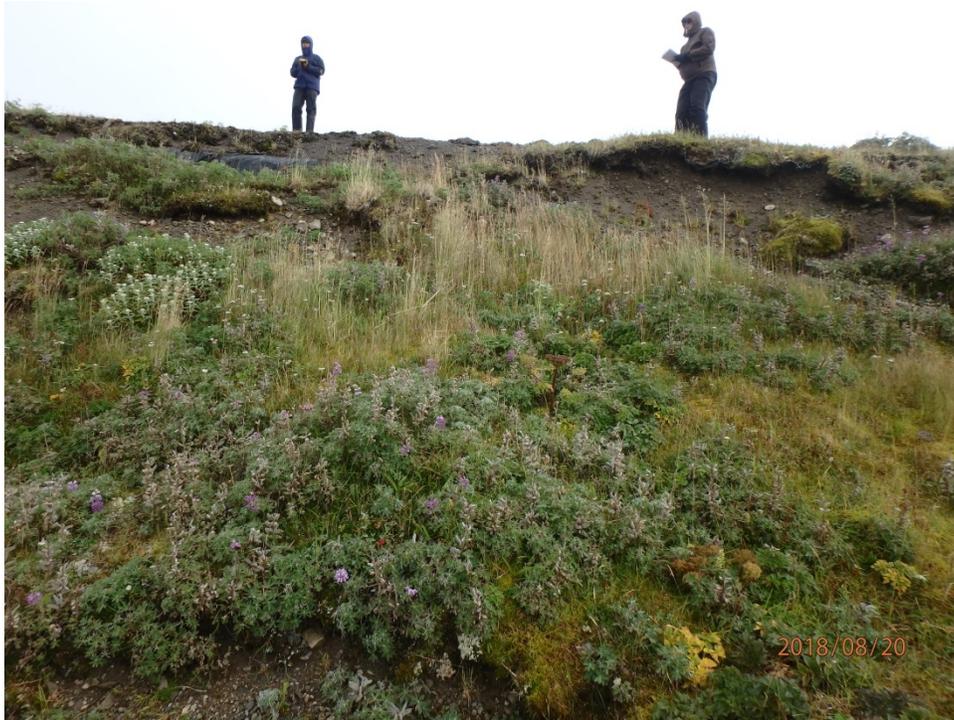
Photo D05: Exposed liner on the south side of the Drill Site D mud pit cap, similar to photo PL-D010 in the 2017 Amchitka inspection report (DOE 2017)

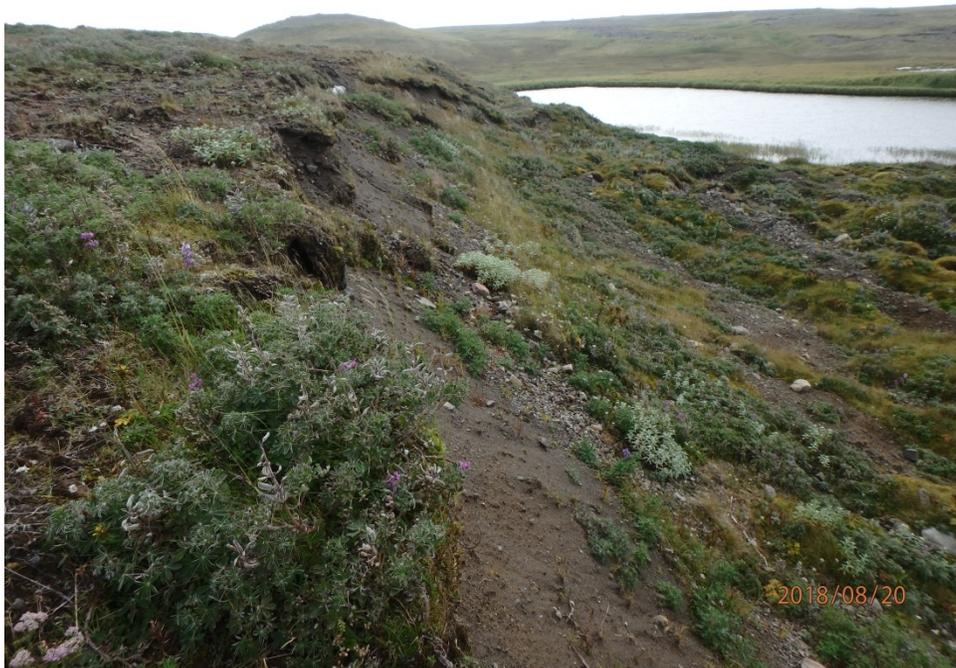
Photo D08: More distant view of exposed liner area on the south side of the Drill Site D mud pit cap

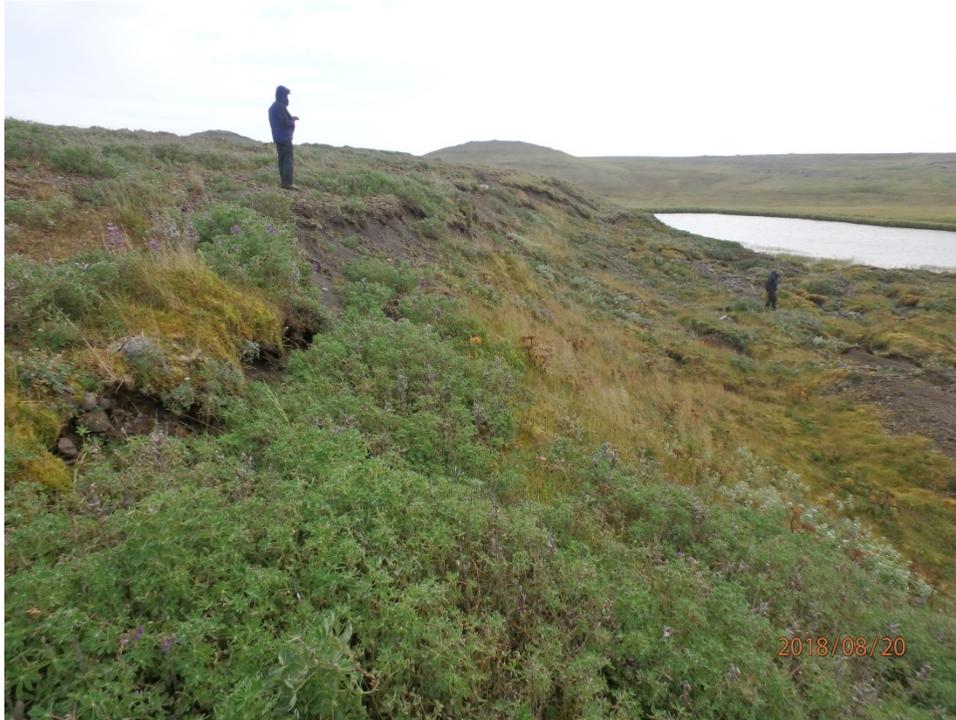
Photo D09: Another view of exposed liner area on the south side of the Drill Site D mud pit cap, similar to photo IMG_747 in the 2016 Amchitka inspection report (DOE 2016)

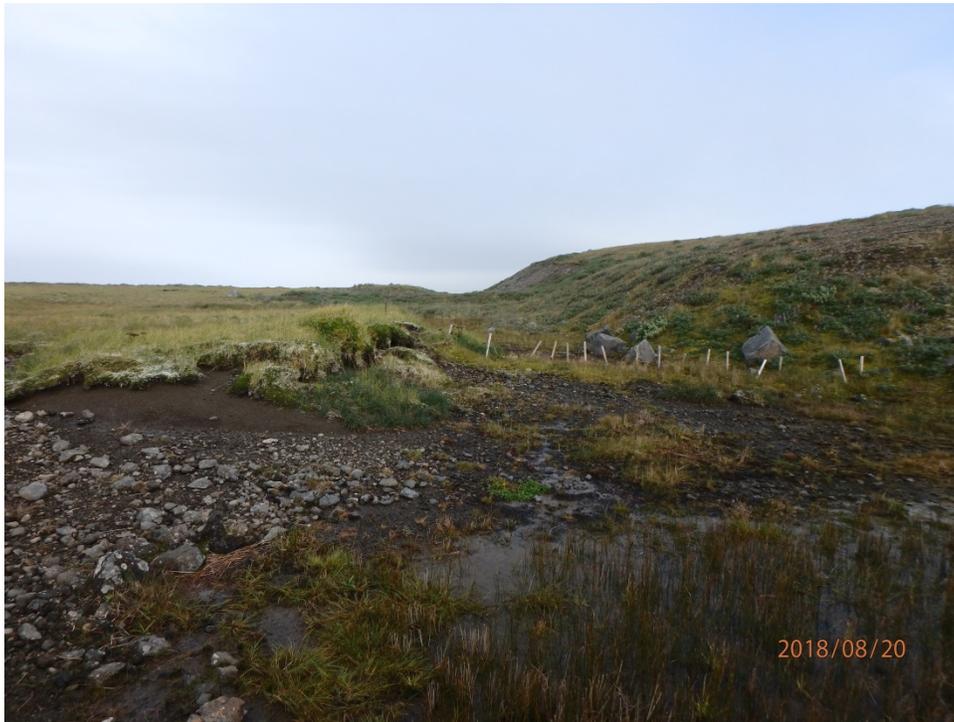
Photo D015: Sediment trap at the Drill Site D mud pit site, similar to photo PL-D013 in the 2017 Amchitka inspection report (DOE 2017)

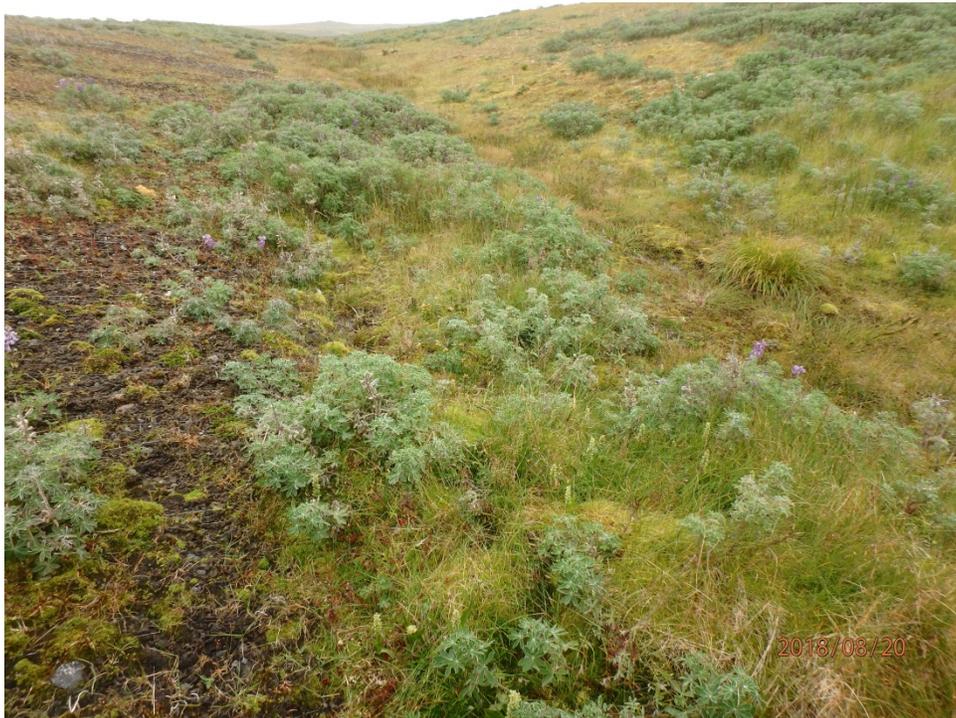
Photo D018: Potential new slump area east of channel D-2 on the west side of the east cap at the Drill Site D mud pit site

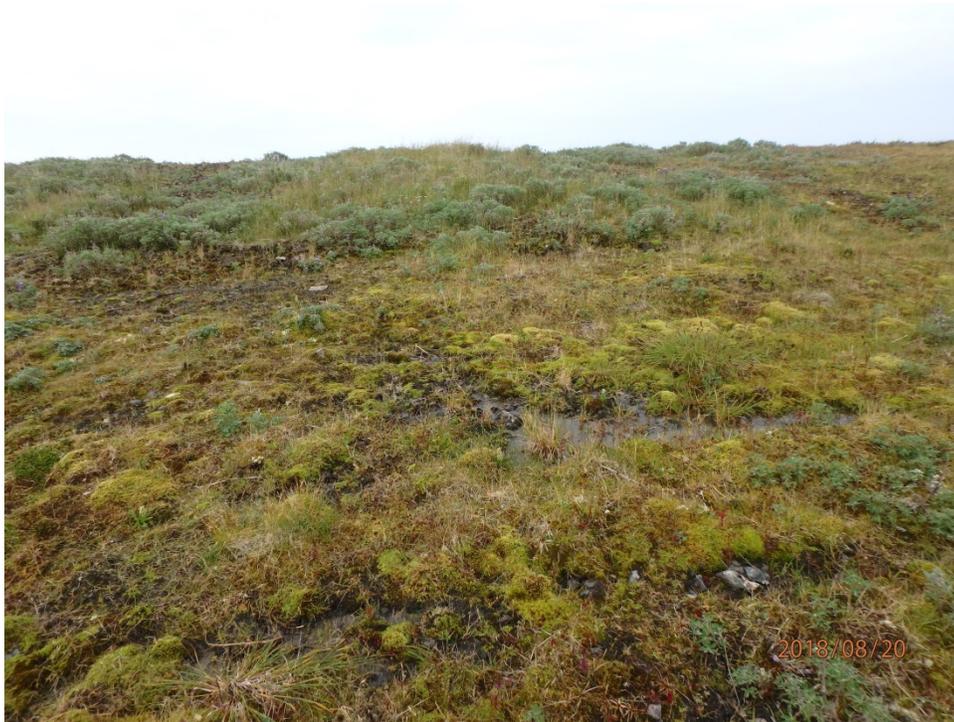
Photo D021: Another view of the standing water and a possible settlement area approximately at the north-to-south midpoint of the east slope of the east cap at the Drill Site D mud pit site

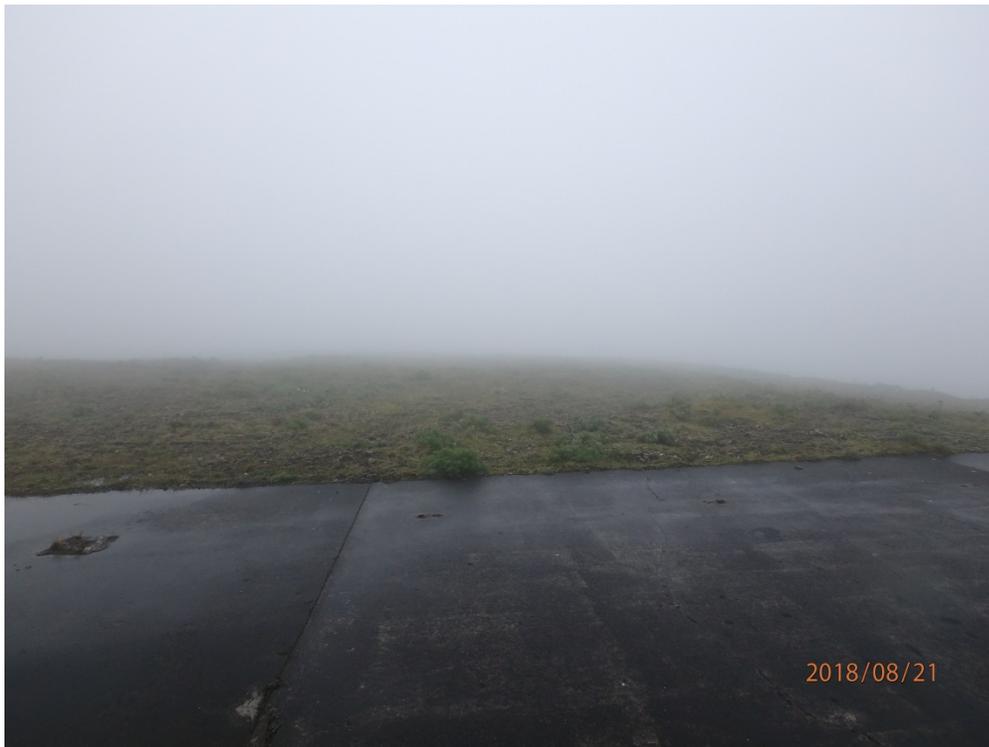
Photo F01: The Drill Site F mud pit cap viewed from the concrete drill pad

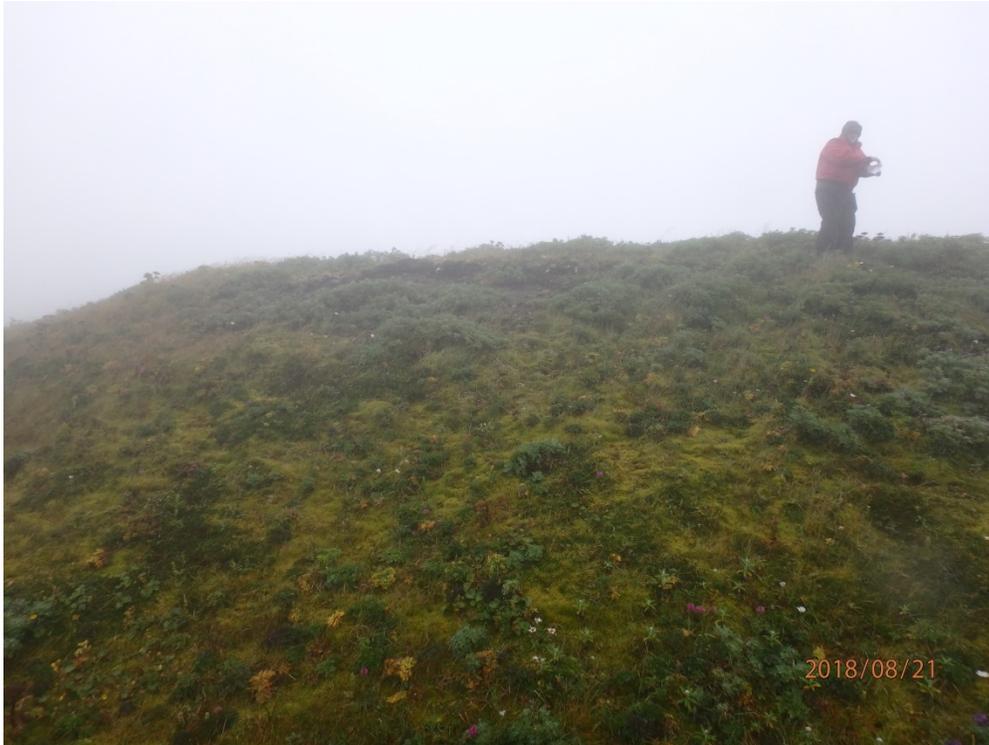
Photo F04: The southern side of the Drill Site F mud pit cap, similar to photo PL-F03 in the 2017 Amchitka inspection report (DOE 2017)

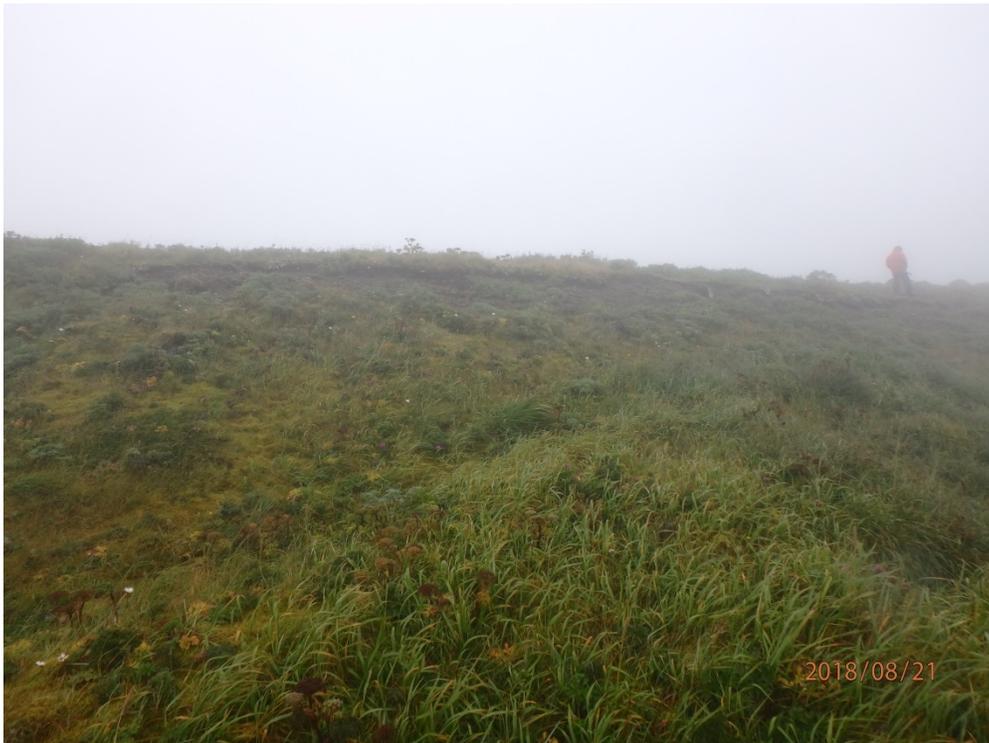
Photo F05: The southern side of the Drill Site F mud pit cap, similar to photo PL-F06 in the 2017 Amchitka inspection report (DOE 2017)

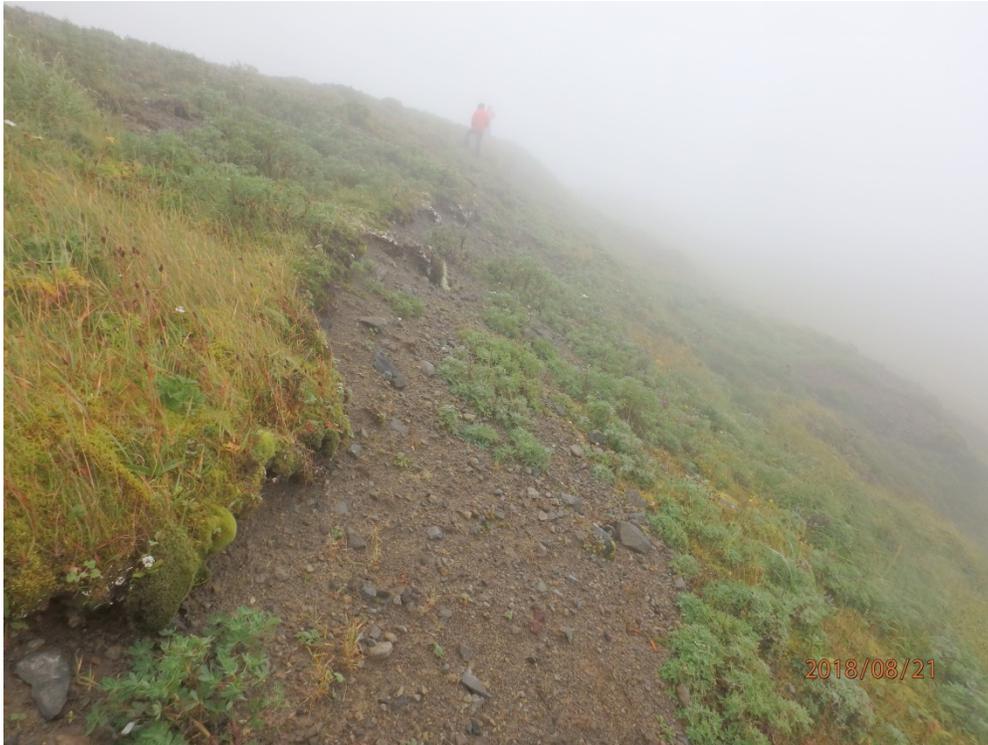
Photo F06: The southern side of the Drill Site F mud pit cap, similar to photo PL-F07 in the 2017 Amchitka inspection report (DOE 2017)

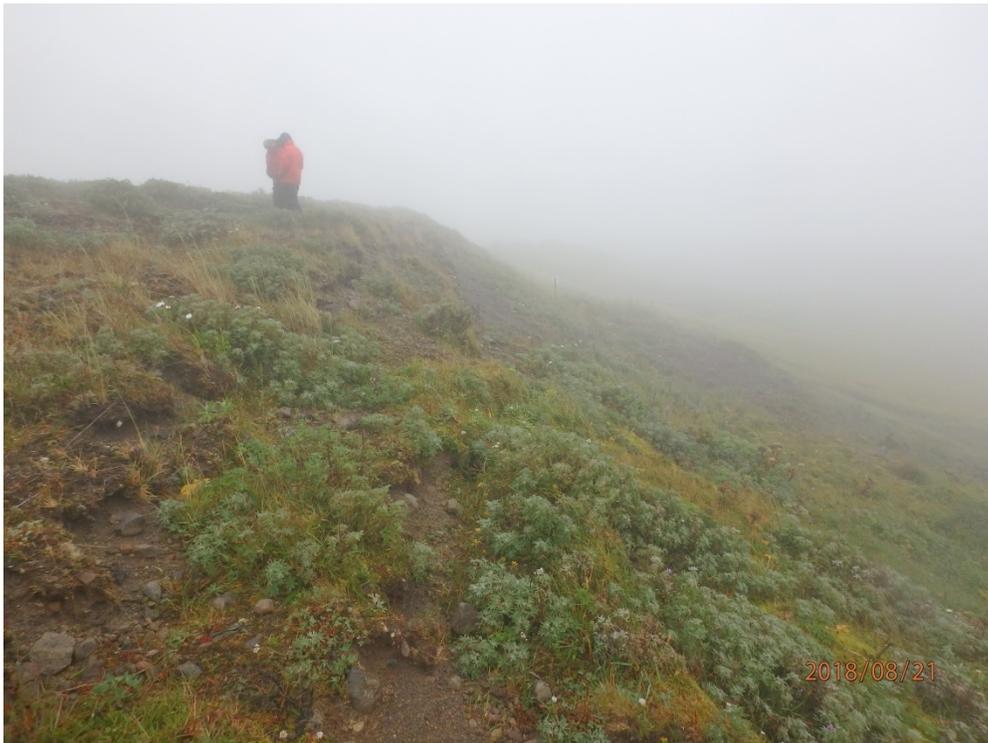
Photo F07: The southern side of the Drill Site F mud pit cap, similar to photo PL-F08 in the 2017 Amchitka inspection report (DOE 2017)

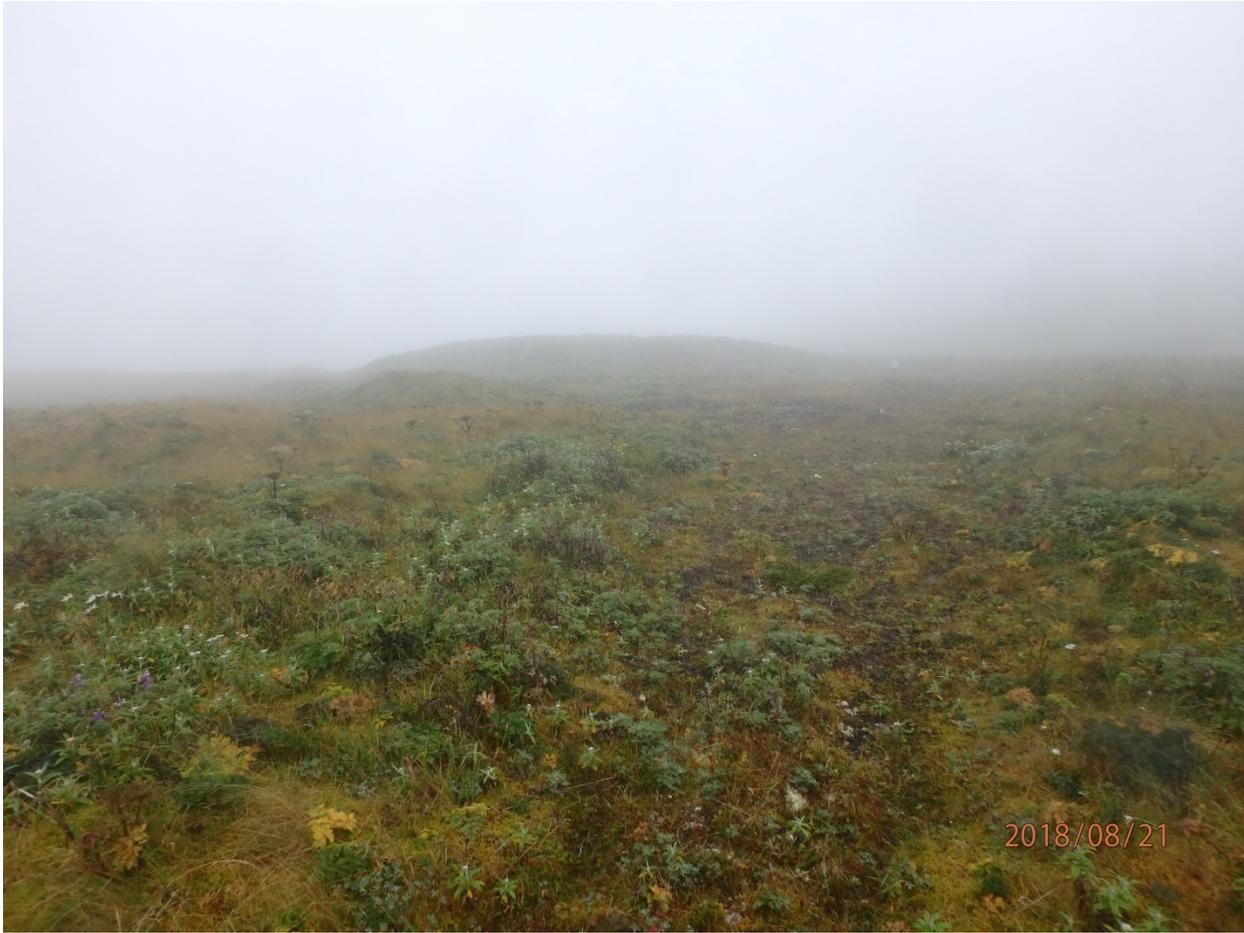
Photo E01: Drill Site E mud pit cap, similar to photo PL-E02 in the 2017 Amchitka inspection report (DOE 2017)
