**DR. MODESTO IRIARTE TECHNOLOGICAL
MUSEUM (FORMER BONUS FACILITY)**

2016 ANNUAL RADIOLOGICAL SURVEY REPORT

**RINCON
PUERTO RICO**

October 2016

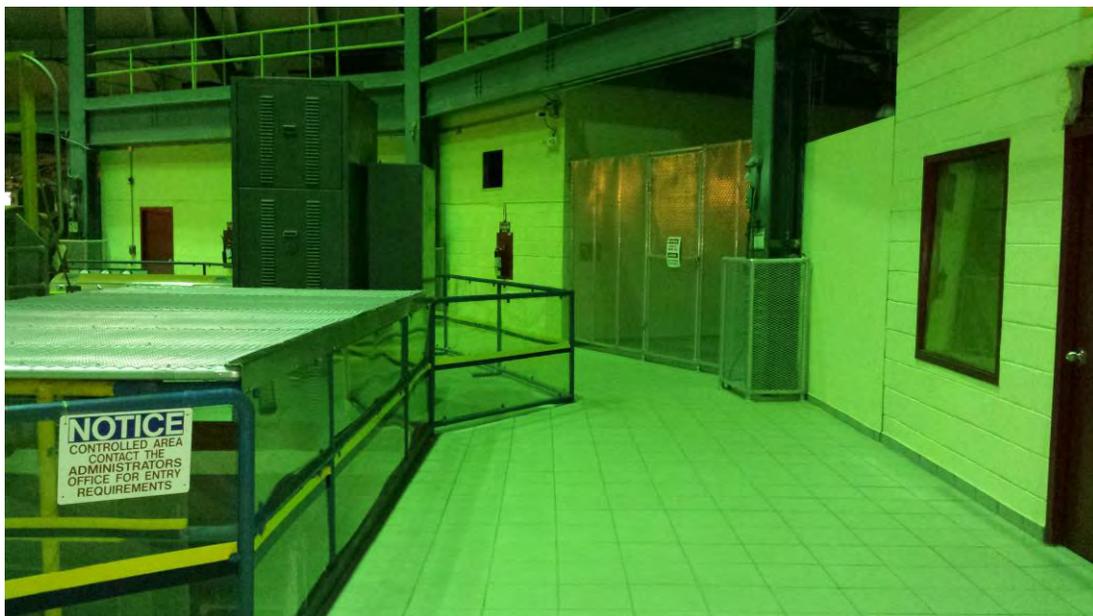
- **Dome-Mezzanine Level:** Access to ladders and stairways leading to the mezzanine level are being effectively maintained and controlled (Appendix A, Figures 11, 12, and 13). The structure appears sound and in good condition. No immediate action is necessary.

Figure 11. Main Level – Locked and Controlled Access to East Mezzanine and Electrical Panels

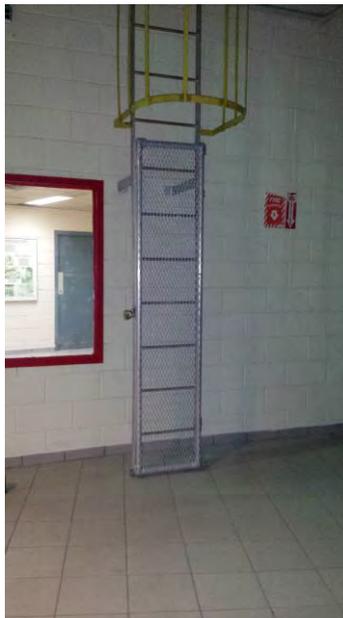
Figure 12. Main Level – Locked and Controlled Access to South Mezzanine

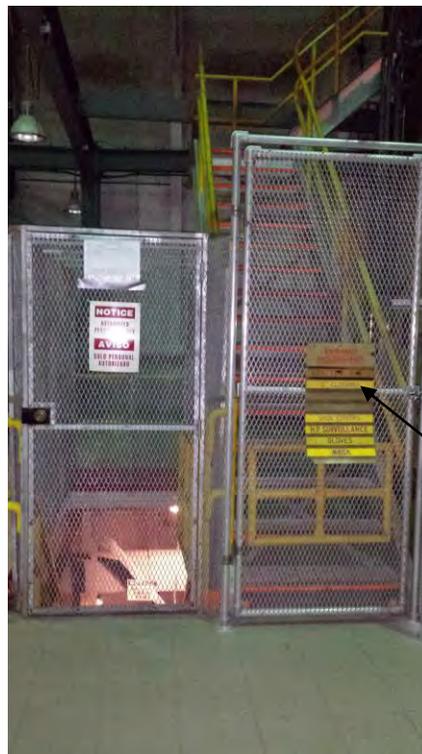
Access to stairways leading to the Basement Level is being effectively maintained and controlled (Appendix A, Figure 13). No action is necessary.

**Figure 13. Main Level (Museum Area) – Locked and Controlled Access to South Side of
Basement Level (Left) and Mezzanine (Right)**

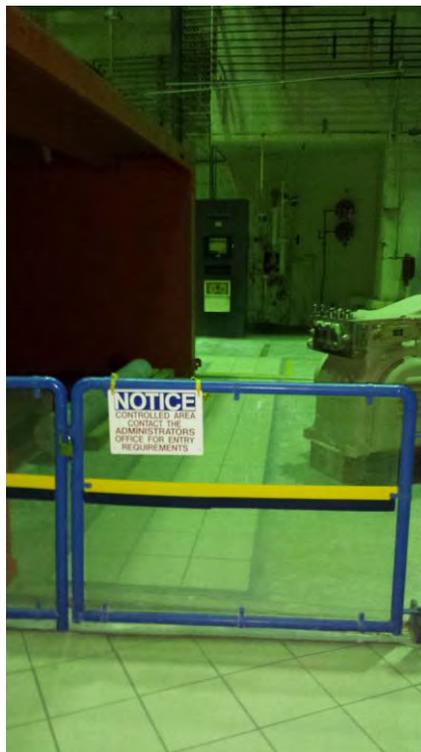
placed along the railing. The pad lock on the gate within the railing system, which provides access from the Museum Area to the Controlled Area, was in place and locked (Appendix A, Figure 15). The PREPA team will continue to monitor the tiles within the Museum Area for signs of cracks/failures.

Figure 15. Main Level (Controlled Area) – Locked Access from Museum Area to Controlled Area

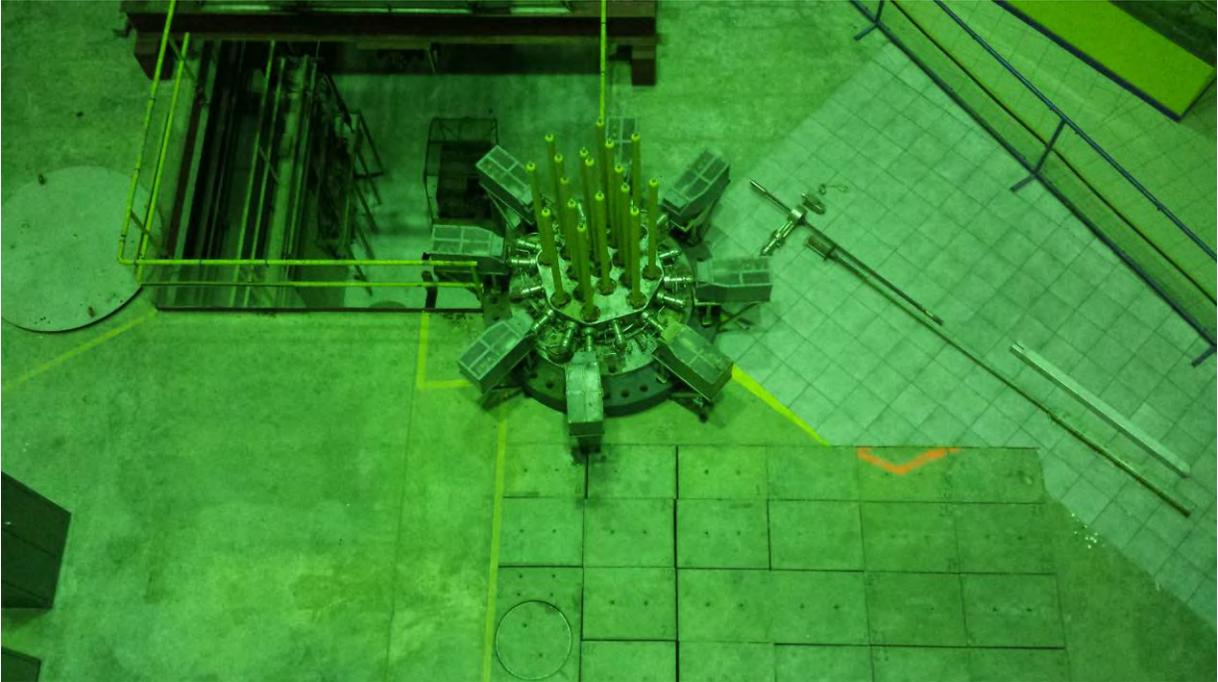
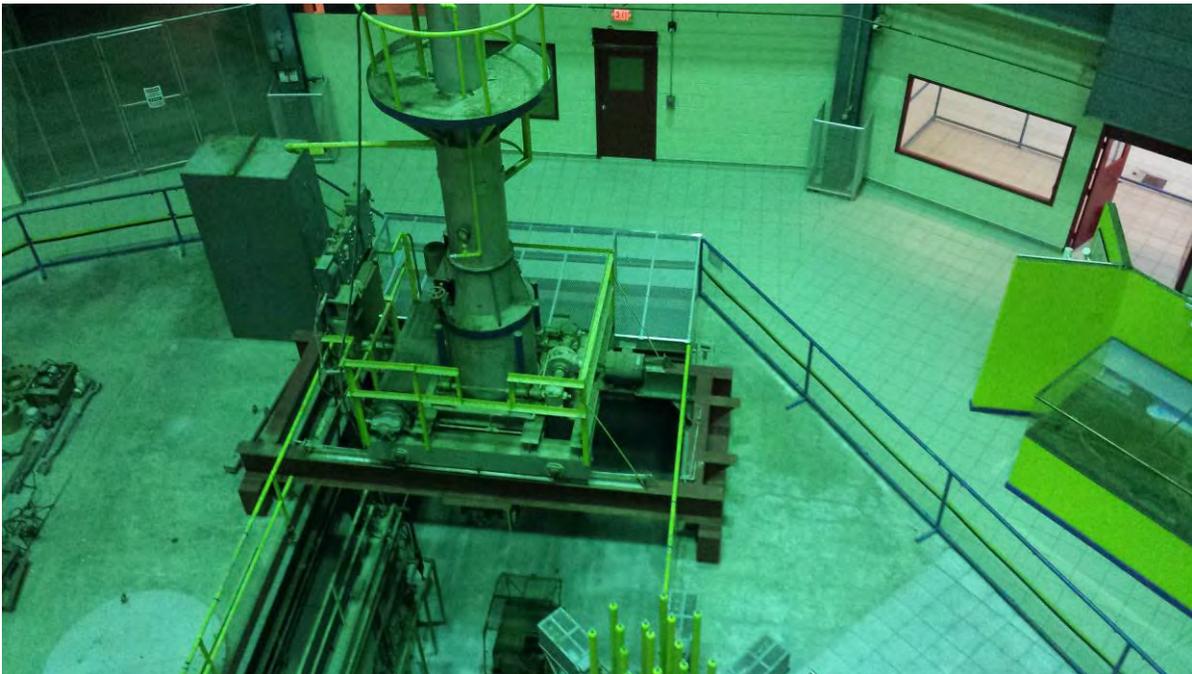
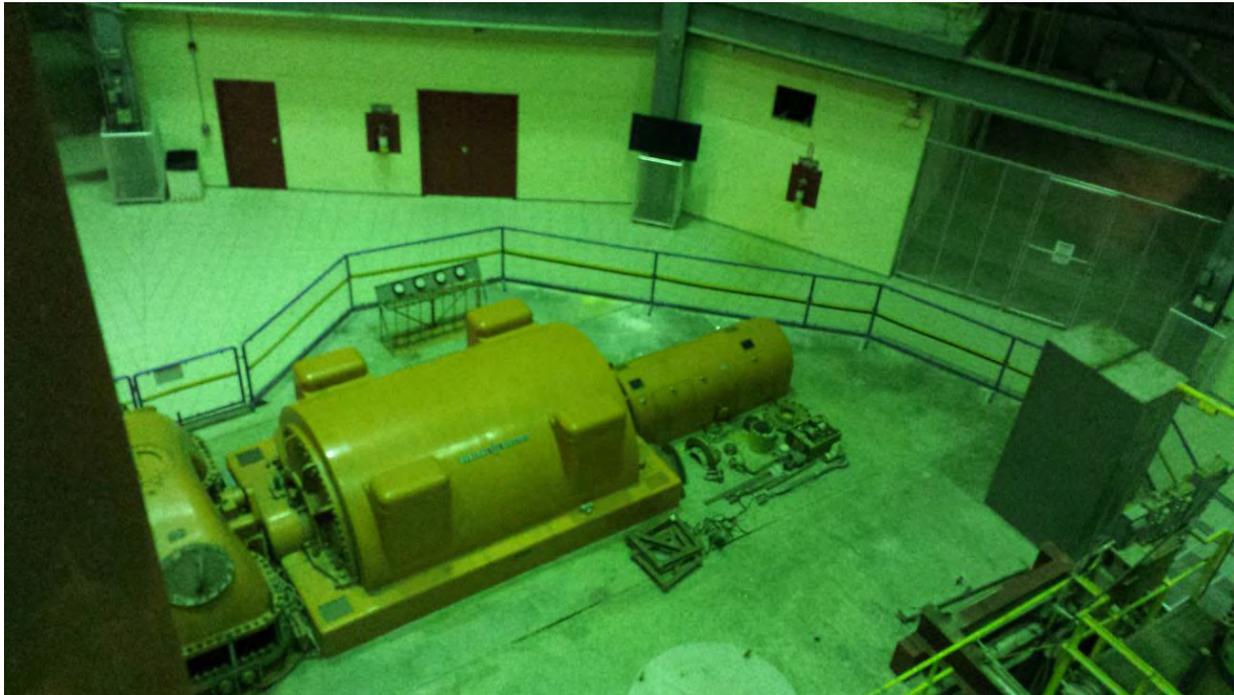
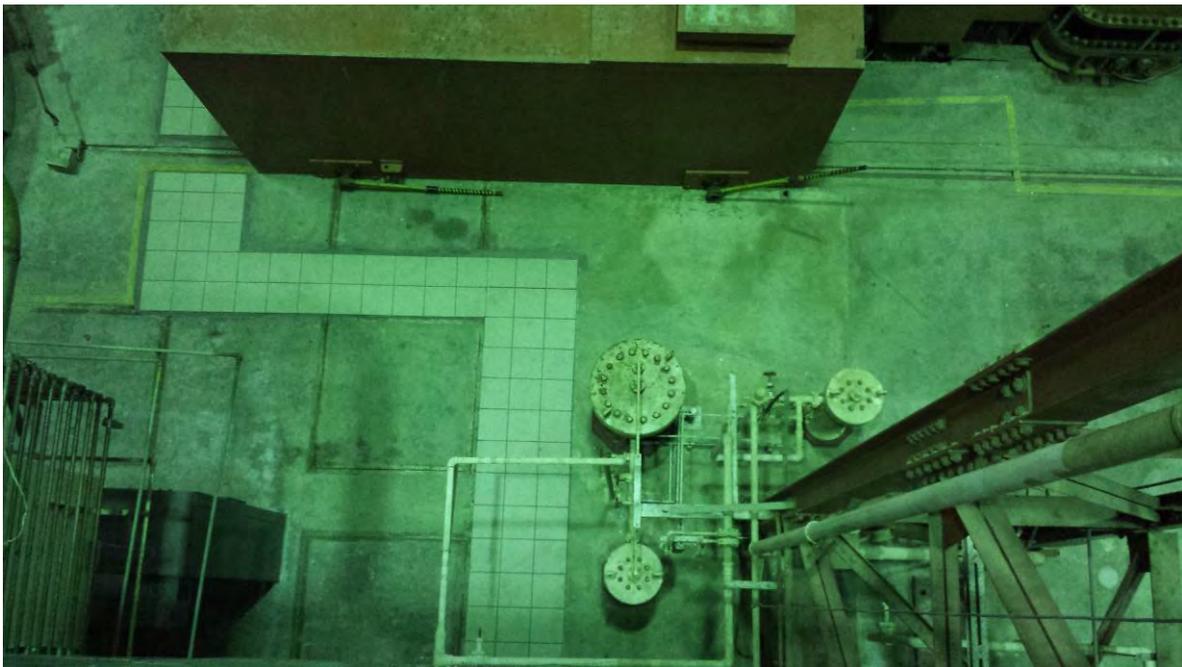
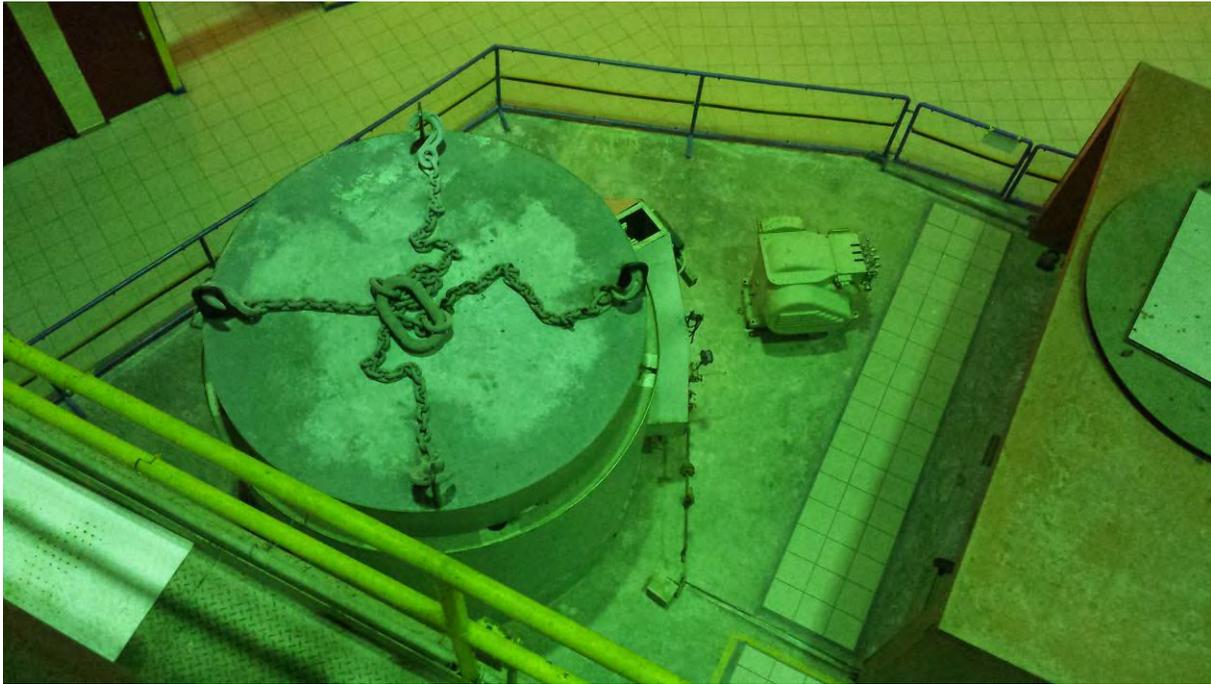
- **Dome-Main Level:** The Main Level (Controlled Area) is that portion of the Main Level that is not accessible to the public (Appendix A, Figures 16 through 20). The two historical contamination sites remain covered with floor tiles; the tile work is in good condition and is effective in reducing the dose levels. One area adjacent to the north side of the Monolith is also covered with lead bricks, which is effective in reducing elevated dose rate levels in this area (Appendix A, Figure 21). Ongoing and routine assessment of the floor tile and lead bricks in this area is recommended. There is also no discernible evidence of work and/or damage affecting the control measures (floor tiles) on the Main Level, Museum Area (Appendix A, Figures 4 through 10 and 14), except for one area near the railing between the Controlled Area and Museum Area where the tiles feel loose or “floating” but no discernable cracks/failures are noticeable. The safety guard along the railing (Appendix A, Figure 17), which protects from falls to the Basement Level below, is in good condition and access control signs are properly

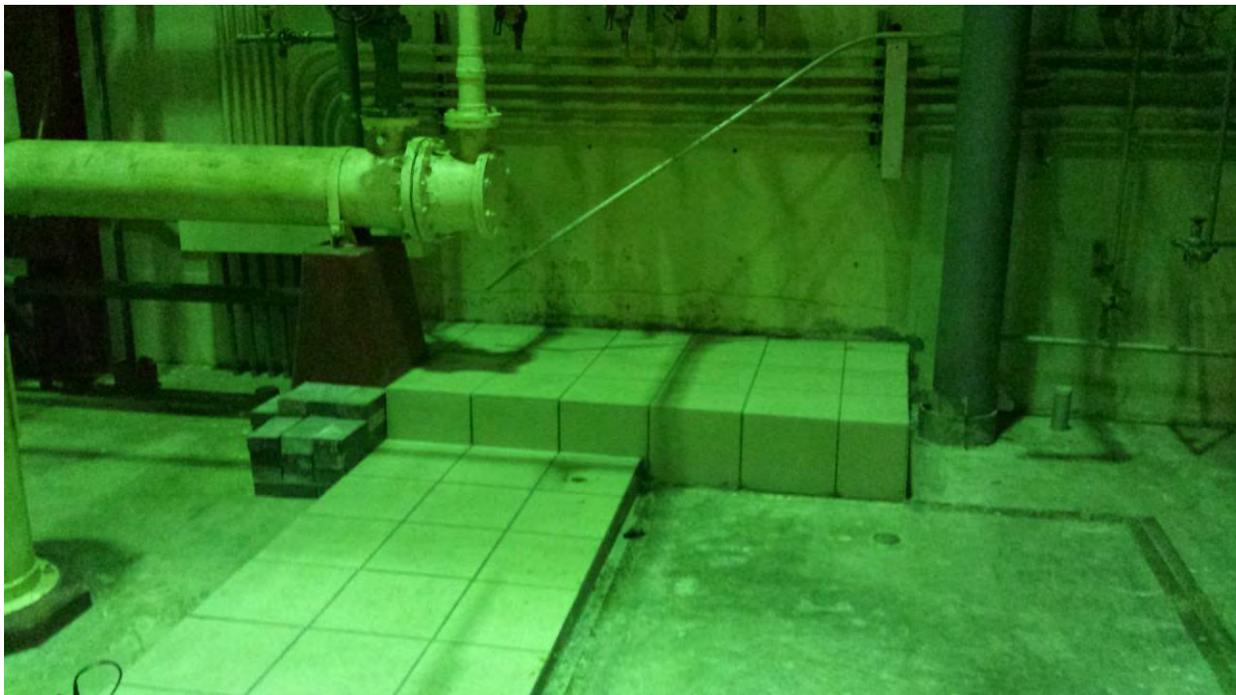
Figure 21. Main Level (Controlled Area) – Engineering Controls (Concrete, Tiles, and Lead Bricks) in Good Condition

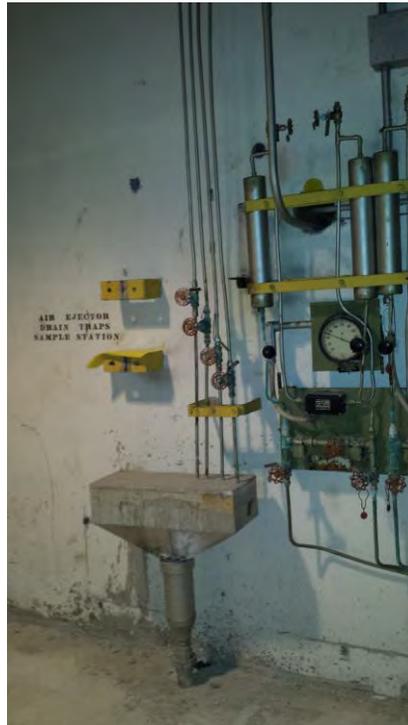
Control measures (fixed with paint and concrete layer in some places), which were previously implemented, were inspected (Appendix A, Figures 26, 28, 29, and 30). The yellow paint on the Liquid Water Retention Tanks is starting to show signs of thinning and wear, but smears indicated no removable contamination at this time. Ongoing and routine assessment of accessible surfaces in the basement is recommended to evaluate the continued effectiveness of the concrete cover flooring and control measures (e.g., paint) emplaced on previous contamination areas. Although immediate action is not critical, it is recommended that yellow paint be re-applied to the three liquid water retention tanks within the next year (Appendix A, Figure 30). Access to areas with historical removable contamination is being effectively controlled.

Figure 26. Basement Level – Concrete Filled Sink

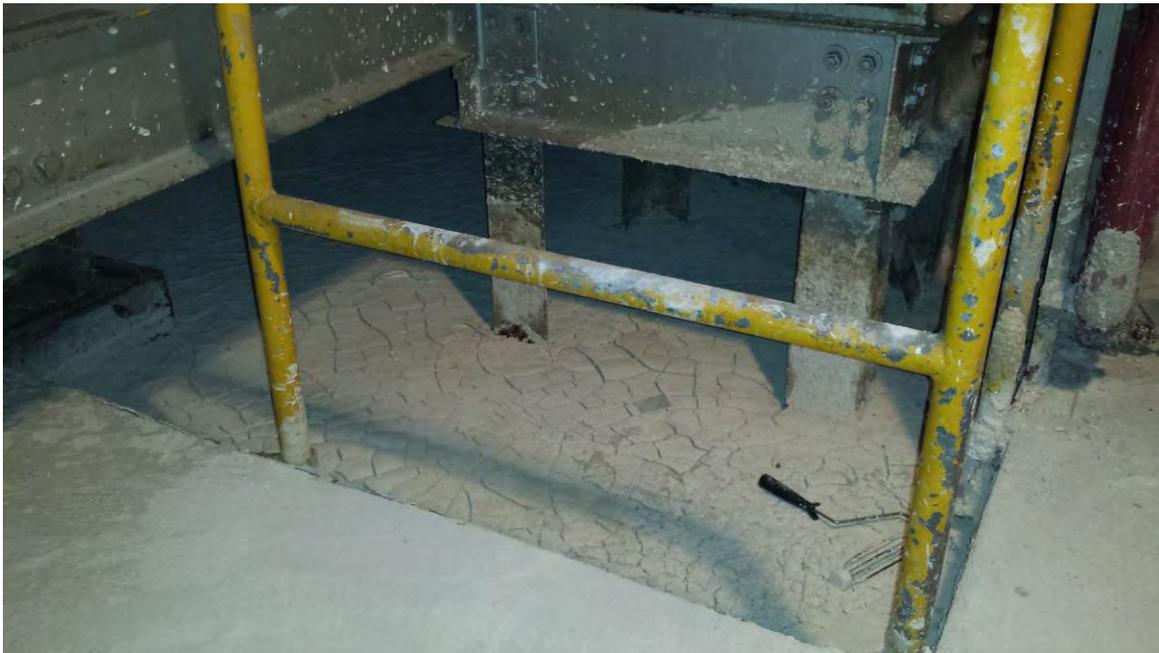
- **Dome-Basement Level Flooding:** Inspection of this level revealed no standing water on the floors. Storm water drains appear to be functioning properly, but silt/mud remains in the sump from historical events (Appendix A, Figure 27). PREPA personnel indicate that water has historically accumulated in the sump, but evaporated leaving silt/mud behind. Sampling and removal of silt/mud should be planned within the next two years (repeat from 2013, 2014, and 2015), which would increase the capacity of the sump to retain water until it evaporates.

- Storm water drains appear to be functioning properly in the Basement Level, but the sump has filled with silt/mud (Appendix A, Figure 27) from past events. Sampling and removal of silt/mud should be planned within

Figure 27. Basement Level – Lowest Point in Basement with No Standing Water

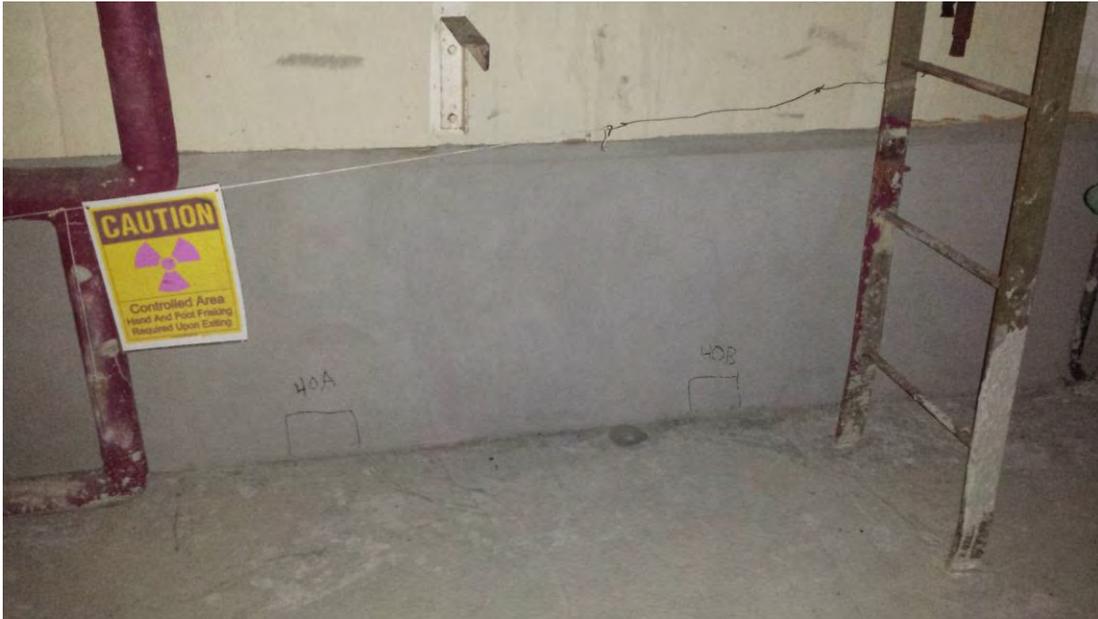
Figure 28. Basement Level – Sample Locations 40A and 40B Covered by Engineering Control (~1/2 Inch Concrete) with Caution Sign Reading “Controlled Area – Hand and Foot Frisking Required Upon Exit”

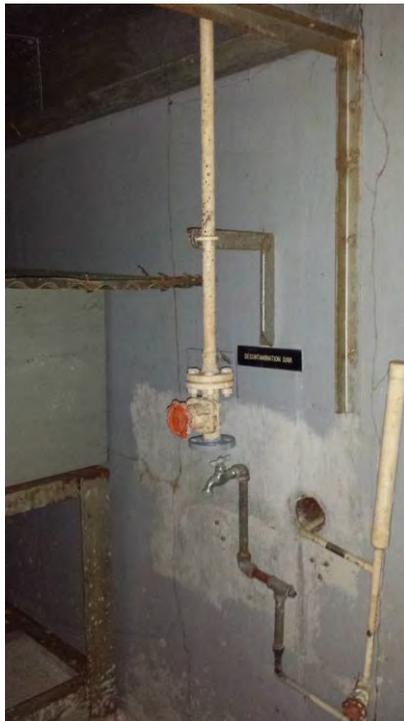
Figure 29. Basement Level – Painted Flange (Engineering Controls) at Former Decontamination Sink Location

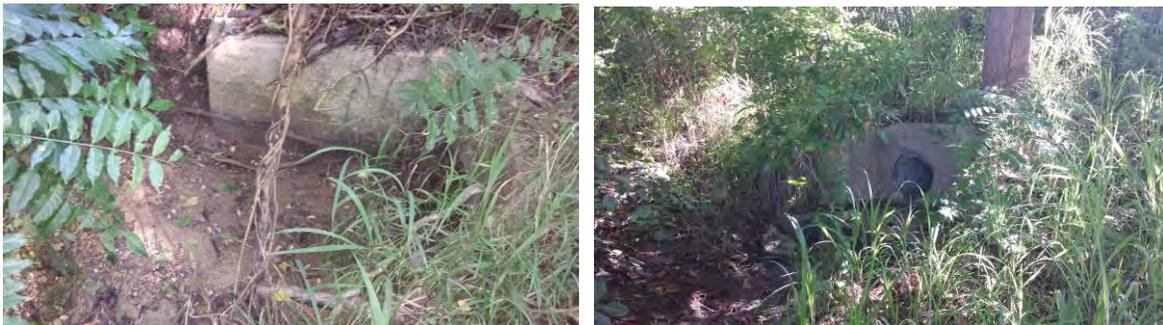
- **Dome-External Piping Systems:** Inspection of accessible external piping systems revealed no significant indications of deterioration. Outfall pipes on the west side of the property (on the beach outside of perimeter fence) and south side of the property (outside of perimeter fence) were inspected (Appendix A, Figure 34). One of the drainage pipes on the west side, where it passes under the main access road, is partially obstructed with silt and debris (Appendix A, Figure 35). It is recommended that the accumulated silt and debris be removed.

Figure 34. Dome Structure – Drainage Outfall Points and Ditches (Western Outfall on Left and Southern Outfall on Right)

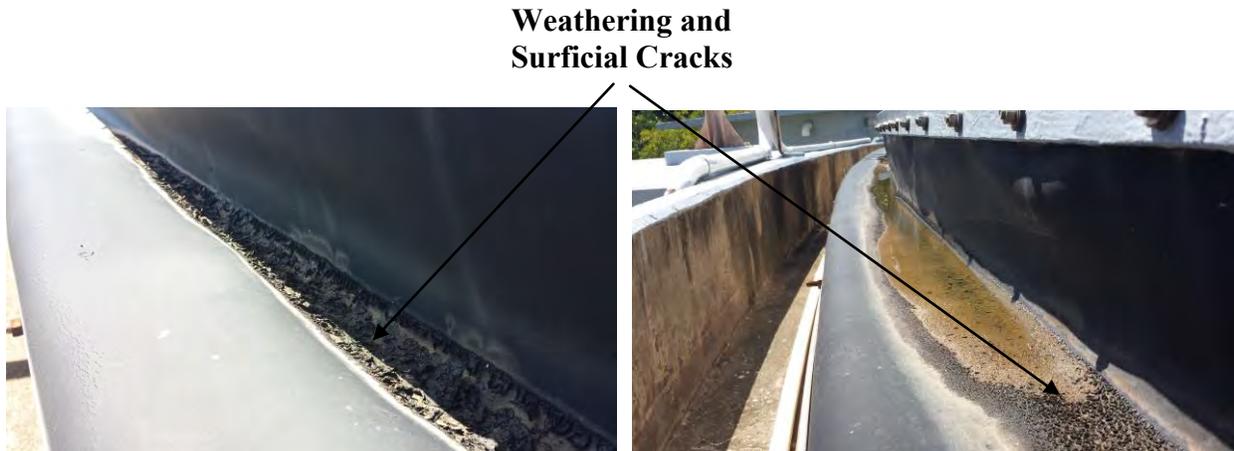
The gasket around the exterior base of the Dome, which is at ceiling level of the basement, remains intact and effective (Appendix A, Figure 25). The gasket is showing signs of weathering and surficial cracks in the low areas of the gasket where it holds rain water and dries in the sun (Appendix A, Figure 37). The drains in the trough below the gasket are clear and draining rain water properly (Appendix A, Figure 38). The large bay door at the Basement Level remains sealed with expanding foam to prevent rainwater infiltration into the Basement Level. It is recommended that, when the gasket around the base of the Dome is replaced, the gasket is installed in a manner that does not retain rain water.

Figure 37. Dome Structure – Flexible Gasket/Seal – Dome Perimeter

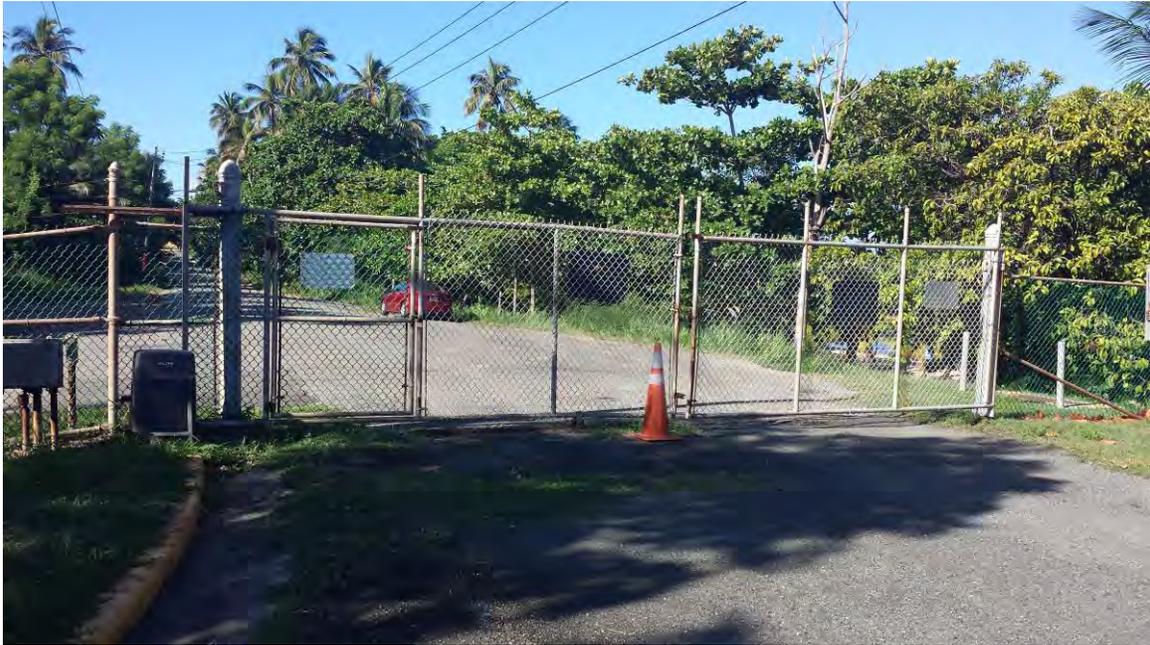
- **Site Surveillance Features:** Asphalt of the access road and parking area remains in fair and usable condition. There is some broken asphalt, but it is still functional. The entrance gate's motor is not operational; however it is manually operated by the attending guard (Appendix A, Figure 39). The security guard controlled access into the gated facility and kept a sign-in log of visitors. The fence surrounding the property is mostly functional at controlling access. However, it has been patched in many places as a temporary fix; there are also areas with gaps under the fence; and vegetation is crowding the fence in some areas (Appendix A, Figure 36). Recommend instructing the maintenance contractor to cut vegetation away from fencing to maintain a clear path around the perimeter of the property. One section of fence near the front gate is in need of repair (Appendix A, Figure 36). The Dome monolith plaques are in good condition – no change.

Figure 39. Security – Main Gate in Good Working Condition (Manual Open/Close)
