3.0 Canonsburg, Pennsylvania, Disposal Site

Figure 3-1. 2016 Annual Inspection Drawing for the Canonsburg Disposal Site

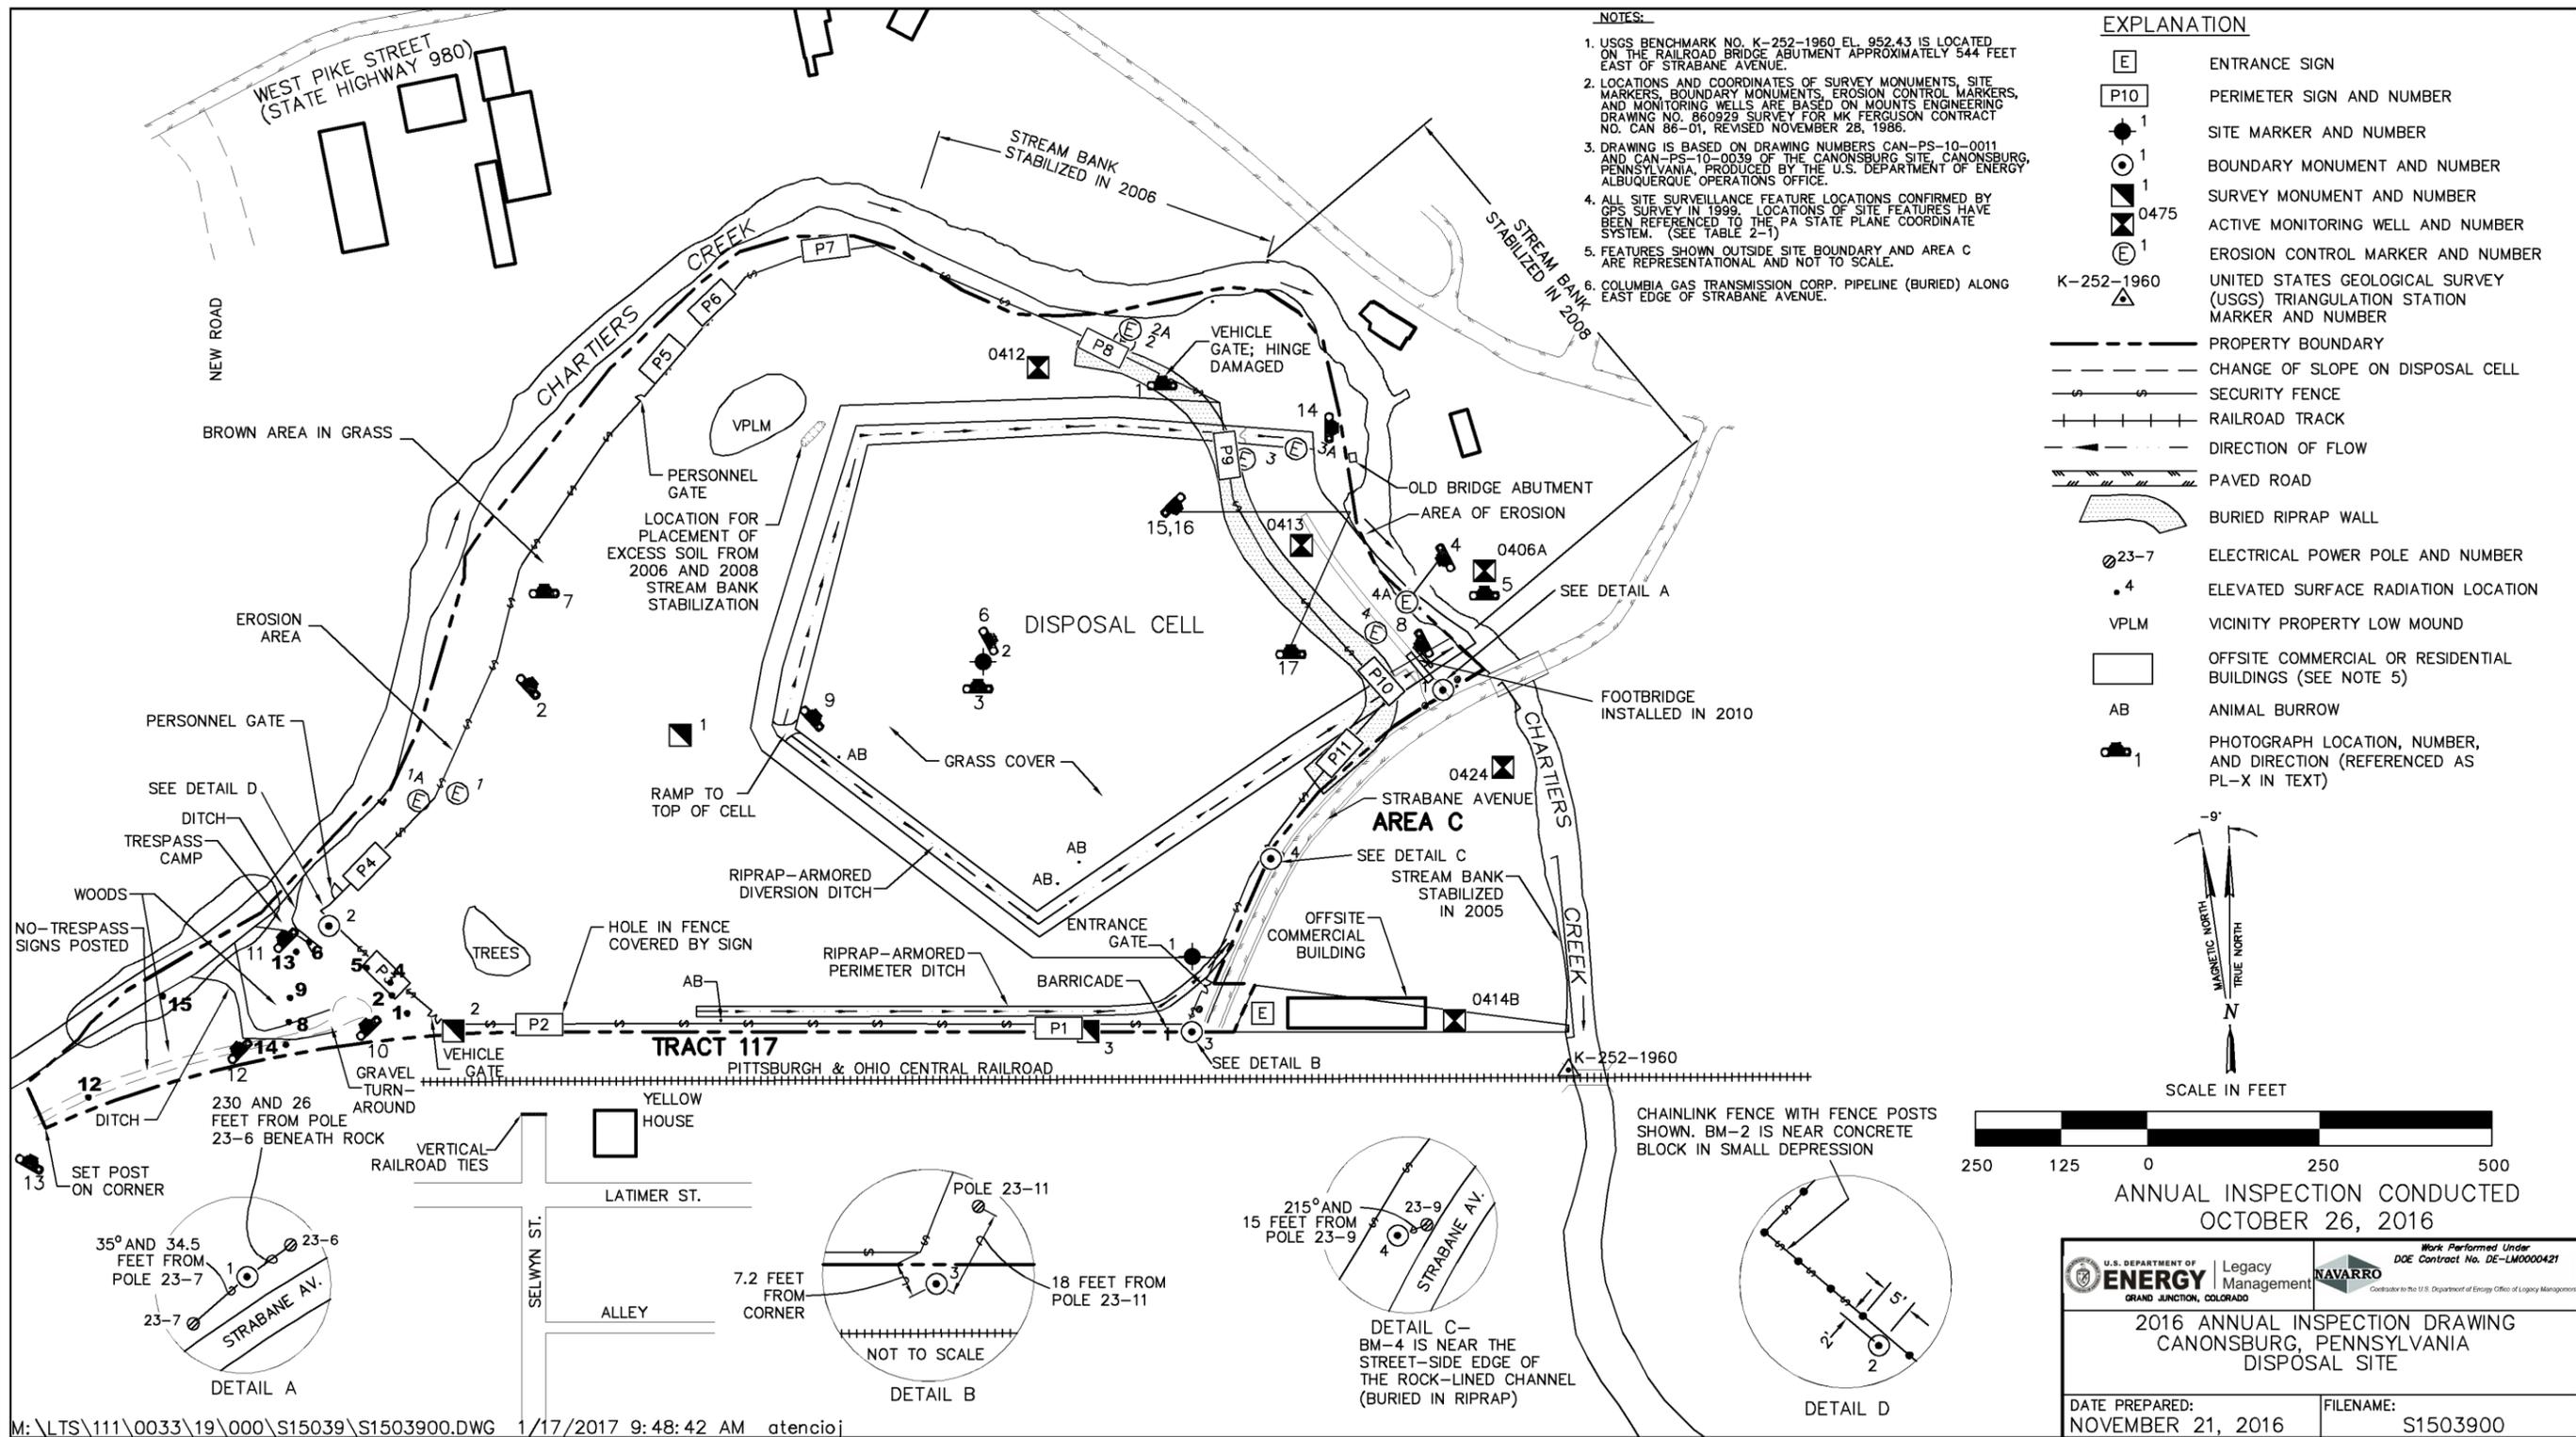
Most of the site is enclosed by a 7-foot-high chainlink fence, which replaced the previous fence in 2007 (PL-2). A vegetation-free buffer zone is being maintained around the entire site security fence. An area of erosion under the west security fence remains (see Figure 3-1). The area appears to be stable and has not grown in several years. For added security, slats were installed across the area beneath the fence to help fill in the gap. There are 11 perimeter signs attached to the security fence. No maintenance needs were identified.

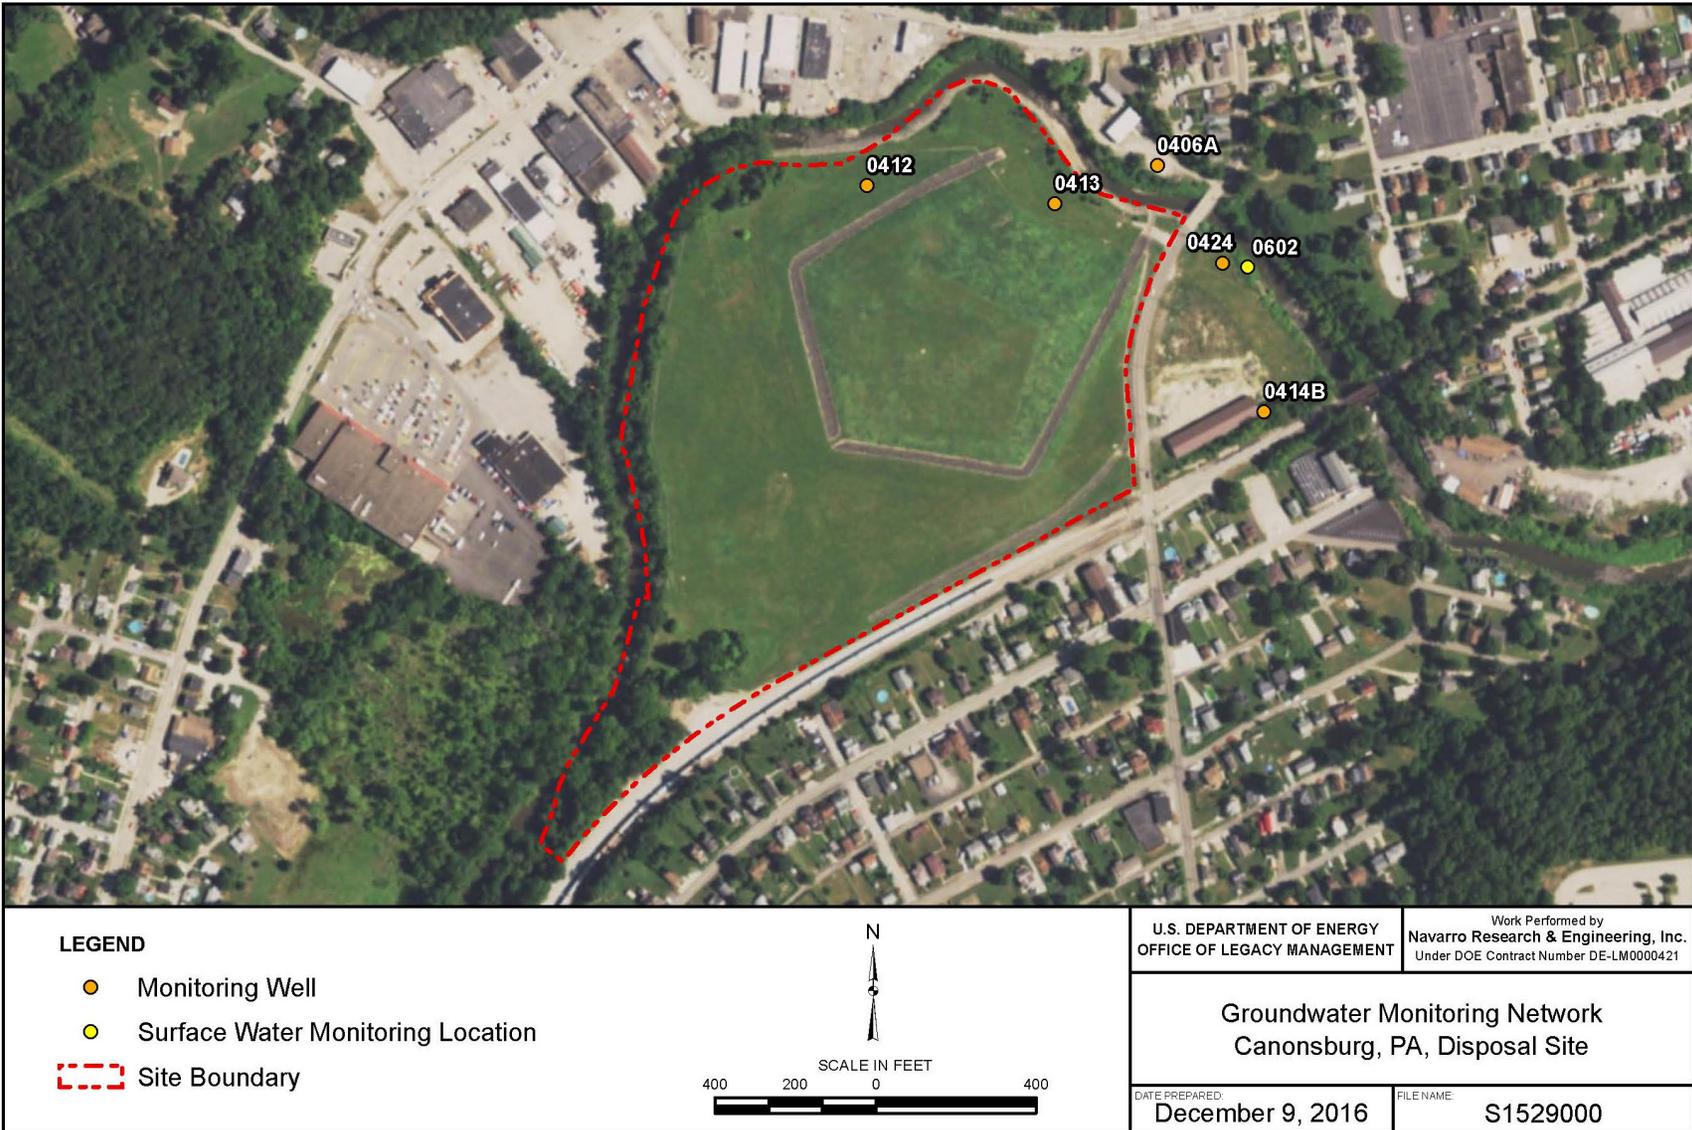
Figure 3-2. Groundwater Monitoring Network for the Canonsburg Disposal Site

As reported in the 2014 inspection report, groundwater uranium concentrations in 2013 were considerably below the established alternate concentration limit. With the exception of monitoring wells 0412 and 0413, uranium concentrations in 2013 were also below the maximum concentration limit. Only one surface water location (0602) is sampled under the revised LTSP.
