3.0 Canonsburg, Pennsylvania, Disposal Site

The Canonsburg, Pennsylvania, Uranium Mill Tailings Radiation Control Act (UMTRCA) Title I Disposal Site (site) was inspected on October 12, 2017. No changes were observed on the disposal cell or in the associated drainage features. Inspectors identified several routine maintenance needs. A follow-up inspection was conducted in May 2017 in response to stream bank erosion identified the 2016 annual inspection. Repairs to the riprap armoring of the stream bank were made in September 2017. Another follow-up inspection will be completed by engineering staff in spring 2018 to evaluate additional erosion along the stream bank identified during the 2017 annual inspection.

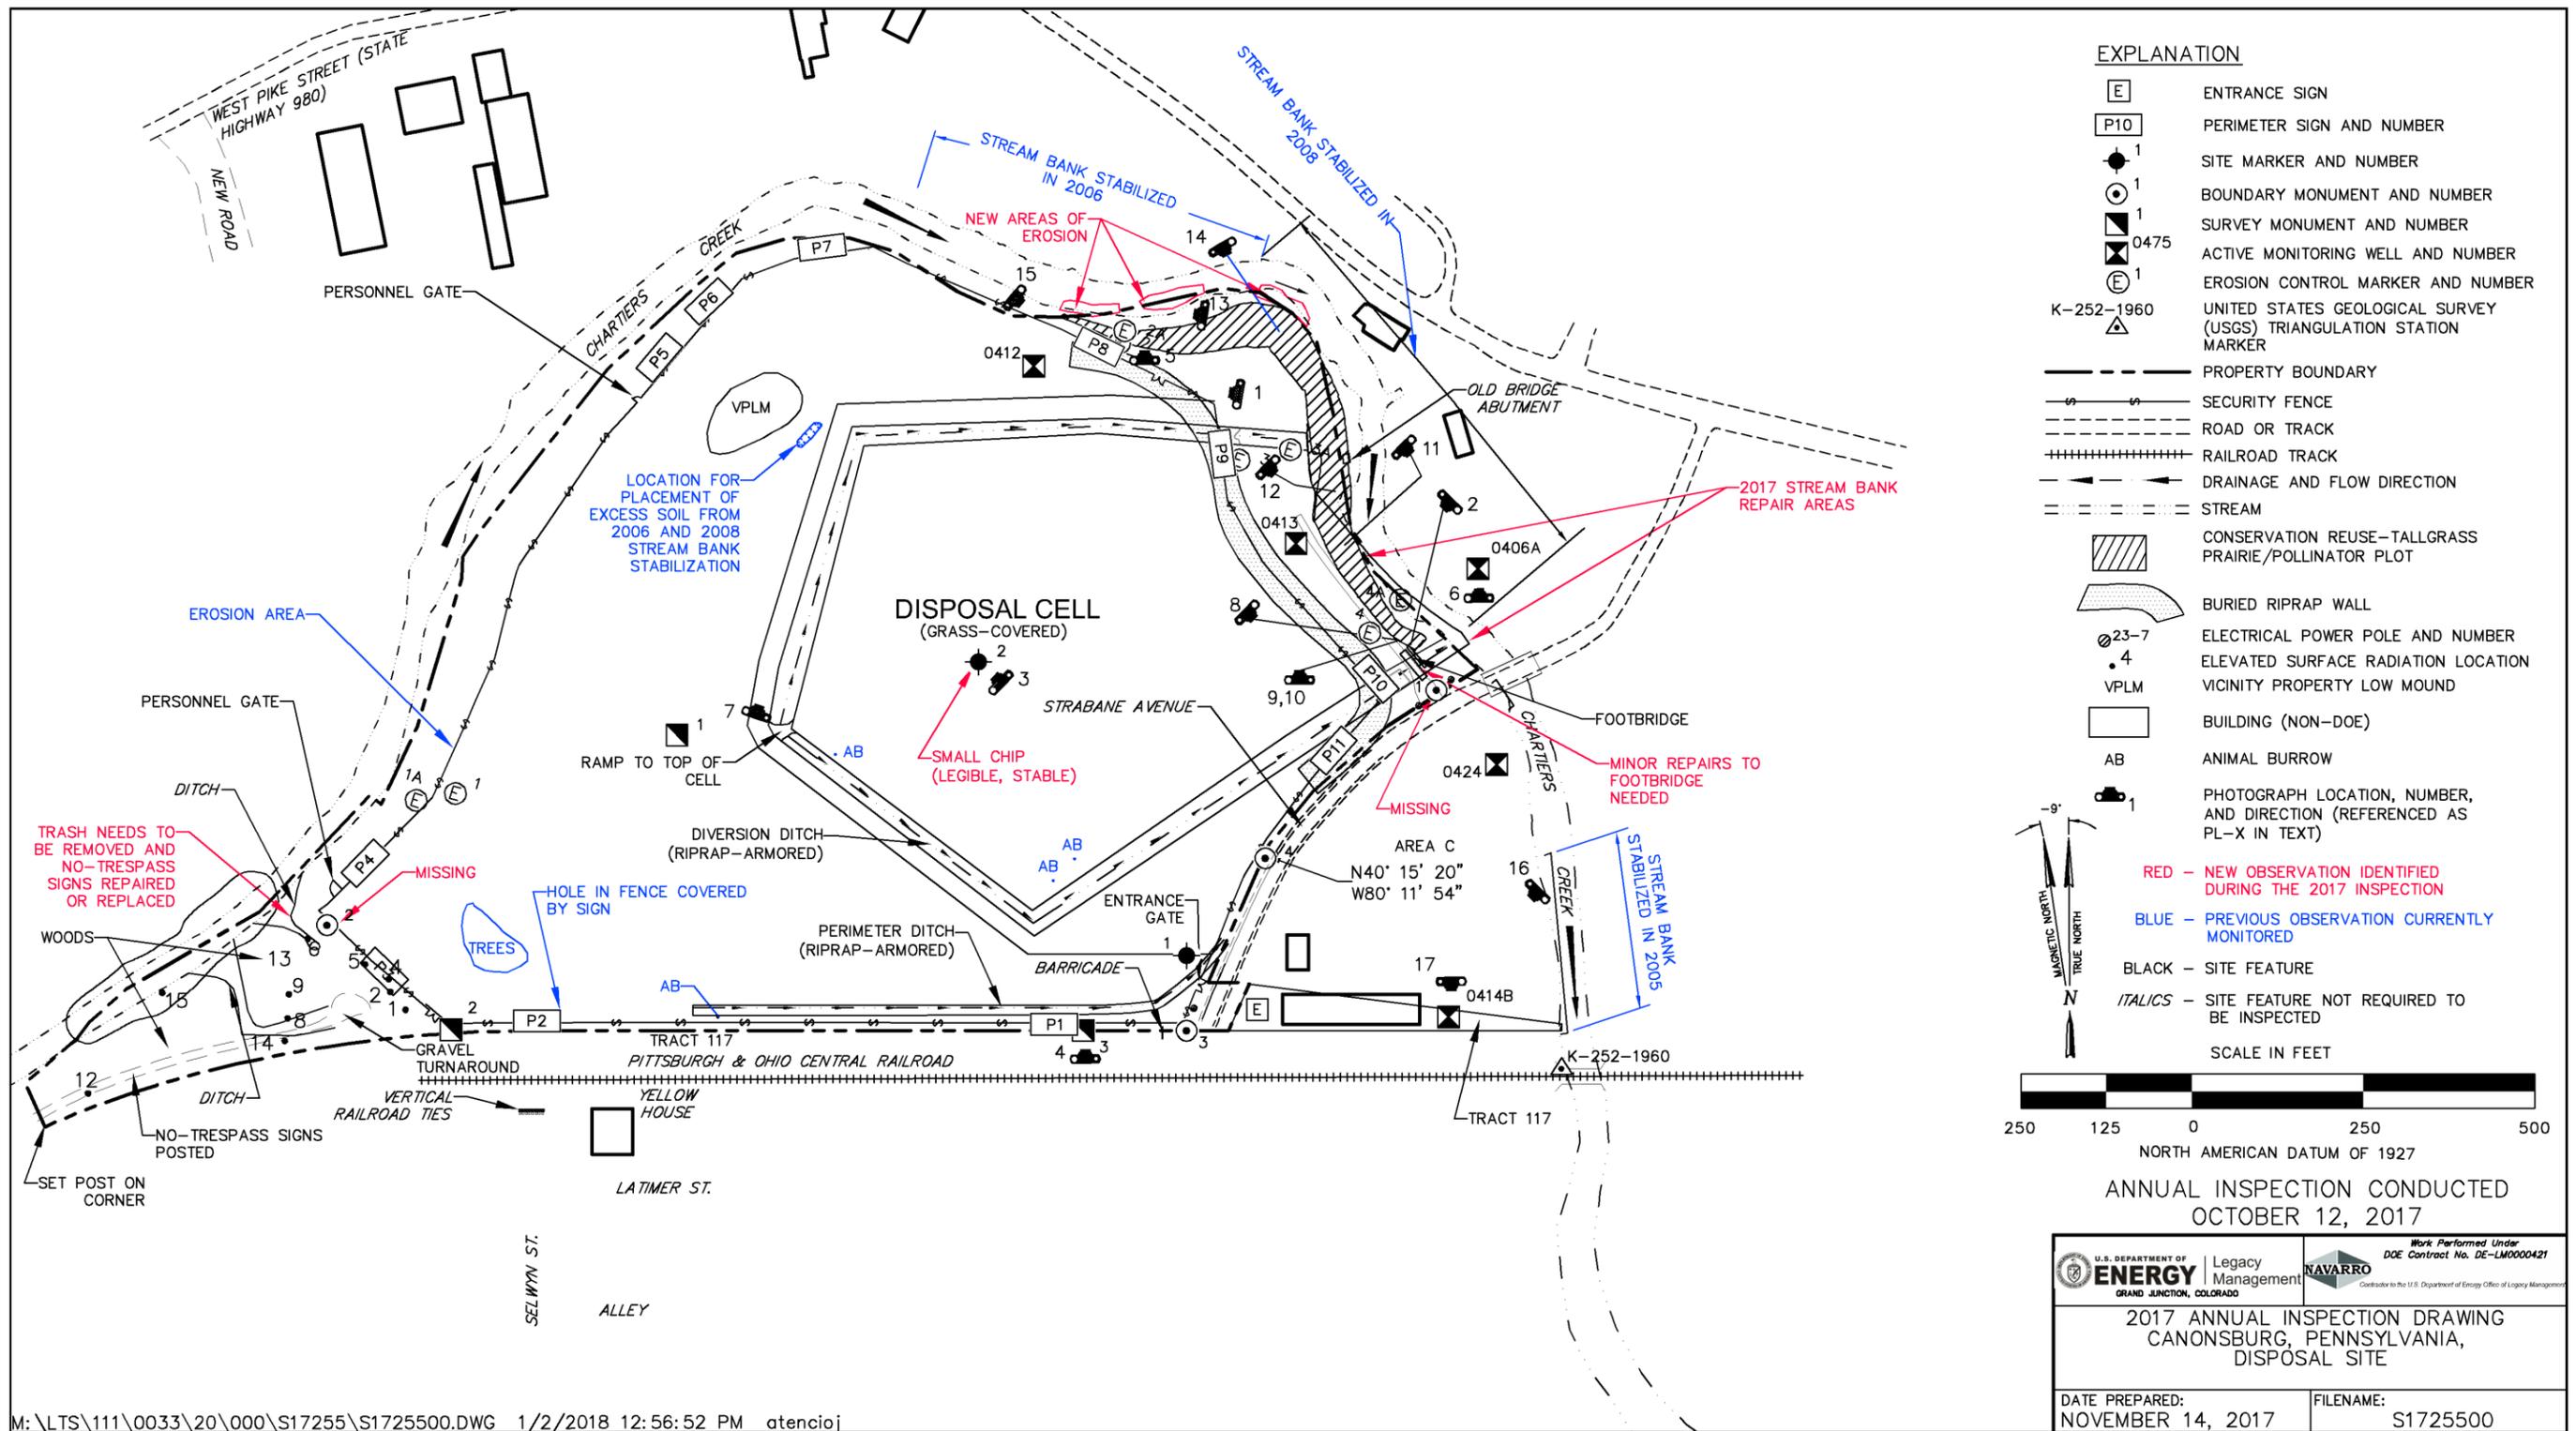
Figure 3-1. 2017 Annual Inspection Drawing for the Canonsburg, Pennsylvania, Disposal Site

Figure 3-1 shows in black the locations of site features, including site surveillance features and inspection areas. Site features that are present but not required to be inspected are shown in italic font. Observations from previous inspections that are currently monitored are shown in blue text, and new observations identified during the 2017 annual inspection are shown in red. Inspection results and recommended maintenance activities associated with site surveillance features are included in the following subsections. Photographs to support specific observations are identified in the text and in Figure 3-1 by photograph location (PL) numbers. The photographs and photograph log are presented in Section 3.10.

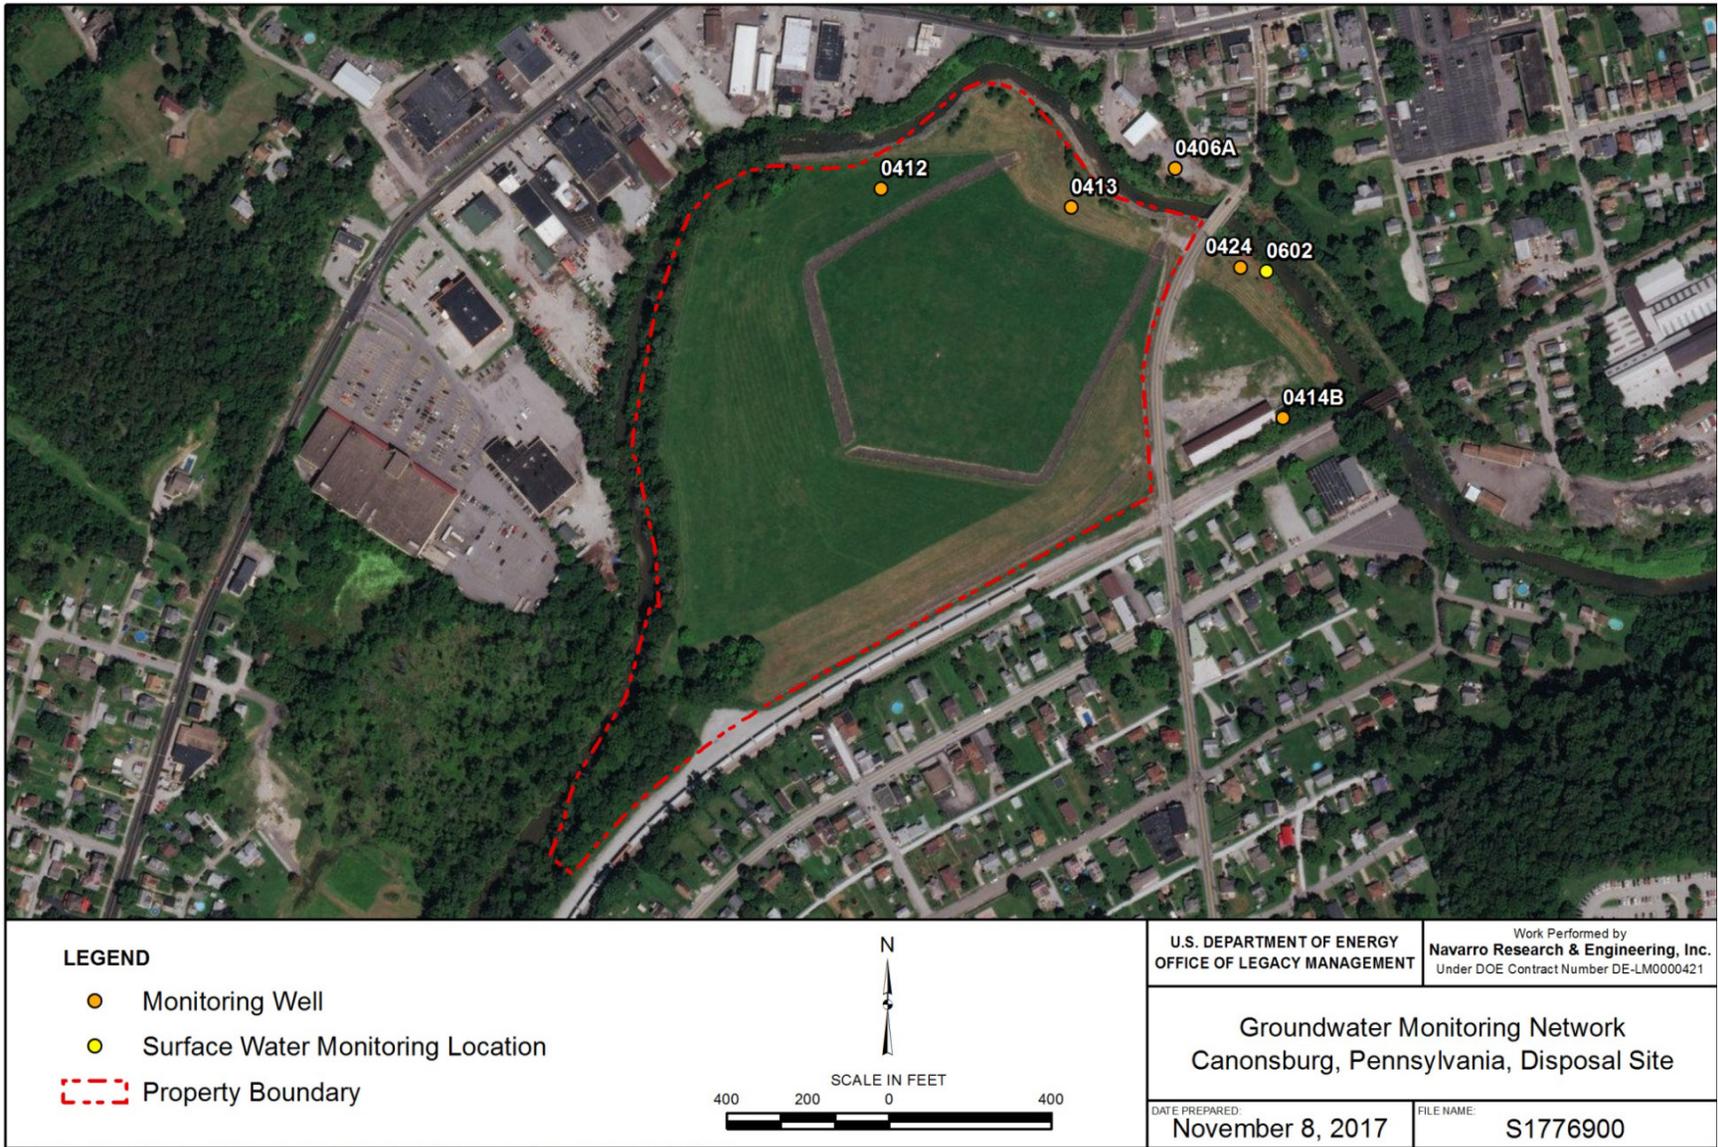
Figure 3-2. Groundwater Monitoring Network for the Canonsburg, Pennsylvania, Disposal Site

In accordance with the LTSP, DOE conducts groundwater monitoring every 5 years to evaluate disposal cell performance. The most recent sampling event occurred in November 2013. The groundwater monitoring network consists of five monitoring wells, including three point of compliance (POC) wells and two best management practice wells (Table 3-2 and Figure 3-2). All monitoring wells are completed in the uppermost aquifer (shallow unconsolidated materials). Groundwater is sampled for the constituent of concern, uranium. The site-specific alternate concentration limit (ACL) is 1.0 milligrams per liter (mg/L) at the POC wells.

As reported in the 2014 *Annual Site Inspection and Monitoring Report for Uranium Mill Tailings Radiation Control Act Title I Disposal Sites* (DOE 2014), monitoring results remain below the uranium ACL at all monitoring wells and below the maximum concentration limit at most monitoring wells, with the exception of monitoring wells 0412 and 0413.

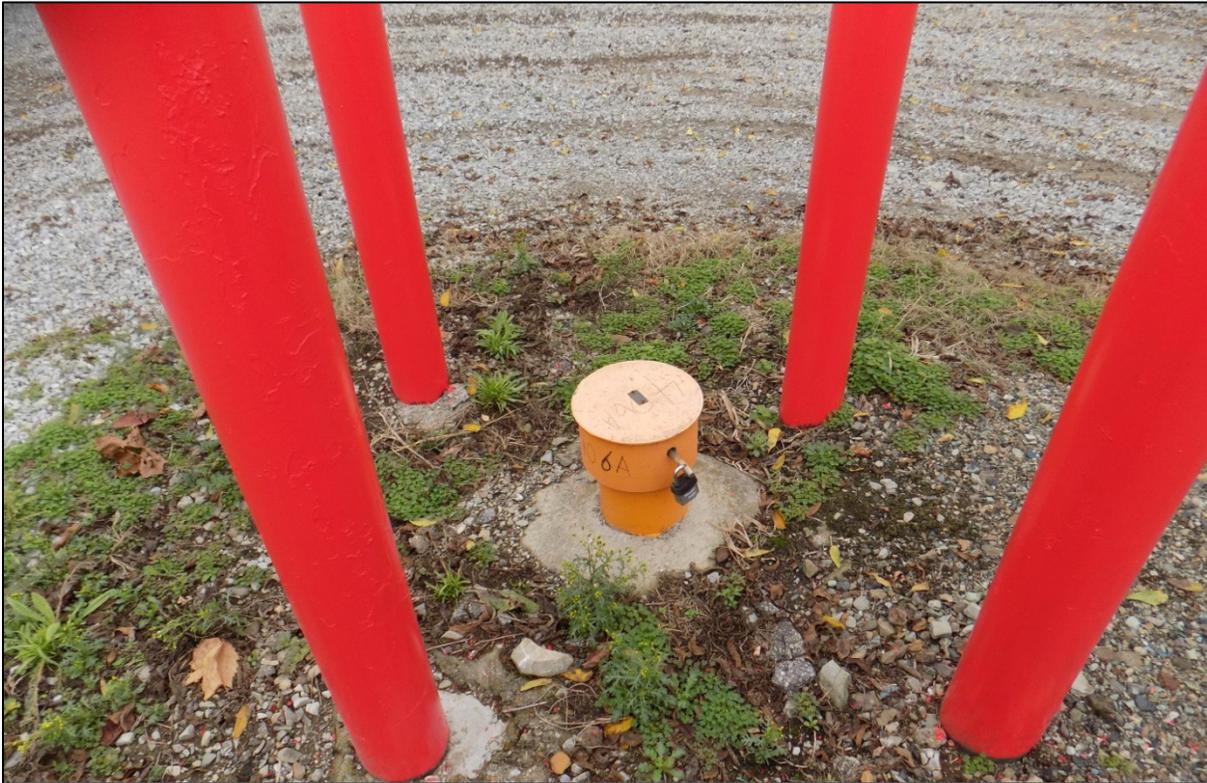
PL-6. Monitoring Well 0406A

The site has five groundwater monitoring wells, which are inspected when the monitoring wells are sampled (PL-6). All wellhead protectors that were observed during the inspection were undamaged and locked. No maintenance needs were identified.

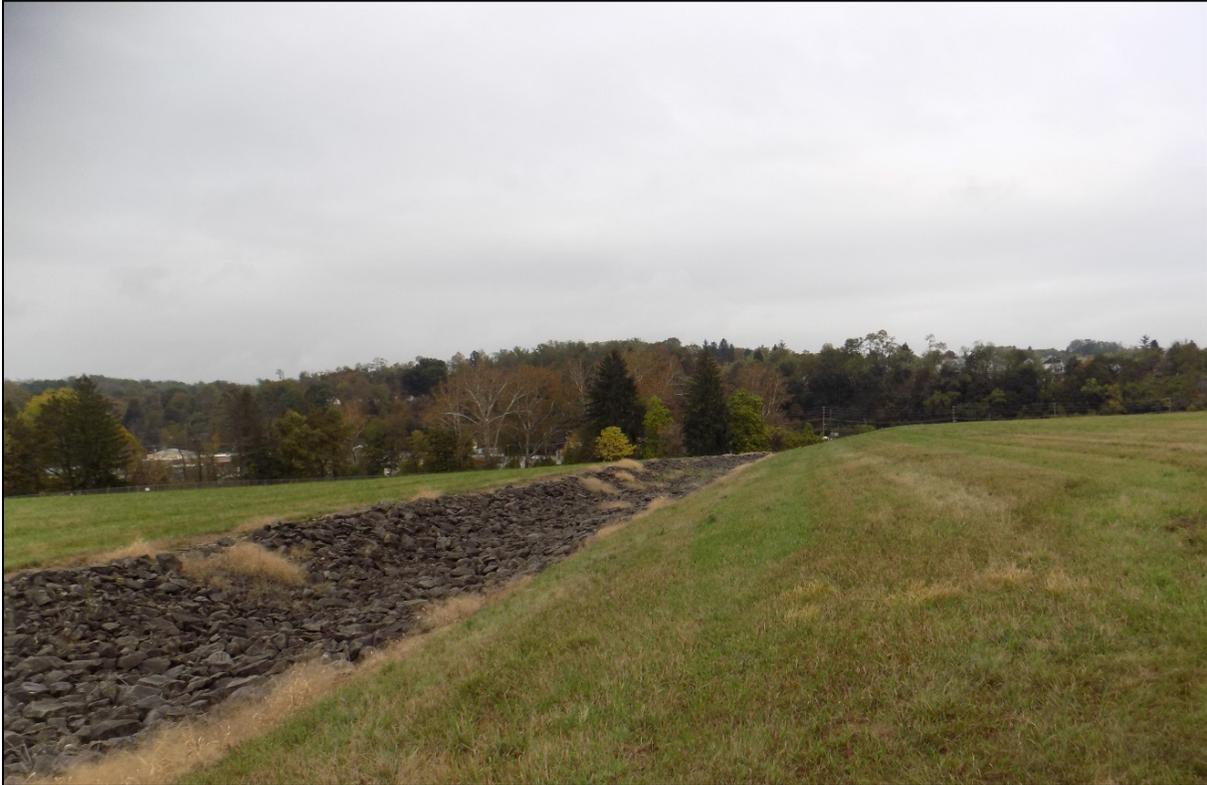
PL-7. Riprap-Armored Diversion Ditch

There was no evidence of rock deterioration or woody vegetation in the diversion channels and perimeter ditches. Periodic physical removal and spot herbicide applications have been effective at reducing woody vegetation and will continue to be conducted as needed. No maintenance needs were identified.
