3.0 Canonsburg, Pennsylvania, Disposal Site

3.1 Compliance Summary

The Canonsburg, Pennsylvania, Uranium Mill Tailings Radiation Control Act (UMTRCA) Title I Disposal Site (site) was inspected on October 23, 2019. No changes were observed on the disposal cell or in the associated drainage features. Inspectors identified several minor maintenance needs.

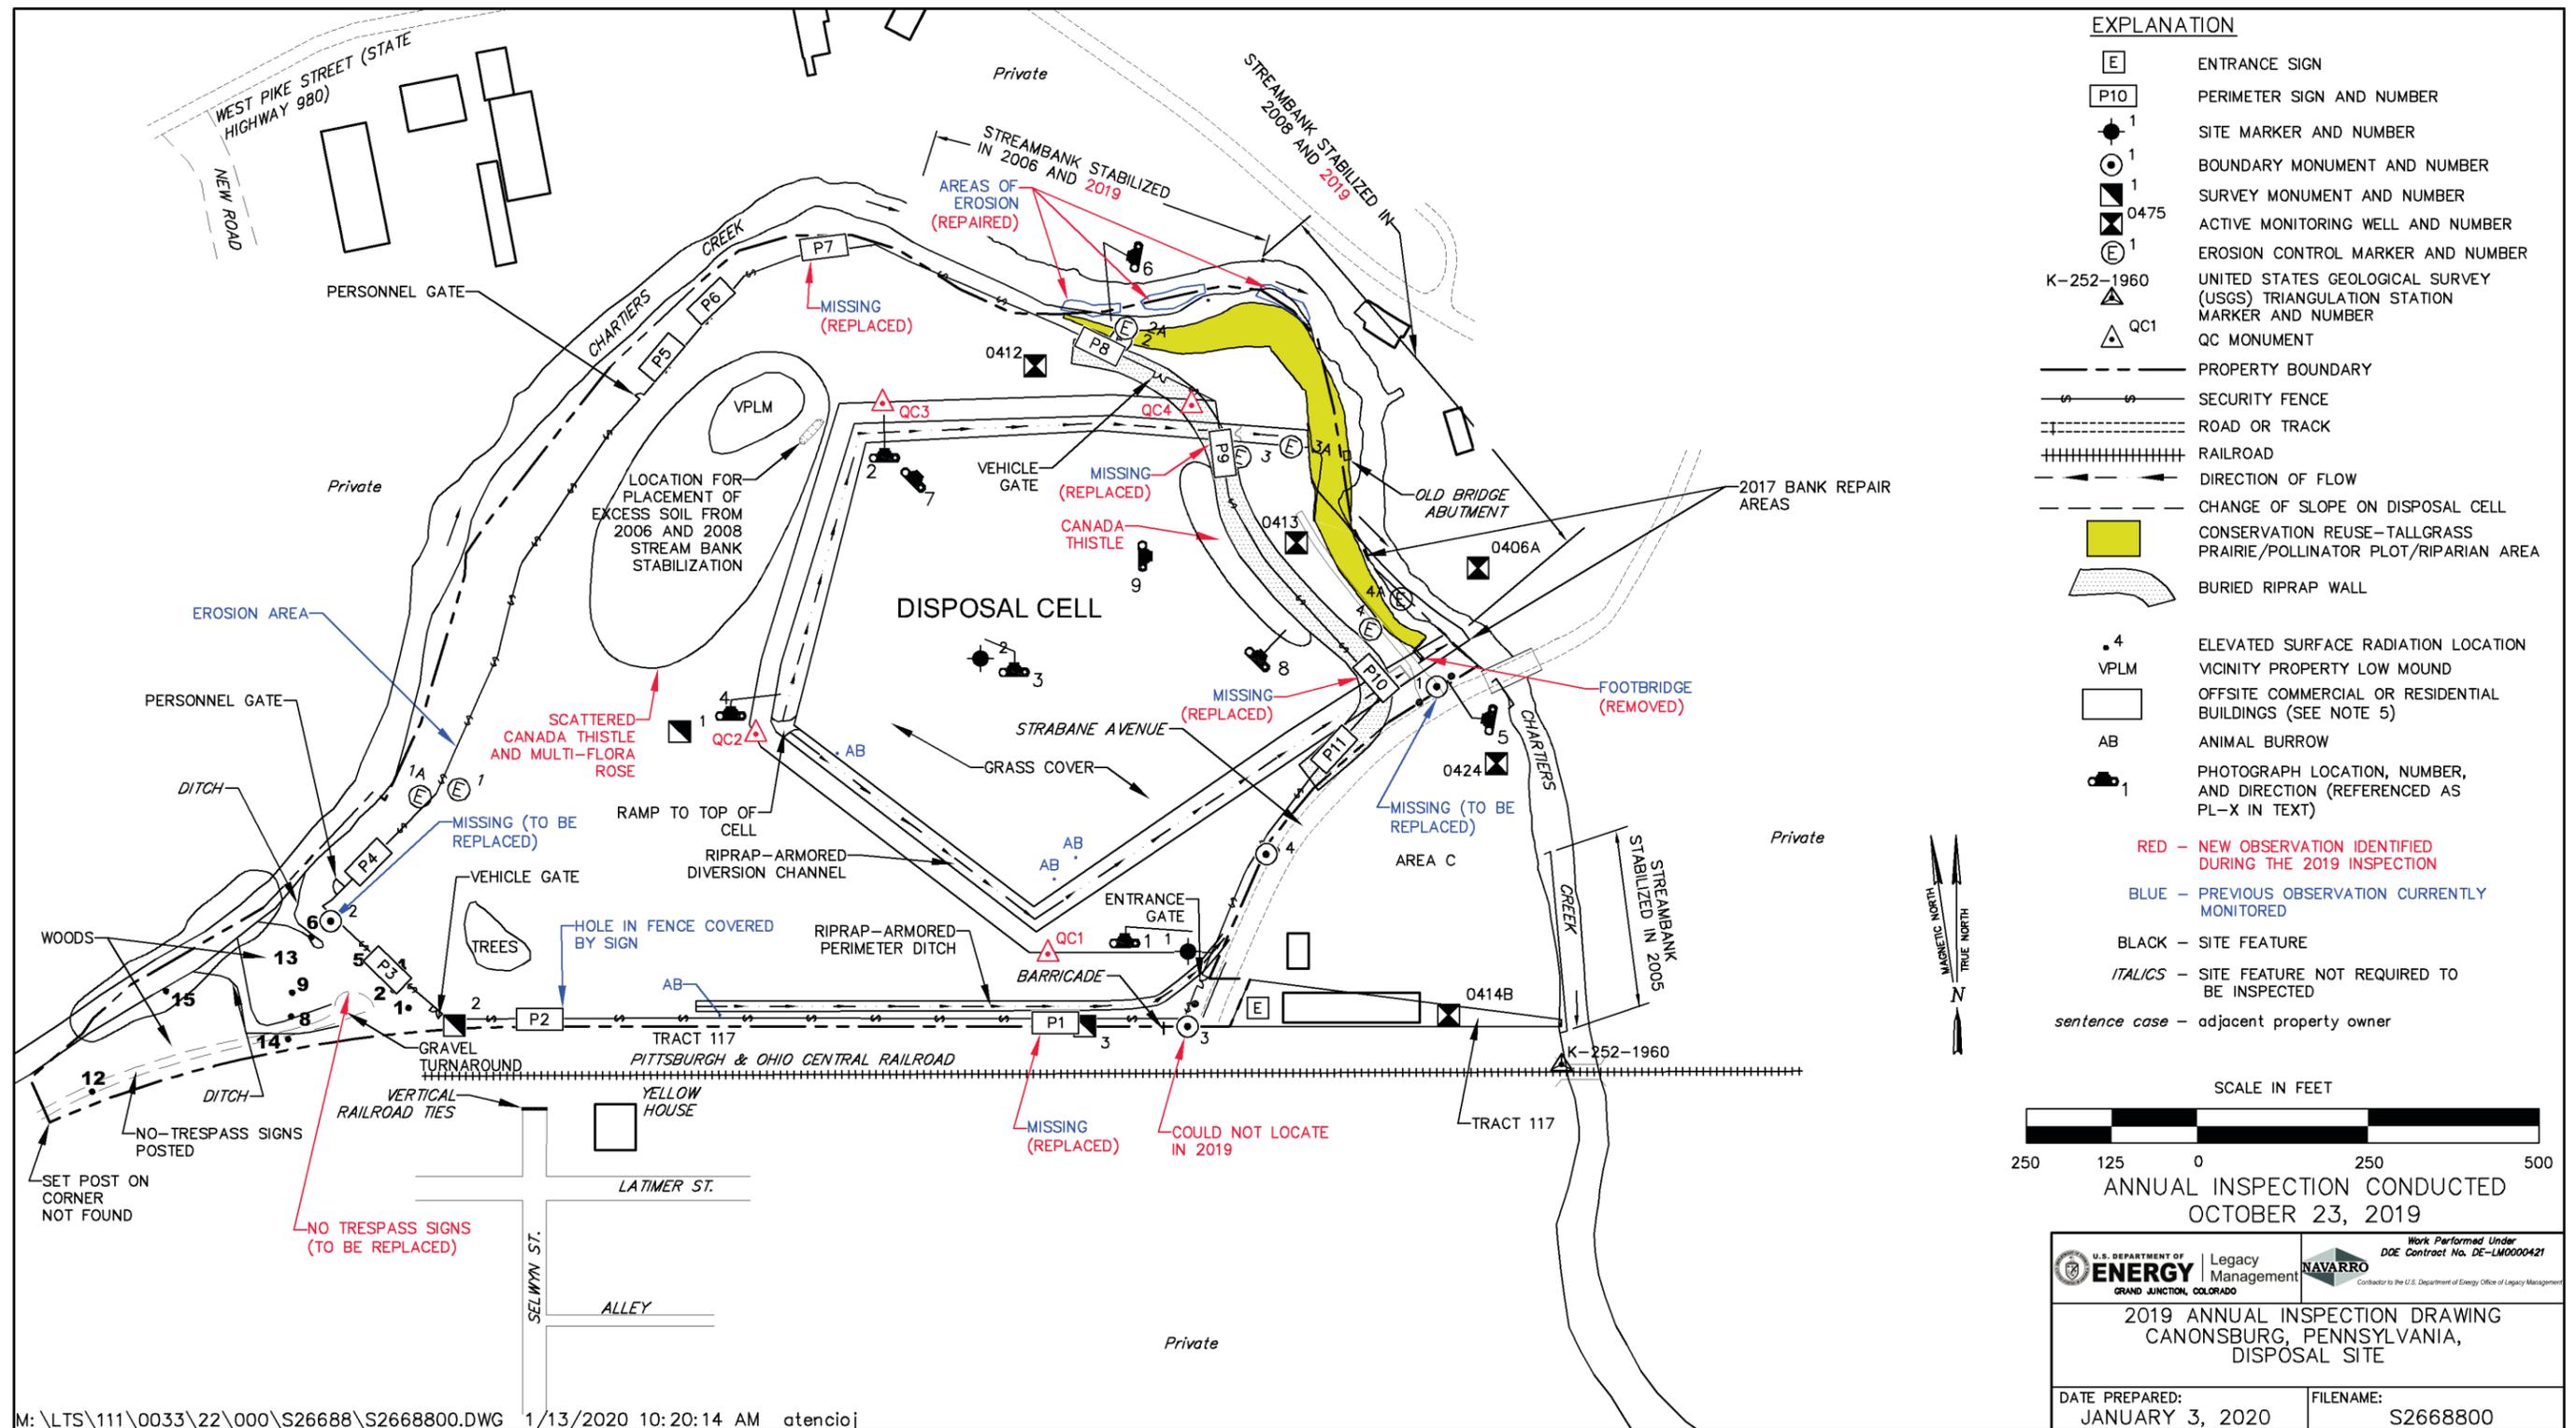
Figure 3-1. 2019 Annual Inspection Drawing for the Canonsburg, Pennsylvania, Disposal Site

Figure 3-1 shows the locations of site features in black, including site surveillance features and inspection areas. Site features that are present but not required to be inspected are shown in italic font. Observations from previous inspections that are currently monitored are shown in blue text, and new observations identified during the 2019 annual inspection are shown in red. Inspection results and recommended maintenance activities associated with site surveillance features are included in the following subsections. Photographs to support specific observations are identified in the text and in Figure 3-1 by photograph location (PL) numbers. The photographs and photograph log are presented in Section 3.10.

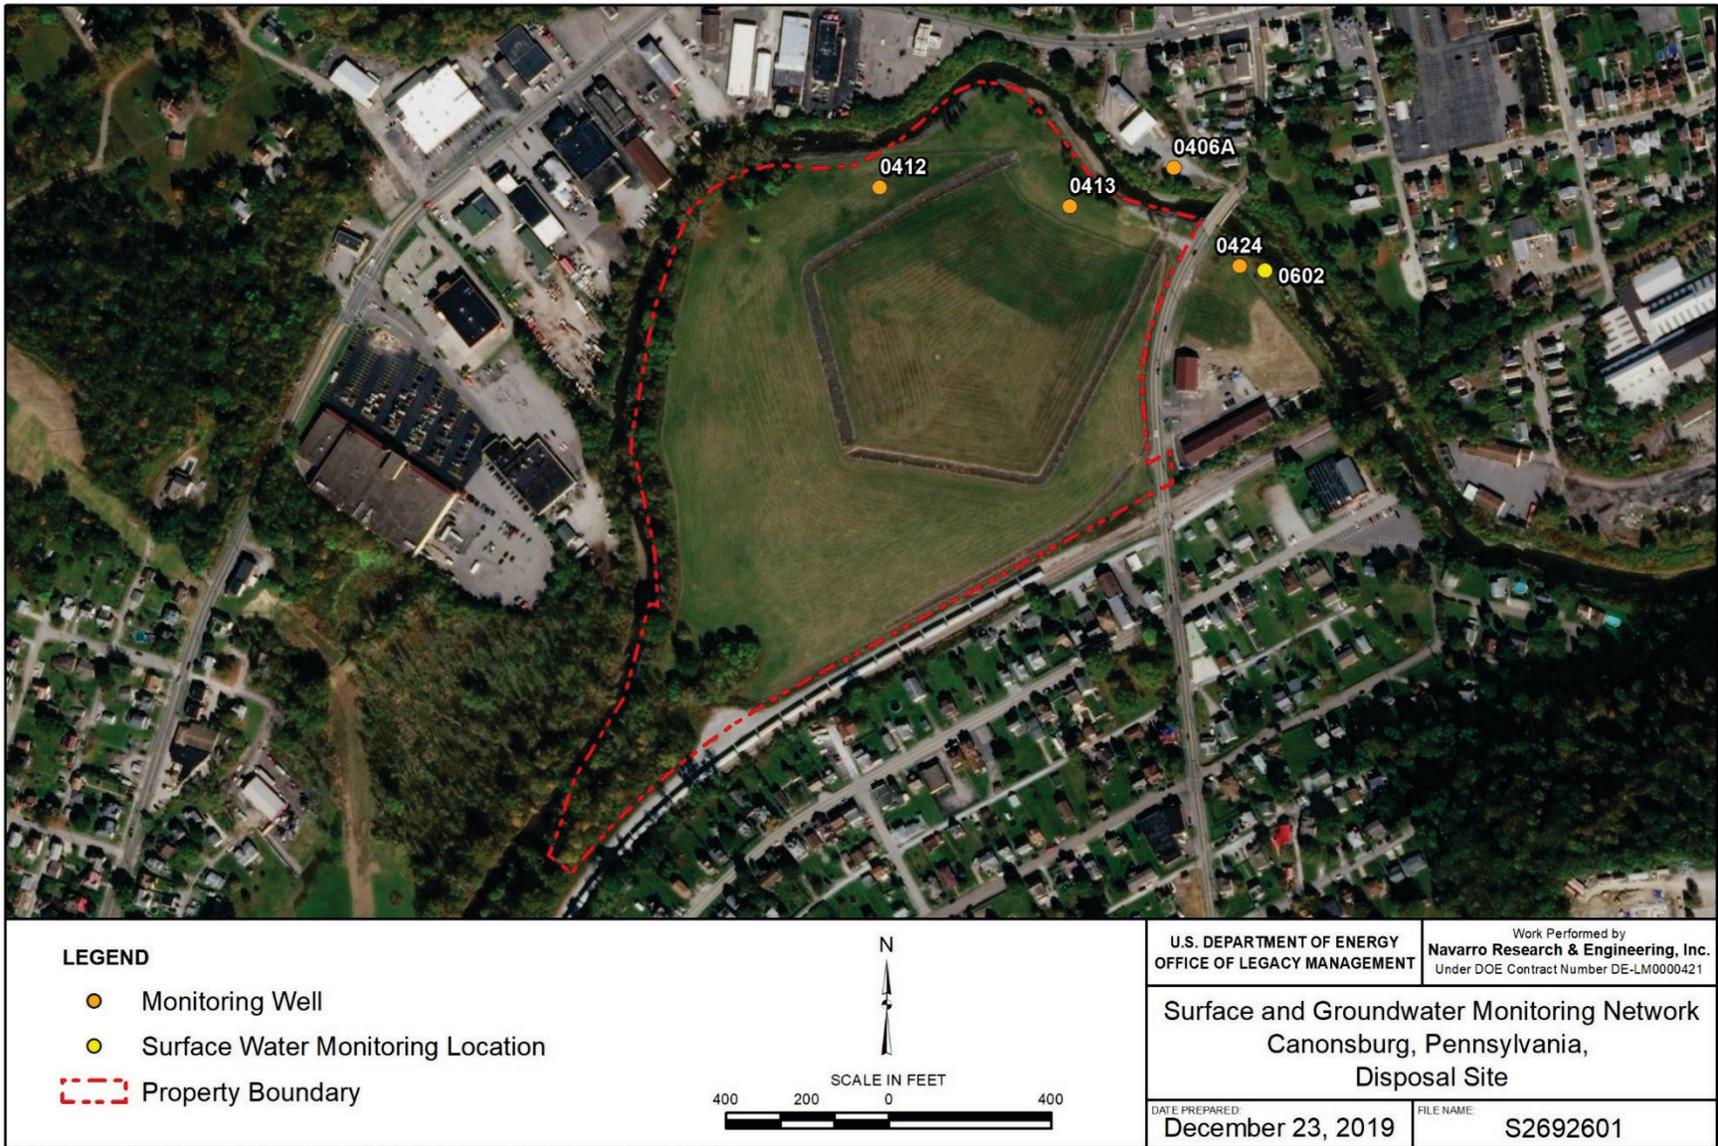
Figure 3-2. Groundwater Monitoring Network for the Canonsburg, Pennsylvania, Disposal Site

The groundwater monitoring network consists of five monitoring wells, including three POC wells and two best management practice wells (Table 3-2 and Figure 3-2). All monitoring wells are completed in the uppermost aquifer (shallow, unconsolidated materials). Groundwater is sampled and analyzed for the one constituent of concern, uranium. The ACL is 1.0 milligram per liter (mg/L) at the POC wells. With the exception of monitoring wells 0412 and 0413,
