LMS/CIS/S31187

**2020 Annual Inspection
Colonie, New York, Site
July 13–17, 2020**

December 2020

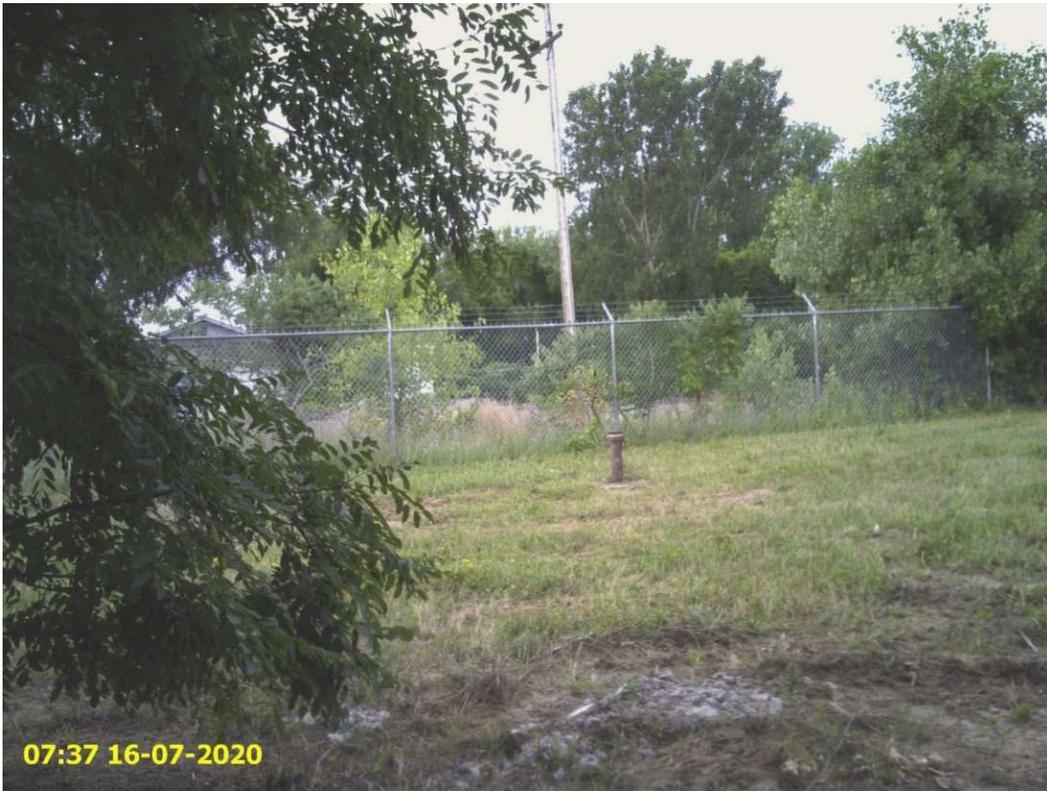
- A succession in tree types appears to be occurring in the center of the site where black locusts are displacing quaking aspens (Figure 10). Quaking aspens are efficient consumers of aqueous-phase solvent contamination in water table aquifers, but black locusts are not as well studied. Black locusts are considered an invasive species in New York (Waugh 2020).

Figure 10. Looking South at Black Locust Tree and Monitoring Well MW-42S

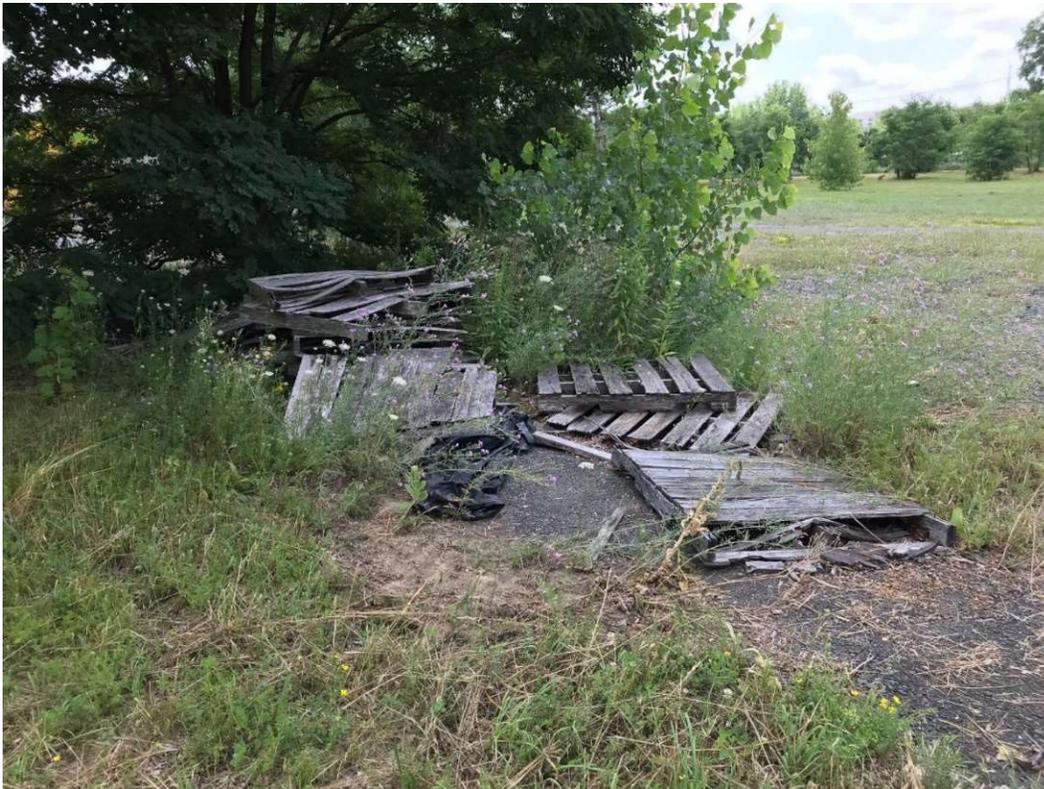
- Debris remains from previous site work; it includes old pallets, used bollards, and tree branches from grubbing work (Figure 13).

Figure 13. Discarded Pallets Behind Shed

- Approximately 0.3 acre of shrubs and trees has grown in from the fence line on the western side of the site. This dense vegetation makes it difficult to inspect the fence and places the fence at risk of damage from falling trees and ingrowth. This vegetation should be grubbed back to the fence line and chipped onsite.
- Black locusts (and honey locusts) have an extensive root system that allows them to reproduce clonally. Cutting or mowing are ineffective for management and would require systematic herbicides to control (NYSDEC 2020) but which would also inhibit growth of the quaking aspens. There are studies that support the use of black locusts for phytoremediation (Longley 2007).
- Although the site is generally free of trash, personnel should bring a trash bag during site visits to pick up stray discarded or windblown trash for proactive housekeeping.

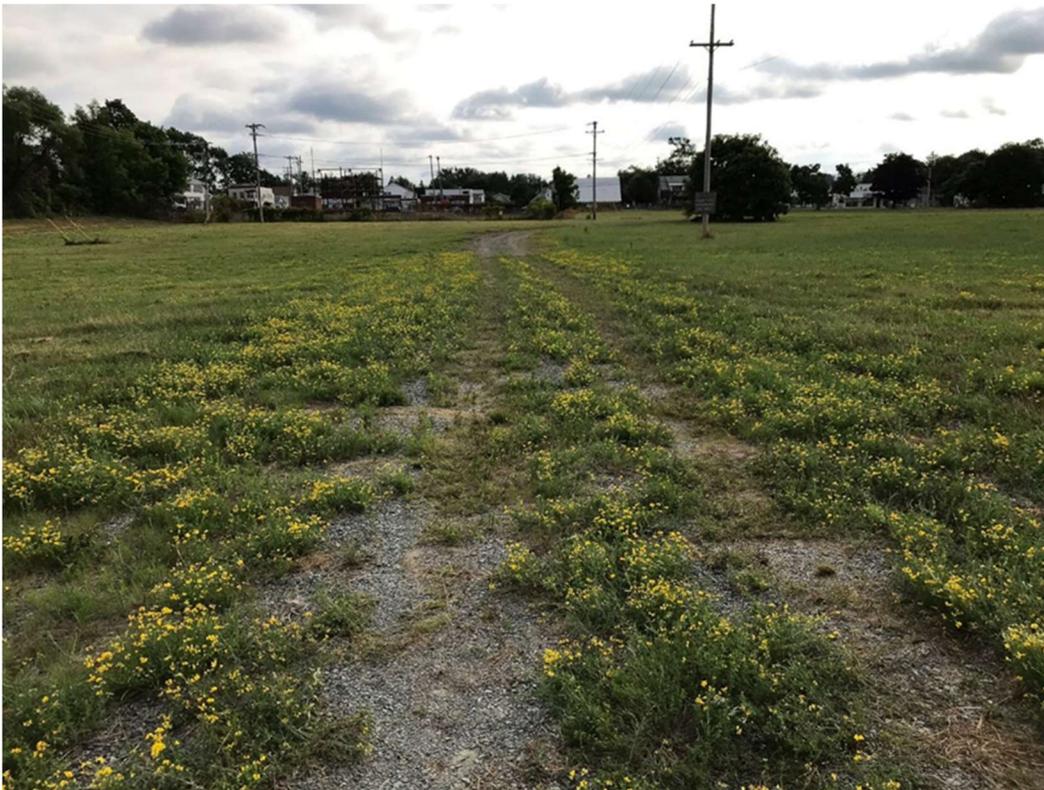
- The road was inspected to identify structural defects. No damage to the road was identified, which allowed personnel to drive the road along its entire distance. The ground was dry, and the area experienced a drought during the summer (Figure 14).
- The parking area was cleared and usable. A few discarded food or drink containers were present as has been observed during previous visits.

Figure 14. Looking North Along Road from Center of Site

Recommendations: Driving off the road on the site is not recommended unless a 4-wheel drive vehicle is used, especially during wet conditions. The grass cover is thin, and the soil type is silty sand.

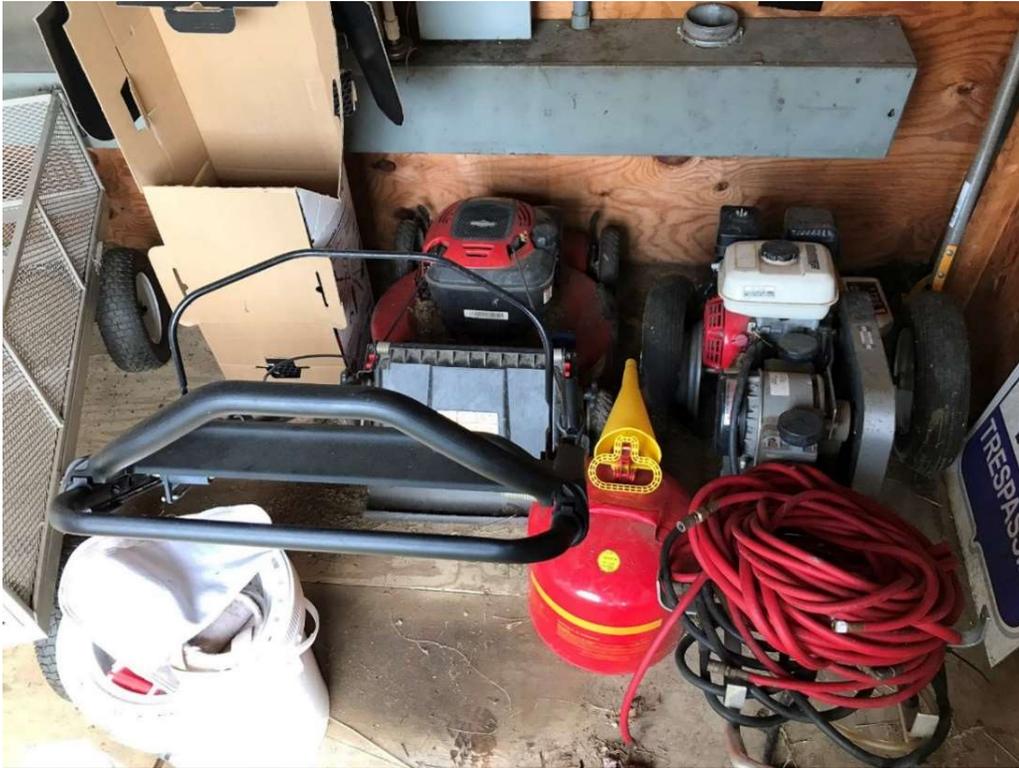
- Additional personal property assets were identified that had not been recognized as government property during the site transfer inspection in October 2019 (DOE 2019a). They are a lawn mower, a gasoline-powered air compressor, two gasoline-powered line trimmers, and a garden cart (Figure 22 and Figure 23).

- The air compressor bears a U.S. government property tag number 019806. USACE was contacted about whether this personal property was intended to transfer with the site. USACE confirmed that the personal property does convey (Moore 2020). Since the equipment is below the cost threshold of \$10,000, it will not be tagged or tracked by DOE according to Title 41 *Code of Federal Regulations* Section 109 (41 CFR 109) and the *Personal Property Manual* (LMS/POL/S24628). The personal property is now tracked on the site's personal property inventory. A copy of the personal property inventory list is included in Appendix E of this report.

Figure 22. Lawn Mower and Air Compressor in the Shed

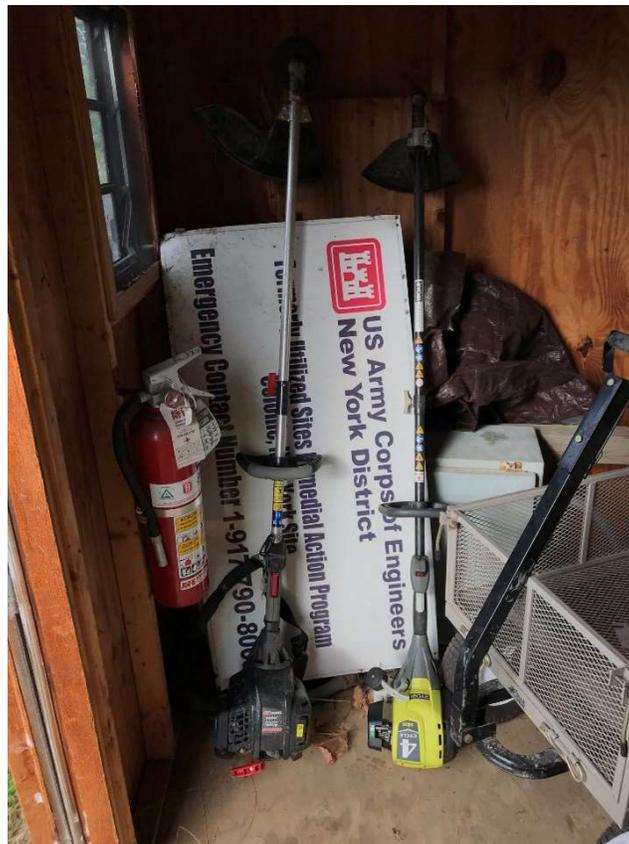
Figure 23. Two Line Trimmers and Garden Cart in the Shed

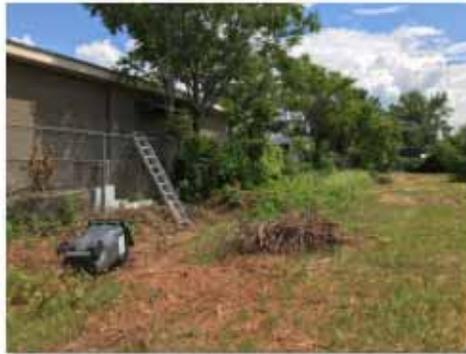
IMG_0343

IMG_0343.JPEG	07/14/20 behind restaurant ladders, trash can, sticks
IMG_0344.JPEG	07/14/20 behind restaurant ladders, trash can, sticks
IMG_0345.JPEG	07/14/20 ladders over fence at restaurant
IMG_0346.JPEG	07/14/20 trash can onsite behind restaurant
IMG_0347.JPEG	07/14/20 corner near restaurant with dumped branches
IMG_0348.JPEG	07/15/20 MW-34S sampling
IMG_0349.JPEG	07/15/20 MW-34S sampling
IMG_0350.JPEG	07/15/20 MW-34S staghorn sumac
IMG_0351.JPEG	07/15/20 MW-37S hidden in brush
IMG_0352.JPEG	07/15/20 MW-37S hidden in brush
IMG_0353.JPEG	07/15/20 MW-37S hidden in brush, conditions after sampling
IMG_0354.JPEG	07/15/20 MW-34S hidden in brush, conditions after sampling
IMG_0355.JPEG	07/15/20 in shed - compressor & mower
IMG_0356.JPEG	07/15/20 in shed 2 line trimmers
IMG_0357.JPEG	07/15/20 Klozur oxidant in shed
IMG_0358.JPEG	07/15/20 MW-44S sampling
IMG_0359.JPEG	07/15/20 looking E from MW-44S w/ sampling equipment

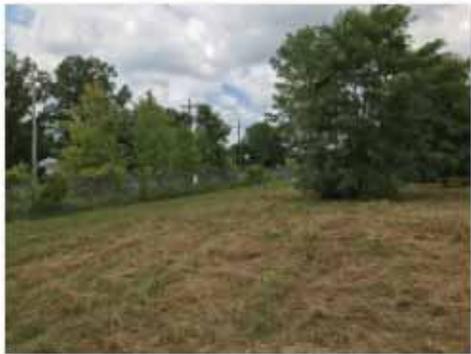
IMG_0360

IMG_0360.JPEG	07/15/20 looking SW from MW-44S
IMG_0361.JPEG	07/15/20 looking SW from MW-44S
IMG_0362.JPEG	07/15/20 MW-41S
IMG_0363.JPEG	07/15/20 bent fence post E of MW-41S
IMG_0364.JPEG	07/15/20 bent fence post E of MW-41S
IMG_0365.JPEG	07/15/20 broken fence post W of MW-42S
IMG_0366.JPEG	07/15/20 broken fence post W of MW-42S
IMG_0367.JPEG	07/15/20 broken fencepost S fence near former deed line
IMG_0368.JPEG	07/15/20 broken fencepost S fence near former deed line
IMG_0369.JPEG	07/15/20 looking W along S fence near old deed line
IMG_0370.JPEG	07/15/20 looking W along S fence near old deed line
IMG_0374.JPEG	07/15/20 MW-30S looking W
IMG_0375.JPEG	07/15/20 MW-30S looking E
IMG_0376.JPEG	07/15/20 S fenceline looking W near MW-30S
IMG_0377.JPEG	07/15/20 S gate from inside looking S
IMG_0378.JPEG	07/15/20 S gate from inside looking S
IMG_0379.JPEG	07/15/20 SWC near gate with power poles
IMG_0380.JPEG	07/15/20 SW fence line tree limb on barbed wire and top rail
