## 4.0 Durango, Colorado, Disposal Site

### 4.1 Compliance Summary

Figure 4-1. 2015 Annual Inspection Drawing for the Durango Disposal Site

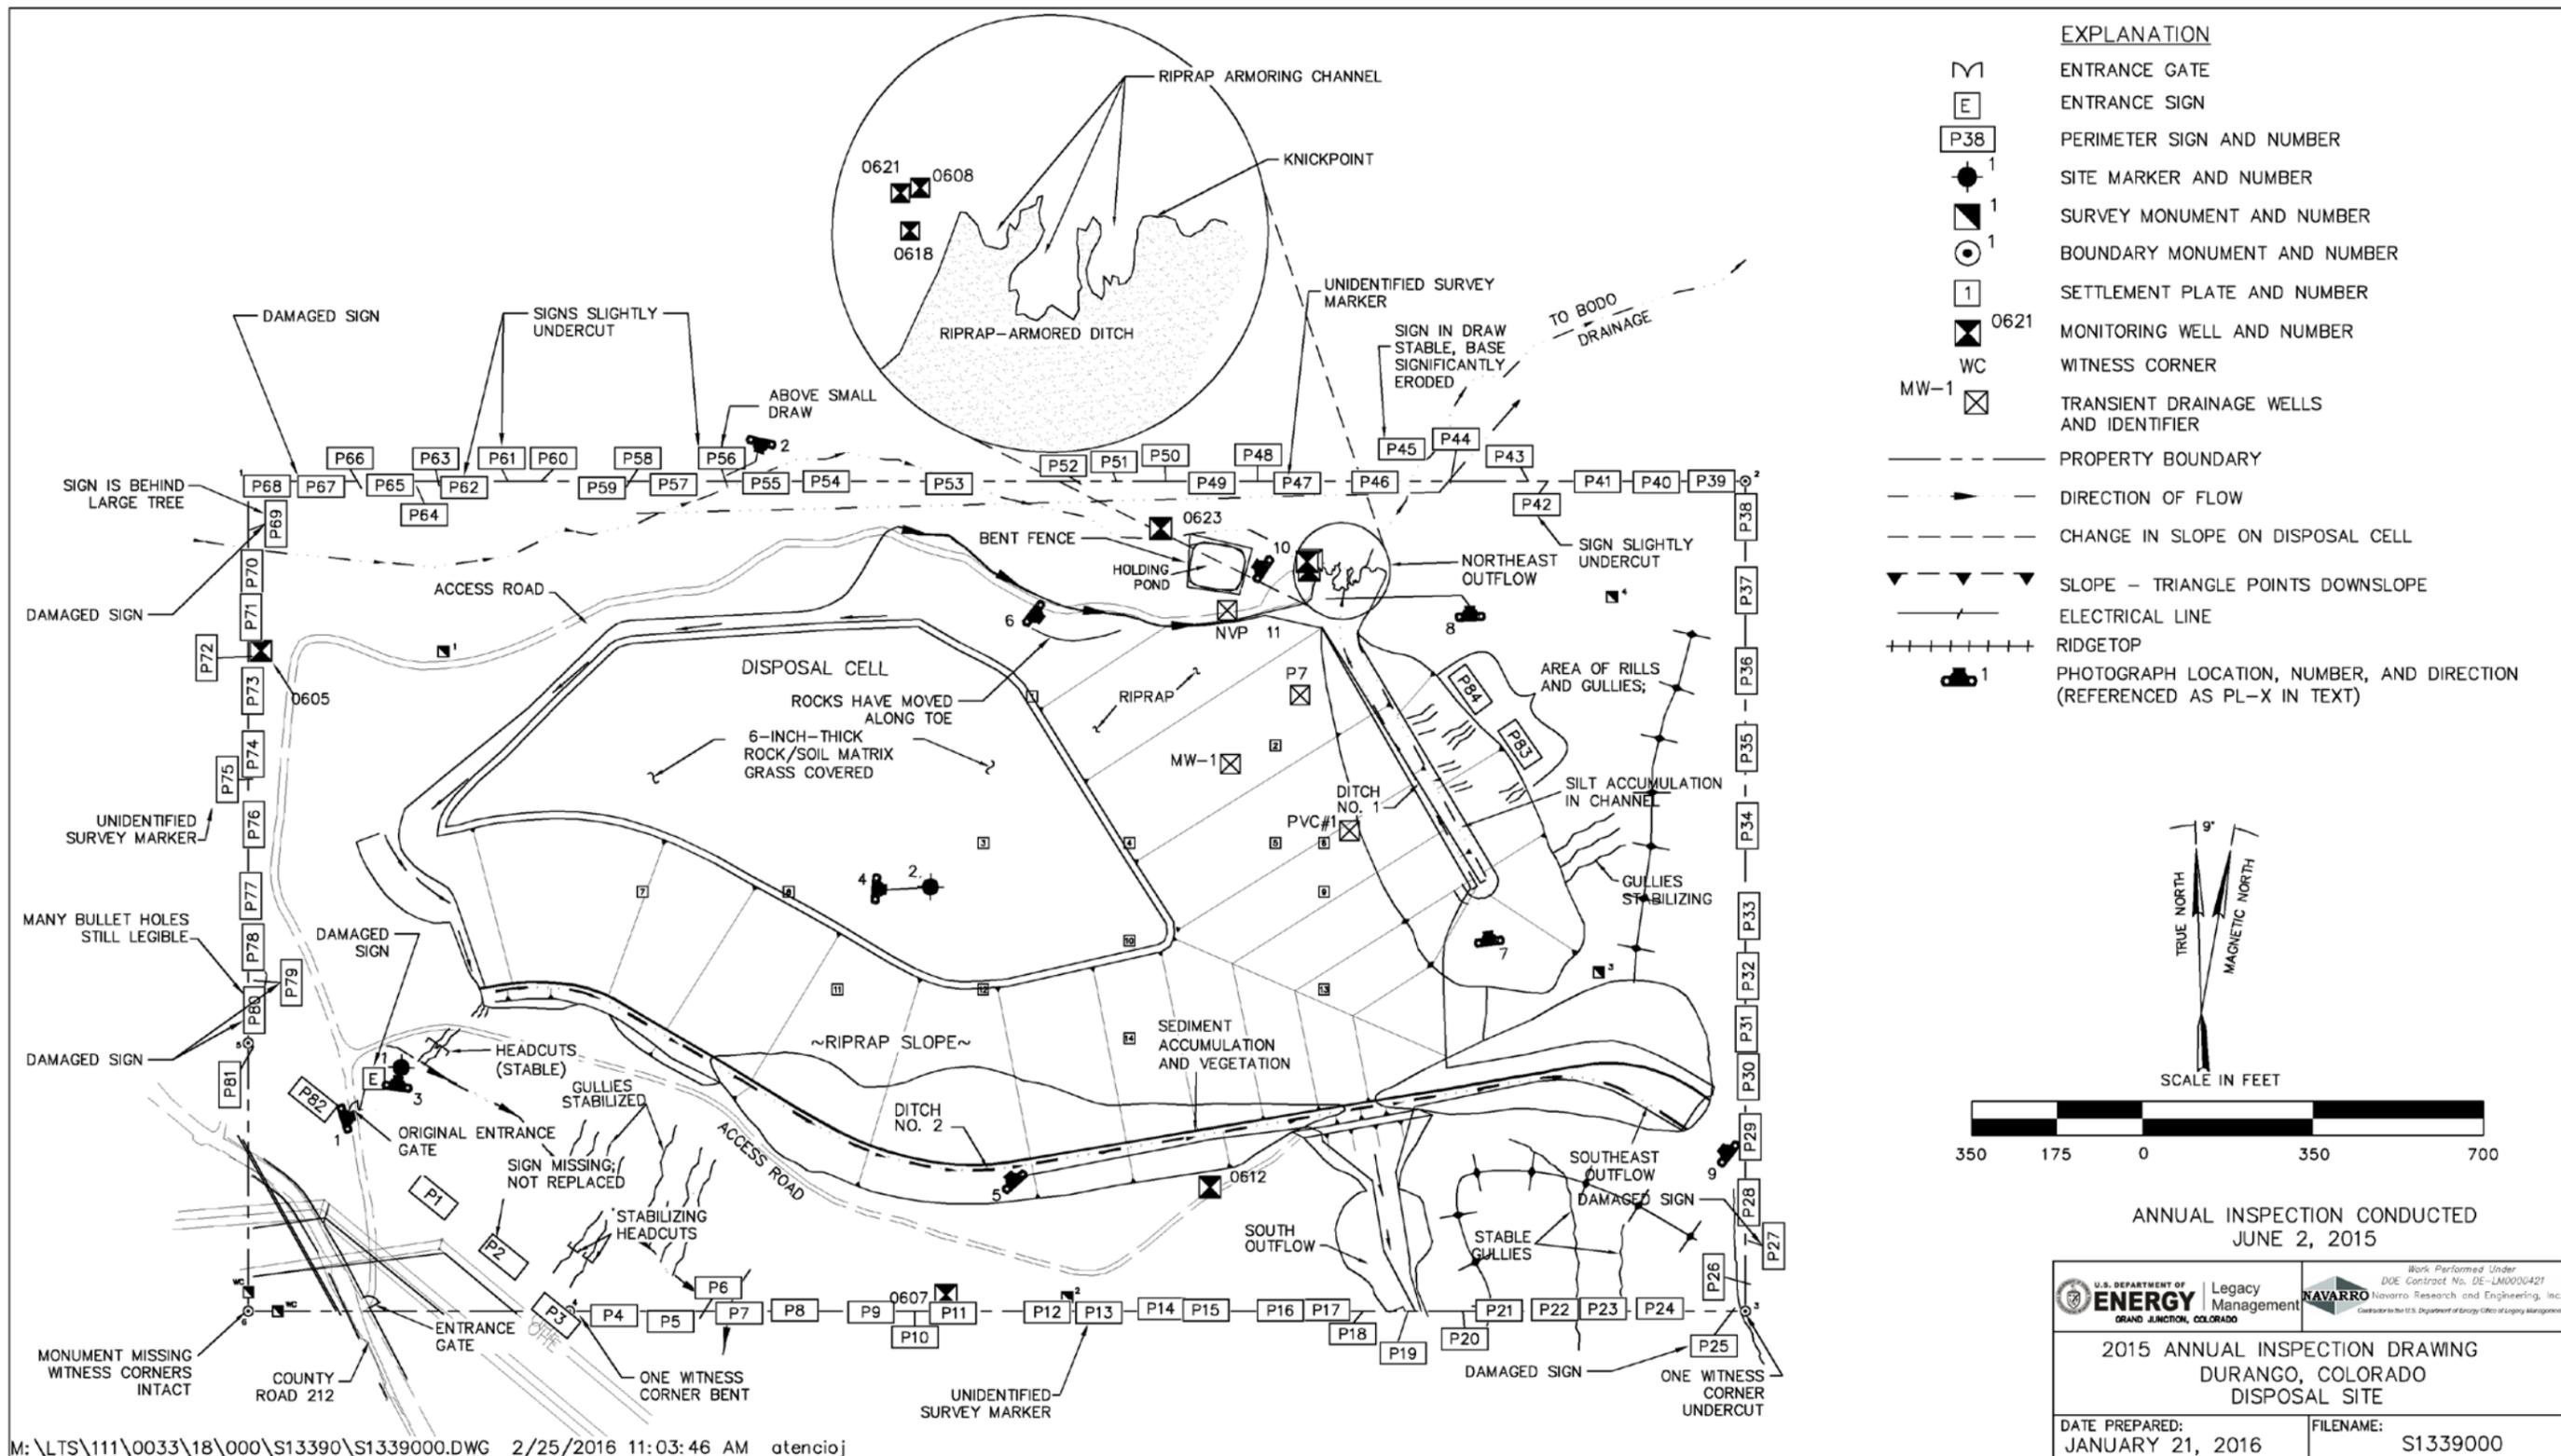
Figure 4-1 shows the locations of site surveillance features. Inspection results and recommended maintenance activities associated with site surveillance features are included in the following subsections. Photographs to support specific observations are identified in the text and on Figure 4-1 by photograph location (PL) numbers.

Eighty-four perimeter signs mark the unfenced site boundary (PL-2). Two signs (P83 and P84) were installed after the 2014 annual inspection. Numerous perimeter signs have bullet holes or other markings. Although they remain legible, they are beginning to weather and will need to be replaced in the next few years. Damaged signs are shown on Figure 4-1.

The site is not fenced. Boundary monuments and perimeter signs delineate the boundary except as follows. The boundary of the site marked by boundary monument BM-6 is not delineated with signs, because the signs cut across the corner of the site (signs P82, P1, and P3 in Figure 4-1).
