Annual Inspection of the Grand Junction, Colorado, Site

1.1 Inspection Summary

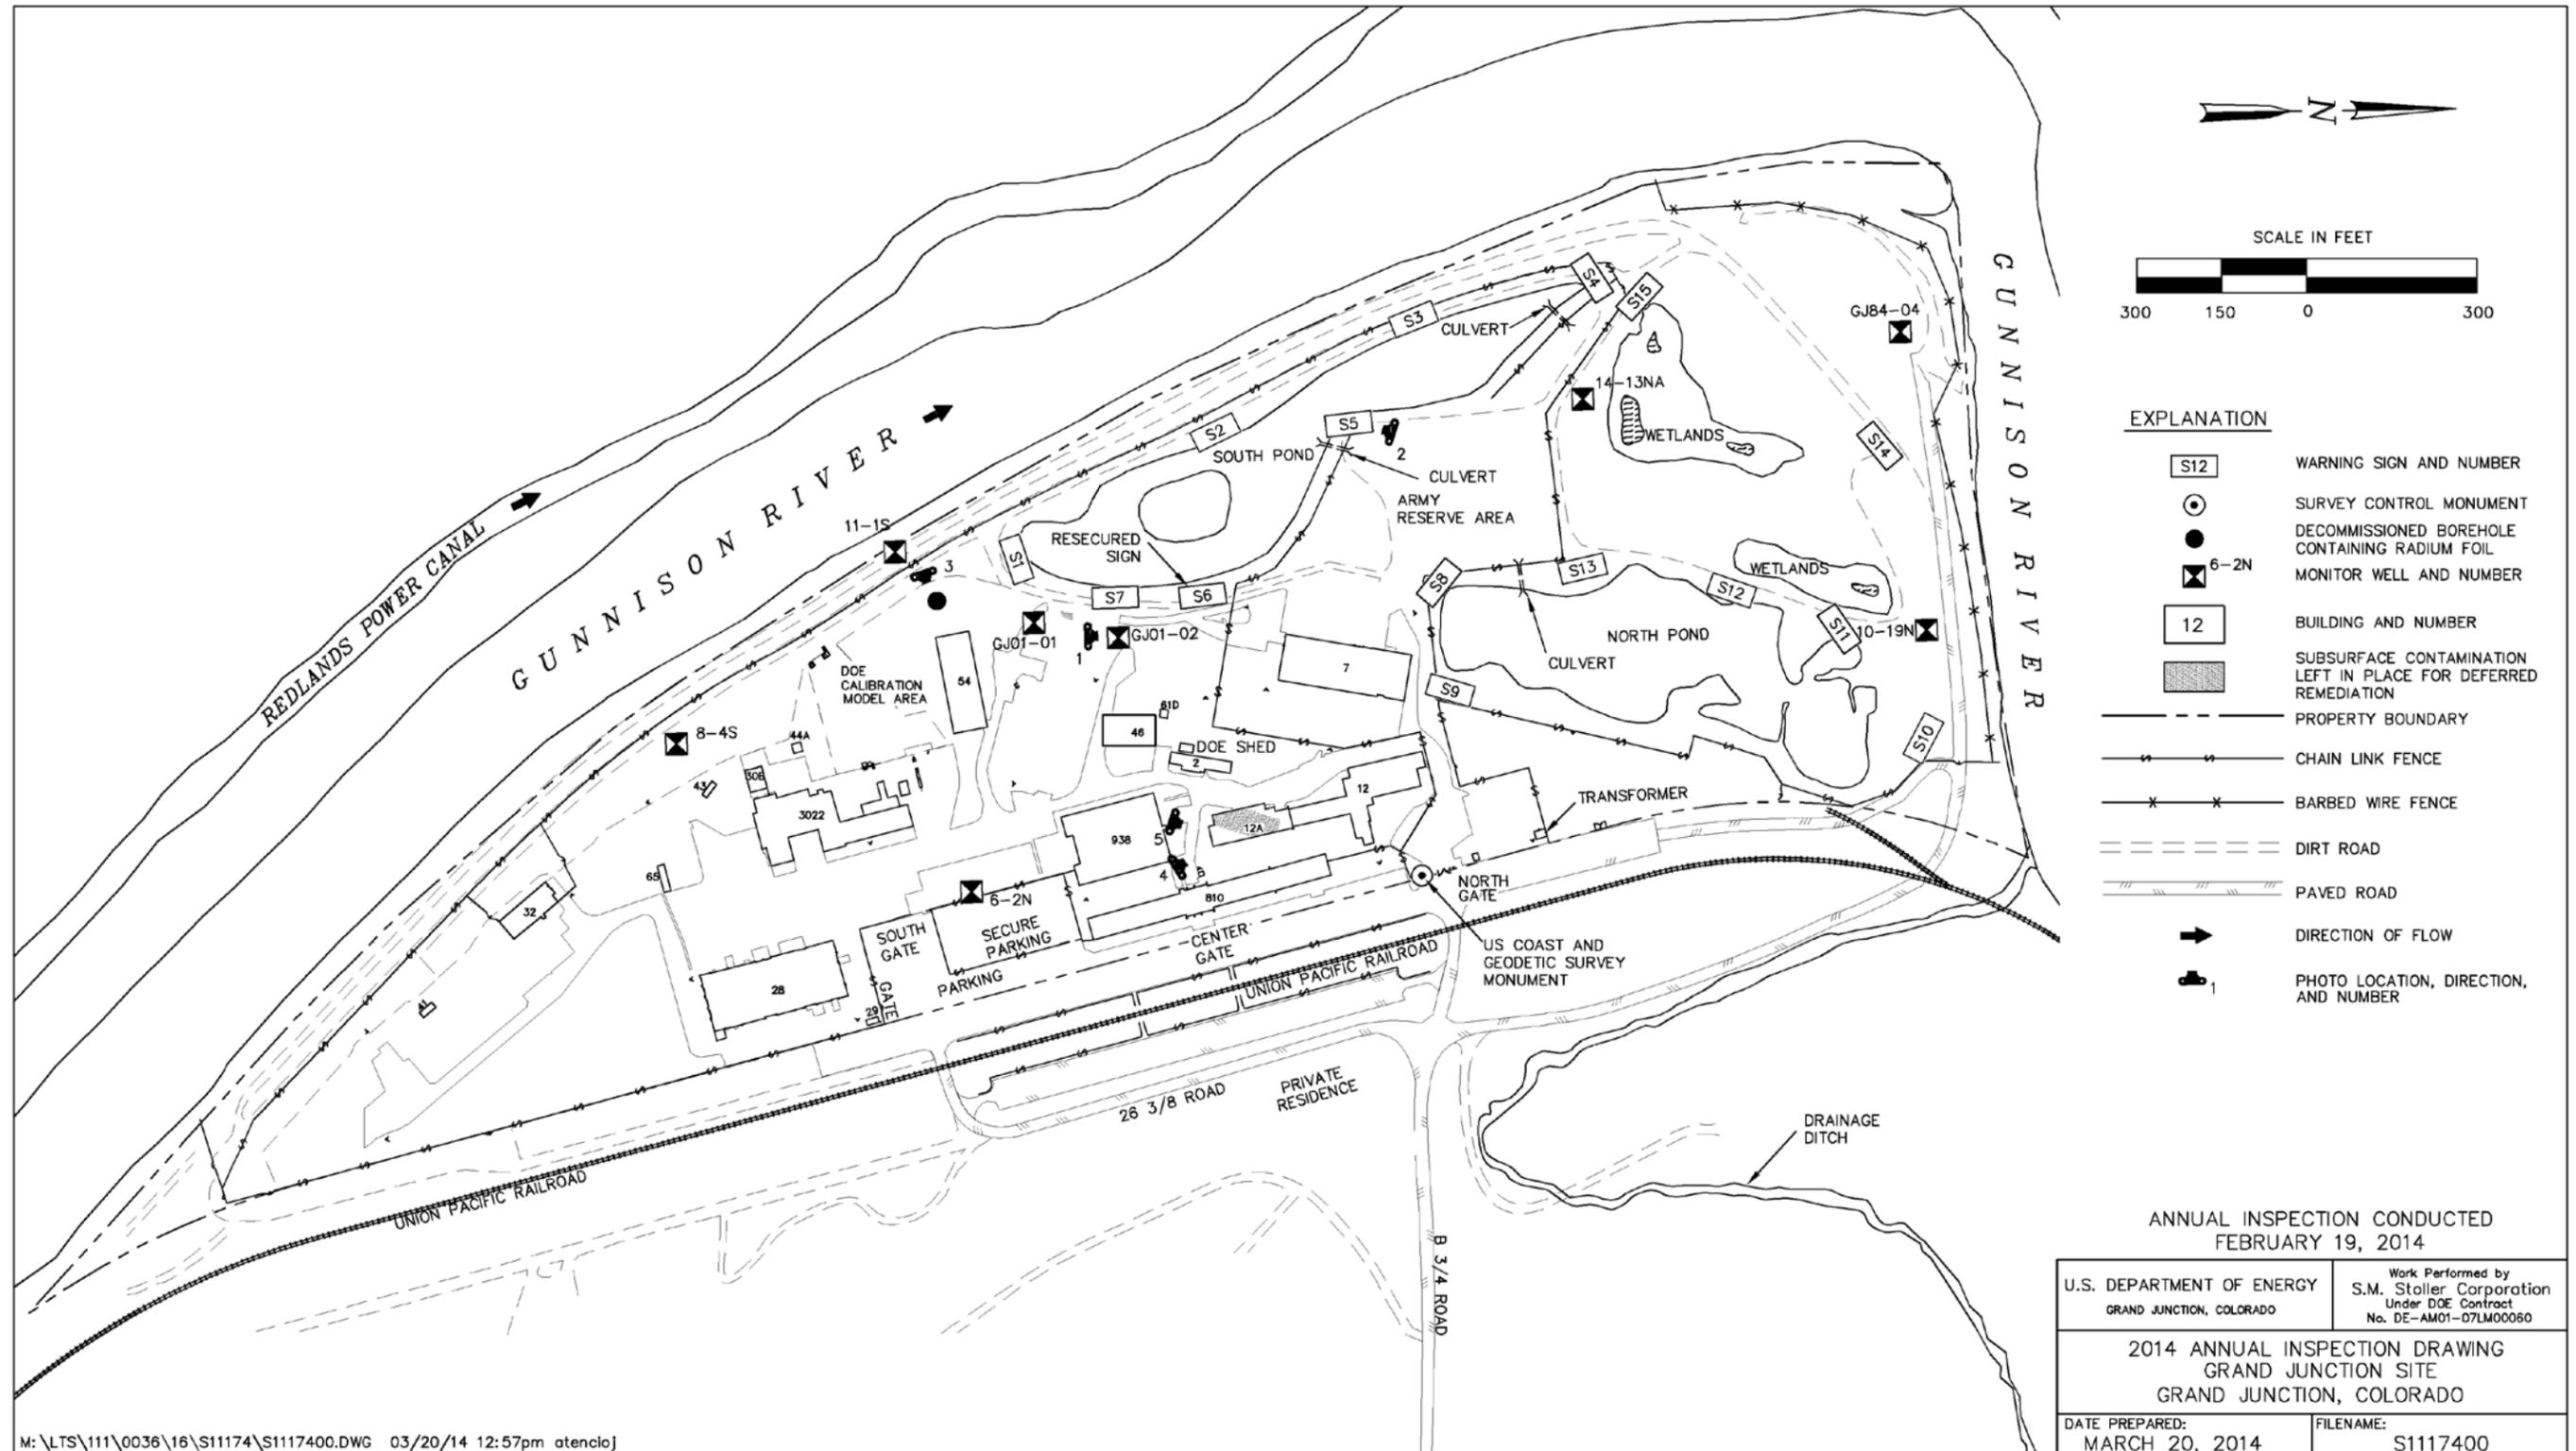
Figure 1. 2014 Annual Inspection Drawing for the Grand Junction Site

Figure 1 shows the locations of site surveillance features. Inspection results and recommended maintenance activities associated with site surveillance features are included in the following subsections.
