8.0 Gunnison, Colorado, Disposal Site

8.1 Compliance Summary

The site, southeast of Gunnison, Colorado, was inspected on June 27, 2016. The inspection was conducted by R. Johnson and S. Campbell of the DOE Legacy Management Support (LMS)

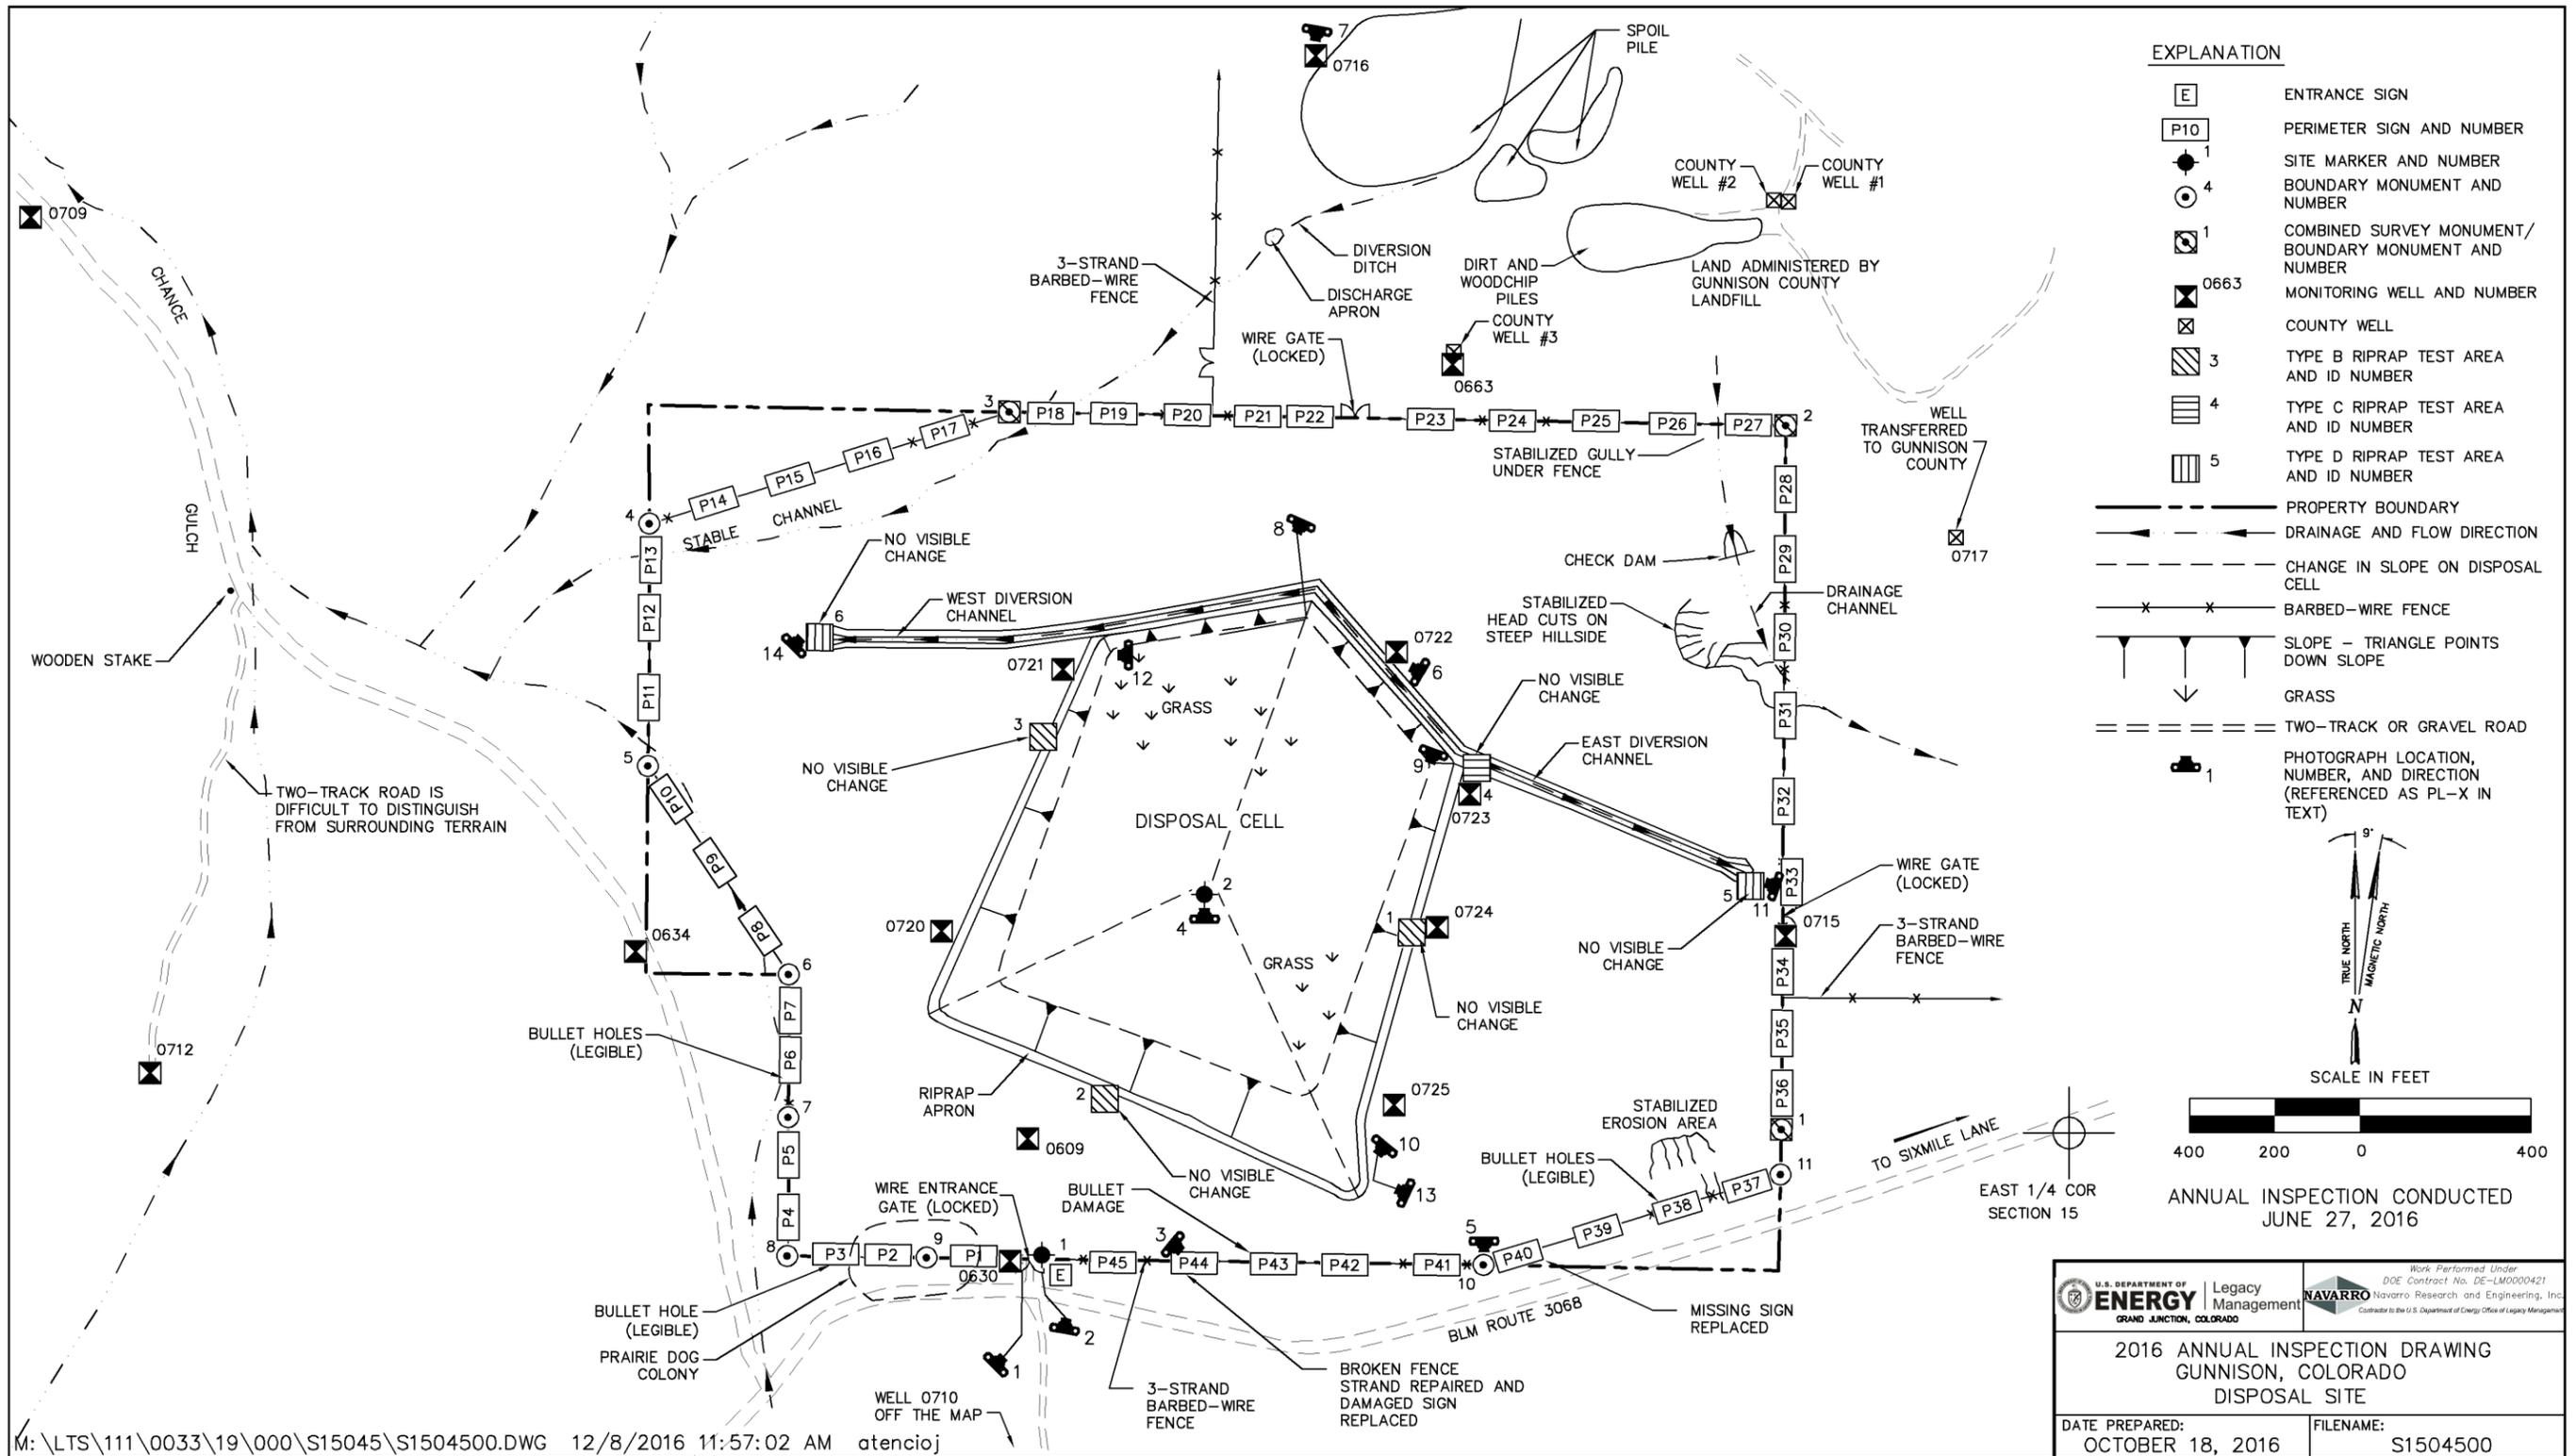
Figure 8-1. 2016 Annual Inspection Drawing for the Gunnison Disposal Site

Figure 8-1 shows the locations of site surveillance features. Inspection results and recommended maintenance activities associated with site surveillance features are included in the following subsections. Photographs to support specific observations are identified in the text and in Figure 8-1 by photograph location (PL) numbers.

A three-strand barbed-wire fence encloses the site; most of it is set along the property boundary. The fence was intact except for one broken strand that was repaired during the inspection (PL-3). Two barbed-wire gates—one on the north fence line and the other on the east fence line—provide access to offsite monitoring wells; both gates were locked. There are 45 perimeter signs, which are bolted to perimeter fence posts. Several perimeter signs have bullet holes but were legible. One perimeter sign was missing and one was damaged and could not be properly secured to the fence post; replacement signs were installed during the inspection. No other maintenance needs were identified.

There are three combined survey and boundary monuments (SM-1/BM-1, SM-2/BM-2, and SM-3/BM-3) and eight additional boundary monuments (BM-4 through BM-11) along the site perimeter (PL-5). No maintenance needs were identified.

The disposal cell, completed in 1995, occupies 29 acres. It is covered with basalt rock to protect the disposal cell materials from erosion. Several isolated patches of grass have established on the top slope; however, these shallow-rooted plants do not degrade the performance of the radon barrier. There were no indications of erosion, settling, slumping, rock degradation, or other modifying processes that might affect the integrity of the disposal cell (PL-8). No maintenance needs were identified.

The disposal cell side slopes (PL-9), an apron to collect and divert precipitation runoff from the disposal cell (PL-10), and two diversion channels to protect the disposal cell from precipitation run-on (PL-11 and PL-12), are all protected by basalt riprap. There were no indications of erosion, settling, slumping, rock degradation, or other modifying processes that might affect the integrity of the disposal cell side slopes, apron, or diversion channels.

Precipitation runoff from the disposal cell occasionally ponds in a low-lying area at the southeast corner of the disposal cell; standing water was present at the time of the inspection (PL-13). The riparian-type vegetation that has become established there indicates that the area retains moisture much of the time. Water collection in this area does not pose a problem because the disposal cell is designed to drain to the southeast and any water that ponds there is below the elevation of the encapsulated tailings material. No maintenance needs were identified.

A broken fence strand was repaired and two perimeter signs were replaced during the inspection. No other maintenance needs were identified.

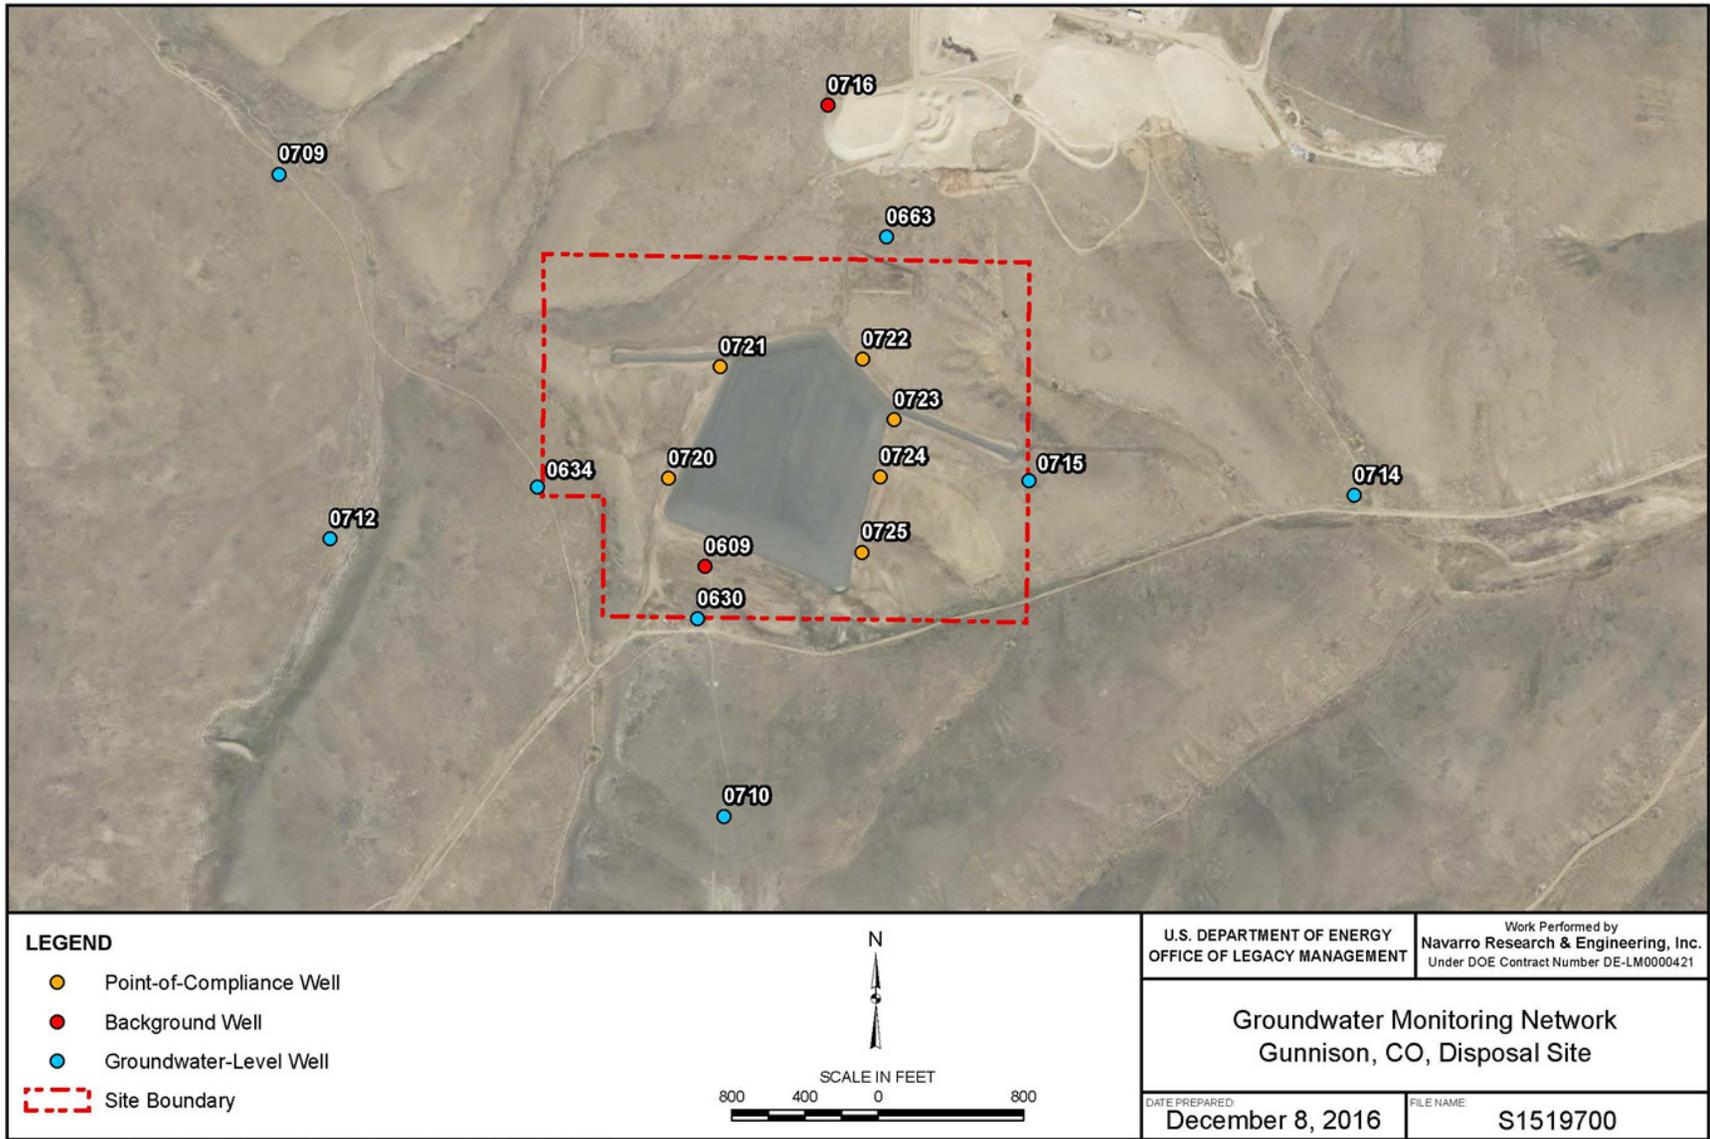
Figure 8-2. Groundwater Monitoring Network at the Gunnison Disposal Site

DOE monitors groundwater at the site to demonstrate compliance with U.S. Environmental Protection Agency (EPA) groundwater protection standards in 40 CFR 192.03 and to demonstrate that the disposal cell is performing as designed. The monitoring network consists of 16 wells, including 6 point-of-compliance (POC) wells to monitor disposal cell performance, 2 wells to monitor background groundwater quality, and 8 wells to monitor groundwater levels (Table 8-2 and Figure 8-2).

In accordance with the LTSP, groundwater was sampled and groundwater levels were measured annually from 1998 through 2001. Following the 2001 sampling event, the monitoring frequency changed to once every 5 years. Sampling and groundwater-level measurements were collected in 2016.
