8.0 Gunnison, Colorado, Disposal Site

8.1 Compliance Summary

Figure 8-1. 2017 Annual Inspection Drawing for the Gunnison, Colorado, Disposal Site

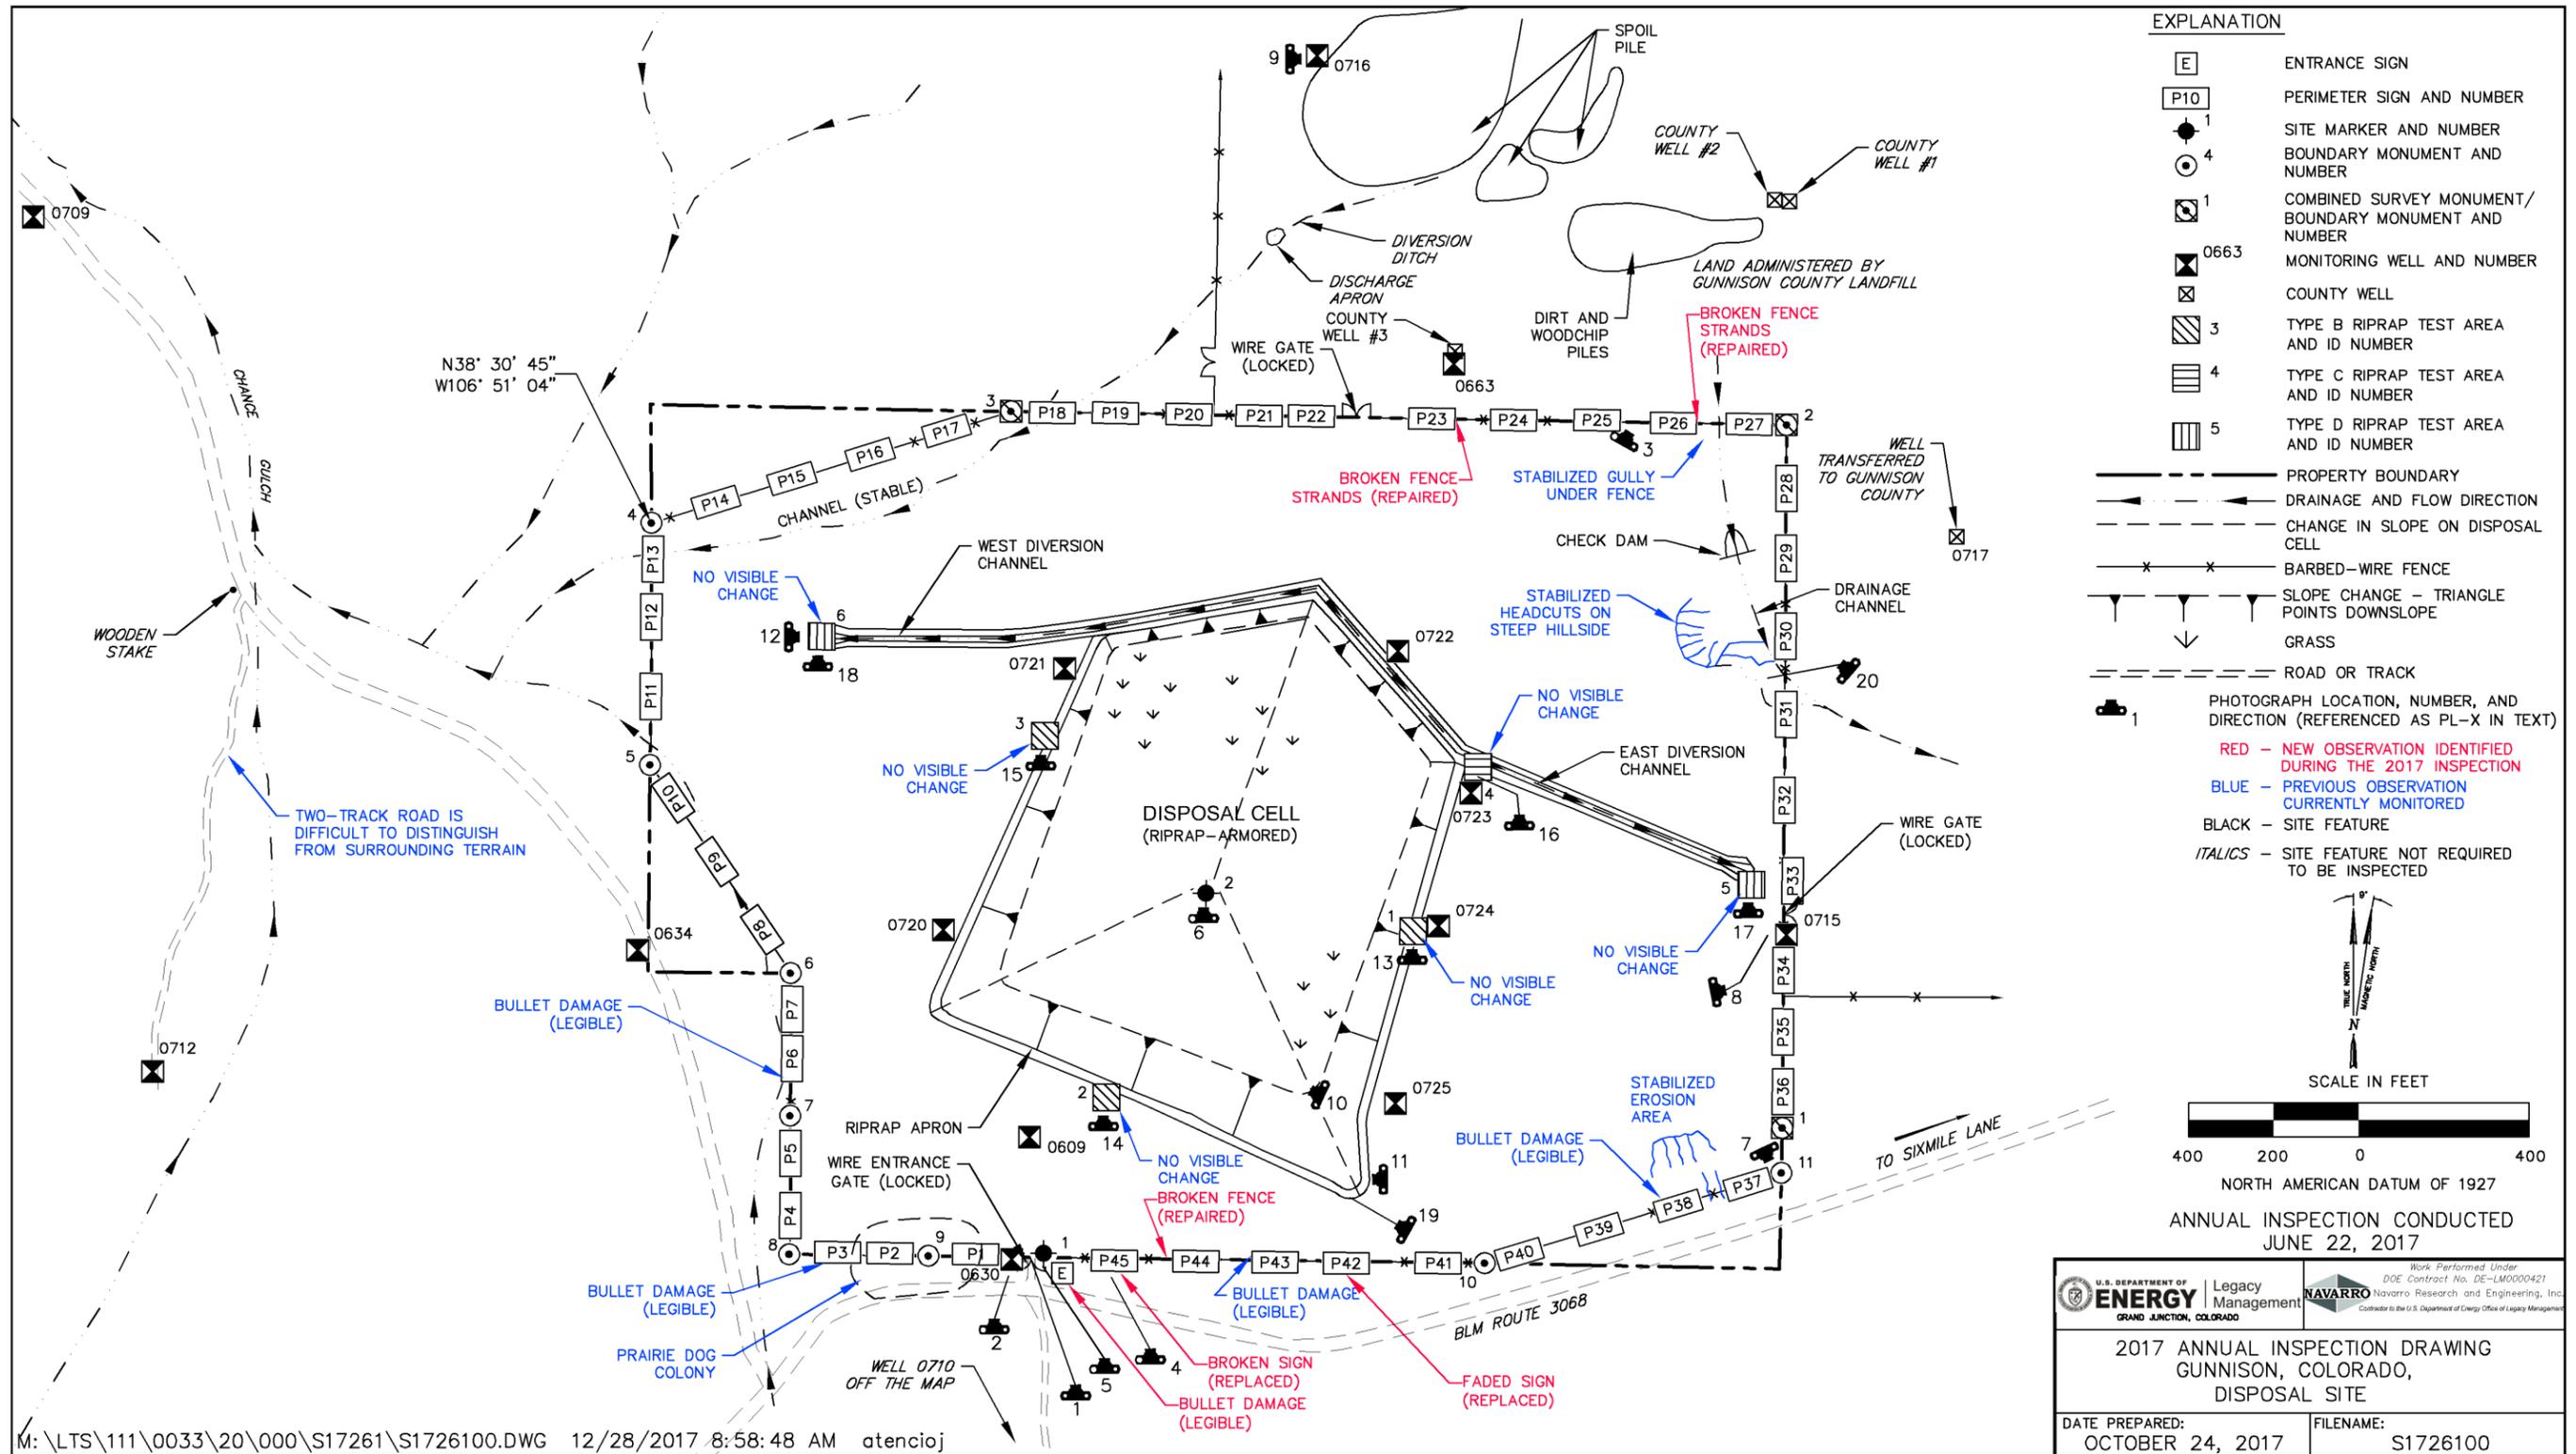
Figure 8-1 shows in black the locations of site features, including site surveillance features and inspection areas. Site features that are present but not required to be inspected are shown in italic font. Observations from previous inspections that are currently monitored are shown in blue text, and new observations identified during the 2017 annual inspection are shown in red. Inspection results and recommended maintenance activities associated with site surveillance features are included in the following subsections. Photographs to support specific observations are identified in the text and in Figure 8-1 by photograph location (PL) numbers. The photographs and photograph log are presented in Section 8.10.
