8.0 Gunnison, Colorado, Disposal Site

The U.S. Department of Energy (DOE) Office of Legacy Management (LM) conducted the Gunnison, Colorado, Uranium Mill Tailings Radiation Control Act (UMTRCA) Title I Disposal Site (site) annual site inspection on July 31, 2018 and the five-year groundwater monitoring event in July 2016. No cause for a follow-up inspection was identified.

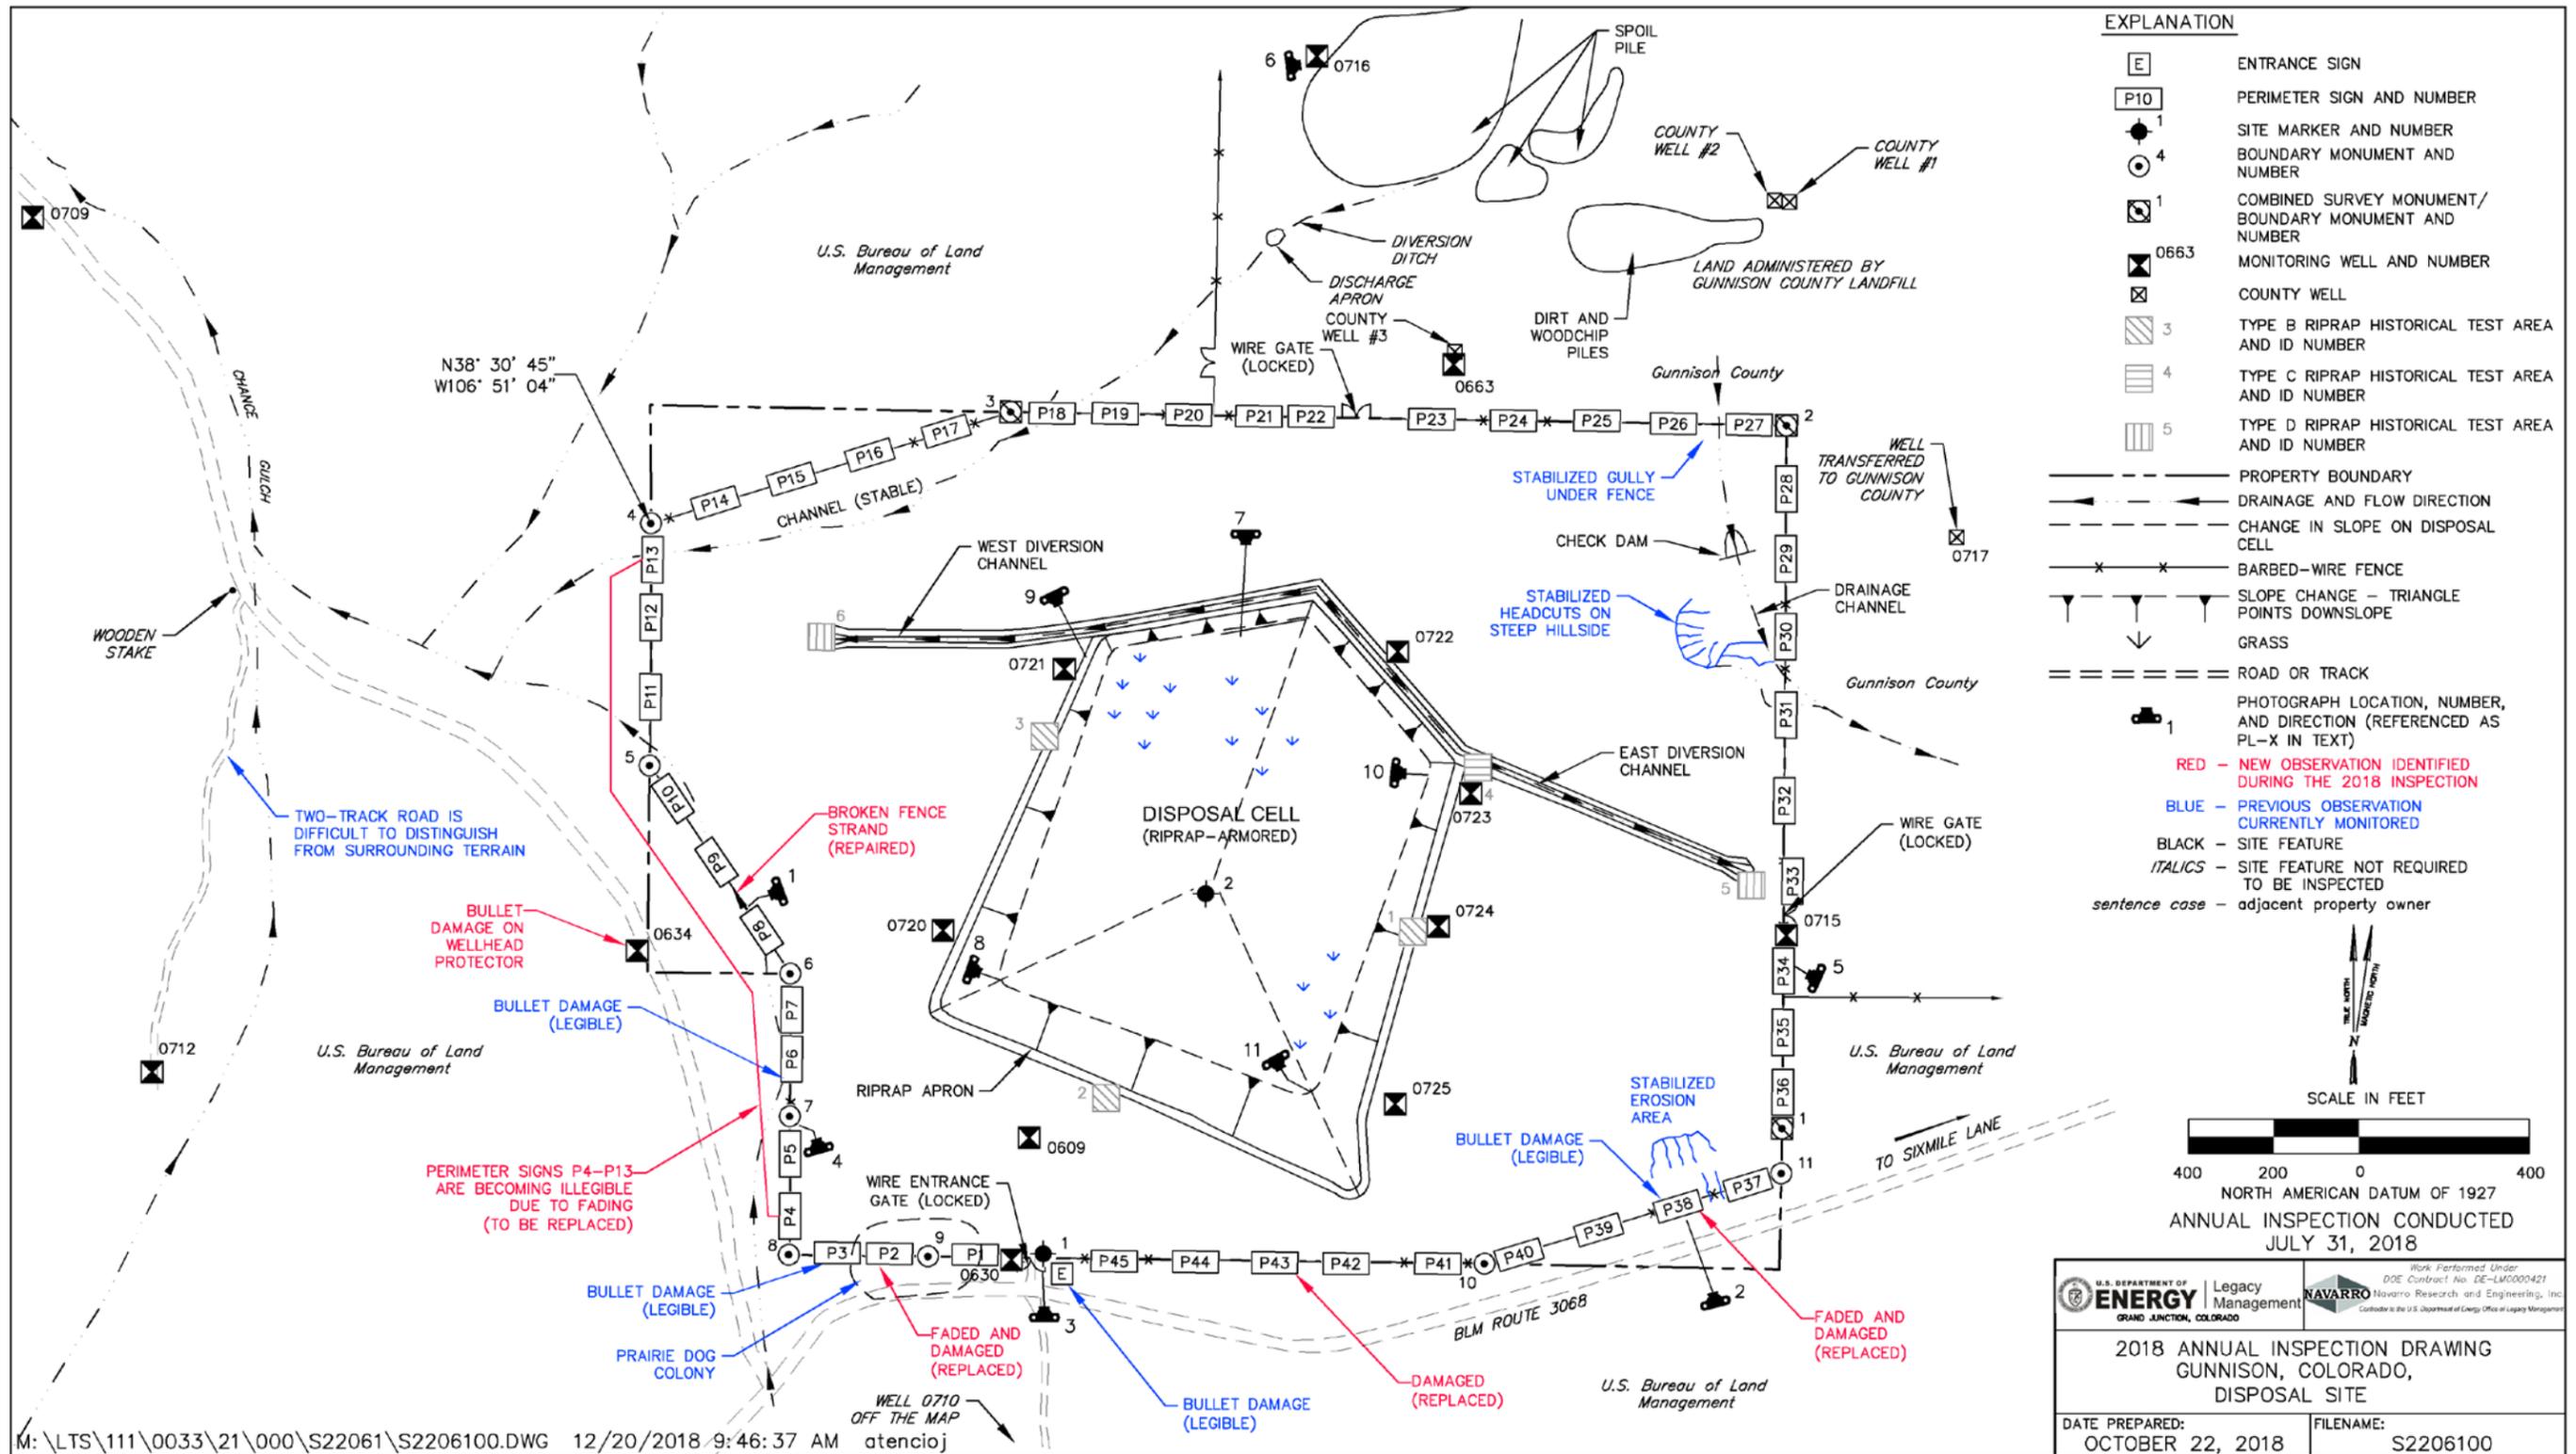
Figure 8-1. 2018 Annual Inspection Drawing for the Gunnison, Colorado, Disposal Site

No changes were observed on the disposal cell or in the associated diversion channels. Inspectors identified several minor maintenance needs and addressed most during the inspection.

Figure 8-1 shows the locations of site features in black, including site surveillance features and inspection areas. Site features that are present but not required to be inspected are shown in italic font. Observations from previous inspections that are currently monitored are shown in blue text, and new observations identified during the 2018 annual inspection are shown in red. Inspection results and recommended maintenance activities associated with site surveillance features are included in the following subsections. Photographs to support specific observations are identified in the text and in Figure 8-1 by photograph location (PL) numbers. The photographs and photograph log are presented in Section 8.9.

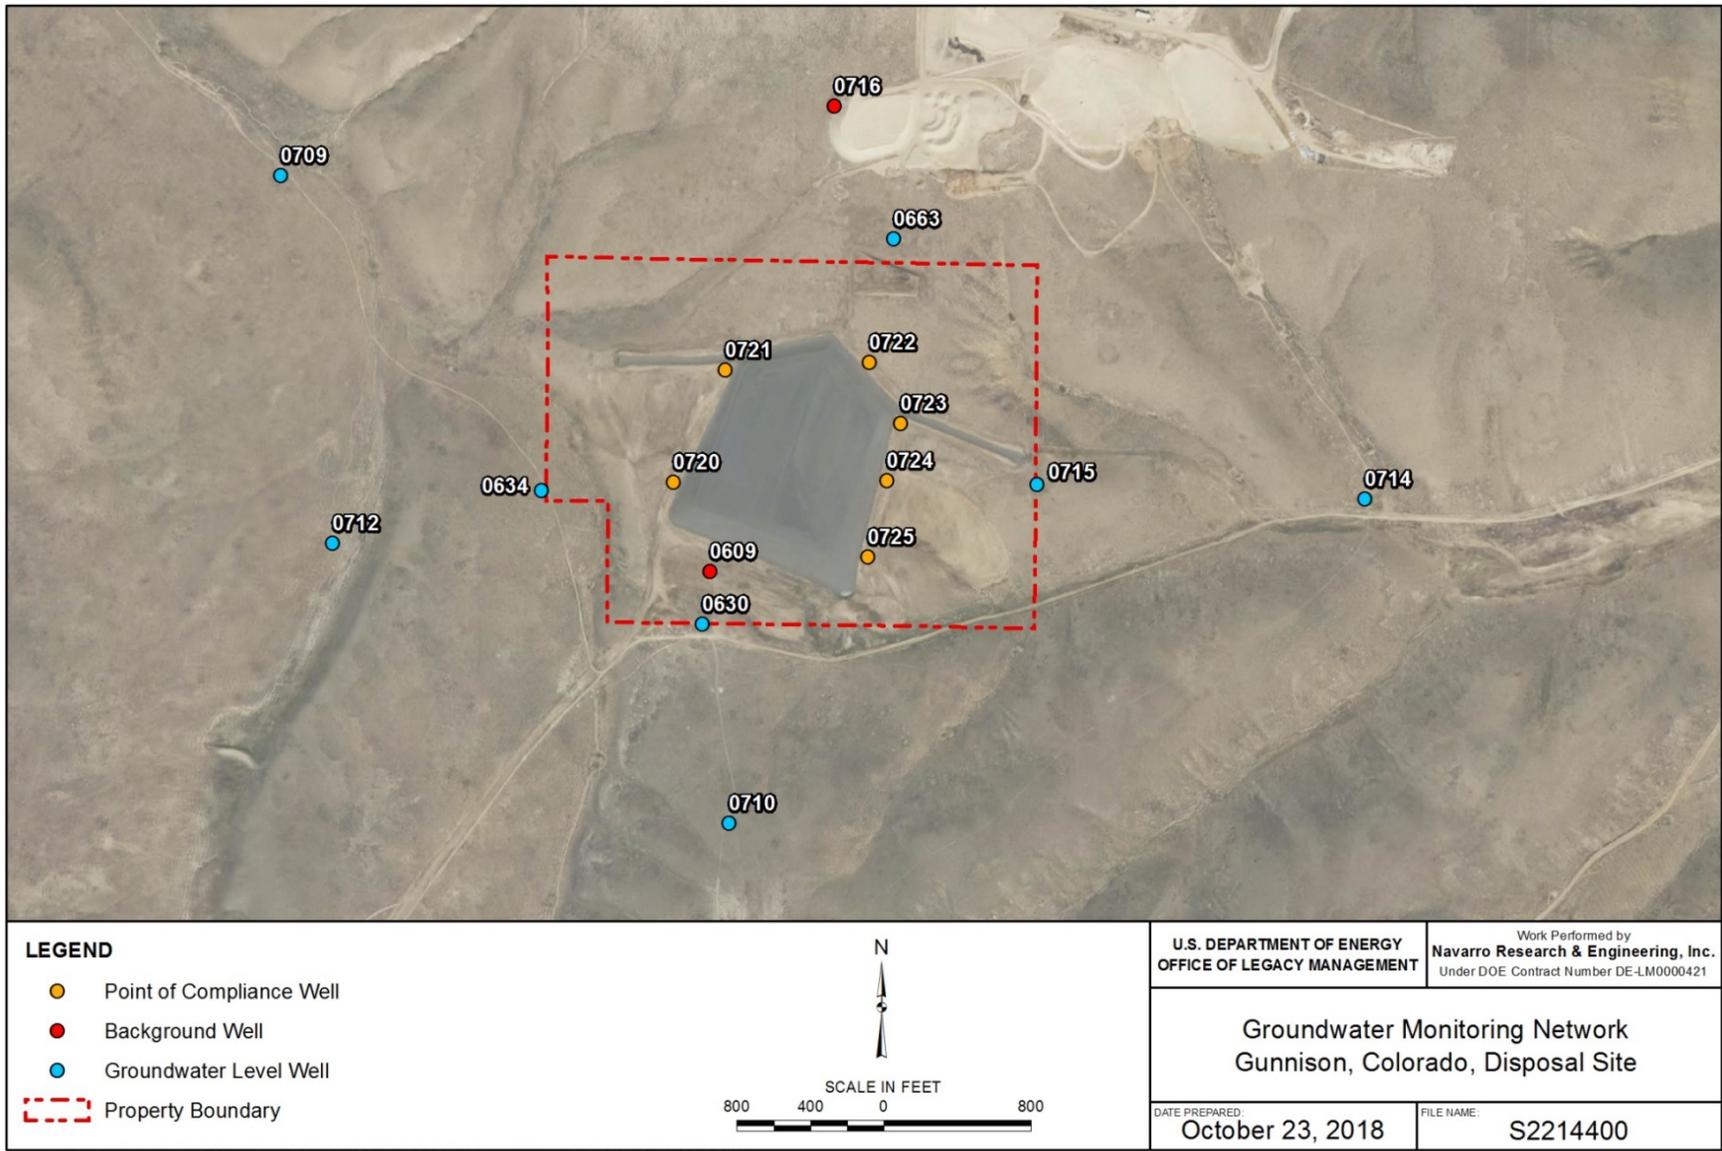
Figure 8-2. Groundwater Monitoring Network at the Gunnison, Colorado, Disposal Site

The most recent groundwater monitoring results were below the site-specific uranium action level in all point-of-compliance (POC) wells.

The groundwater monitoring network consists of 16 monitoring wells, including six POC wells, two monitoring wells to monitor background groundwater quality, and eight wells to monitor groundwater levels (Table 8-2 and Figure 8-2). The indicator analyte for disposal cell performance is uranium, which was selected because of its presence in tailings pore fluid, its relatively high mobility in groundwater, and its low concentration in upgradient (background) groundwater. The site-specific screening monitoring action level (action level) concentration for
