8.0 Gunnison, Colorado, Disposal Site

8.1 Compliance Summary

Figure 8-1. 2006 Annual Compliance Drawing for the Gunnison, Colorado, Disposal Site

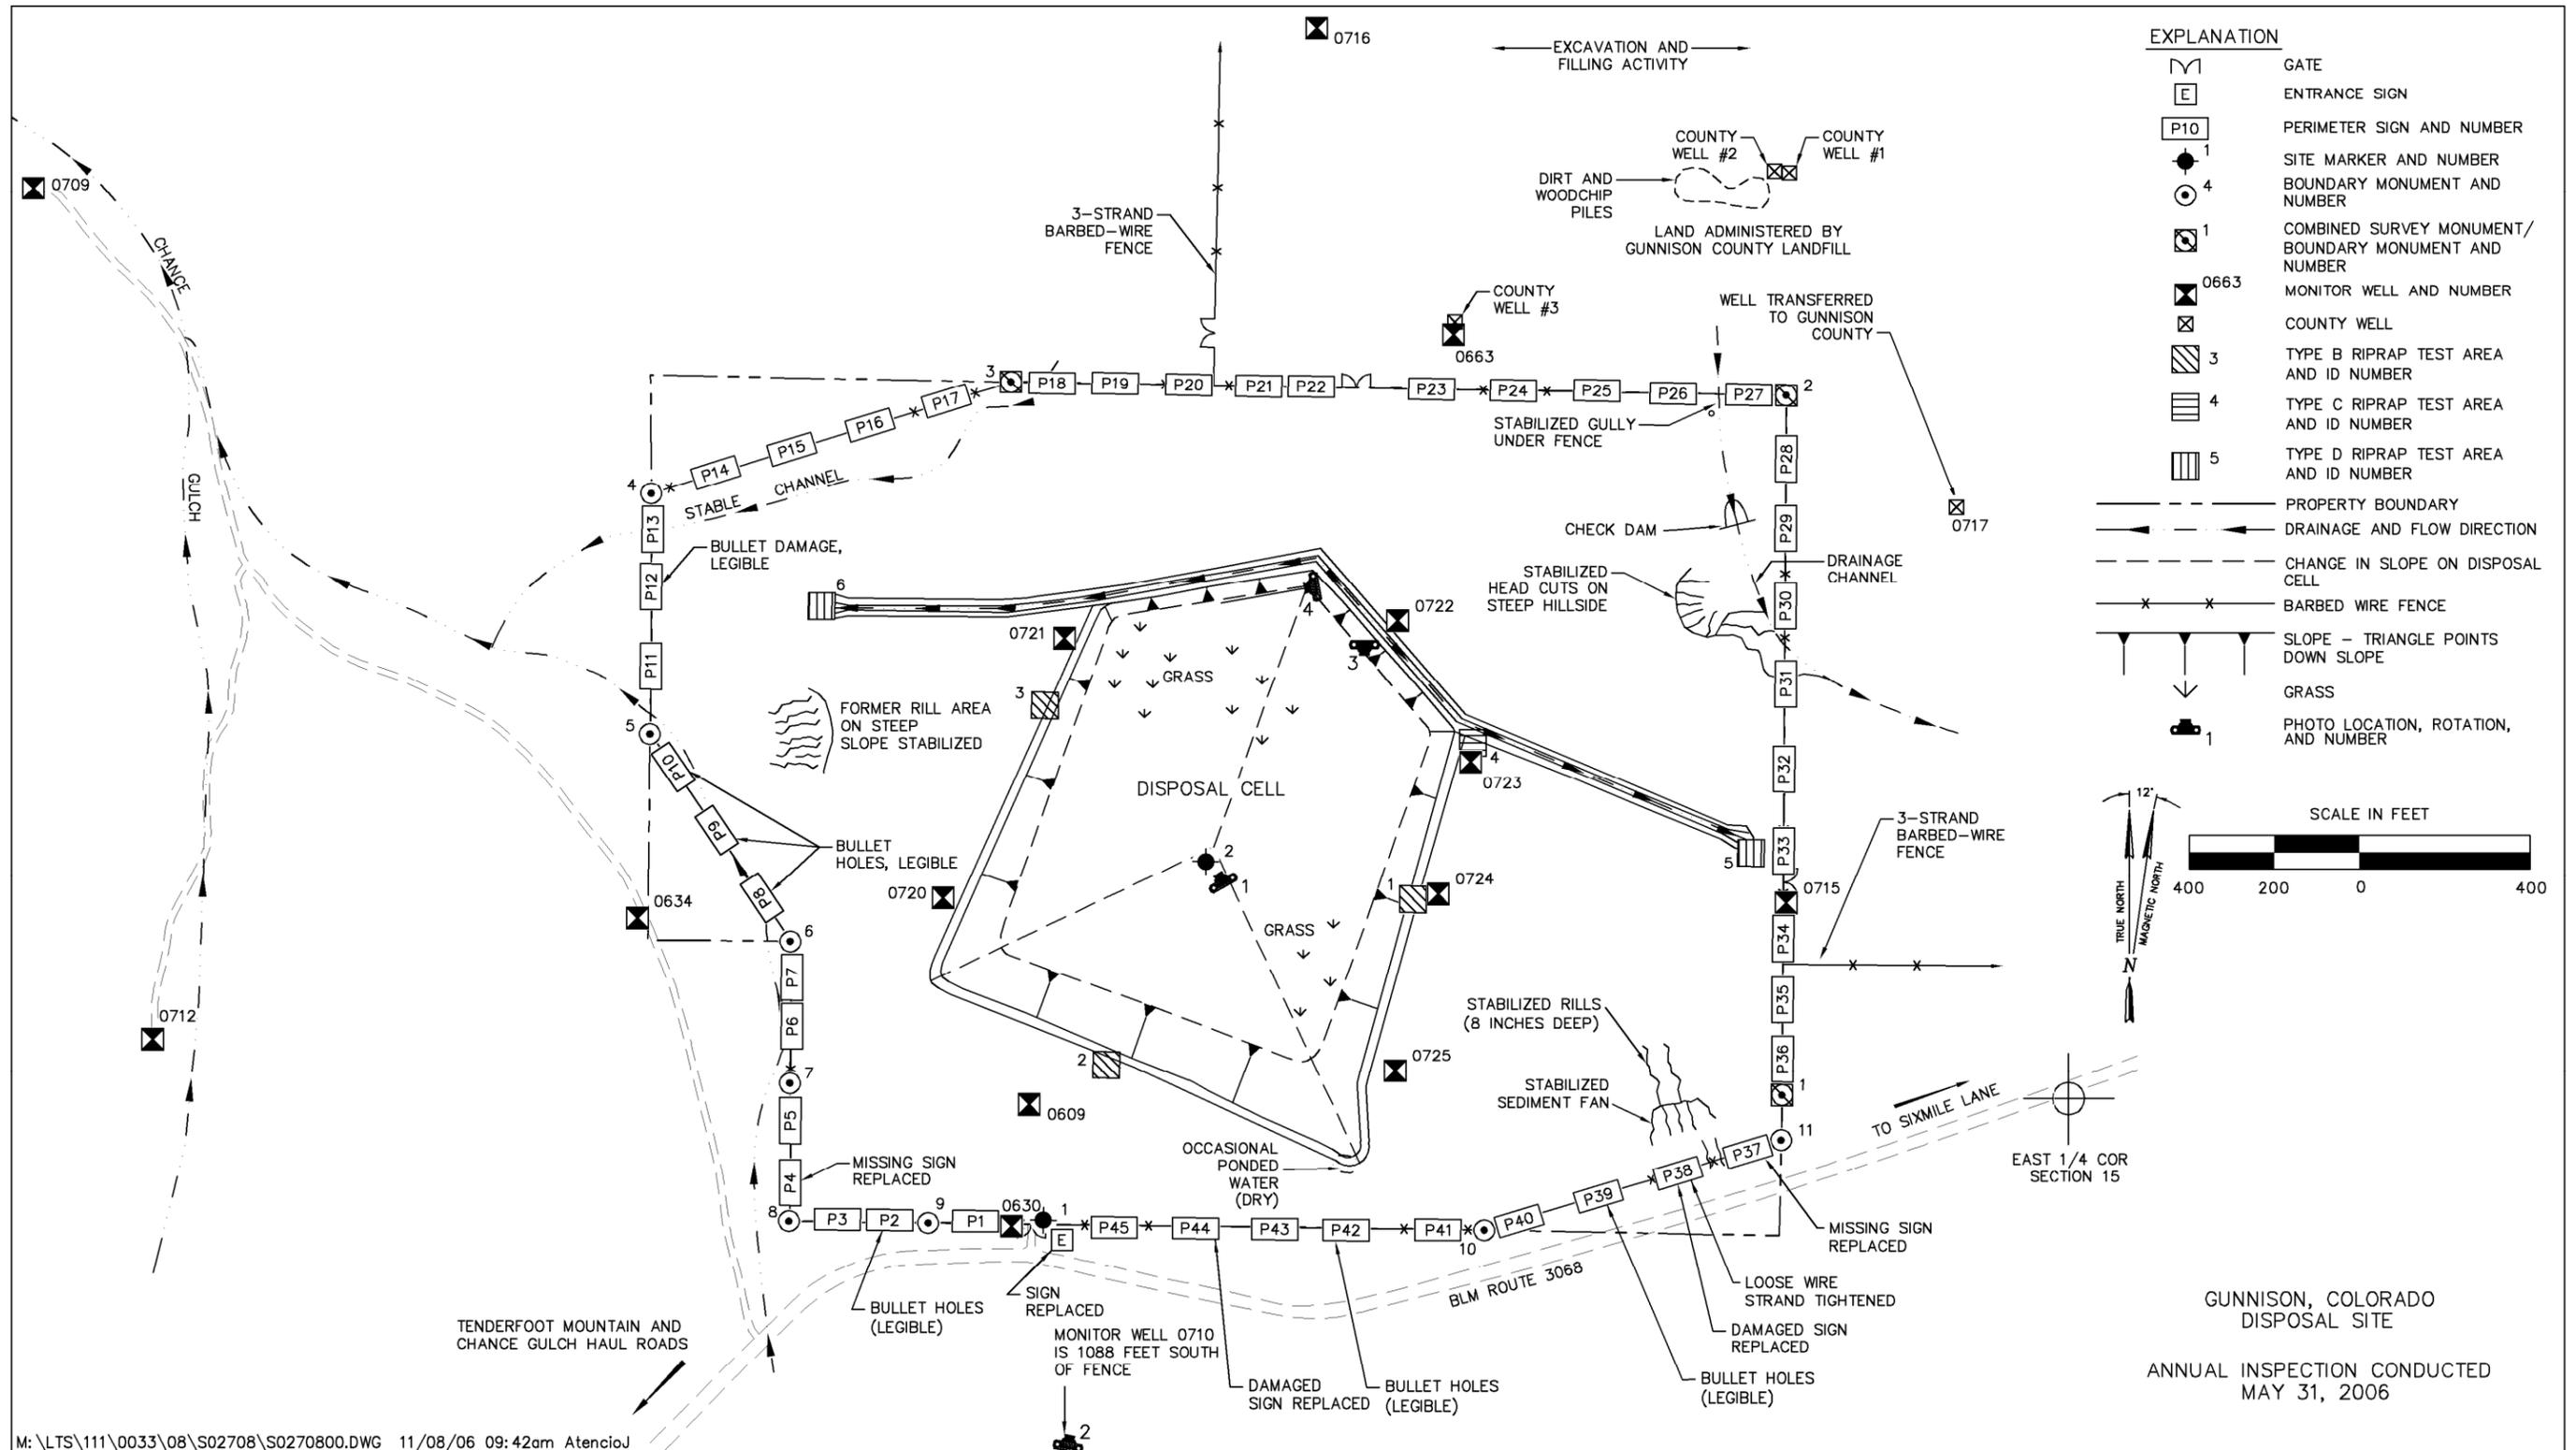
8A An entrance sign and 45 perimeter signs are attached to the posts of the perimeter fence. The entrance sign, missing at the time of the inspection, was replaced. Perimeter signs P4 and P37 were also missing, and signs P38 and P44 were illegible due to extensive bullet damage; all were replaced. Several other perimeter signs have bullet damage but are still legible. The remaining signs are in excellent condition.

A 3-strand barbed-wire fence delineates the site perimeter. Two barbed-wire gates—one on the north fence line, the other on the east fence line—provide monitor well access. The top strand of wire was broken at perimeter sign P38 and was repaired; otherwise, the fence and gates are in excellent condition.

Top of Disposal Cell—The top of the disposal cell was in excellent condition (PL-3). There was no evidence of erosion, settling, slumping, or rock degradation. Several isolated patches of grass were observed on the disposal cell cover; however, these shallow-rooted plants do not impact the performance of the cover. Many small indentations were present on the cell cover. The indentations, with dimensions up to 4 inches across and up to 4 inches deep, appear to have been caused by pronghorn antelope. None of the indentations penetrate into the bedding layer under the rock cover and are not a cause for concern.

At the southeast corner of the cell apron, water draining from the cell occasionally ponds in a low-lying area along the edge of the riprap. The riparian-type vegetation that has become established indicates this area retains moisture much of the time. Water collection in this area does not pose a problem because the cell is designed to drain to the southeast, and any water that ponds is below the elevation of the tailings. This area was dry at the time of the inspection.

- In the southeast erosional area, several 8-inch-deep rills had formed in the steeper portion of the slope, and a fan-like accumulation of eroded sediments had formed just below the rills. The area was found to be in stable condition. Vegetation is well established on the steeper portions of the eroded slopes. No recent erosion was evident.

- In the northeast portion of the property, a series of deep gullies and headcuts had formed at a natural slope break in the terrain. No new erosion was noted, and the gullies continue to stabilize with the successful establishment of sagebrush and various grasses. No evidence of new erosion or sediment transport off site was observed at the drainage channel between perimeter signs P30 and P31.
