12.0 Mexican Hat, Utah, Disposal Site

12.1 Compliance Summary

The Mexican Hat, Utah, Uranium Mill Tailings Radiation Control Act (UMTRCA) Title I Disposal Site (site) was inspected on April 30, 2019. Depressions in the riprap cover identified during the 2016 annual site inspection continue to be observed along lower portions of the disposal cell's northeast side slope and north side slope (as identified in 2018 inspections). Inspectors identified several minor maintenance needs and conducted follow-up inspections.

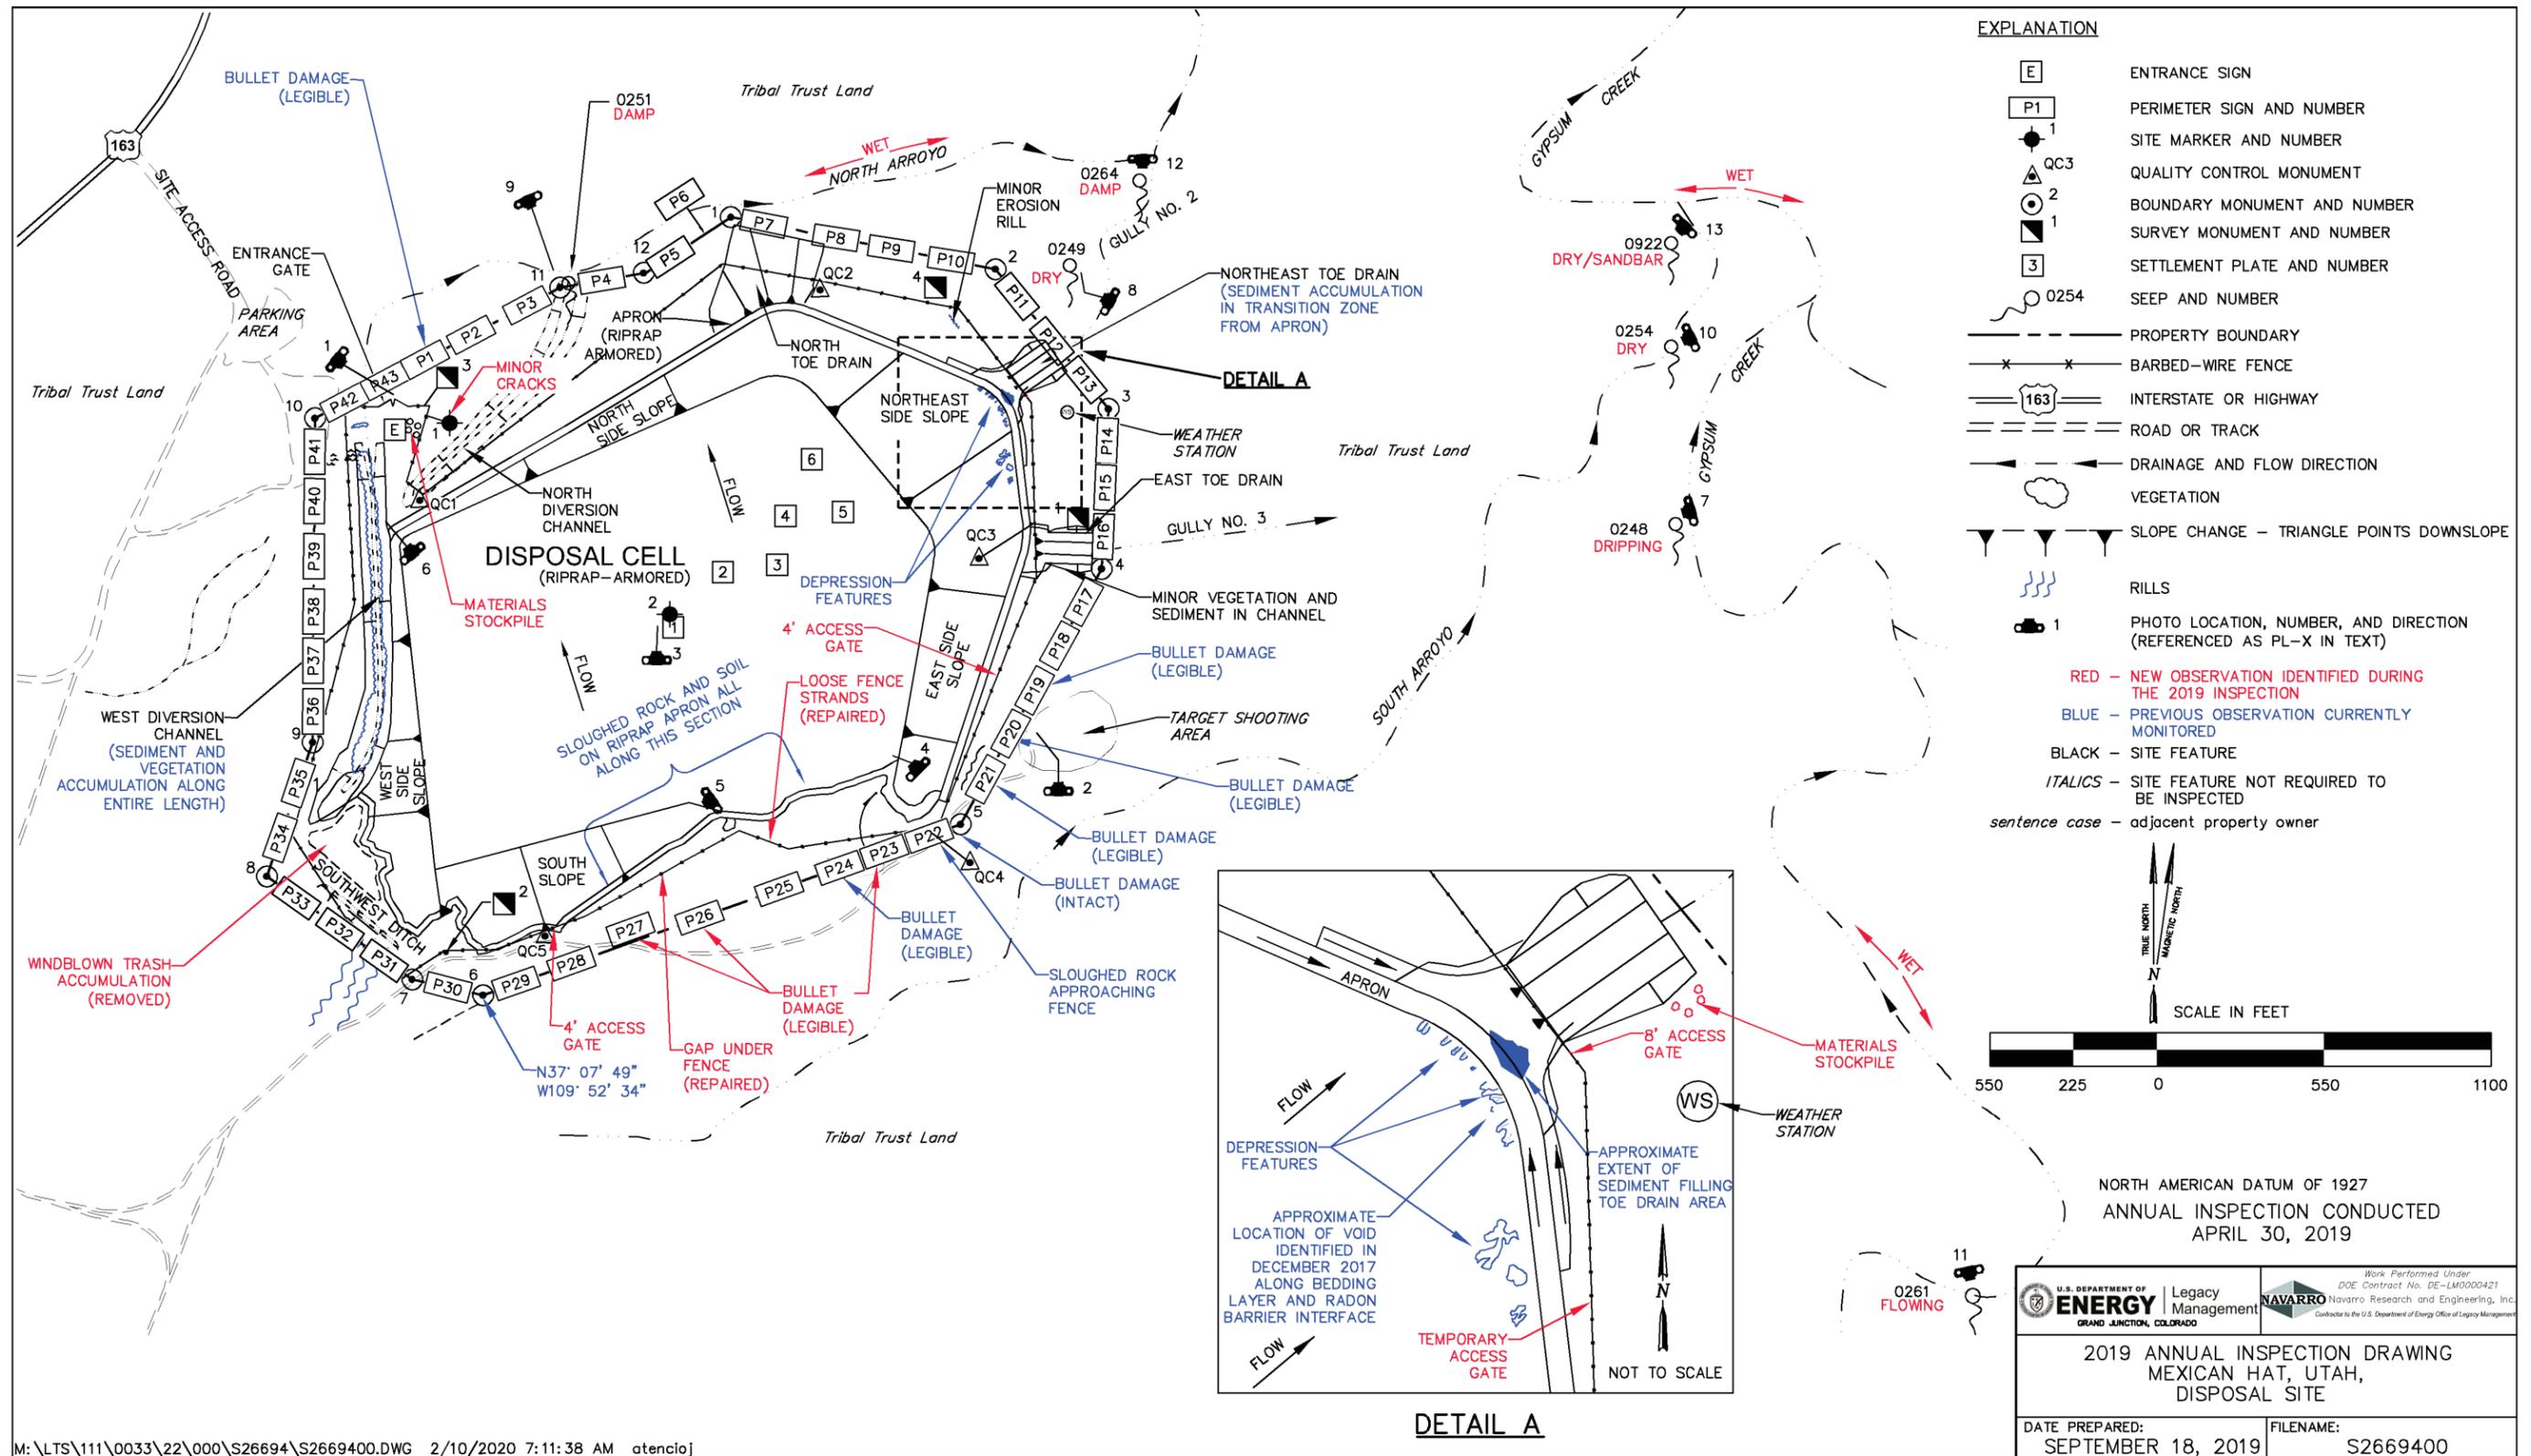
Figure 12-1. 2019 Annual Inspection Drawing for the Mexican Hat, Utah, Disposal Site

Figure 12-1 shows the locations of site features in black, including site surveillance features and inspection areas. Site features that are present but not required to be inspected are shown in italics. Observations from previous inspections that are currently monitored are shown in blue text, and new observations identified during the 2019 annual inspection are shown in red. Inspection results and recommended maintenance activities associated with site surveillance features are included in the following subsections. Photographs to support specific observations are identified in the text and in Figure 12-1 by photograph location (PL) numbers. The photographs and photograph log are presented in Section 12.10.

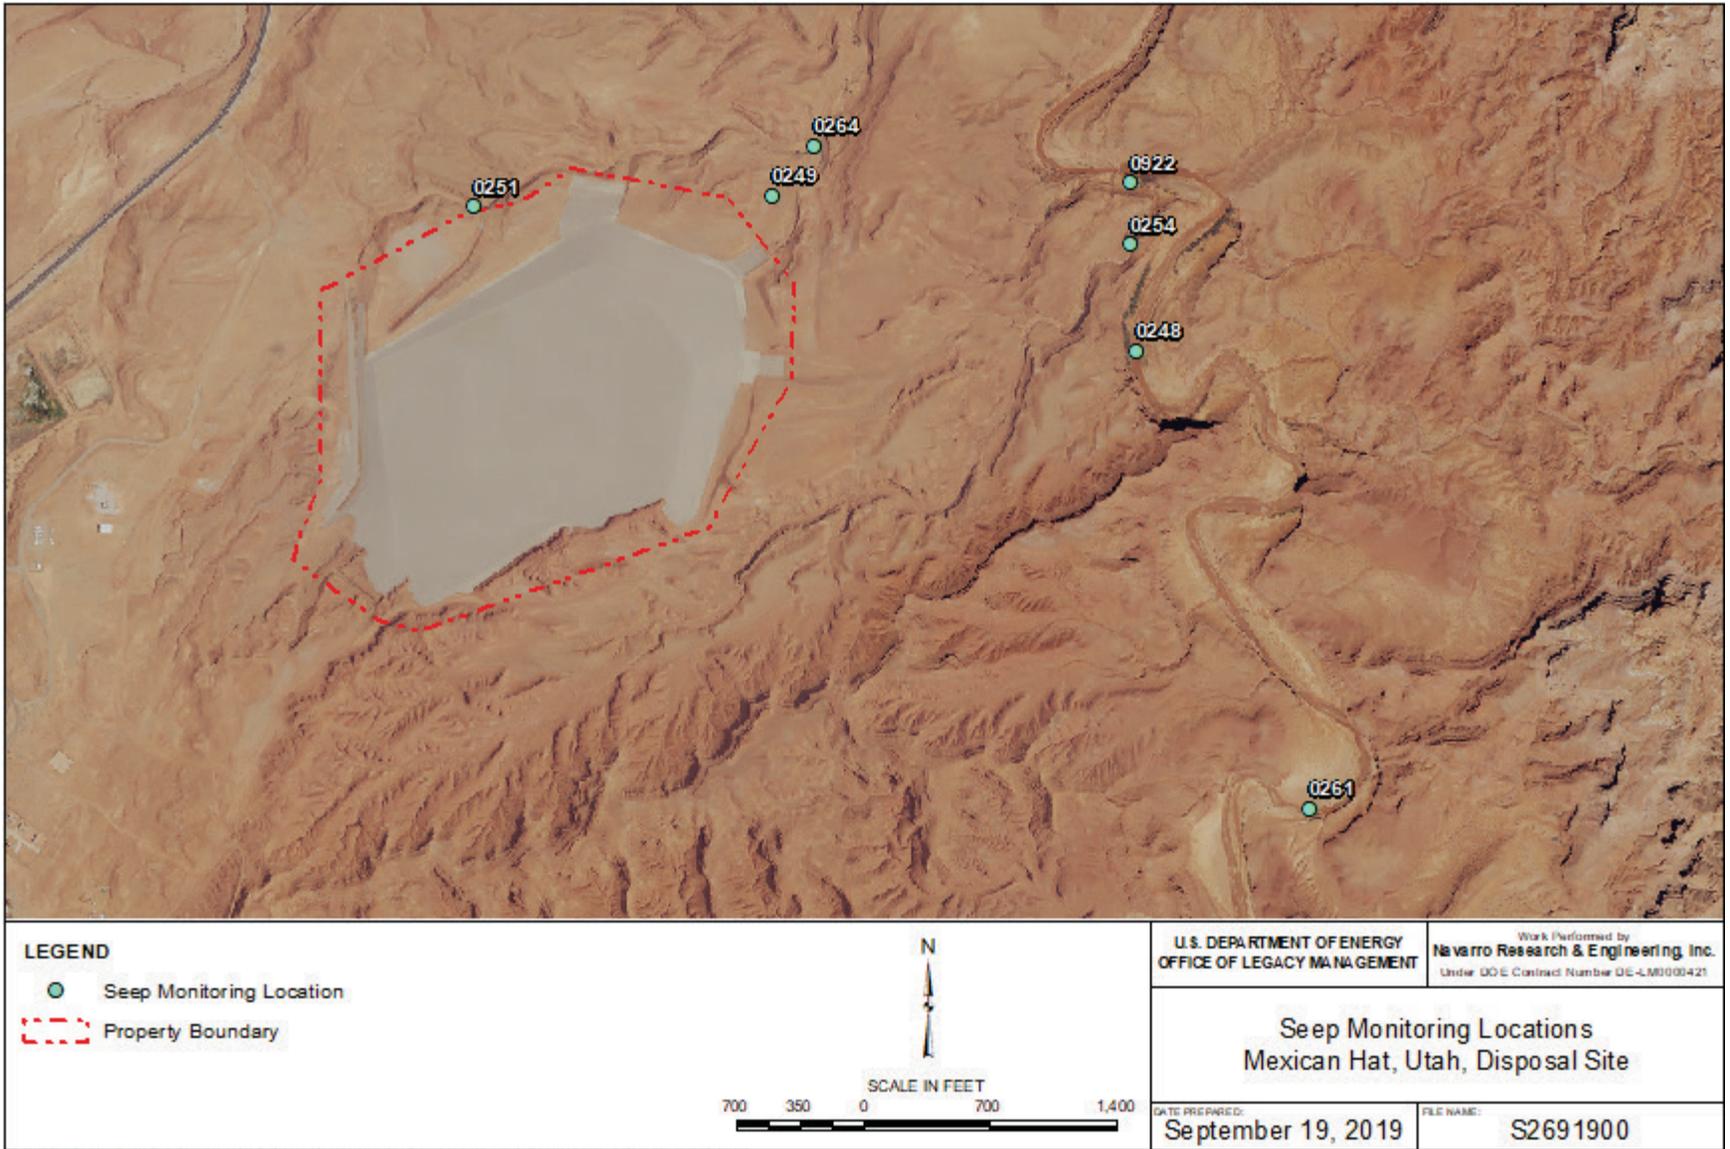
Figure 12-2. Seep Monitoring Locations at the Mexican Hat, Utah, Disposal Site

Since 2010, groundwater discharge from seeps had only been observed at cross-gradient Seep 0248, which typically exhibits dripping conditions. During the inspection, Seep 0248 was observed dripping; since the seep was only dripping and did not exhibit steady flow, an estimated flow rate was not evaluated. Additionally, Seeps 0251 and 0264 were damp, and upgradient (background) Seep 0261 was observed to be flowing during the inspection. Seep 0261 is approximately 0.50 mile upstream of Seep 0248 in Gypsum Creek.

The remaining seeps on the annual monitoring plan exhibited dry conditions during the inspection. Table 12-2 documents the conditions of each monitored seep that was observed during the inspection, including the respective drainage in which each seep occurs and a reference to photographic documentation.
