## 13.0 Naturita, Colorado, Disposal Site

### 13.1 Compliance Summary

Figure 13-1. 2019 Annual Inspection Drawing for the Naturita, Colorado, Disposal Site

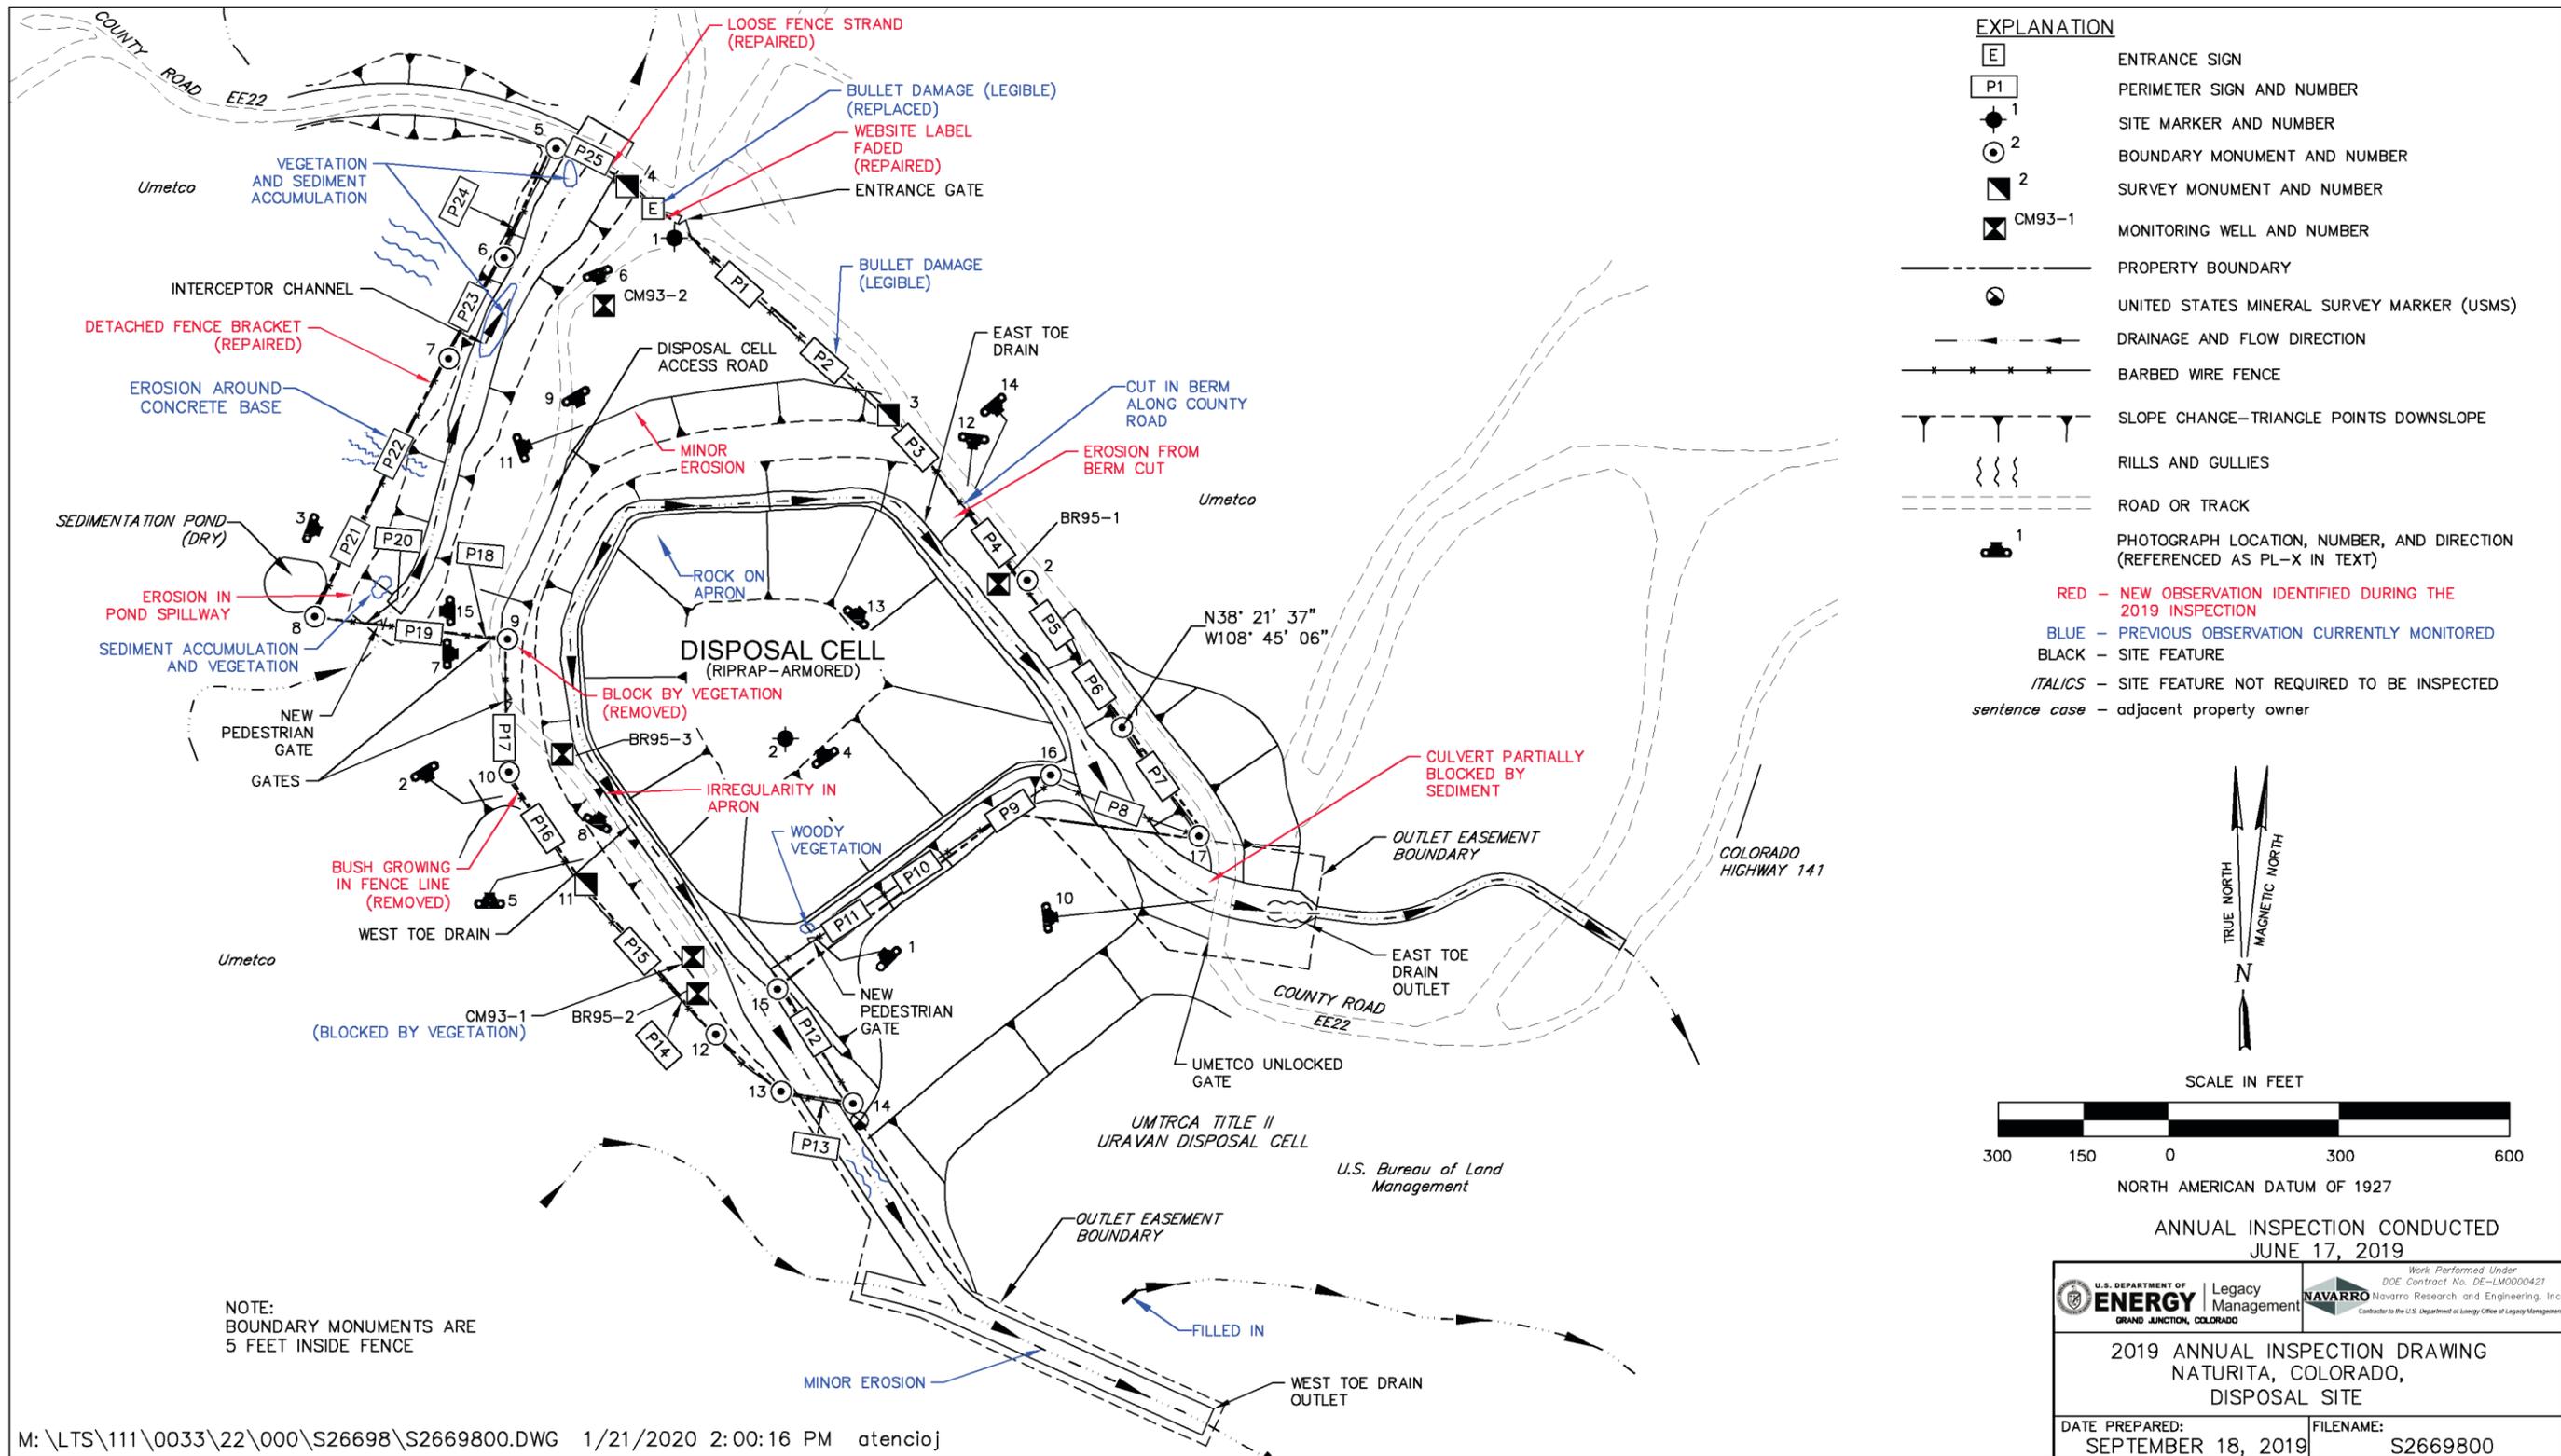
Figure 13-1 shows the locations of site features in black, including site surveillance features and inspection areas. Site features that are present but not required to be inspected are shown in italic font. Observations from previous inspections that are currently monitored are shown in blue text, and new observations identified during the 2019 annual inspection are shown in red. Inspection results and recommended maintenance activities associated with site surveillance features are described in the following subsections. Photographs to support specific observations are identified in the text and in Figure 13-1 by photograph location (PL) numbers. The photographs and photograph log are presented in Section 13.10.
