# **Overview of the Third Quarter 2020 Surveillance and Maintenance Report for the Rocky Flats Site, Colorado**

July - September 2020

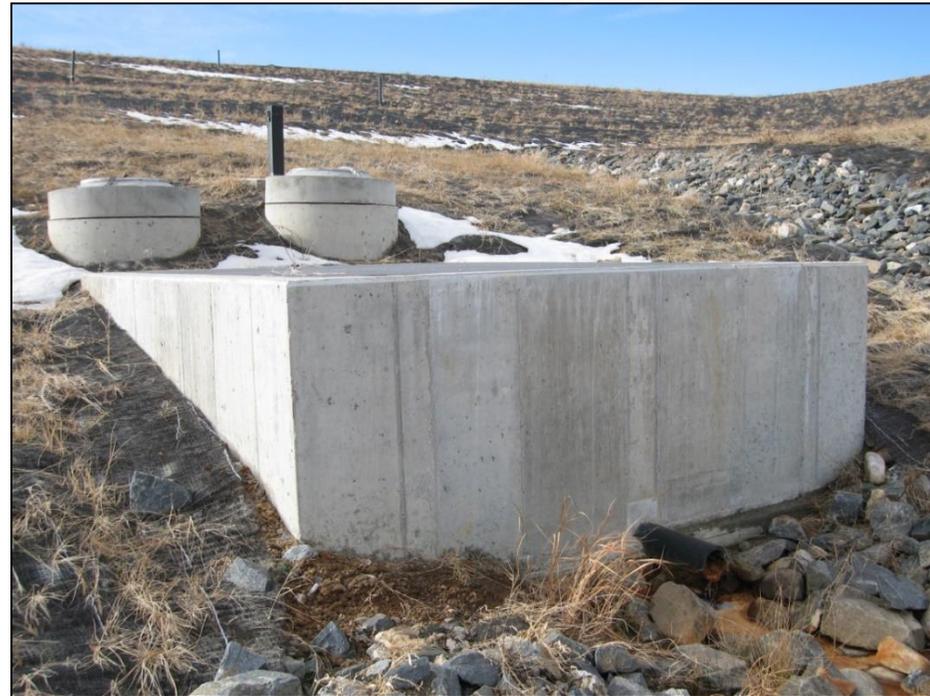
- Present Landfill Treatment System (PLFTS) — location PLFSYSEFF
  - During the third quarter of 2020 at the system effluent, the arsenic concentration was 22 micrograms/liter ( $\mu\text{g/L}$ ), exceeding the standard of 10  $\mu\text{g/L}$ 
    - According to RFLMA protocols, sampling frequency was increased to monthly
    - Arsenic was measured at 4.4  $\mu\text{g/L}$  in the subsequent monthly sample (below the standard of 10  $\mu\text{g/L}$ ) and the increased sampling frequency was discontinued
  - Quarterly concentrations for all other analytes were below applicable RFLMA standards
