5.0 Sherwood, Washington, Disposal Site

5.1 Compliance Summary

The Sherwood, Washington, Uranium Mill Tailings Radiation Control Act (UMTRCA) Title II Disposal Site (site) was inspected on August 19, 2020. The disposal cell, containment dam, and associated drainage features were functioning as designed. Inspectors replaced one missing perimeter sign. No additional maintenance needs or cause for a follow-up inspection were identified.

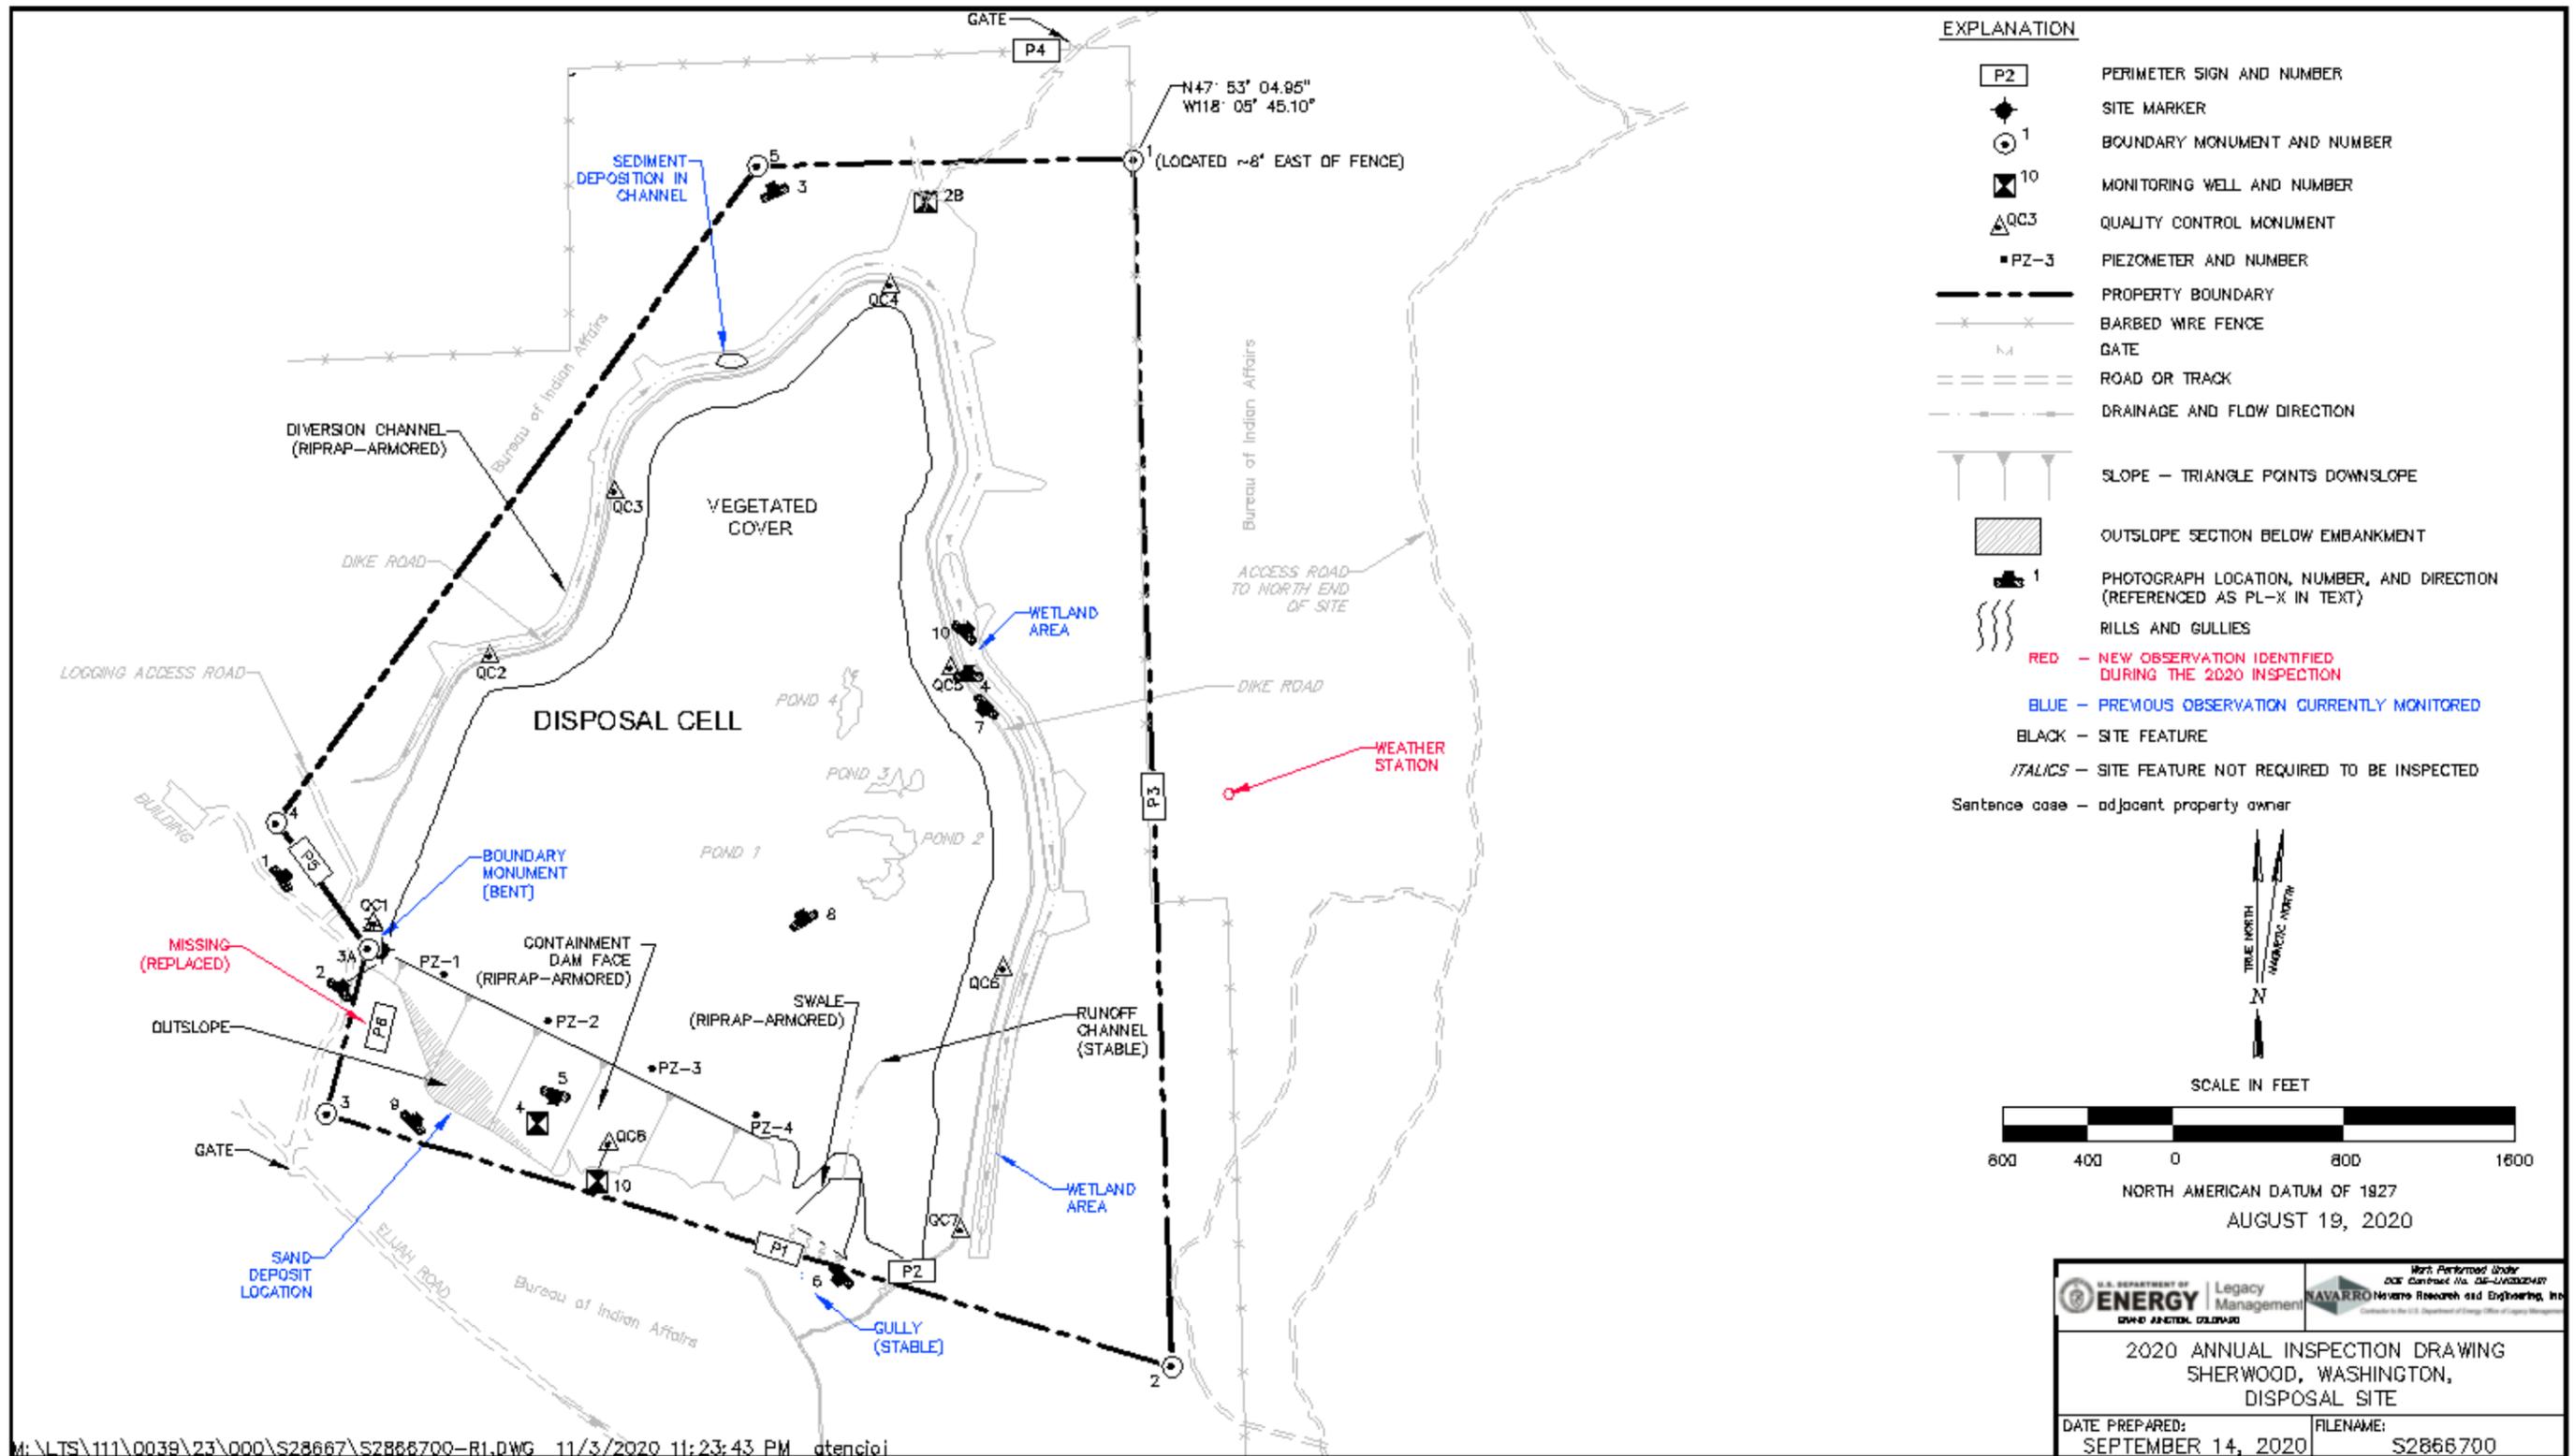
Figure 5-1. 2020 Annual Inspection Drawing for the Sherwood, Washington, Disposal Site

Figure 5-1 shows the locations of site features in black and gray font, including site surveillance features and inspection areas. Site features that are present but not required to be inspected are shown in italic font. Observations from previous inspections that are currently monitored are shown in blue text, and new observations identified in the 2020 annual inspection are shown in red. Inspection results and recommended maintenance activities associated with site surveillance features are included in the following subsections. Photographs to support specific observations are identified in the text and in Figure 5-1 by photograph location (PL) numbers. The photographs and photograph log are presented in Section 5.9.

During the 2016 annual inspection, one location at the base of the rock-covered containment dam face was found to have a deposit of sand that had washed out from underneath the rock cover, as evidenced by a shallow rock-filled erosion feature upgradient of the deposit (Figure 5-1). A subsequent follow-up inspection and evaluation identified that the sandy material was the same as natural undisturbed material nearby. During reclamation, this area of the site was used as a source for fill material used to contour the area below the toe of the containment dam. Review of

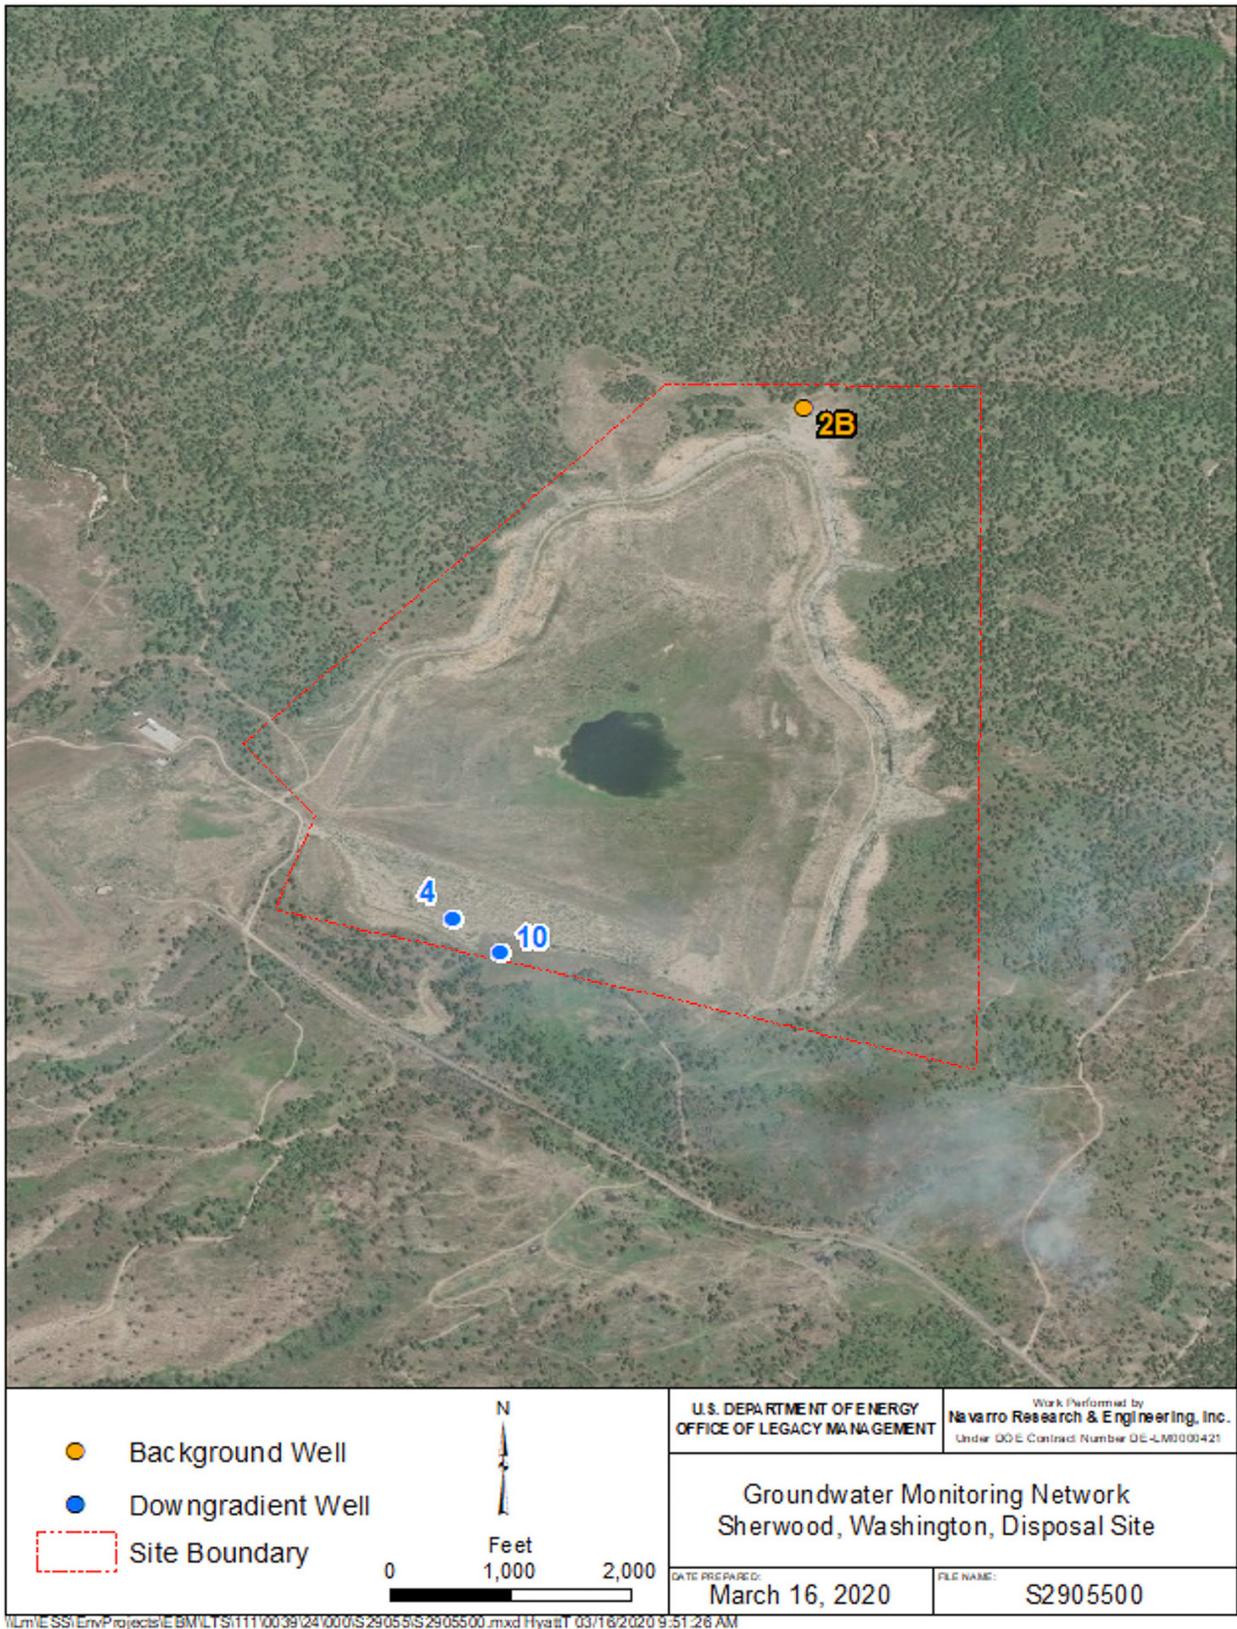
Figure 5-3. Groundwater Monitoring Network at Sherwood, Washington, Disposal Site

Groundwater compliance monitoring is not required at the site. However, as a best management practice stipulated in the LTSP, LM conducts limited groundwater monitoring for several indicator parameters. Samples are collected annually from background monitoring well 2B north of the disposal cell and from downgradient wells 4 and 10 near the base of the containment dam (Figure 5-3). Samples are analyzed for chloride and sulfate, which are primary indicator

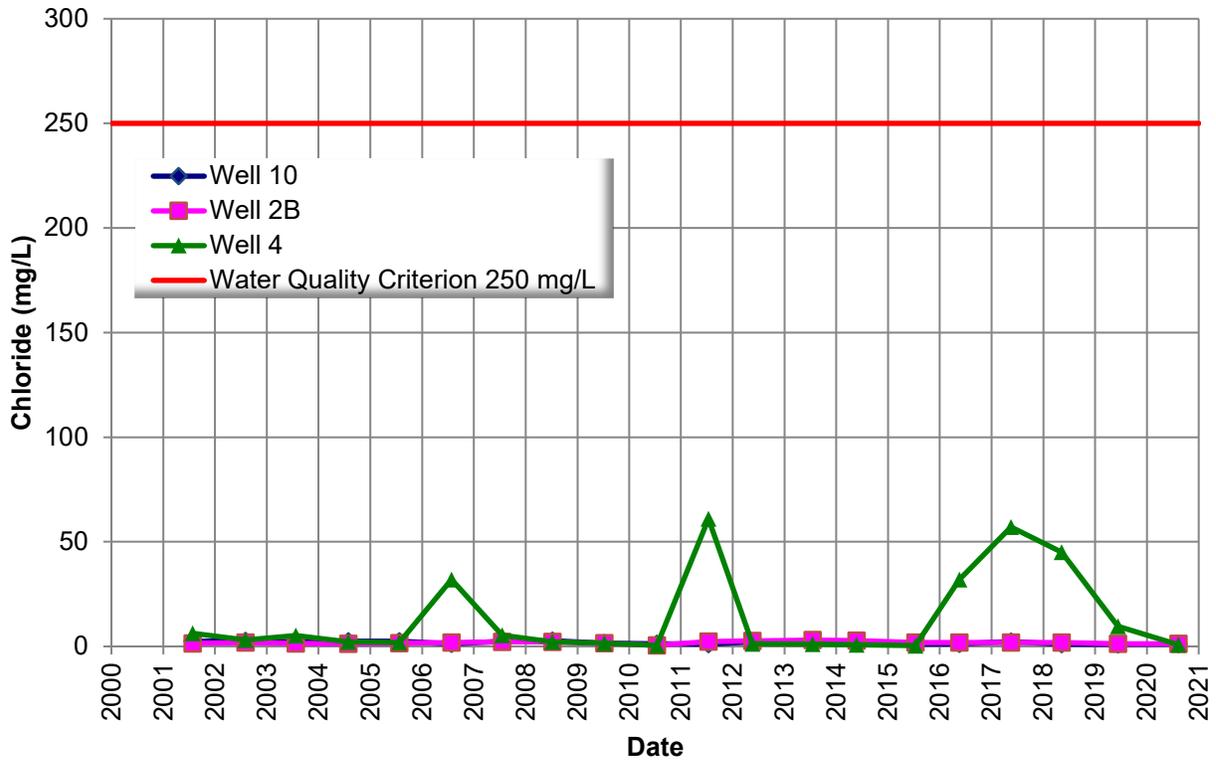
Figure 5-4. Chloride Concentrations at the Sherwood, Washington, Disposal Site

Figure 5-4 and Figure 5-5 show concentrations of chloride and sulfate, respectively, in the three monitoring wells since 2001. Occurrences of slightly elevated chloride levels in well 4 correspond with the higher sulfate levels measured at the same location. Water elevations for each of the monitoring wells are shown in Figure 5-6 and Figure 5-7. Groundwater occurs in two hydrostratigraphic units: (1) the alluvium that lies on top of the bedrock surface and (2) the conductive bedrock, including weathered bedrock in the upper portion and unweathered or competent bedrock below. Monitoring well 10 is completed in the alluvium, and wells 2B and 4 are completed in the bedrock.

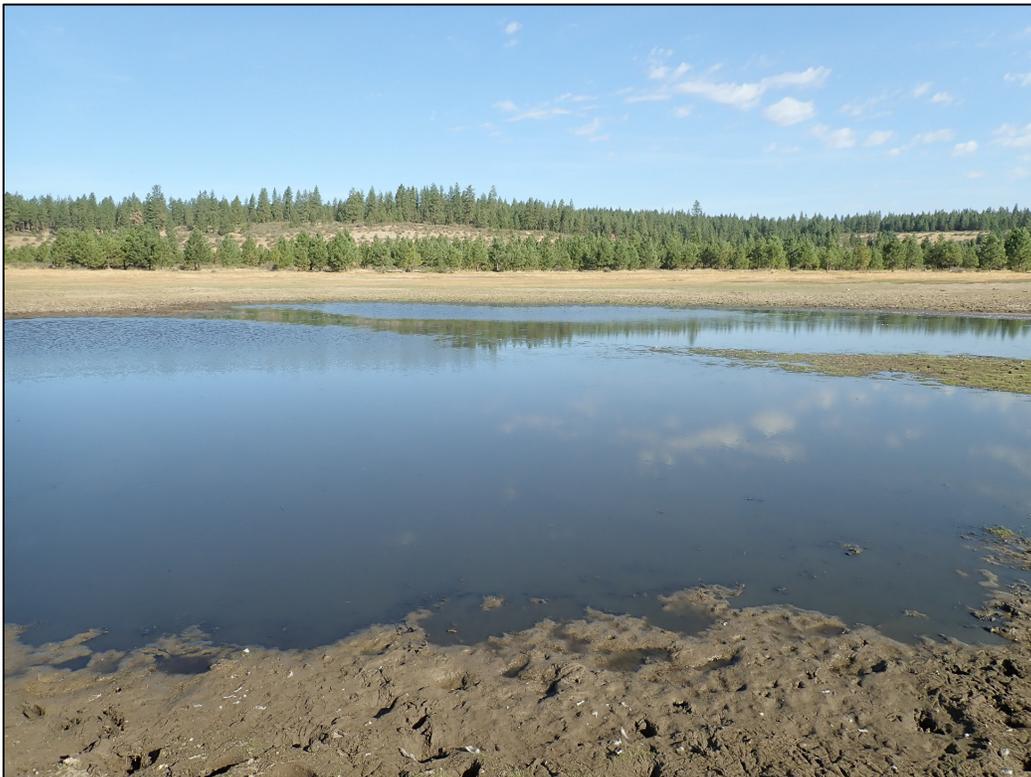
PL-8. Disposal Cell Pond 1, View Northwest

Designers of the disposal cell predicted that some settlement would continue after the uncompacted cover was put in place. As explained on page 2-14 of the LTSP, the cover was designed to be self-healing with regard to impacts from freezing and thawing, biointrusion, and settlement (DOE 2001). The largest area of settlement is referred to as Pond 1 (PL-8). The plant species present indicate the presence of year-round moisture below the surface of the pond area. Other minor depressions—designated as Ponds 2, 3, and 4—were dry at the time of inspection. An evaluation of topographic surveys conducted in 2016 and 2017 indicated that up to 4.4 ft of settlement has occurred near the ponds since construction of the disposal cell. The cover was designed to withstand up to 10 ft of settlement (DOE 2018a). The shallow ponds are considered favorable features on the disposal cell cover, but LM will continue to monitor the surface for unusual settlement features to verify the cover’s integrity and ensure that the disposal cell is performing as designed. Periodic aerial remote sensing surveys to collect high-resolution topographic data are anticipated to begin in 2021 to monitor the surface of the disposal cell. No maintenance needs were identified.
