Post-Closure Inspection Report for the Tonopah Test Range and Nevada Test and Training Range, Nevada

For Calendar Year 2018

May 2019

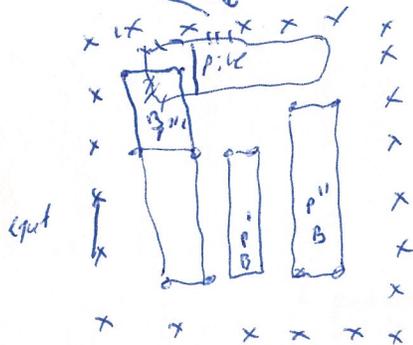
1240 arrive 453 P^{iv} tunnels (60")

- Pⁱ - Pic 6 hadger hole center tunnel
- Pⁱⁱ - Pic 7 " " north tunnel
- Pⁱⁱⁱ - Pic 8 " " south tunnel
- P^{iv} - Pic 9 tunnel
- Pic 10 tunnels

- **CAU 453**, CAS 09-55-001-0952 (Area 9 Landfill): Three animal burrows were observed in each of the waste trenches. Also, the soil mound to the west of the trenches had deep runnels along the west side. The covers and soil mound were repaired during the week of October 8, 2018.
