**OPERABLE UNIT 9,  
SITE SCOPING REPORT  
VOLUME 6 - PHOTO HISTORY REPORT**

**MOUND PLANT  
MIAMISBURG, OHIO**

February 1992

**Department of Energy  
Albuquerque Field Office**

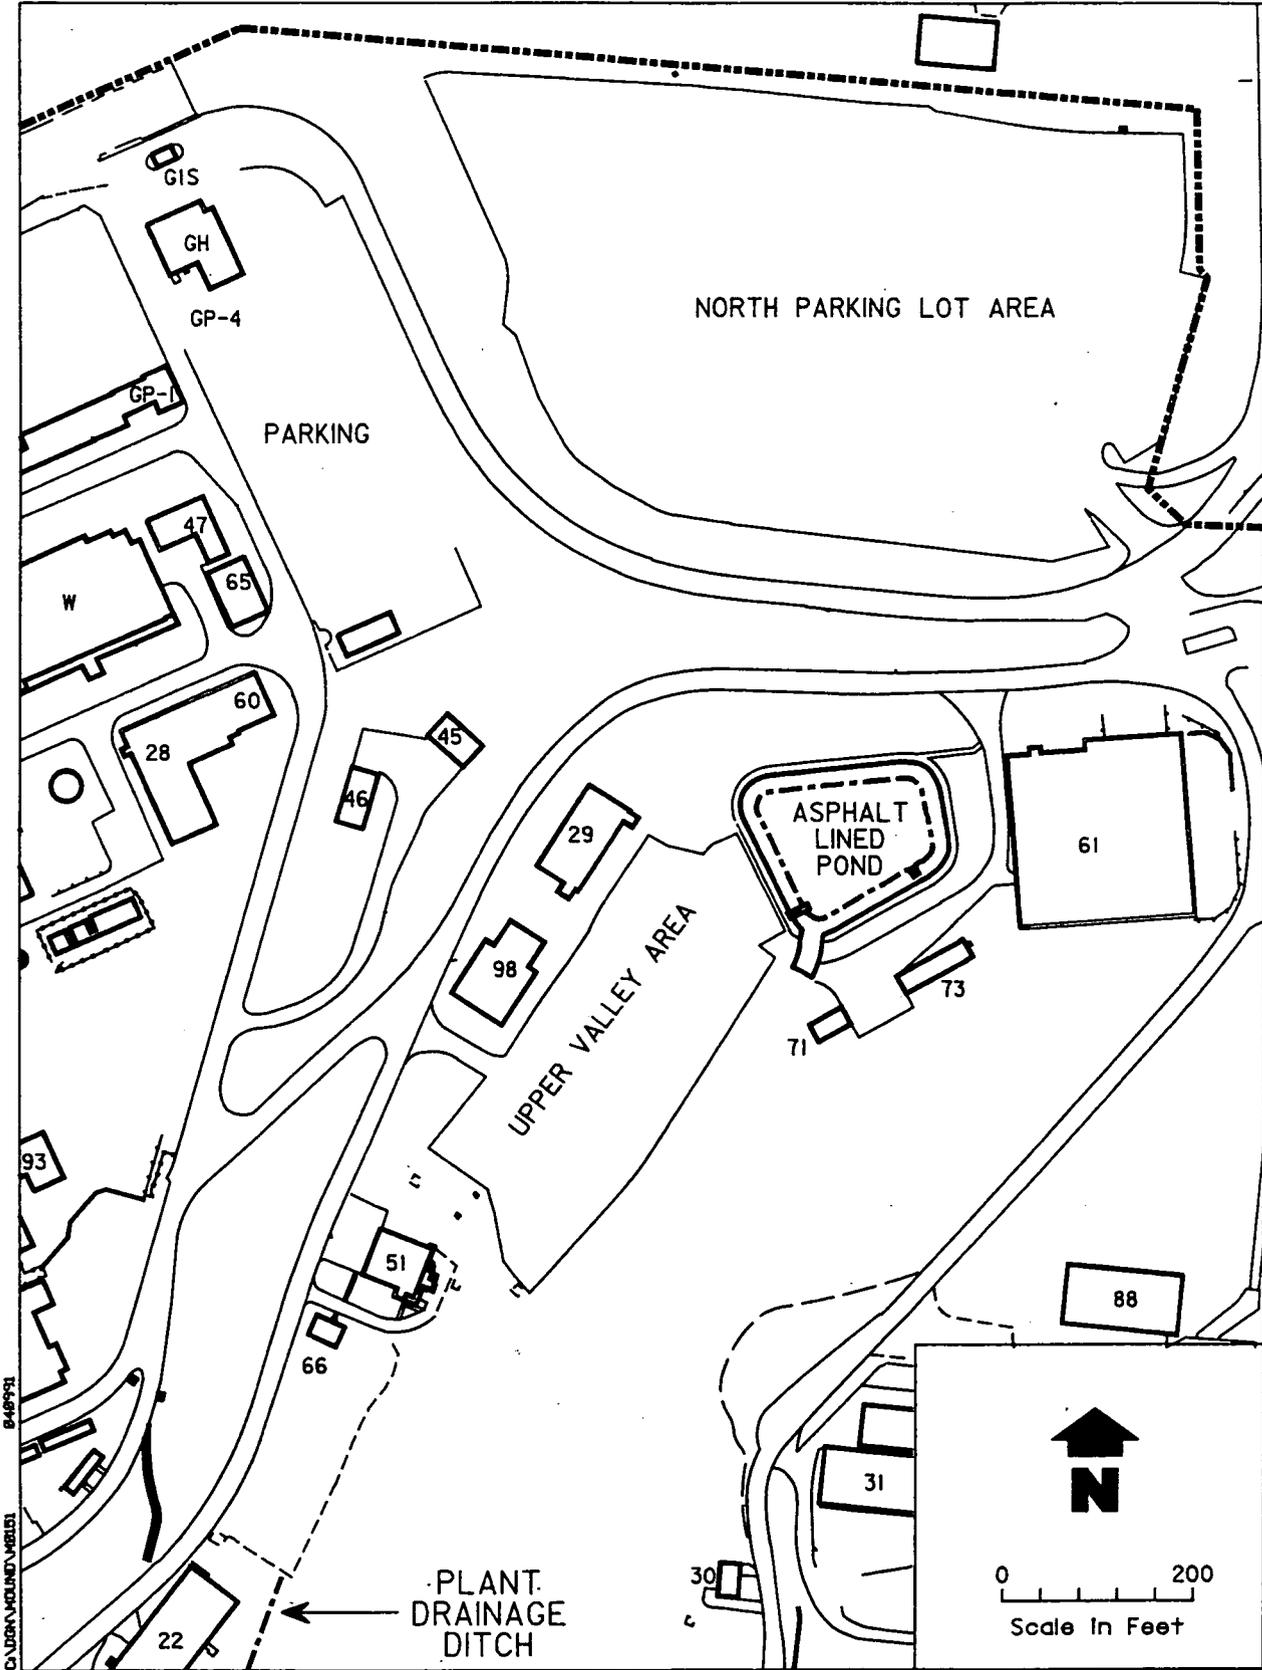
Figure 4.4. Interpretive map of Northern Study Area - 1968.

The small paved parking lot near the guard house (Figure 4.4) had been paved by 1968. The hillslopes east and south of this parking lot have been regraded. All previous evidence of surface disturbance have been obscured. This parking lot continues in use with no major changes in 1973, 1975, 1979, and 1981.

By 1968, the tiered parking lot is considerably expanded to the north and east extending to the limits shown on the base map. The area to the south of the access road shown in the 1964 photograph has been completely regraded (Figure 4.4). These activities obscure all previous evidence of surface disturbance. The expanded parking lot continues in use in 1973, 1975, 1979, and 1981.

By 1968, channel in-filling has proceeded to the extent that an extensive building platform has been constructed to the west of the old drainage course, partially obscuring the drainage (Figure 4.4). The buildings on the 1964 platform have been replaced, with Building 29 situated farther to the north in an area identified as a storage area in 1964. Storage of materials is evident south of this building along the platform and some piles of material are present on the channel in-fill platform. An area of disturbed soil lies north of the remaining intact drainage, which is bordered on the west by an area of debris. The eastern portion of the North Valley Area is crossed by linear patterns of disturbed or cleared and re-vegetated areas. The site of the smaller drum storage area in 1959 has now been completely graded, resulting in a large pile of dirt lying just north of the road. Downslope from this feature and bordering it on the northeast is a C-shaped earthen berm the width of the dirt pile. Across the road, Building 31 has been constructed on a site that had been used for drum storage in 1959.

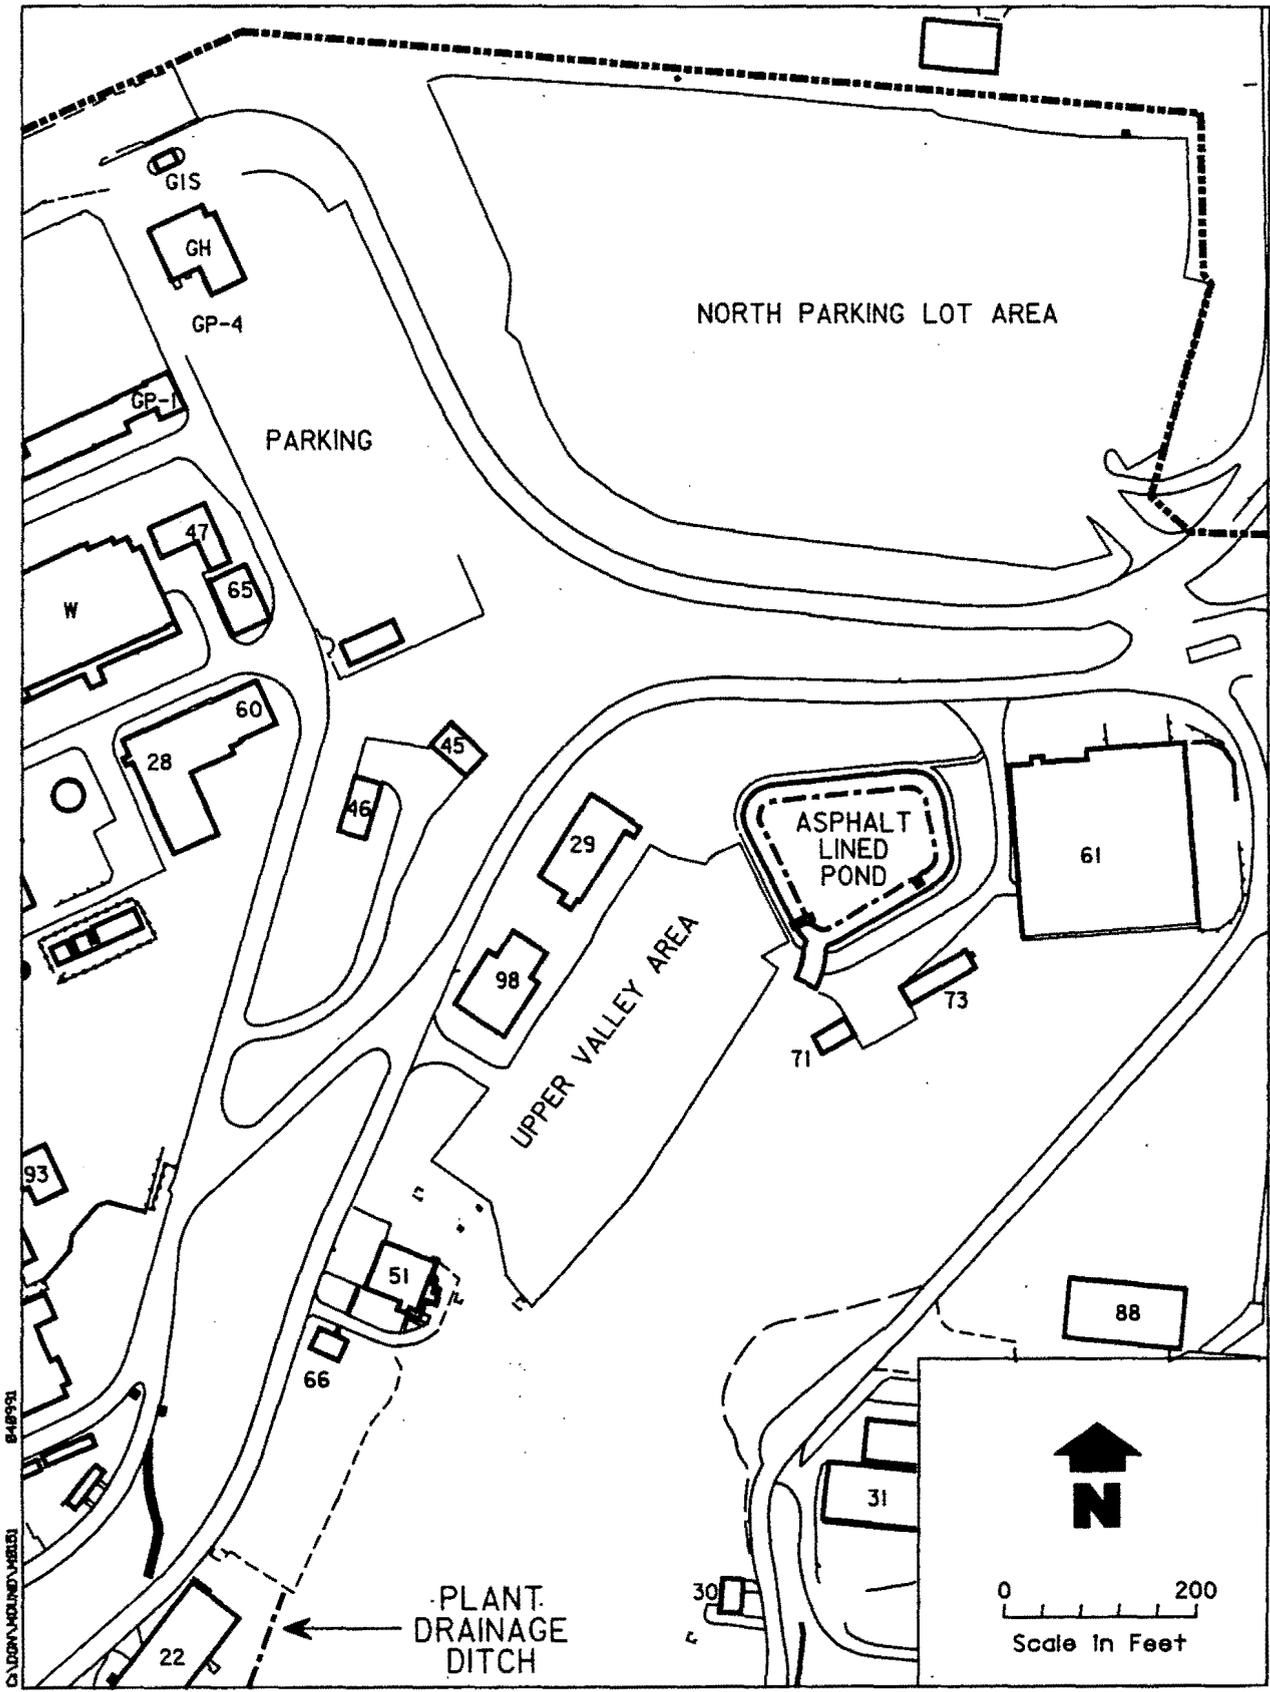
Figure 4.5. Interpretive map of Northern Study Area - 1973.

pipeline. Debris is evident on the channel in-fill surface behind the buildings and a new road enters the area on the north where none existed in 1968. The large dirt pile northeast of Building 31 in 1968 has been leveled resulting in a platform and disturbed slope which continue to be bordered by a large earthen berm. Re-vegetated and cleared linearities remain evident to the east of the old drainage course, and shallow drainages flow to the northwest and west down this slope.

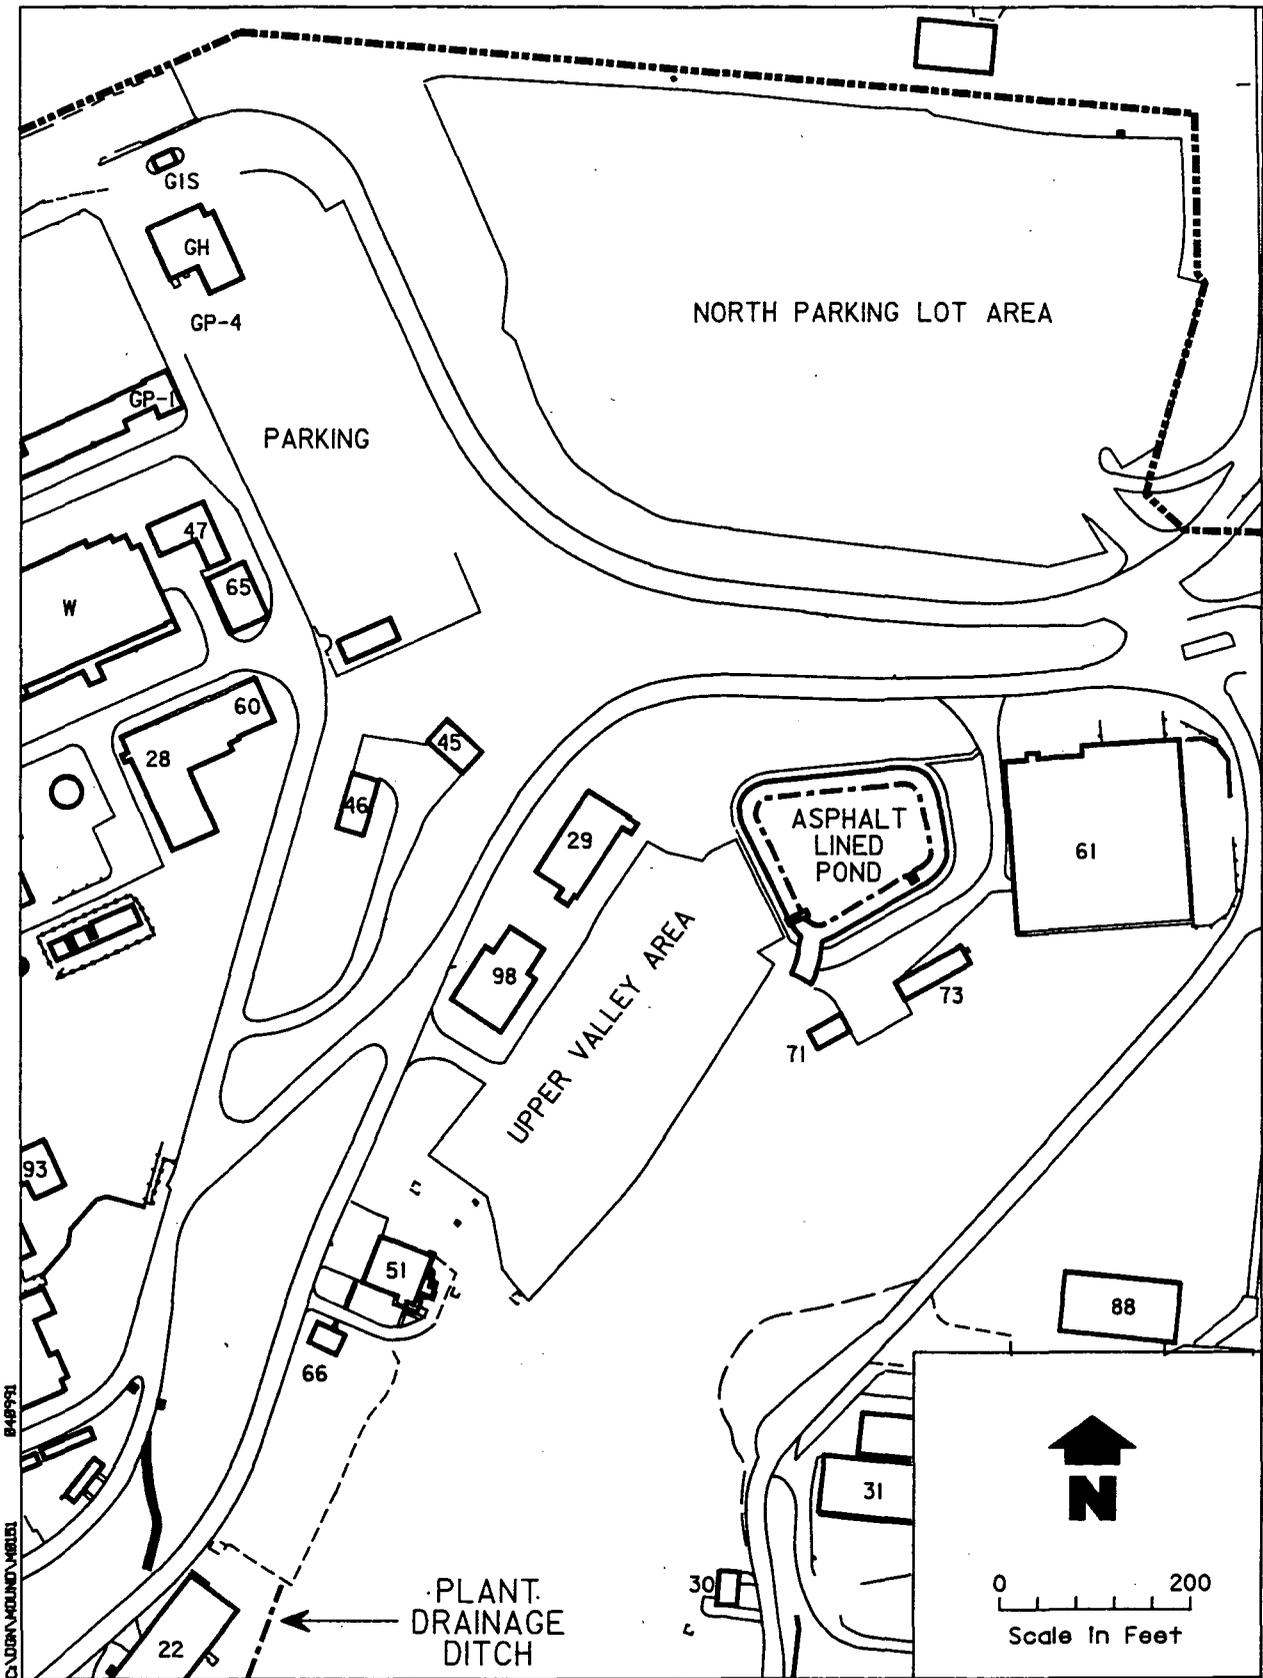
Figure 4.6. Interpretive map of Northern Study Area - 1975.

Large portions of the platform formed by channel in-fill are re-vegetated by 1975 (Figure 4.6), but the central valley area behind the buildings still appears cleared. The drainage channel appears to have reestablished itself north of Building 22 and a berm now exists north of Building 51 that forms the southern edge of a drainage impoundment. In-filling continues near Building 22. A large cleared surface now exists between Buildings 51 and 22. Two large cleared areas are situated at the top and bottom of the eastern side of the North Valley Area. Numerous small drainages flow to the north and west down this slope. A new road "turnout" is in use along the main road at the northern end of the area. Two undefined channels are situated downslope from the berm on the east.

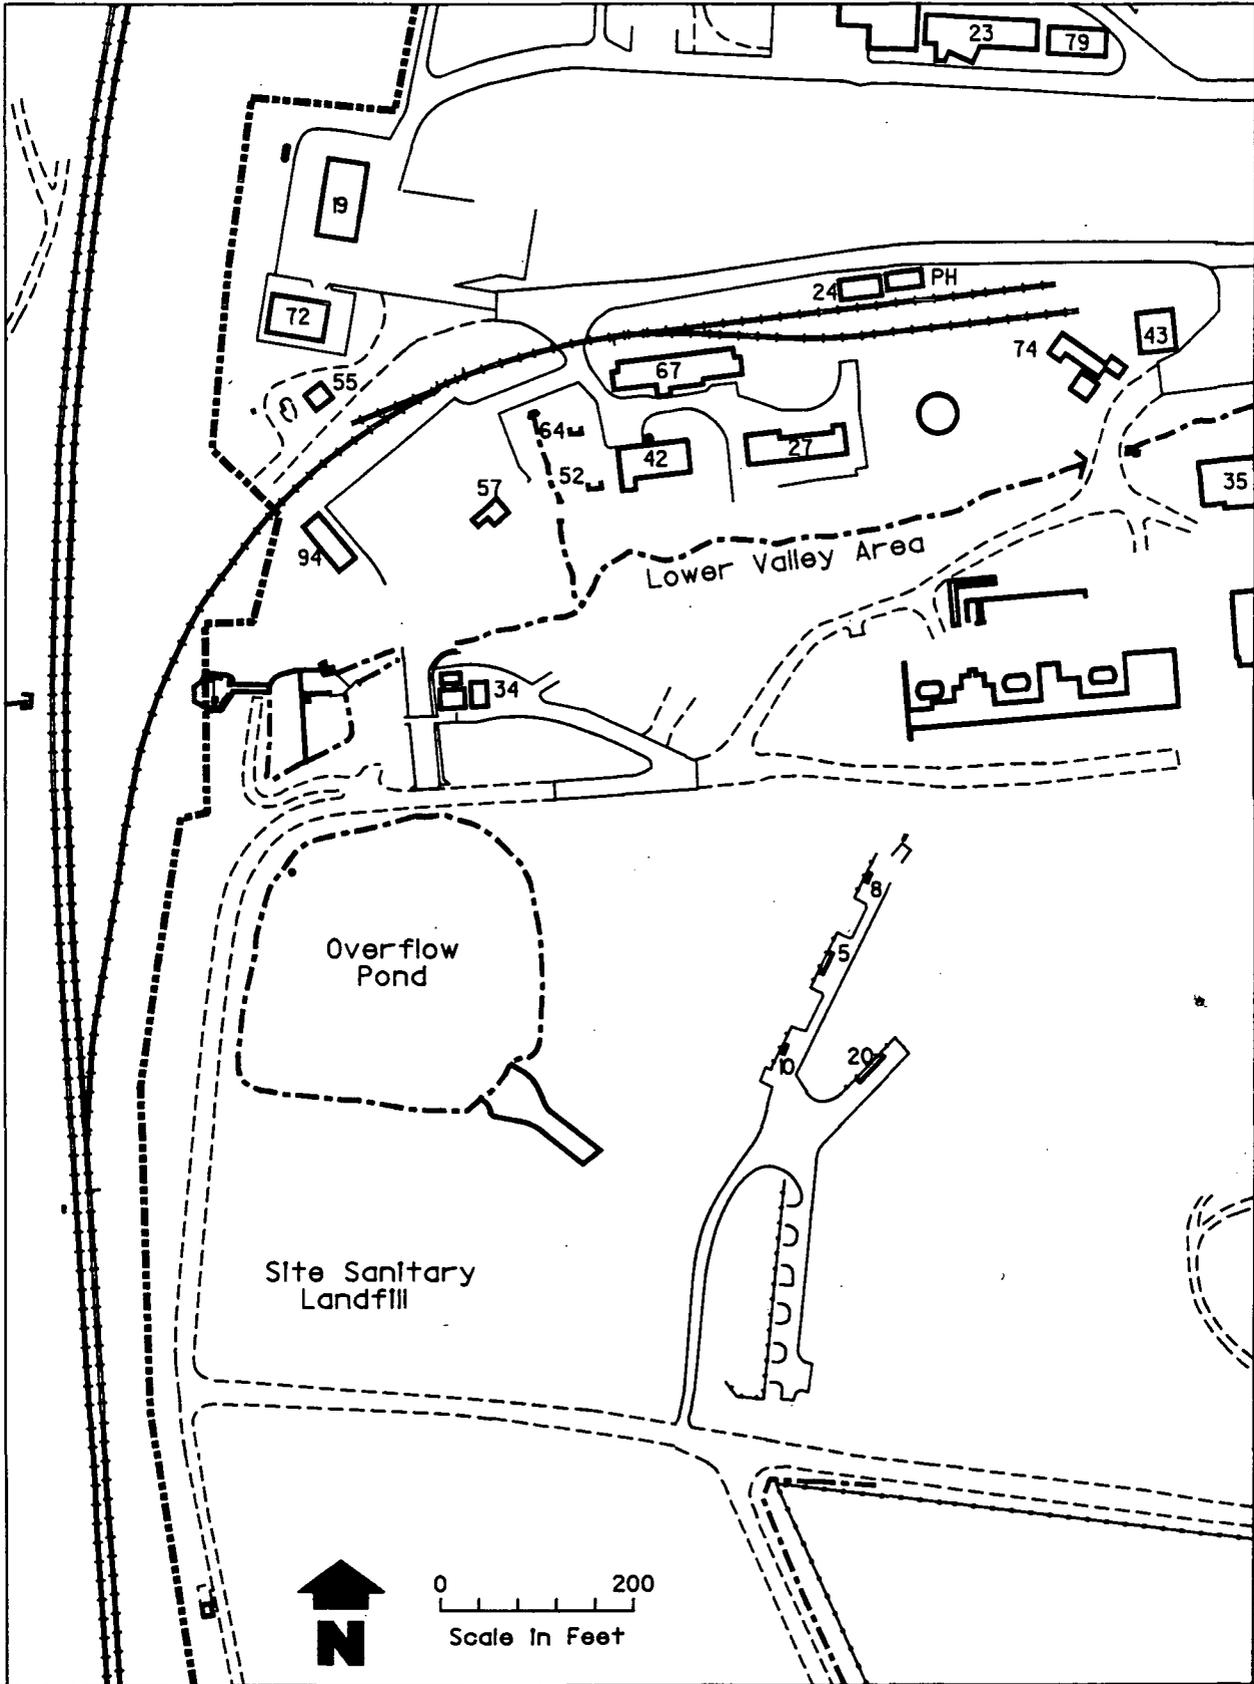
Figure 4.10. Interpretive map of Southern Study Area - 1964.

In the 1964 photograph, although on a much smaller scale, a long clearing has been exposed immediately west and parallel to the 1959 fence line (Figure 4.10). A large cleared surface extends across the location of the excavated firing range materials and the 1959 S-shaped road. Cleared areas in the landfill are expanded, possibly by excavation. They border the western and southern edges of the landfill and extend over the current southwest junction of the road as shown on the base map (Figure 4.10). Container storage is evident along the western edge of the road, and debris or debris piles are present in cleared areas to the east of the roadway. Regrading of the entire 1959 landfill area is evident by 1964 as the eastern trench and western trench identified in the 1959 photograph are no longer evident. A large elongated pile of materials in the central portion of the landfill is surrounded by clearings. A broad east-west trench appears to the northeast of the cleared areas. Smoke is evident in the area.

In 1964, the large clearing south of the drainage ditch is still visible (Figure 4.10) with a road or trail leading across it to the west. The small clearing is no longer sharply defined, but there are three small disturbed areas in its former location. Lying to the east and upslope from the large clearing is another large cleared surface. Disturbed soil borders it on a northwest-facing slope. To the north of the drainage, the 1959 storage area has been cleared of materials and the area around the encircling road has been cleared. Some debris is present to the south of this road. South of the railroad, to the west of the former storage area, are multiple lines of storage containers on a cleared surface. Storage containers are also evident in a storage area north of the railroad.

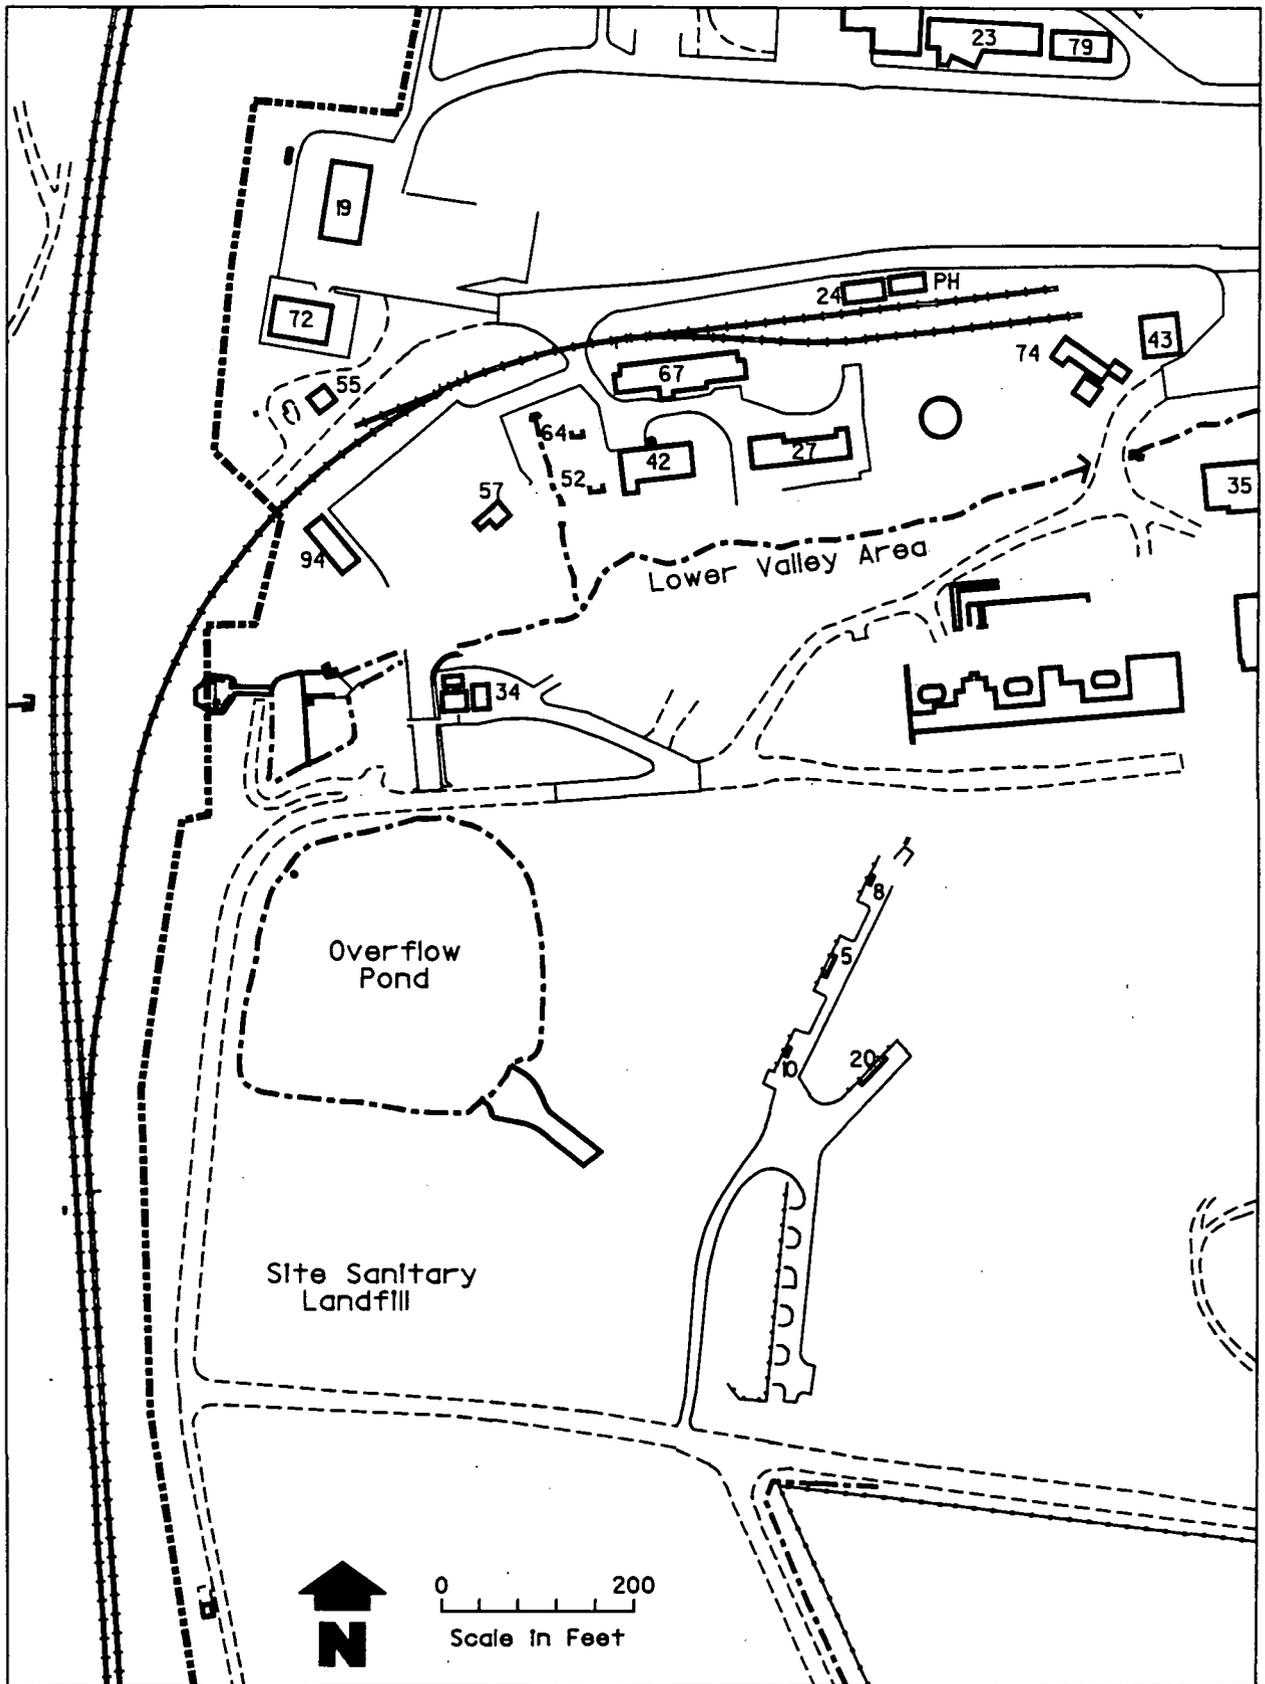
Figure 4.11. Interpretive map of Southern Study Area - 1968.

Activities visible in the 1968 photograph are extensive and varied (Figure 4.11). A new access road extends north on the hillside to meet the main road. Bordering the western edge of the new access road in the northern part of the landfill is a disturbed hill top surface containing unidentified circular areas. This road provides access to a large cleared surface in the central portion of the landfill. Drainage is evident across this surface to the south, and a massive pile of fill is situated on the southern end of this cleared area. The cleared area is bordered on the west by another new road, which provides access from the south. This new road continues north around the northwestern rim of a pool of standing water and then trends to the northwest to meet the main roadway along the western edge of the landfill. West of this access road and pool is an extensive disturbed surface that includes debris piles and piles of fill. Storage areas containing debris and storage drums are located between the fence line and landfill area. Surface debris, possibly in the form of drums, is contained in the storage areas and in debris piles in the landfill. The old S-shaped road on the east appears to be re-established, and additional fill from the firing range can be seen near the southern end. Drainage from the east slopes continues to flow into the center of the landfill.

Building 34 is established in the clearing south of the drainage in the 1968 photograph (Figure 4.11). The large cleared surface to the east in the 1964 photograph now appears smaller in areal extent and includes areas of disturbance or vegetation near the center. Farther to the west of the cleared surface holding Building 34 is an area of disturbed soil, possibly on a slope, bordering a small, semi-circular, flat, cleared surface. The straight, upslope edge of the semicircle is backed by a linear east-west excavation, possibly in the form of a retaining wall. A small circular depression is visible on the northwestern edge of this cleared surface. Three areas of disturbed soil lie to the north of the main road (Figure 4.11). Former storage areas to the north of the drainage ditch appear to be cleared. Building 27 is established by 1968. A new drum storage area is located to the northwest of Building 27 at a road intersection. The large drum storage area evident in the 1964 aerial photograph south of the railroad, is cleared and its surface expanded. No containers are evident. It is bordered on the south by a disturbed surface and slope and is cut on the west by a short drainage channel.

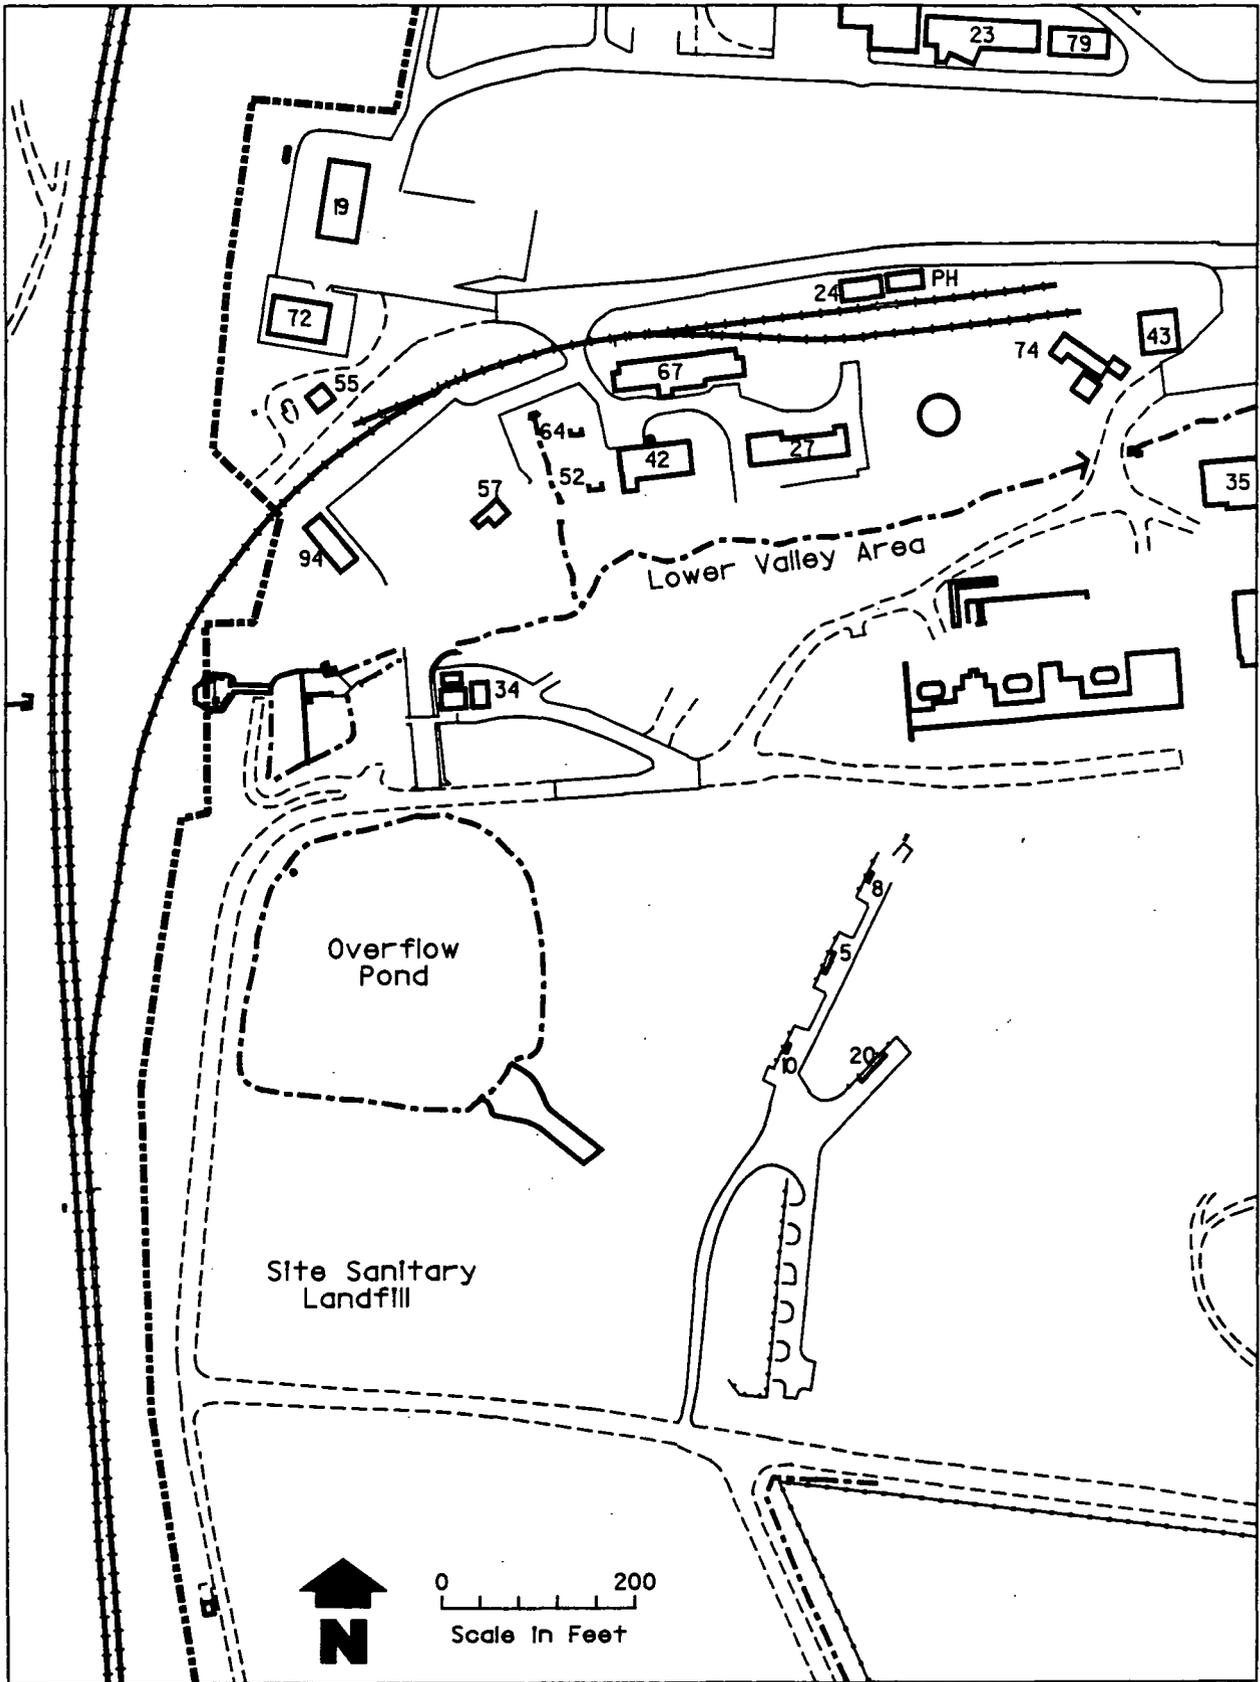
Figure 4.12. Interpretive map of Southern Study Area - 1973.

Formal trenching in the landfill is evident in the 1973 photograph (Figure 4.12). Two trenches bordered on the north and south by three berms have been excavated. Massive piles of fill occur along the eastern edge of the upper level of the landfill, and piles of fill border a southern ramp. The access road established from the north (evident in the 1968 photograph) continues to provide access to the upper level of the landfill on the east. Three roads, one of which appears to be a constructed ramp, provide access to the western lower level of the landfill. The pile of material present on the southern end of the cleared surface in the 1968 photograph remains on the southern edge of the landfill. Cleared surfaces extend north of the main excavation area onto the hill and slope. Debris piles are located on the hilltop. Storage continues between the road and the fence line in the form of drums or other containers. Drums or other containers are also visible in an area of debris between the two northernmost landfill access roads on the west. Southeast of the landfill cells is an undefined pattern of multiple small circles that may be other storage containers. An undefined linear feature intersects the hillslope above the landfill from the west.

In 1973, a second building is present to the east of Building 34 (Figure 4.12). The western end of the surface has been cleared and contains some stored material or possibly a small structure. Farther to the west, the area that appeared as a small, flat, cleared surface in the 1968 photograph is heavily vegetated and may have been sloped to meet the retaining wall, which is no longer visible. The clearing on the slope to the east of Building 34 shows major disturbance and possible debris. To the northwest of this feature is a short trench lying just off the road. North of the drainage ditch, a formal parking lot has been established on the site of the large drum storage area evident in the 1964 photograph. This lot is bordered by a cleared, disturbed surface.

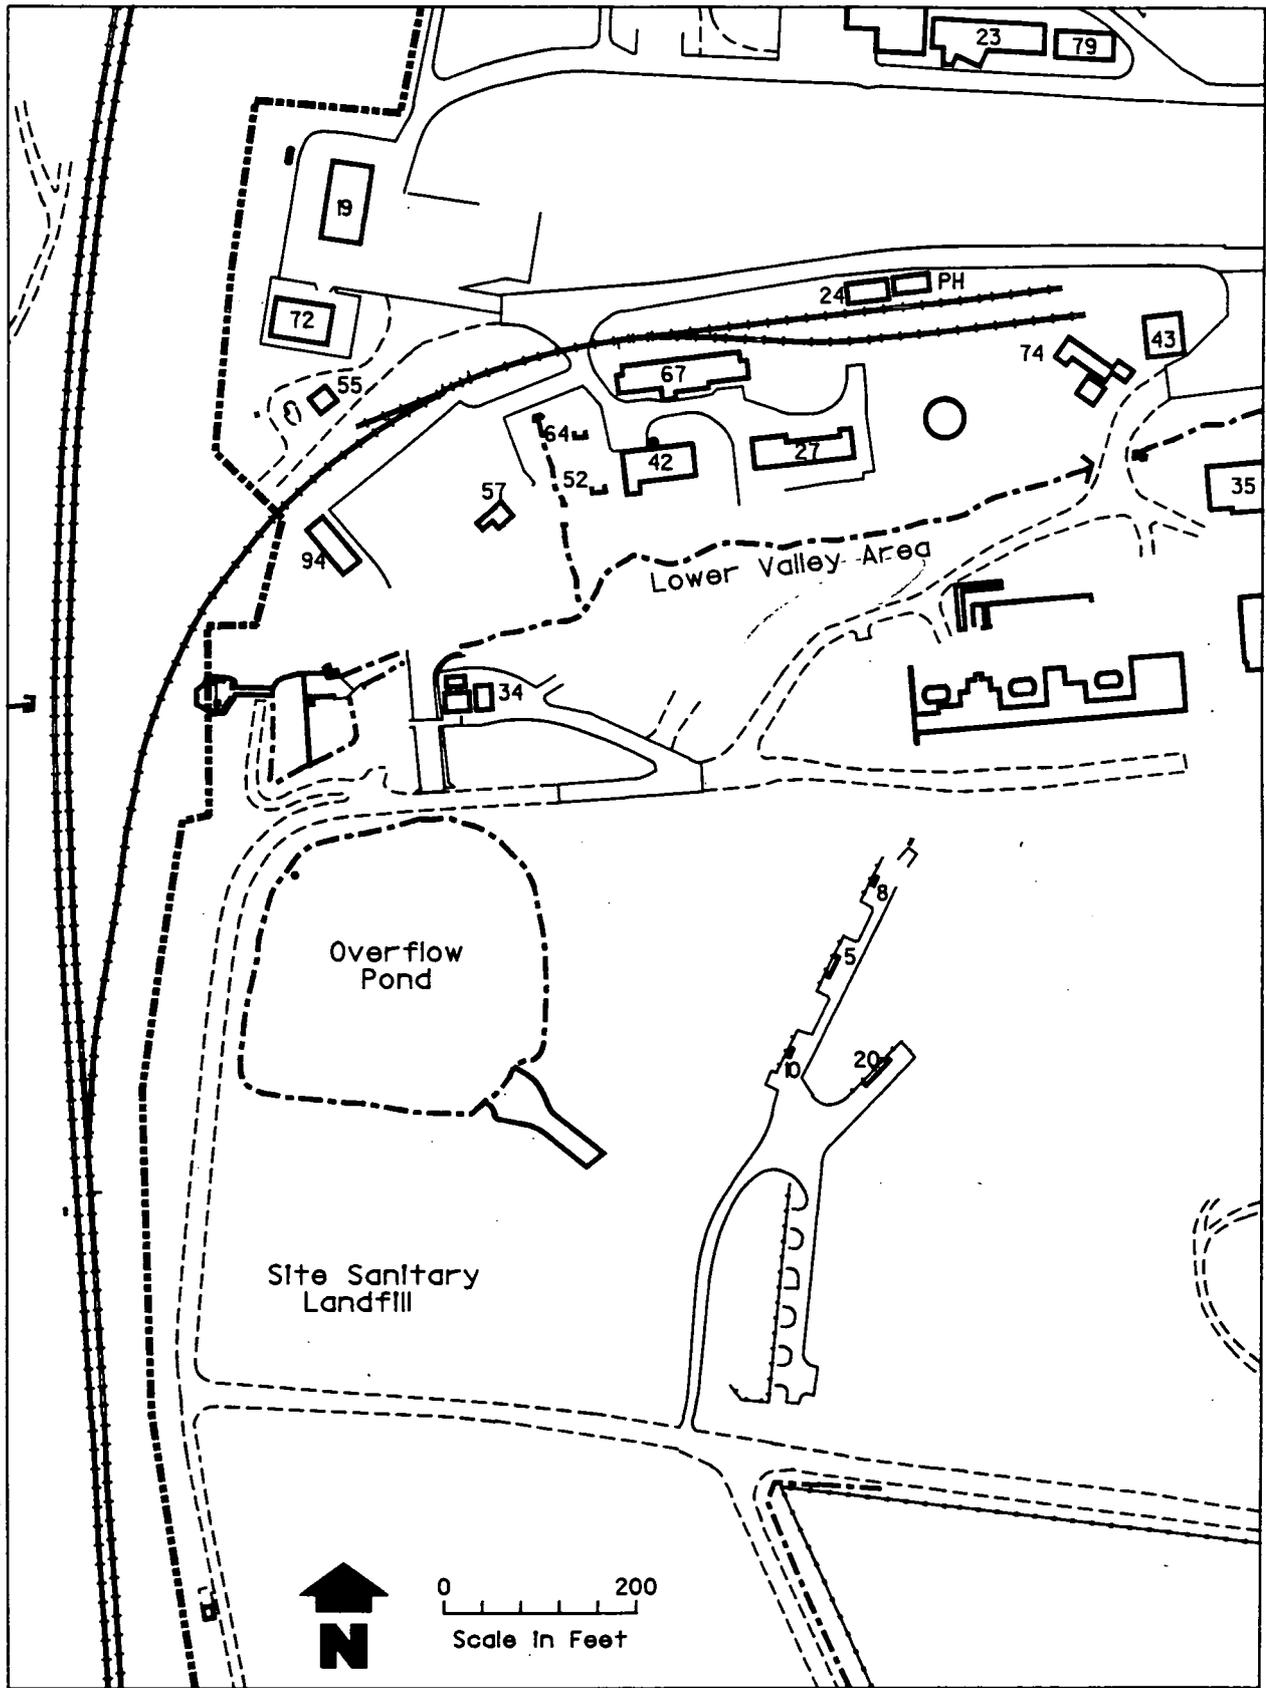
Figure 4.13. Interpretive map of Southern Study Area - 1975.

By 1975, three landfill cells have been established (Figure 4.13), and the northernmost cell has been partial filled. Berms separate all three cells and an additional C-shaped berm is located at the western end of the lower (southernmost) cell. A roadway extends into this lower cell. Remnants of the southern access ramp are still visible. Piles of debris are located along the western edge of the landfill and standing drums are visible in storage areas along the access road to the lower cell. A large pile of fill with a pit excavated into its western end borders the access ramp on the north. Flooding on the western end of this ramp appears to have breached the southwestern junction of the main road. Storage of containers and materials is still

evident on the western side of the main road east of the fence line. Ponding occurs, possibly in a small excavation that borders the main road in the northeast.

In the 1975 photograph, a weir and dam or outfall structures on the lower reach of the plant drainage ditch are evident (Figure 4.13). The clearing that includes Building 34 appears formally established. Two smaller clearings to the west of the Building 34 complex and east of the dam, contain disturbed surfaces with the lower of the two containing some debris. A larger disturbed area to the east of Building 34 shows surface discoloration and a linear pattern that may indicate initial incision of west-flowing drainages. A storage area bordered on the south by a disturbed surface is evident south of Building 27 and the plant drainage ditch. North of the drainage ditch, tributary drainages appear to have been established that flow south of the disturbed surface bordering the parking lot south of the railroad tracks. A debris pile is situated at the southern edge of this surface. Building 18 was constructed by 1975. Some type of storage area is apparent south of Building 19.

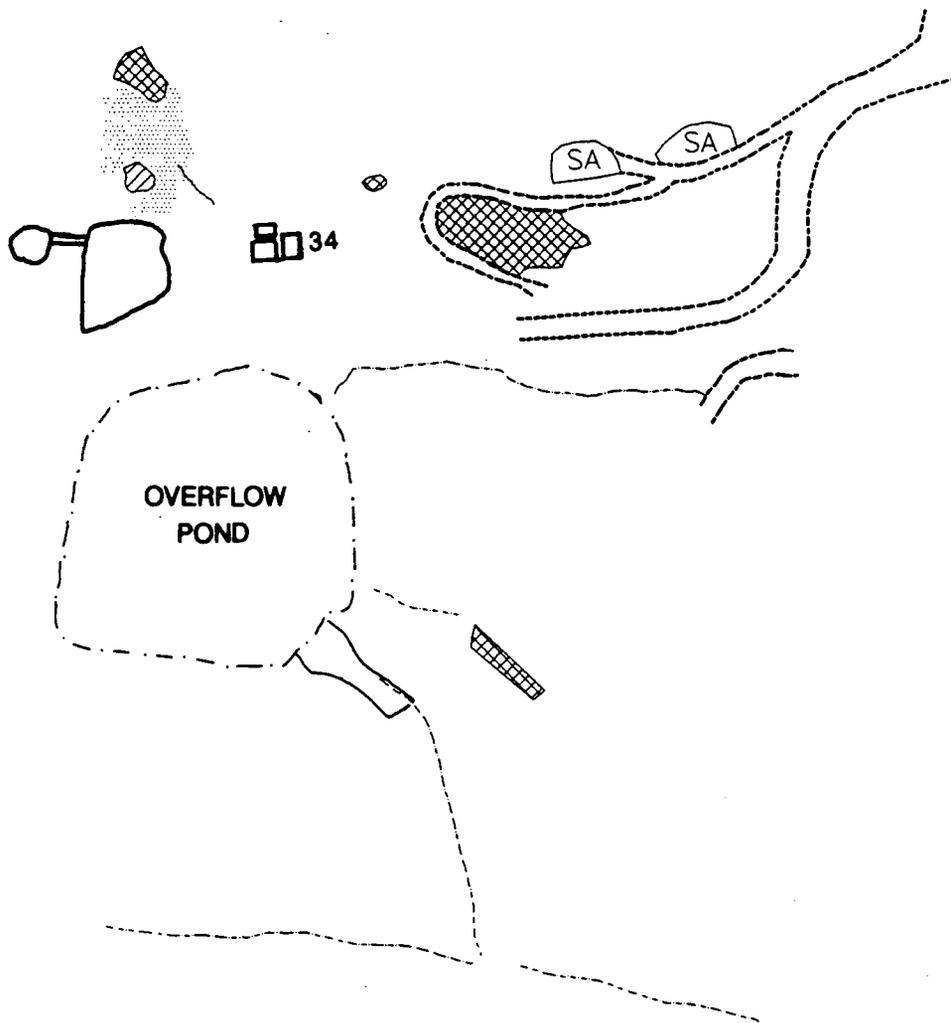
Figure 4.14. Interpretive map of Southern Study Area - 1979.

By 1979, the construction of the overflow pond and site sanitary landfill are complete (Figure 4.14). The overflow pond receives excess storm water flow from the plant drainage ditch via an overflow channel from the north. Surface water runoff from the hillslope to the east flows directly into the overflow by a drainage channel east of the site sanitary landfill. The landfill area assumed its present configuration by 1979, with the exception of a lined flume later installed at the southeast corner at the overflow pond to control erosion.

By 1979, retention basins have been constructed on the lower reach of the drainage ditch (Figure 4.14). The cleared area to the east of Building 34 is heavily vegetated but does show evidence of former disturbance. It is now bordered on three sides by a dirt road. Two storage areas are located to the northeast of this cleared area (south of the Building 27 and the drainage ditch). Drums and other materials

are evident. North of the drainage ditch, the cleared surface southwest of the parking lot in the 1975 photograph is still present, as is the pile of materials visible in the 1975 photograph on its southern edge. Short drainages flow south from this surface. Disturbed soils are evident near the present location of Building 94, possibly in preparation for construction. Considerable construction that is not mapped has taken place north of the drainage ditch (Figure 4.14).

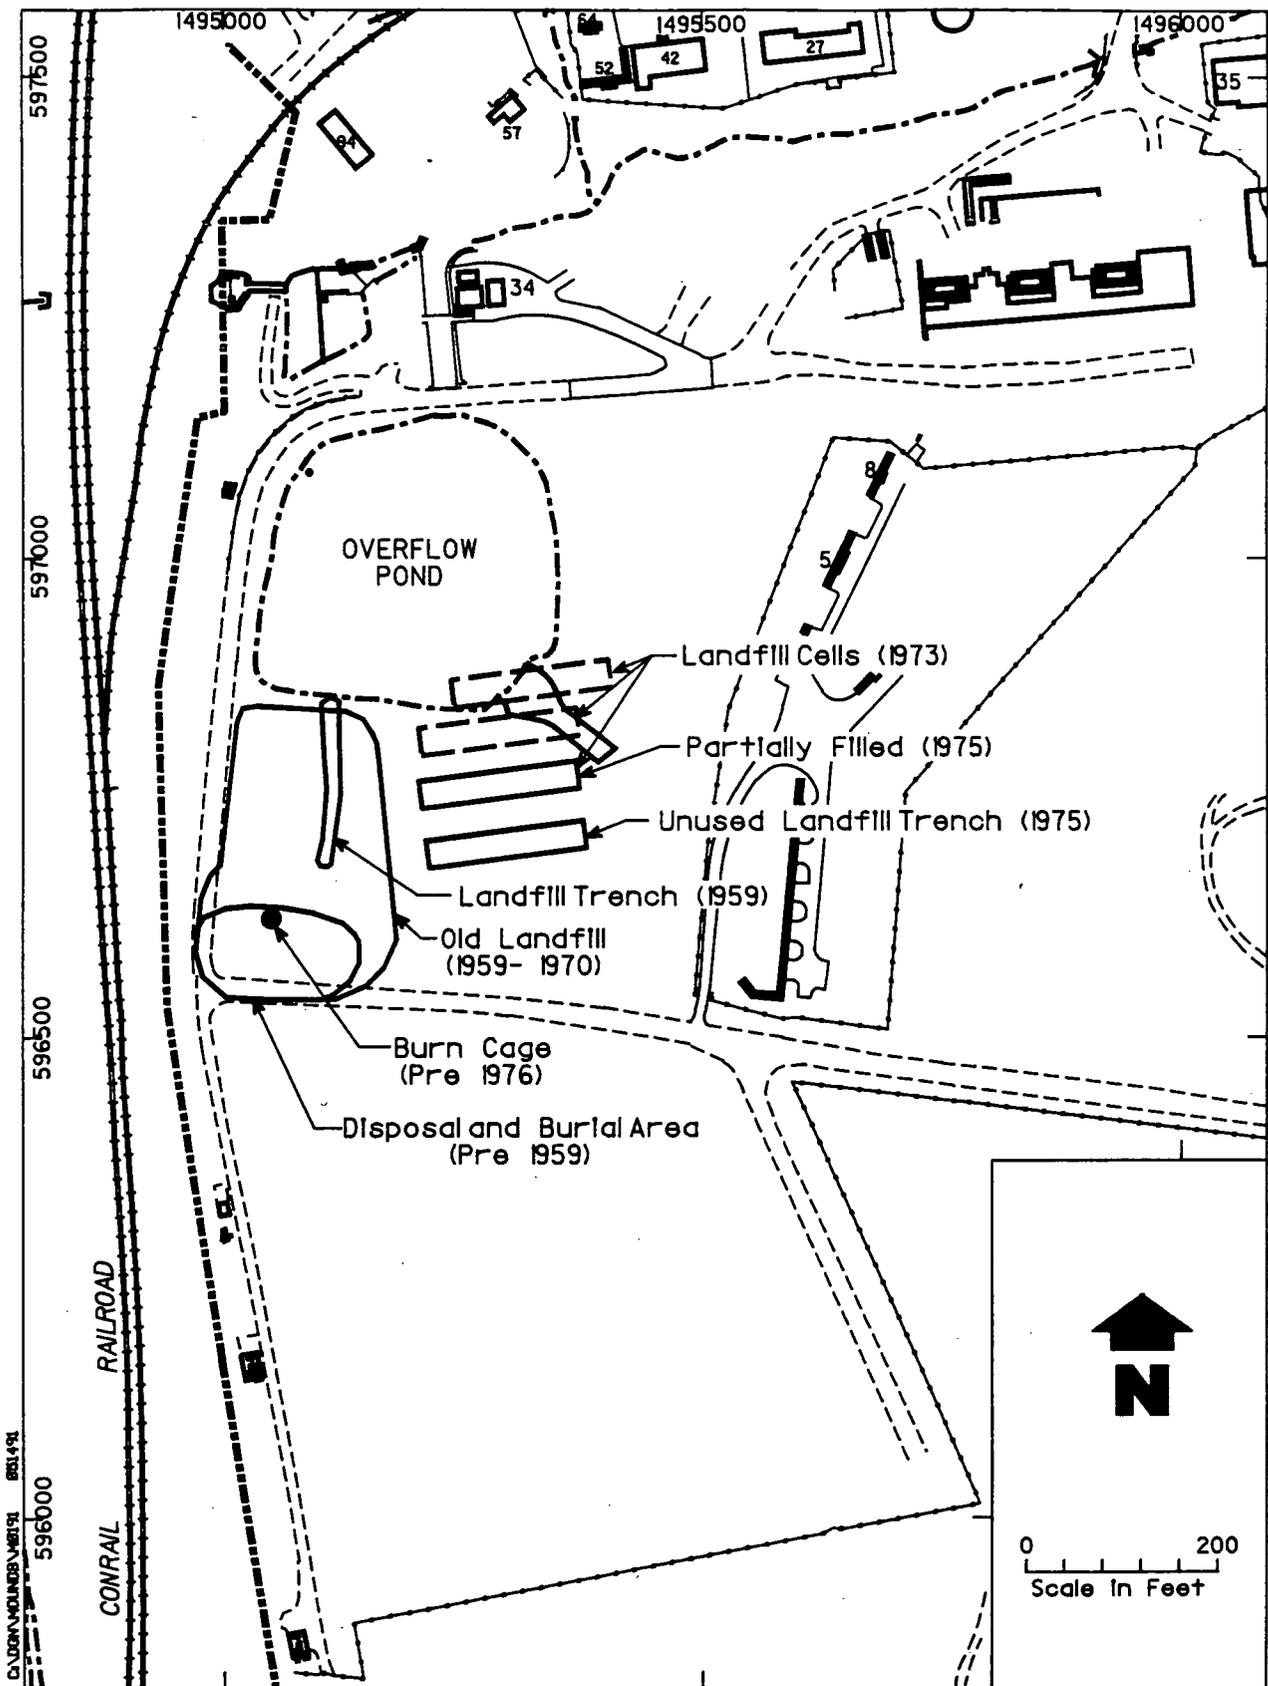
Figure 5.3. Photo interpretation of geometry and extent of historical site sanitary landfill areas.

portion of the landfill area, north and east of the existing roads. In fact, the 1959 photographs indicate that excavation activities extended into the present road intersection. By 1964 the roadway was backfilled enough to permit through traffic, but was subjected to periodic flooding from the east. The burial of many thousands of crushed, empty, thorium ore drums probably extended under the current road intersection (DOE 1991b, 1991c). This investigation indicates that the activities of open burning and general waste and burned trash burial during the period prior to 1968 were limited to central and southwestern portions of Area B. Figure 5.3 presents an updated interpretation of the geometry at Area B from evidence presented in this report.
