**DRAFT PRE-REMEDIAL INVESTIGATION OF IHSS 118 1 DATA SUMMARY REPORT - JEL-120-97**

**DRAFT  
PRE-REMEDIAL  
INVESTIGATION OF  
IHSS 118.1  
DATA SUMMARY  
REPORT**

**RF/RMRS-97-111-UN**

**November 20, 1997**

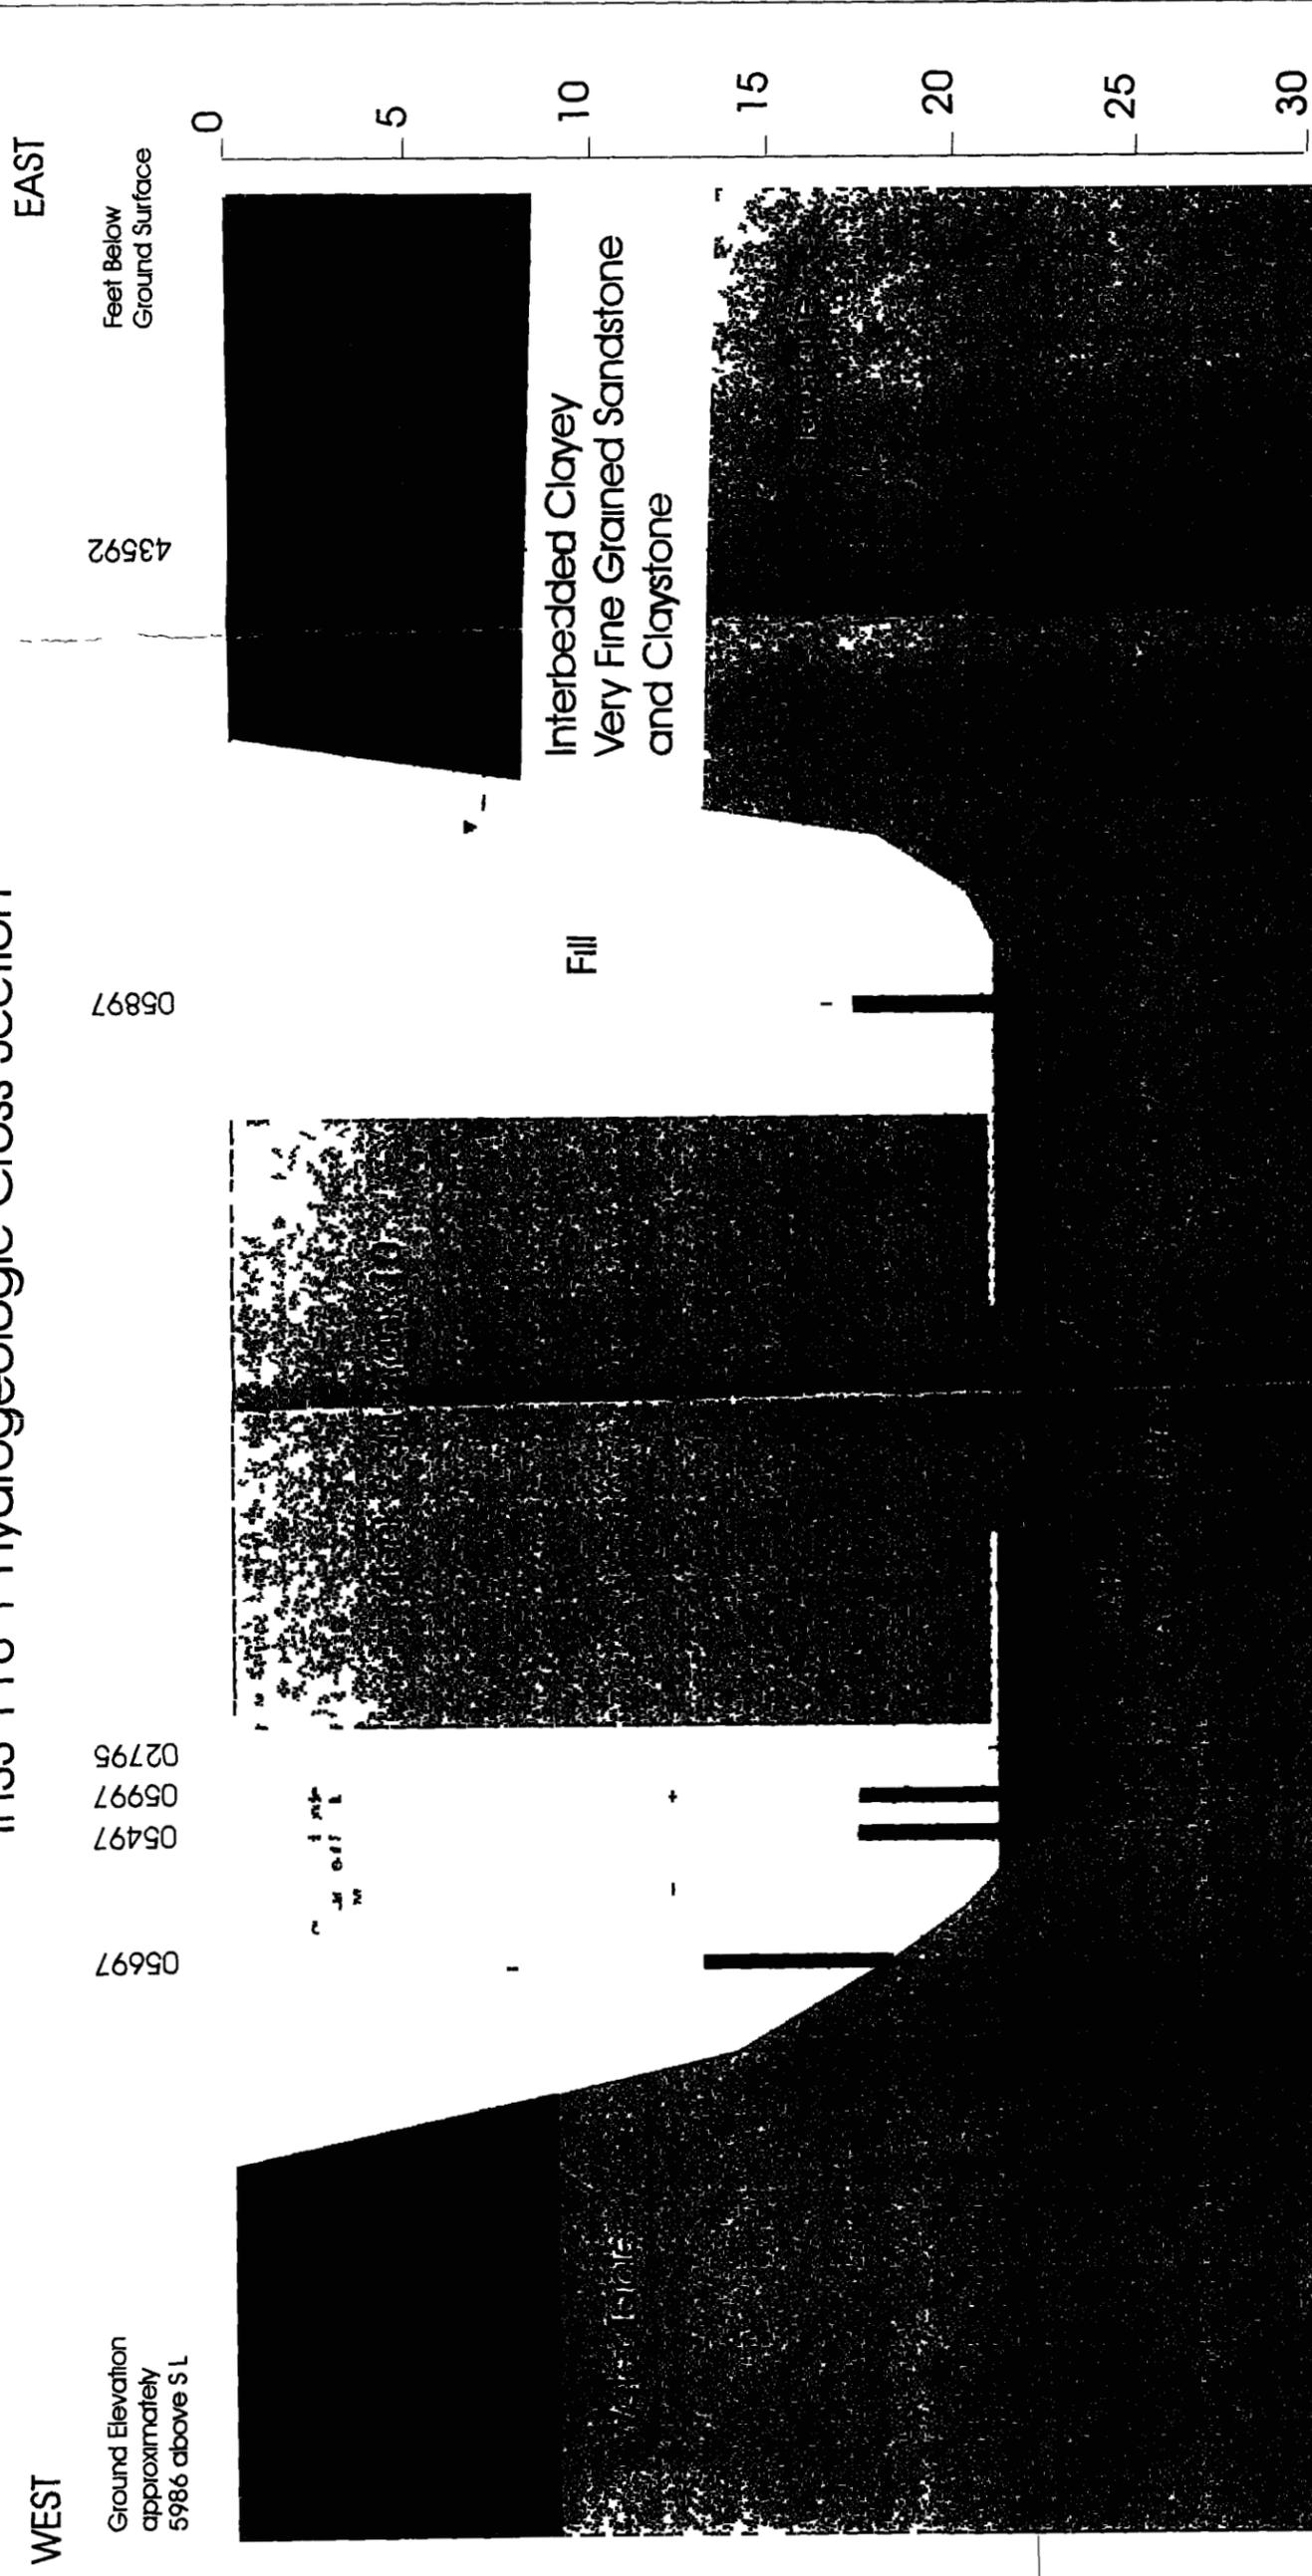
Figure 3  
IHSS 118 1 Hydrogeologic Cross Section

Due to the high concentrations of carbon tetrachloride, and the lack of radiological contamination, the NAPL is assumed to be a result of spills and leaks from the carbon tetrachloride storage tank. Because both the NAPL samples and high concentrations in soil are found only near the bottom of the excavation, the carbon tetrachloride is thought to currently occur in a thin layer, approximately one foot thick, pooled on the bedrock surface at the bottom of the closed depression. The carbon tetrachloride may fill the bottom of the excavation, including underneath Tanks T-9 and T-10 and the associated sump (Figure 3). However, there is
