Pinellas Environmental Restoration Project

Semiannual Progress Report for the Young - Rainey STAR Center's 4.5 Acre Site June through November 2008

December 2008

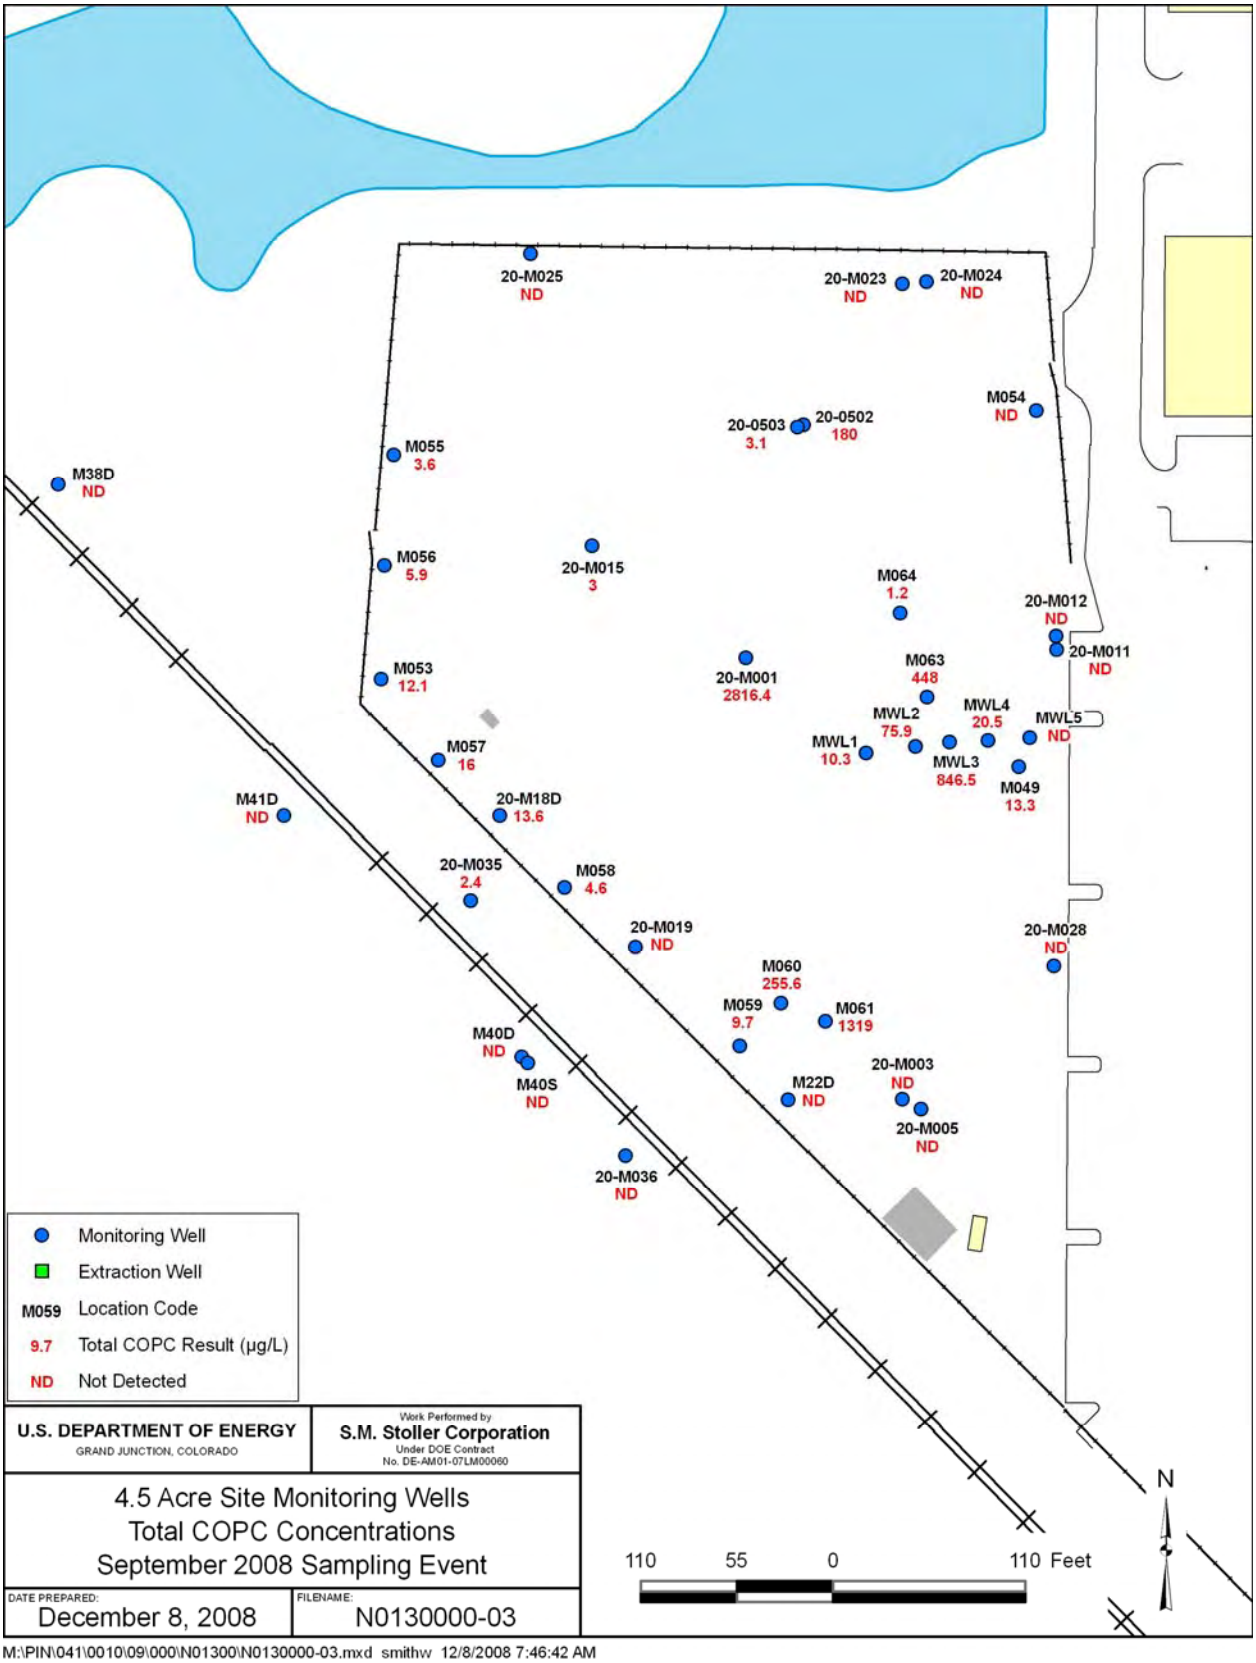
Figure 5. 4.5 Acre Site TCOPC Concentrations September 2008 Sampling Event

Table 4 presents individual contaminants of potential concern (COPC) and total COPCs (TCOPCs) concentrations in samples collected from wells at the 4.5 Acre Site. The previous two semiannual results are included in Table 4 for comparison. Figure 5 shows the TCOPCs concentrations for September 2008.

The maximum TCOPCs value detected in September was 2,816 micrograms per liter (µg/L) at PIN20−M001. The compound detected at the highest concentration in PIN20−M001 was VC at a concentration of 2,300 µg/L.

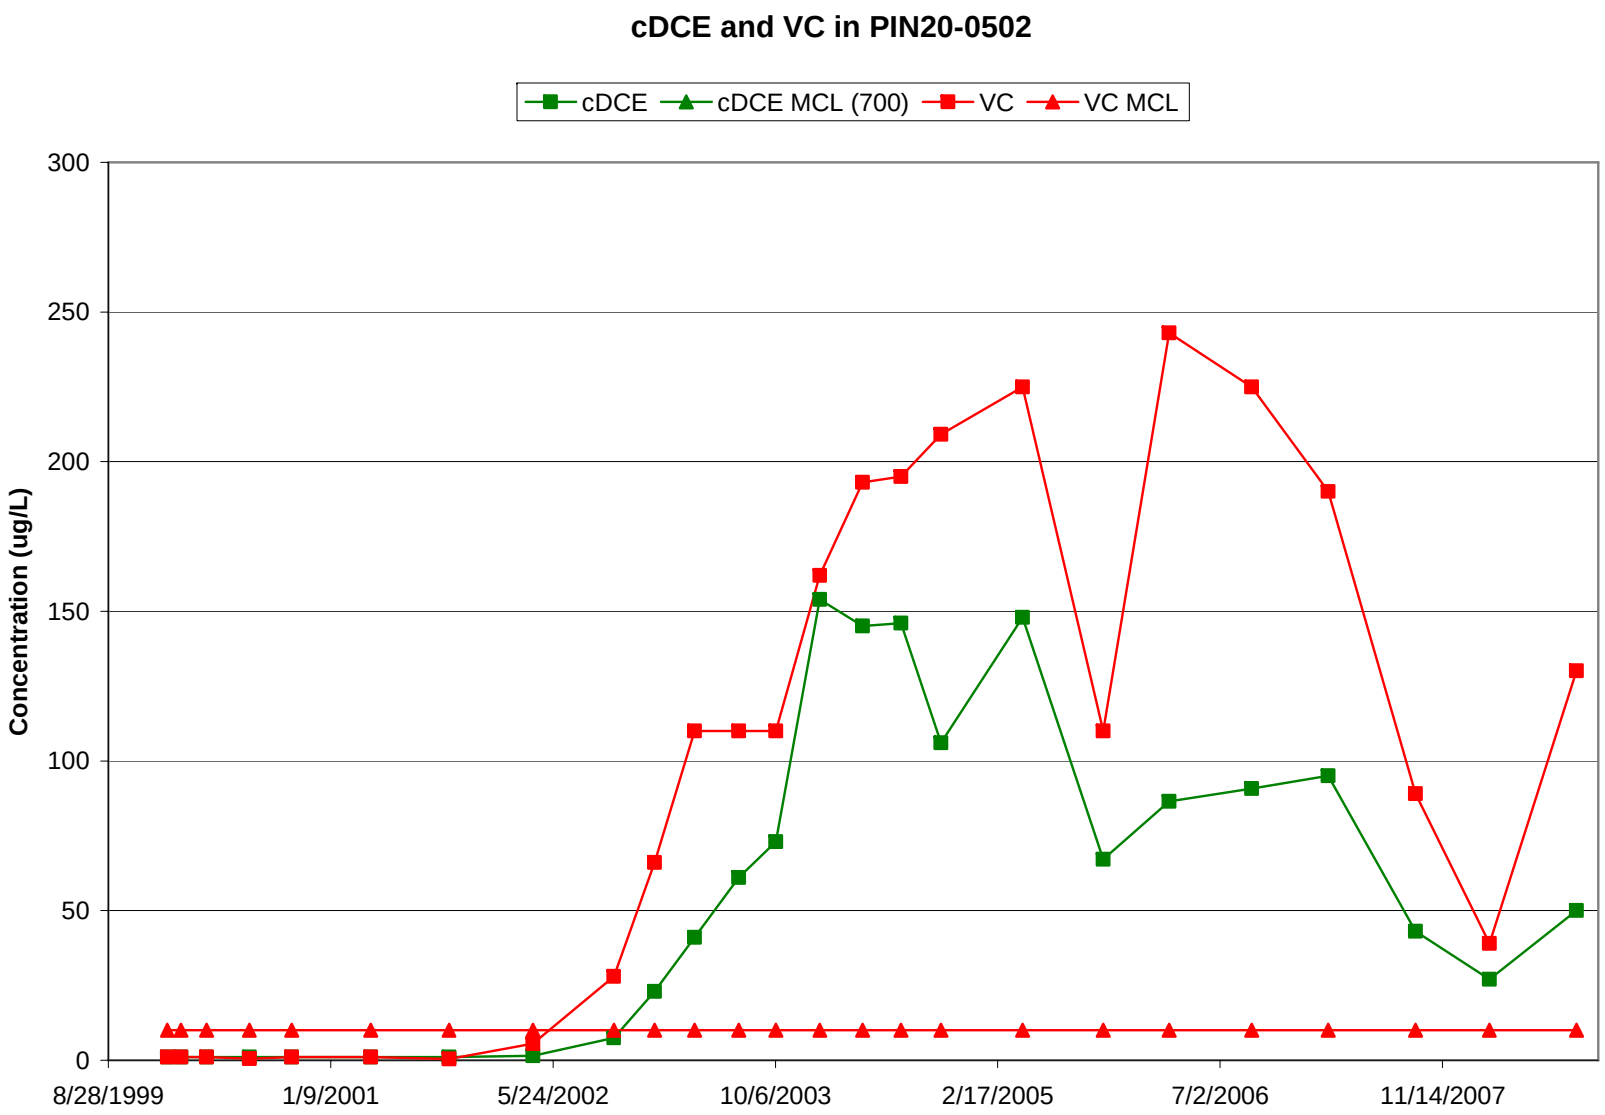
Figure 6. cDCE and VC in PIN20−0502

Figure 6 and Figure 7 show the cDCE and VC concentration trends in wells PIN20-0502 and -M001, respectively. These two wells, located hydraulically downgradient from the area of highest contaminant concentrations, have shown increasing concentration trends over the last few years. This appears to be a result of past operation of the biosparging system, as described in previous reports. However, it appears that the contaminant concentrations in both wells are now decreasing.

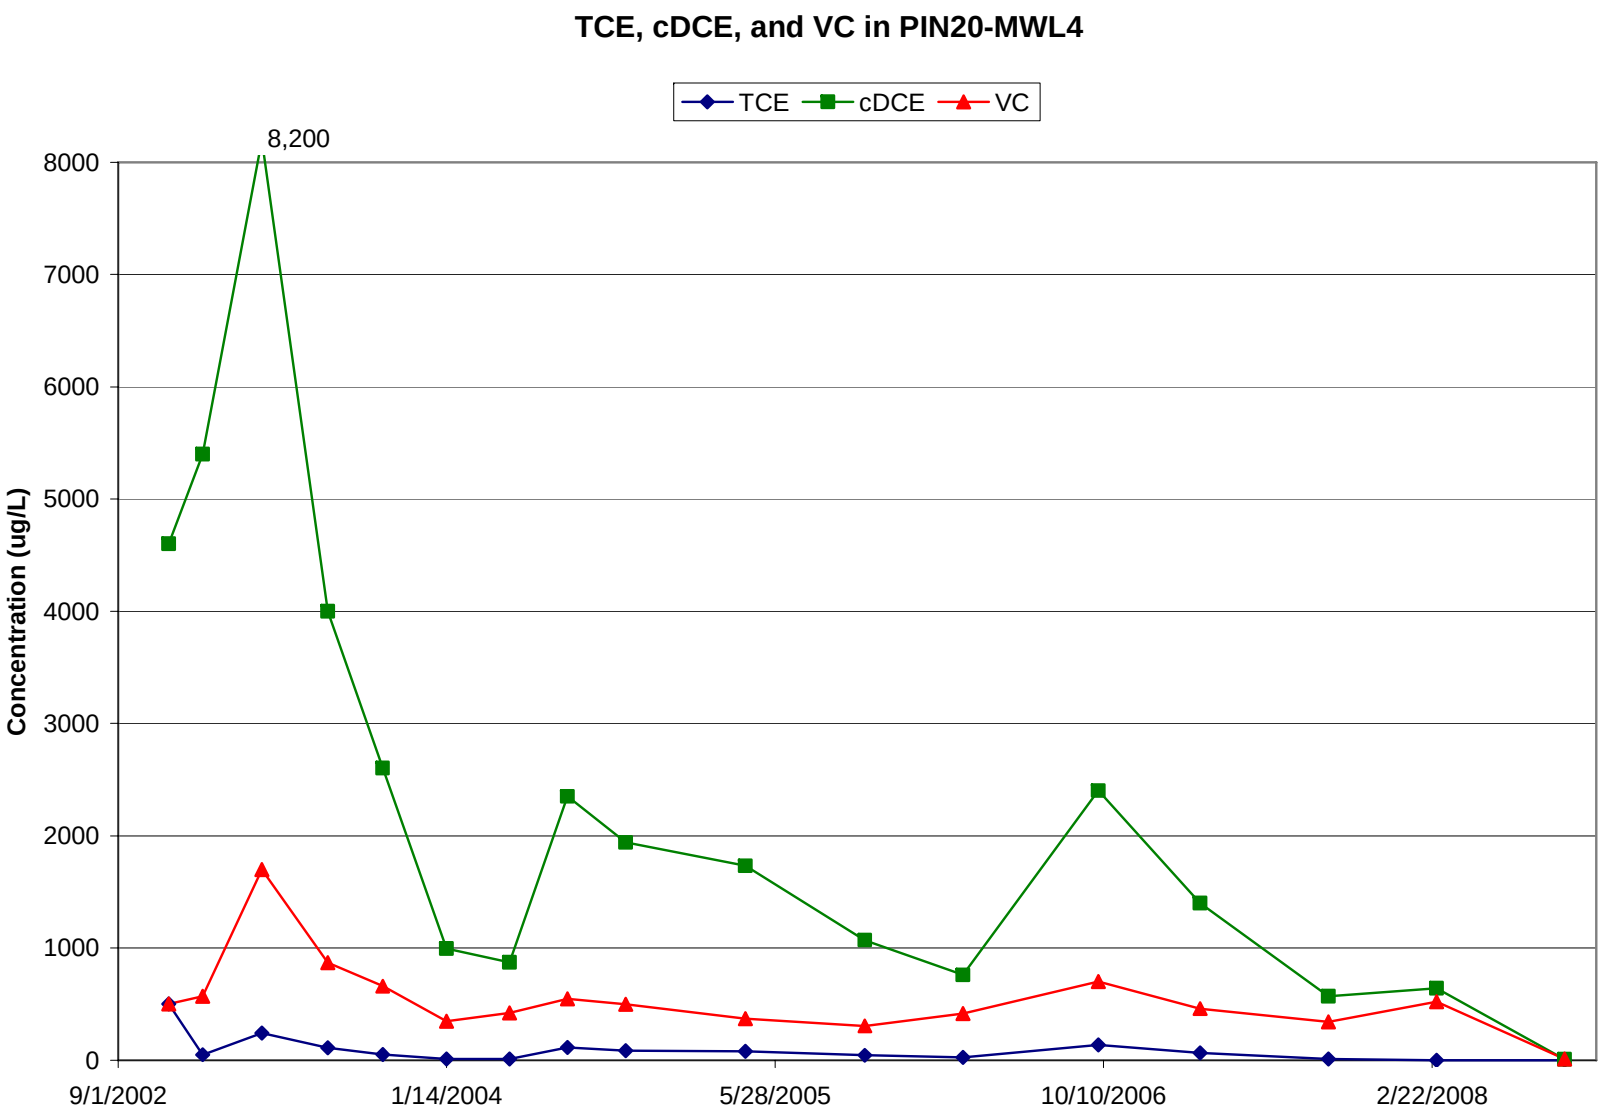
Figure 8. TCE, cDCE, and VC in PIN20−MWL4

Figure 8 and Figure 9 show TCE, cDCE, and VC concentration trends in wells PIN20-MWL4 and -M063. These two wells are in the area of highest contaminant concentrations on the eastern side of the site. Concentrations in these wells have shown an overall decreasing trend. The contaminant concentrations in well M063 decreased significantly since March 2007. This change may be due to a change in the local hydrology caused by numerous soil borings installed during the summer of 2007.

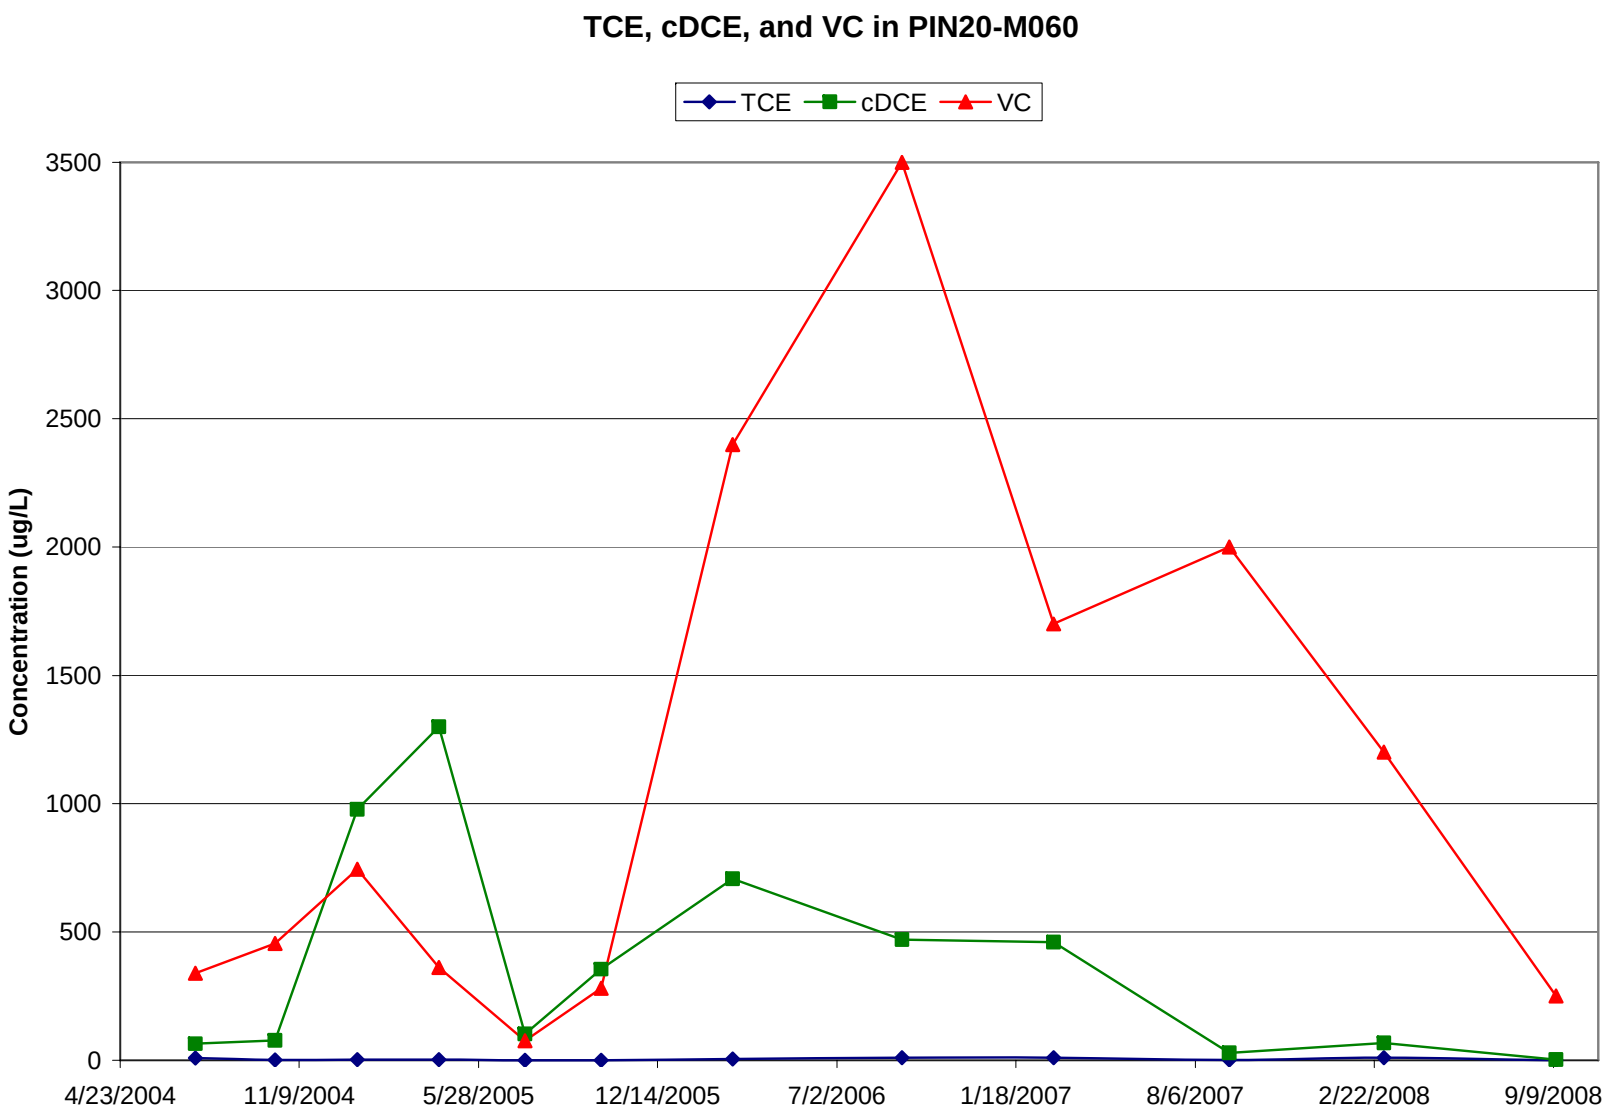
Figure 10. TCE, cDCE, and VC in PIN20−M060

Figure 10 and Figure 11 show TCE, cDCE, and VC concentration trends in wells PIN20-M060 and -M061. These wells are in the area of elevated contaminant concentrations near the southwest property boundary. The contaminant concentrations in these wells do not show distinct trends, with both wells exhibiting significant increases and decreases over time.
