**LONG-TERM SURVEILLANCE  
PLAN FOR THE  
AMBROSIA LAKE, NEW MEXICO  
DISPOSAL SITE**

**July 1996**

Uranium Mill Tailings Remedial Action Project

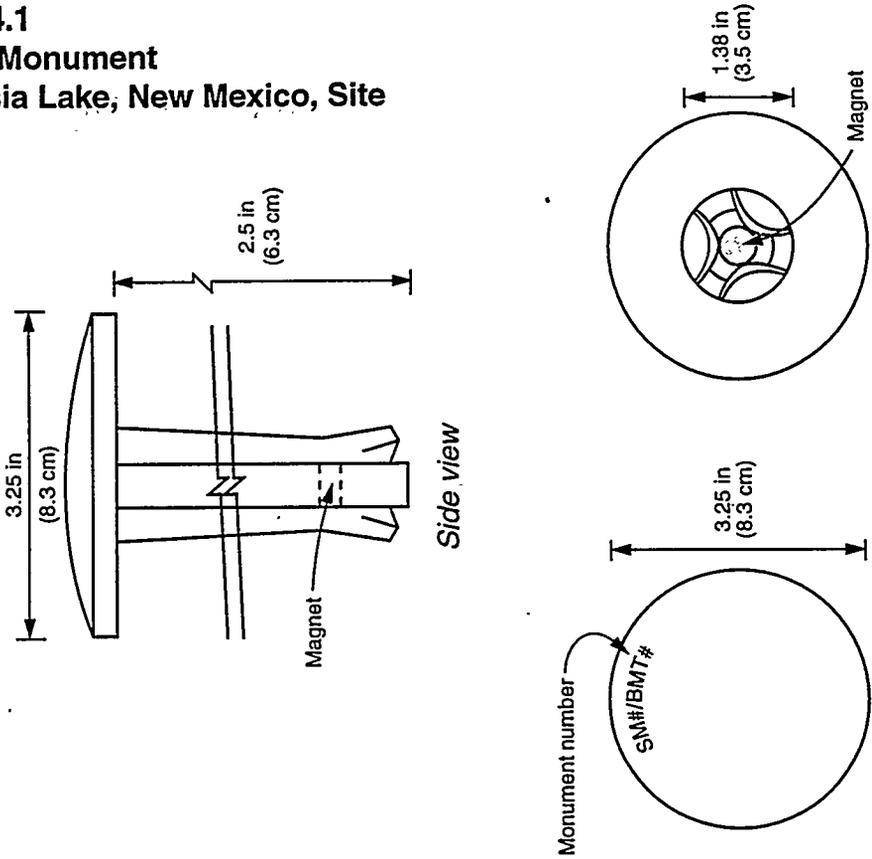
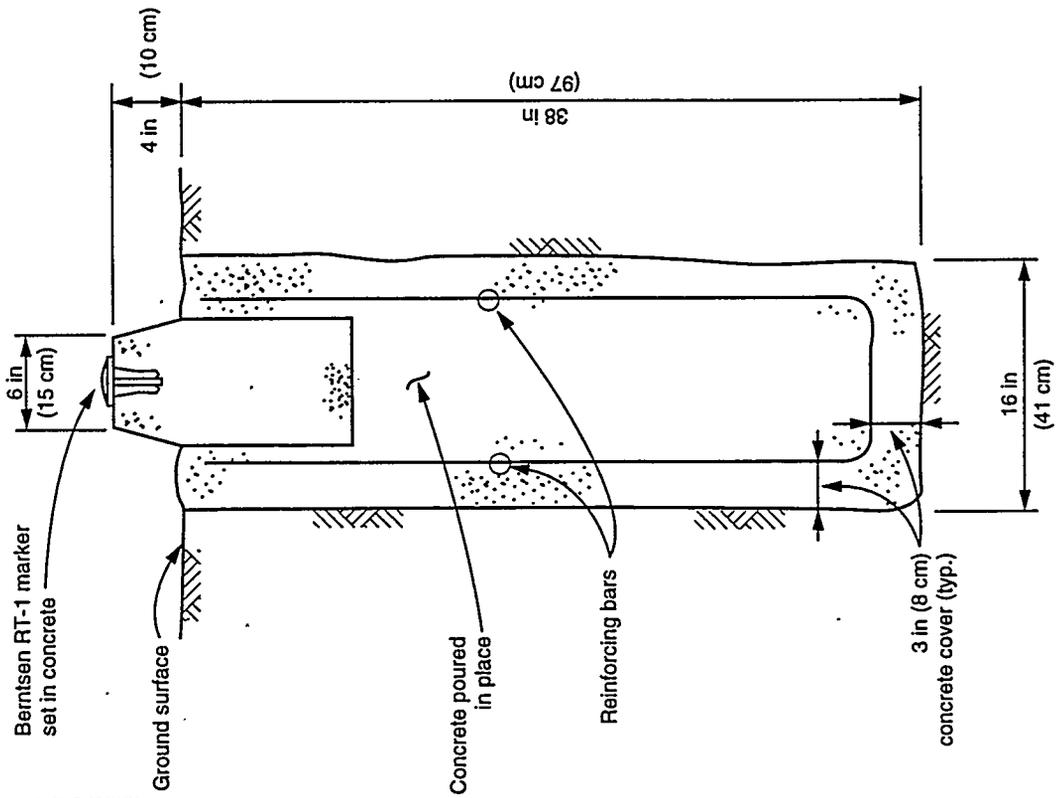
**Figure 4.1**  
**Survey Monument**  
**Ambrosia Lake, New Mexico, Site**

Bernsten RT-1 monument

Detail

Schematic - not to scale

Three survey monuments establish permanent horizontal control based on the New Mexico Western Region State Plane Coordinate Grid System and referenced to the Project Survey Control Point, which is located at an elevation of 6963.58 ft (2122.52 m) near the southwest corner of the site. The three permanent survey monuments (SM-1, SM-2, and SM-3) are Berntsen RT-1 markers set in concrete with the dimensions shown in Figure 4.1. Magnets in the markers permit easier detection if they become buried over time. The survey monument identification number is stamped on the top of the metal cap.

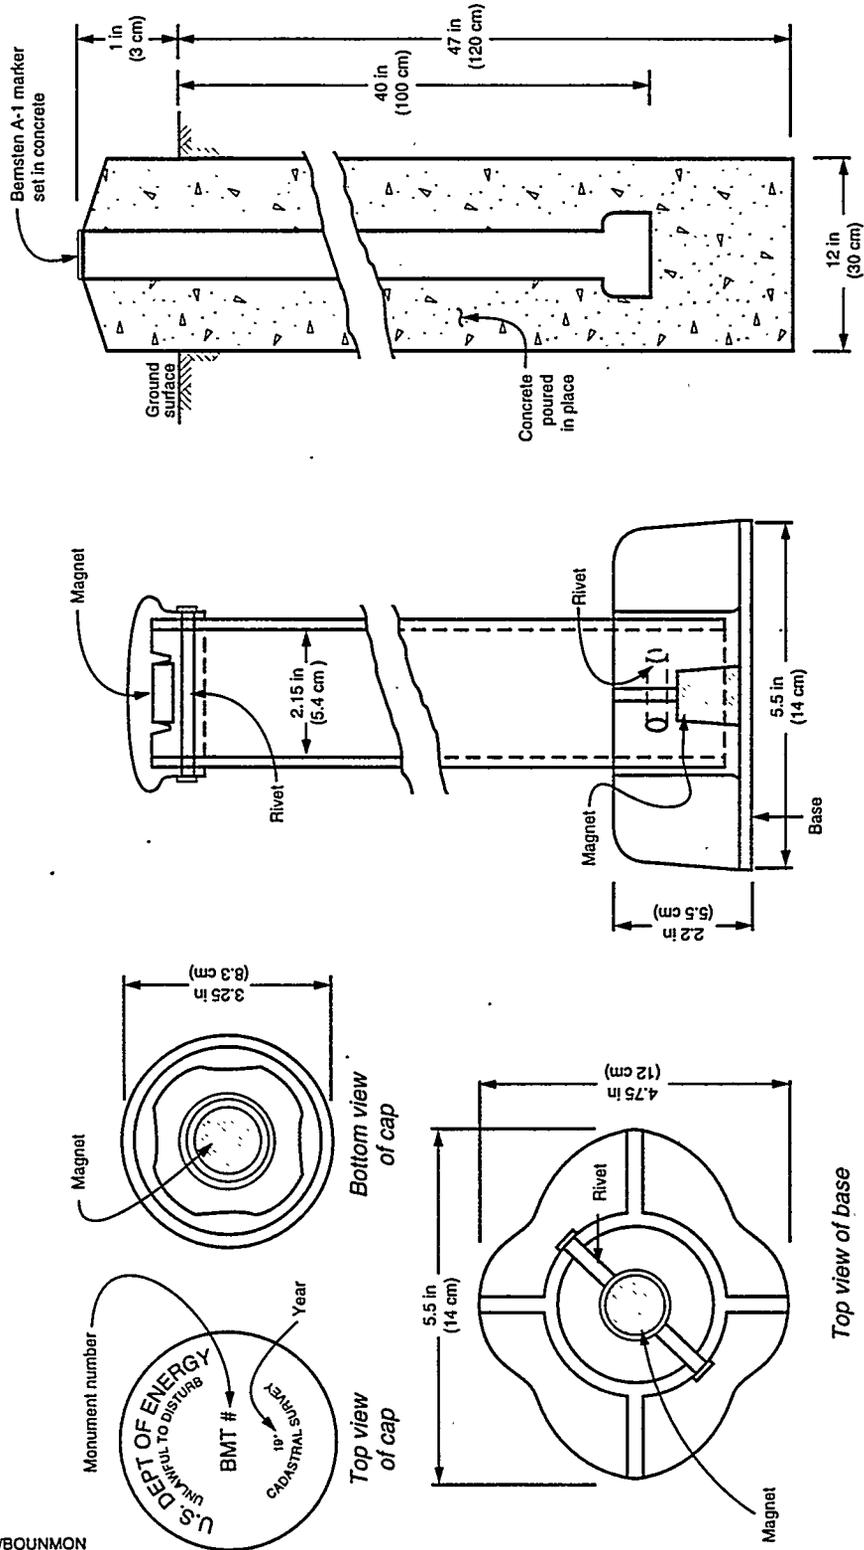
**Figure 4.2**  
**Boundary Monument**  
**Ambrosia Lake, New Mexico, Site**

Berntsen Federal Aluminum Boundary Monument, Model A-1, standard logo cap

Schematic - not to scale

Detail

Eight boundary monuments lie along the final site boundary. The three RT-1 survey monuments serve a dual purpose as boundary monuments (SM-1 as BMT-1, SM-2 as BMT-2, and SM-3 as BMT-3). The remaining five boundary monuments (BMT-4 to BMT-8) are Berntsen Model A-1 survey monuments set in concrete with the dimensions shown in Figure 4.2. Magnets are epoxied in the cap and base of the A-1 monuments to allow easier detection if they become buried. The boundary monument identification number is stamped on the top of the metal cap.

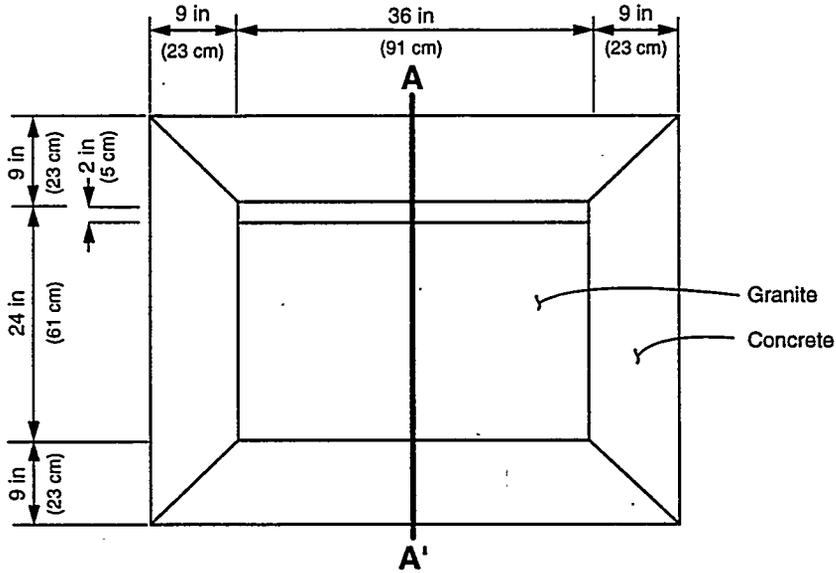
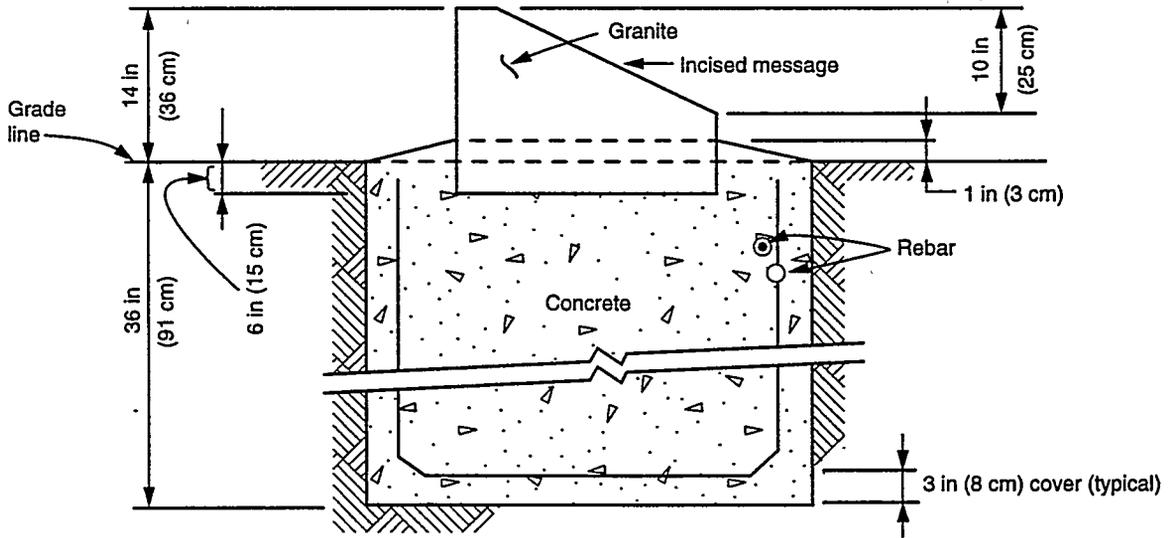
**Figure 4.4**  
**Site Marker at Entrance**  
**Ambrosia Lake, New Mexico, Site**

*Plan view*

*Section A-A'*

Two unpolished granite markers with an incised message identify the Ambrosia Lake disposal site. The message includes a drawing showing the general location of the stabilized disposal cell within the site boundaries, the date of closure, the dry tonnage of tailings, and the amount of radioactivity (Figure 4.3). Site marker SMK-1 near the southwest corner entrance to the site is set in a bed of reinforced concrete that extends 3 ft (0.9 m) below the ground surface (Figure 4.4). Site marker SMK-2 at the crest of the disposal cell is set in a bed of reinforced concrete that extends to the top of the radon barrier (Figure 4.5).

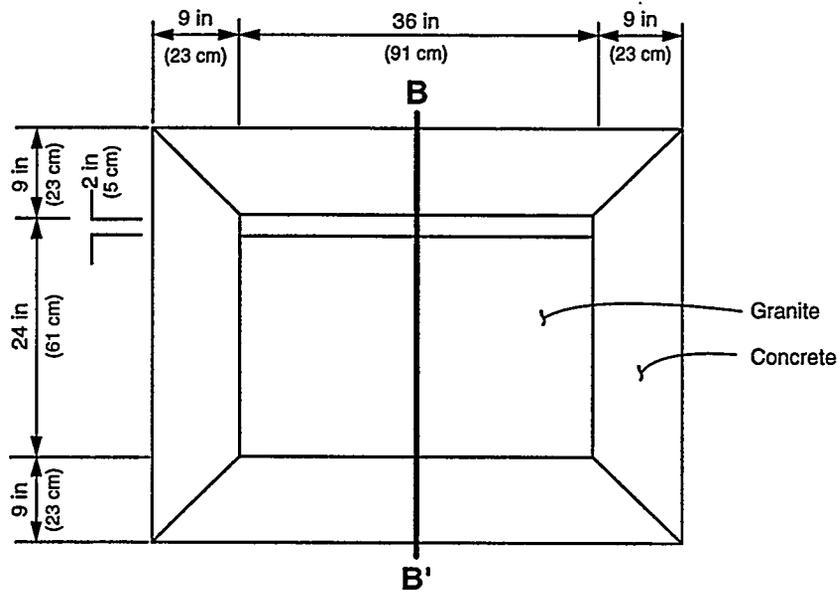
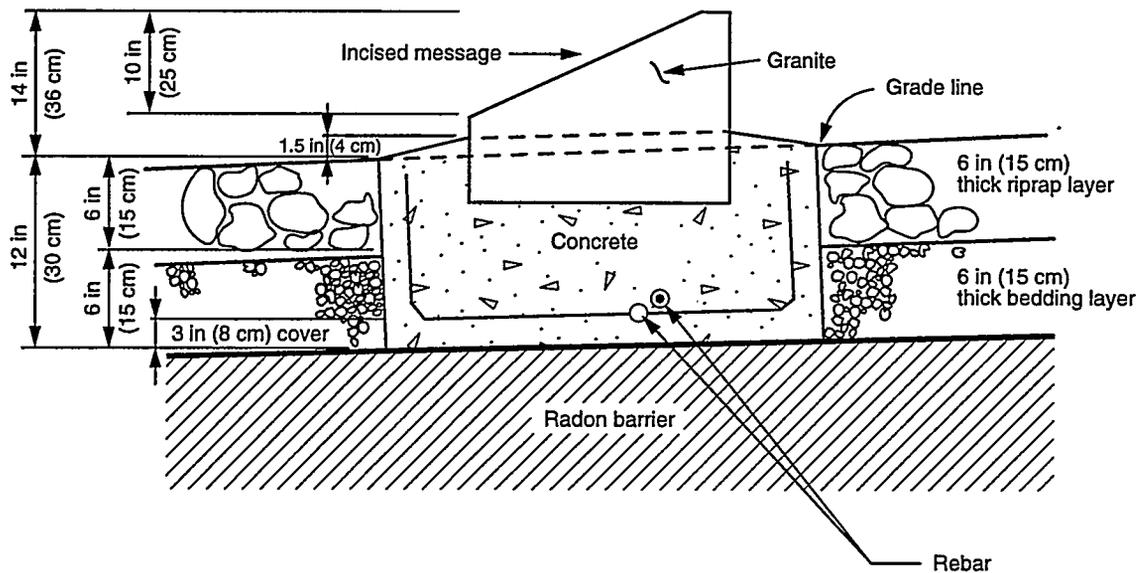
**Figure 4.5**  
**Site Marker at Disposal Cell Crest**  
**Ambrosia Lake, New Mexico, Site**

*Plan view*

*Section B - B'*

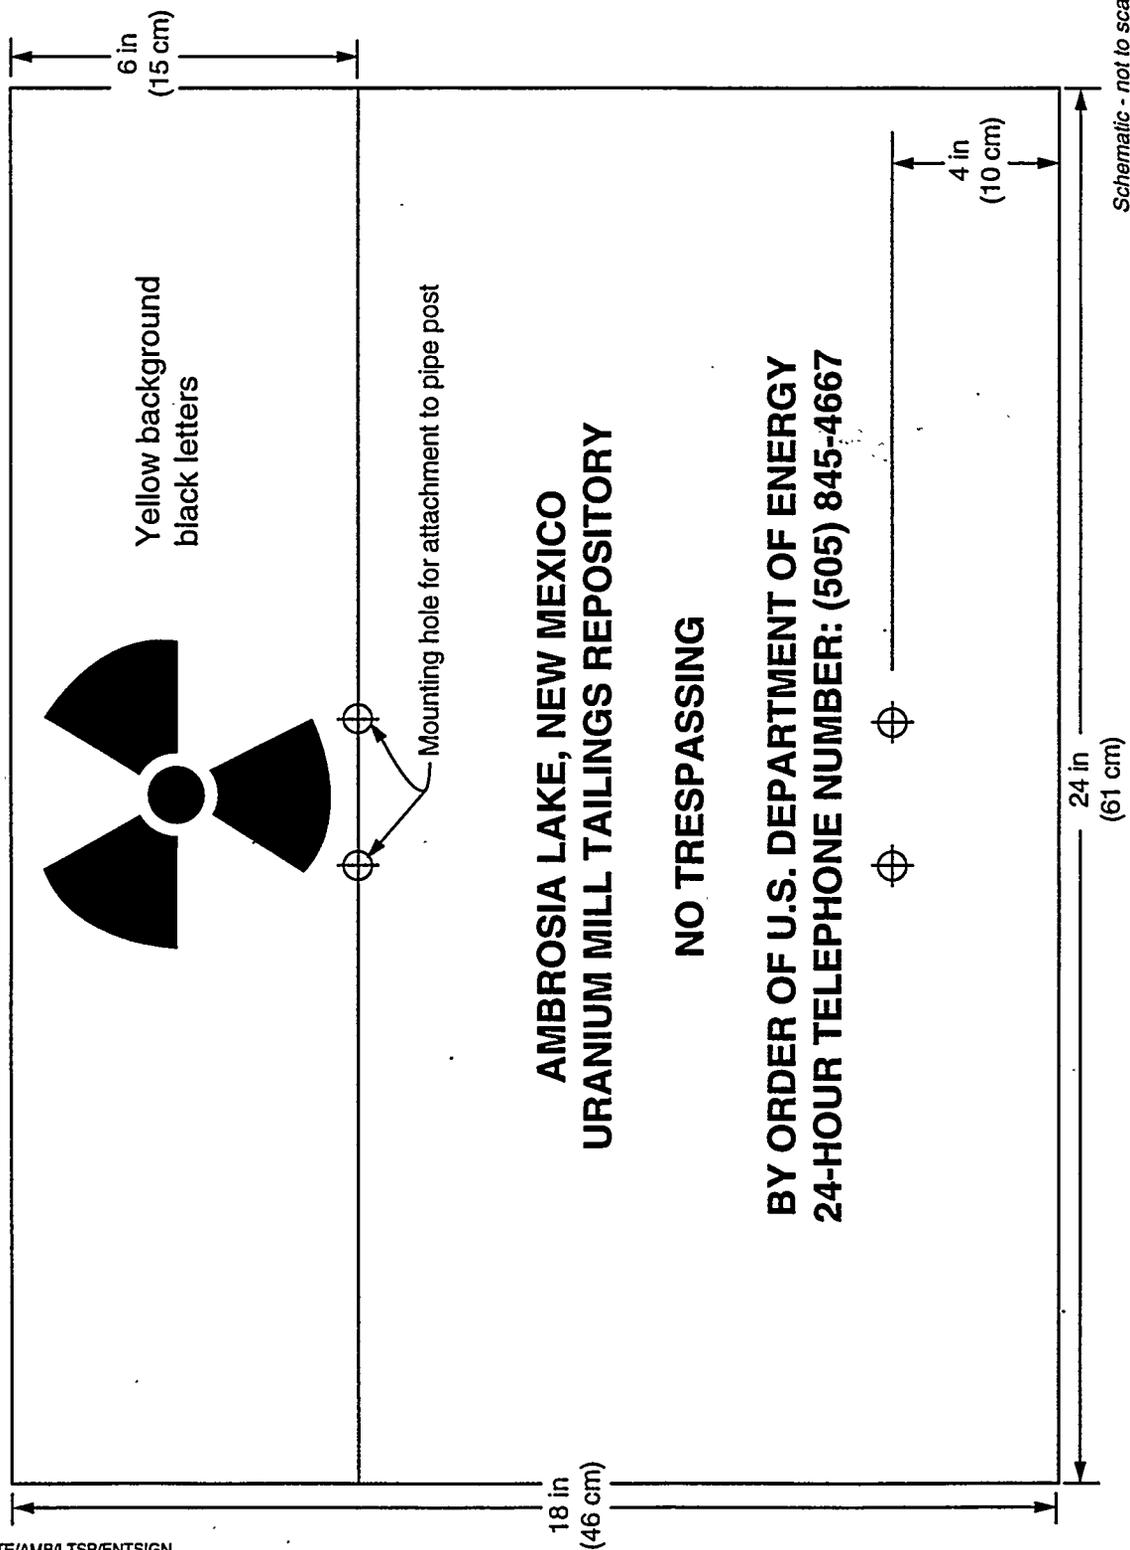
**Figure 4.6**  
**Entrance Warning Sign**  
**Ambrosia Lake, New Mexico, Site**

Schematic - not to scale  
 From MK-F, 1995.

The signs are constructed in accordance with the dimensions and specifications shown in Figures 4.6, 4.7, and 4.8, and mounted with the tops of the entrance and perimeter signs about 6 ft (2 m) above the ground surface. The sign posts are embedded in concrete to a depth of about 3 ft (1 m) below the ground surface.

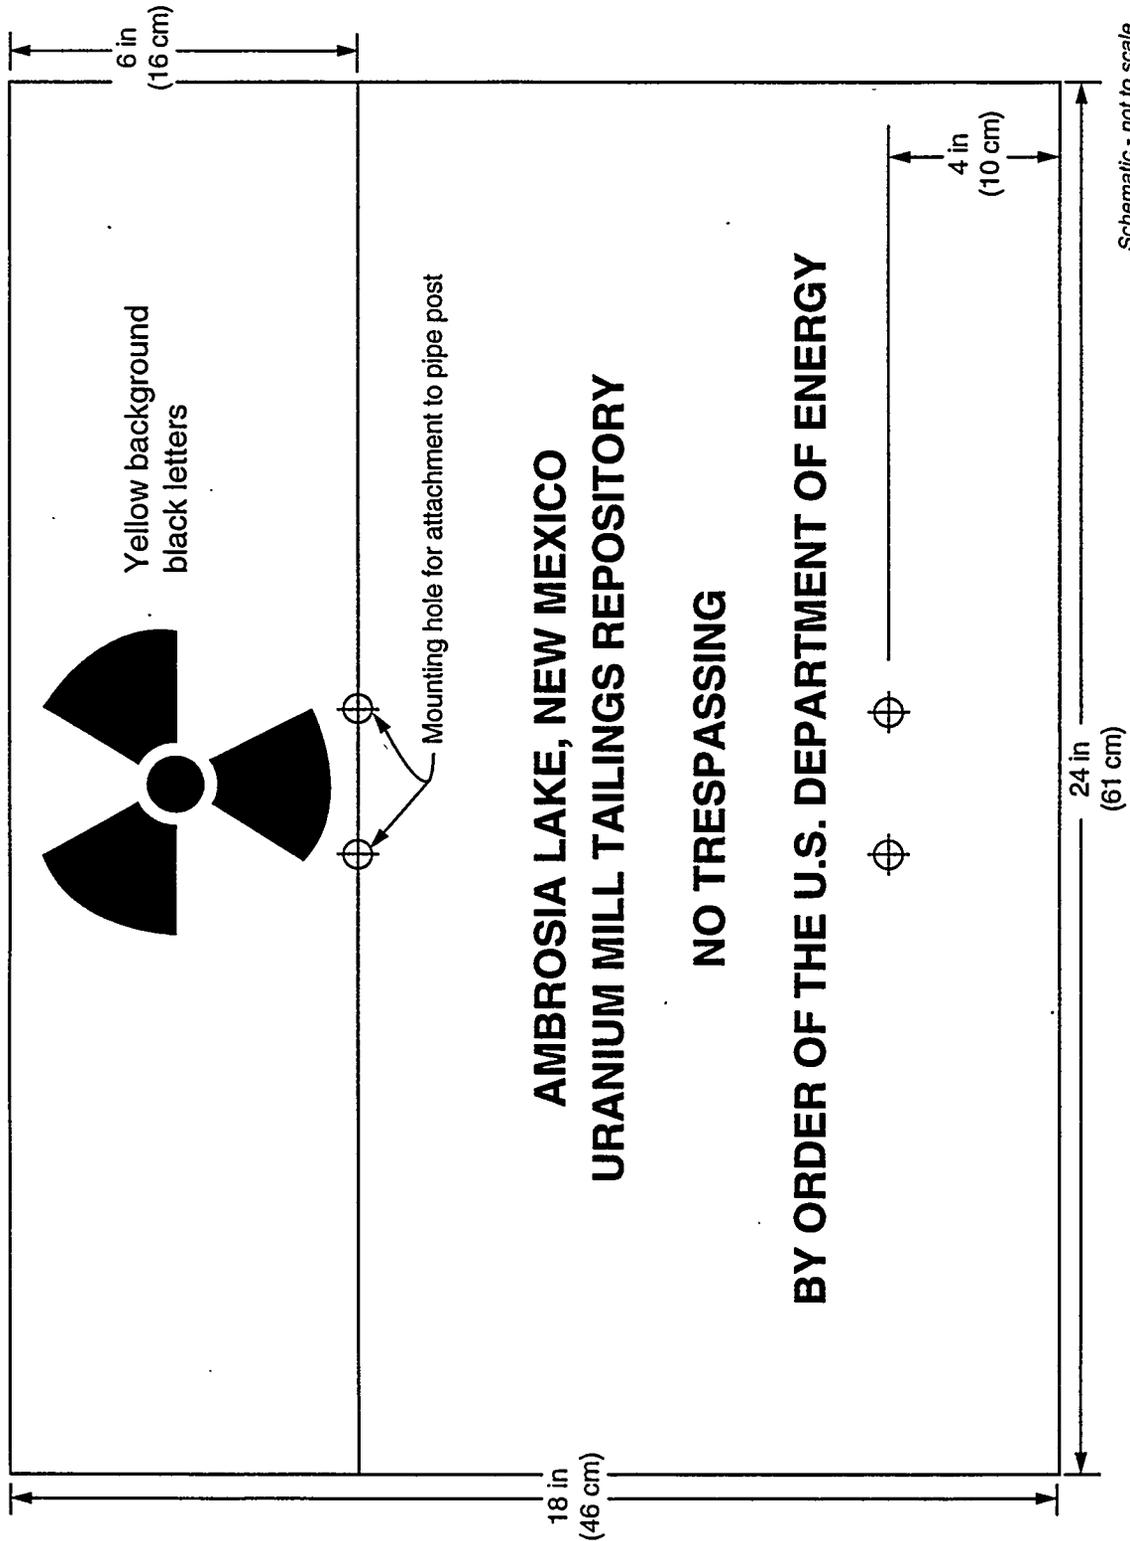
**Figure 4.7**  
**Perimeter Warning Sign**  
**Ambrosia Lake, New Mexico, Site**

*Schematic - not to scale*

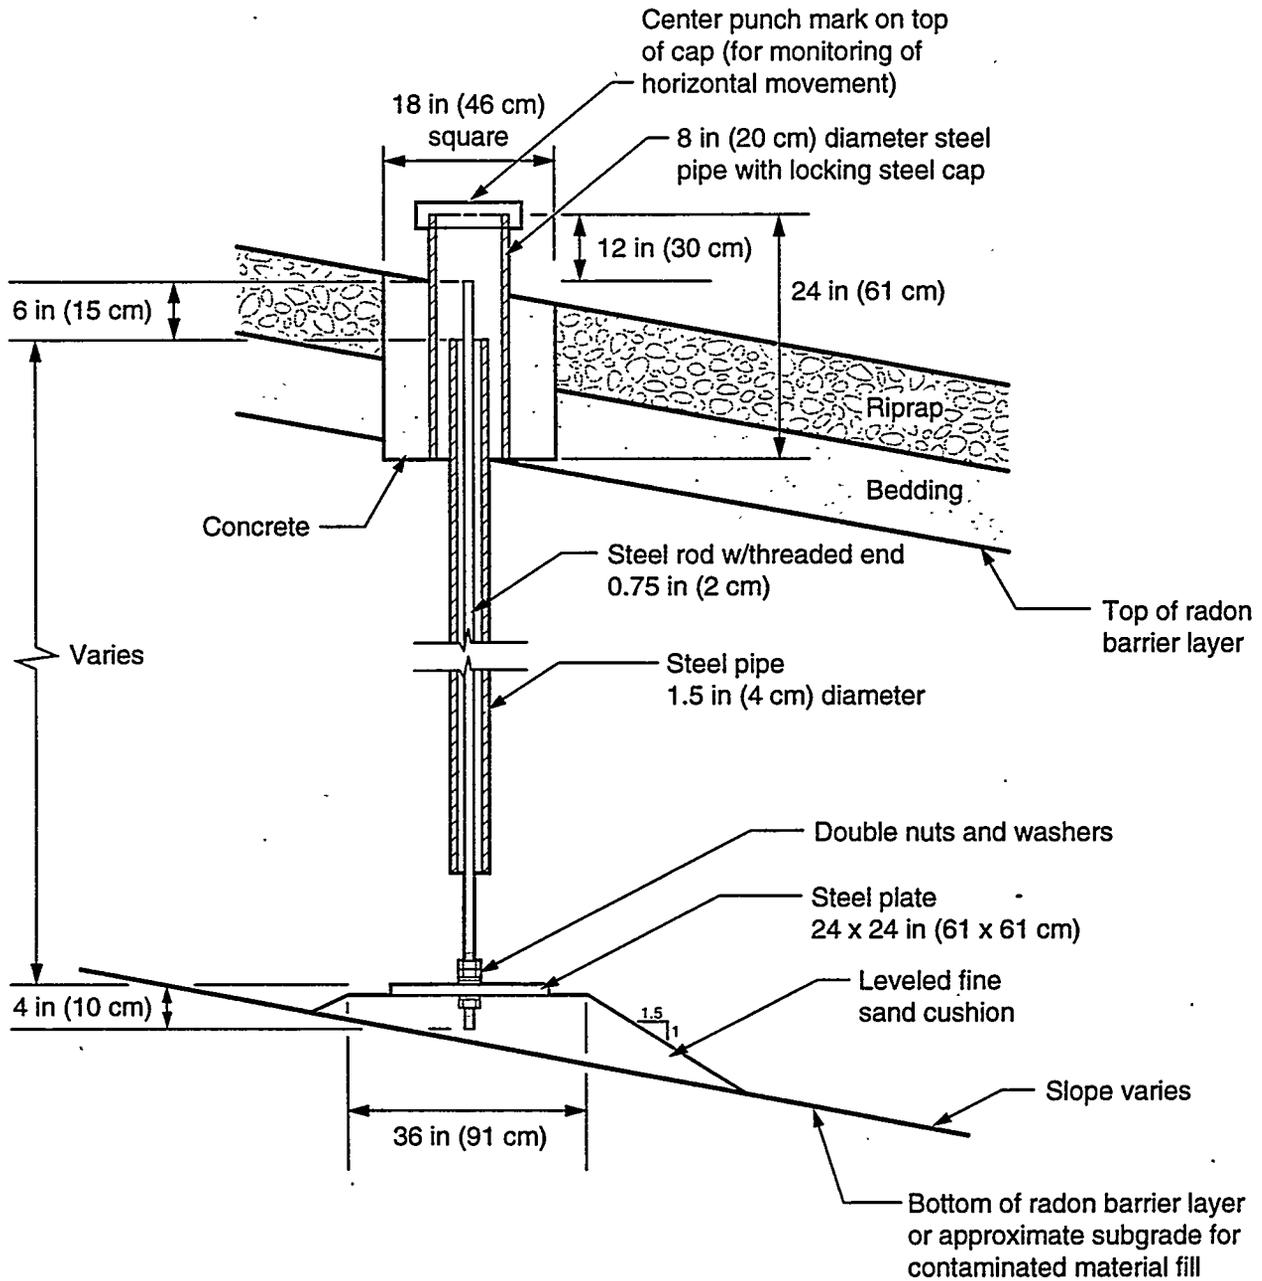
**Figure 4.9**  
**Displacement Monument**  
**Ambrosia Lake, New Mexico, Site**

*Typical detail-not to scale*

Eight displacement monuments are installed on the disposal cell to monitor the anticipated settlement of the tailings embankment during placement of contaminated materials and disposal cell cover (Plate 1). The displacement monuments were installed at various depths to the specifications shown in Figure 4.9. Displacement monuments DM-1 to DM-4 were installed on the compacted subgrade surface; DM-5 to DM-8 were installed on top of contaminated material. The displacement monuments will not be monitored during routine annual inspections. However, if there is a future need, they can be used to measure long-term settlement of the disposal cell.

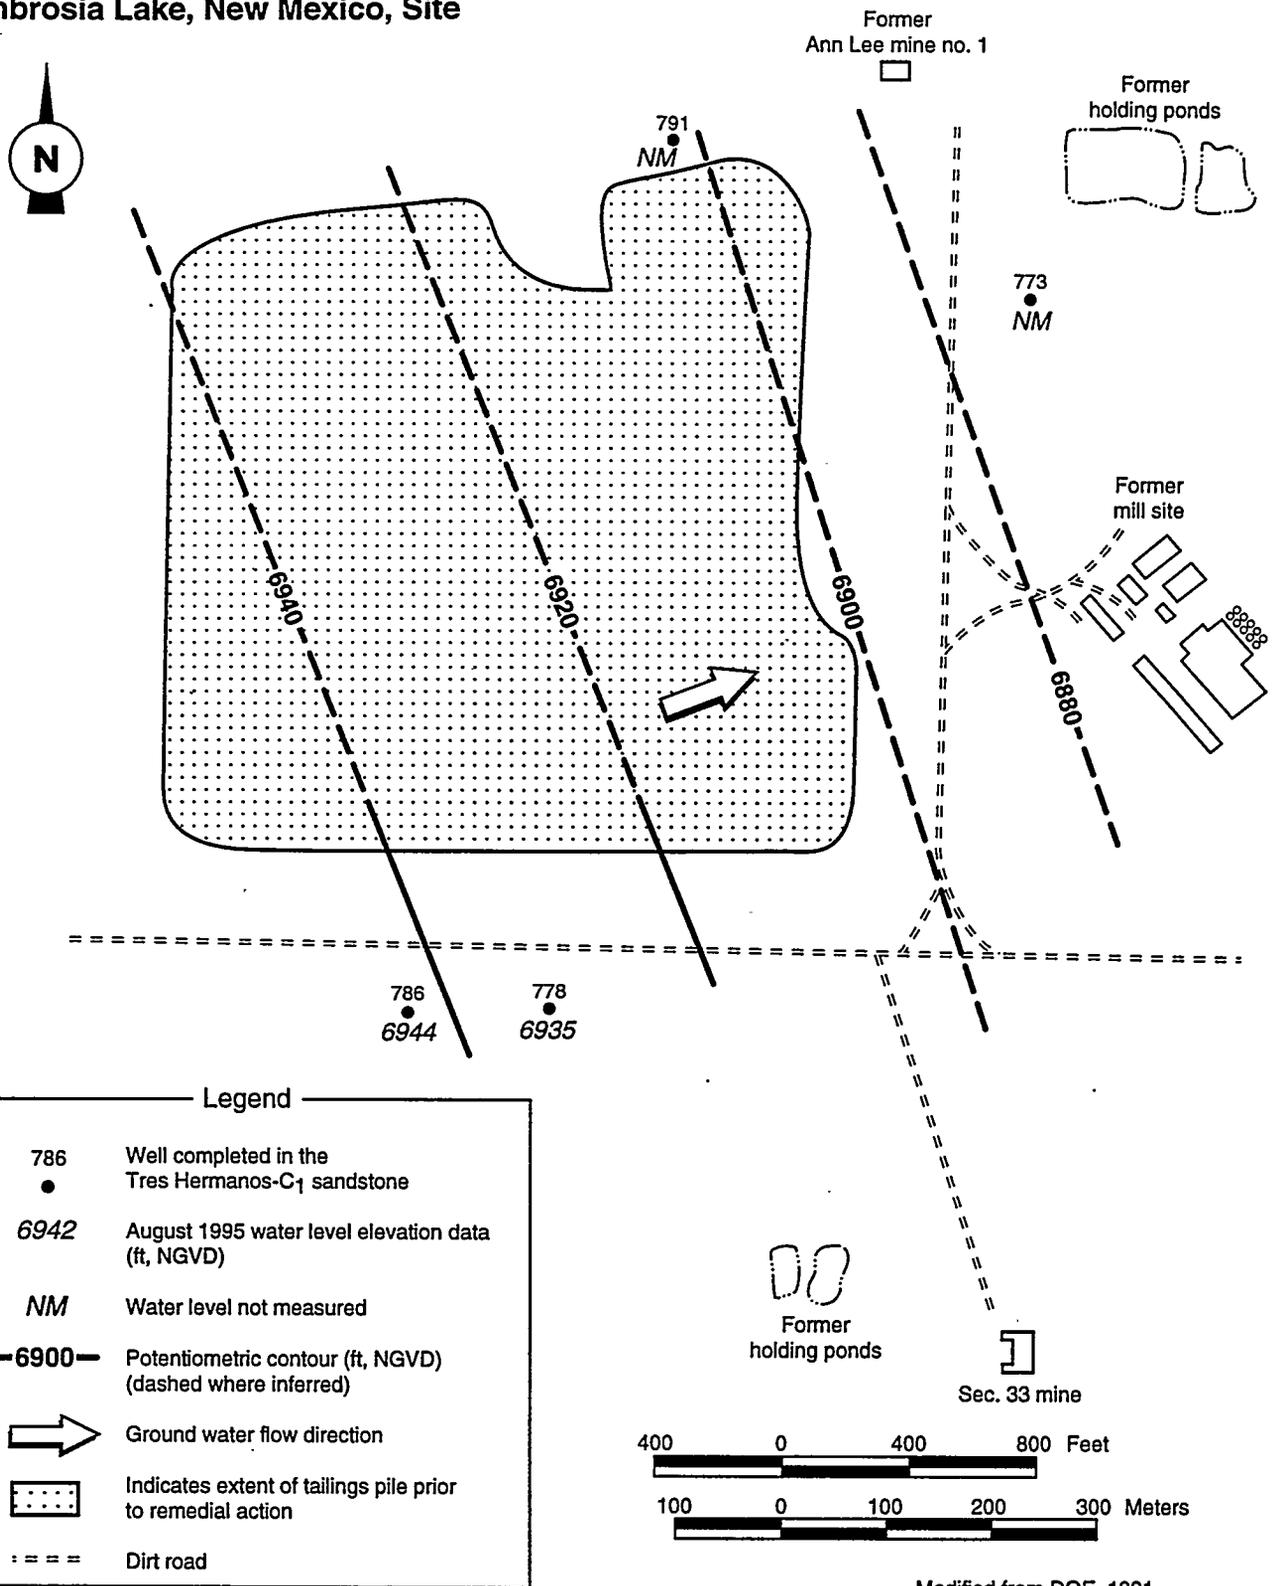
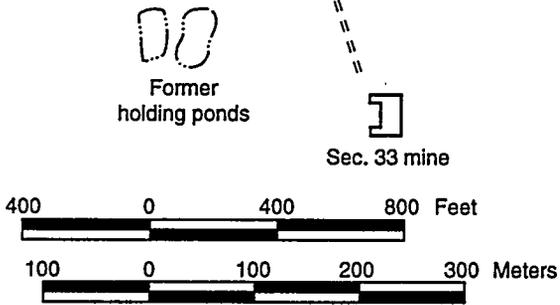
**Figure 5.7**  
**Potentiometric Surface Map for Tres Hermanos-C<sub>1</sub> Sandstone**  
**Ambrosia Lake, New Mexico, Site**

Legend	
786	Well completed in the Tres Hermanos-C <sub>1</sub> sandstone
6942	August 1995 water level elevation data (ft, NGVD)
NM	Water level not measured
-6900-	Potentiometric contour (ft, NGVD) (dashed where inferred)
→	Ground water flow direction
[Stippled Area]	Indicates extent of tailings pile prior to remedial action
- - - -	Dirt road

Ground water within both the Tres Hermanos-C<sub>1</sub> and -C<sub>2</sub> Sandstone units flows to the northeast in the direction of regional dip under a hydraulic gradient averaging 0.026 from observations made in 1995 (Figures 5.7 and 5.8). The average hydraulic conductivity in these units is approximately  $3 \times 10^{-4}$  cm per second (0.9 ft per day) and the average linear ground water velocity is approximately  $1 \times 10^{-4}$  cm per second (0.3 ft per day) (DOE, 1991). The Tres Hermanos-C Sandstone units are unconfined in the vicinity of the Ambrosia Lake site, and ground water elevations from monitor wells completed in both the upper and lower sandstone beds suggest that there is basal saturation in each unit. The Tres Hermanos Sandstone may have been saturated in the premining era, but was dewatered by mine construction activities and seepage down mine shafts and vent holes in the vicinity. The basal saturation evident in recent monitor well ground water level measurements is probably sustained by recharge from the alluvium in the subcrop area.

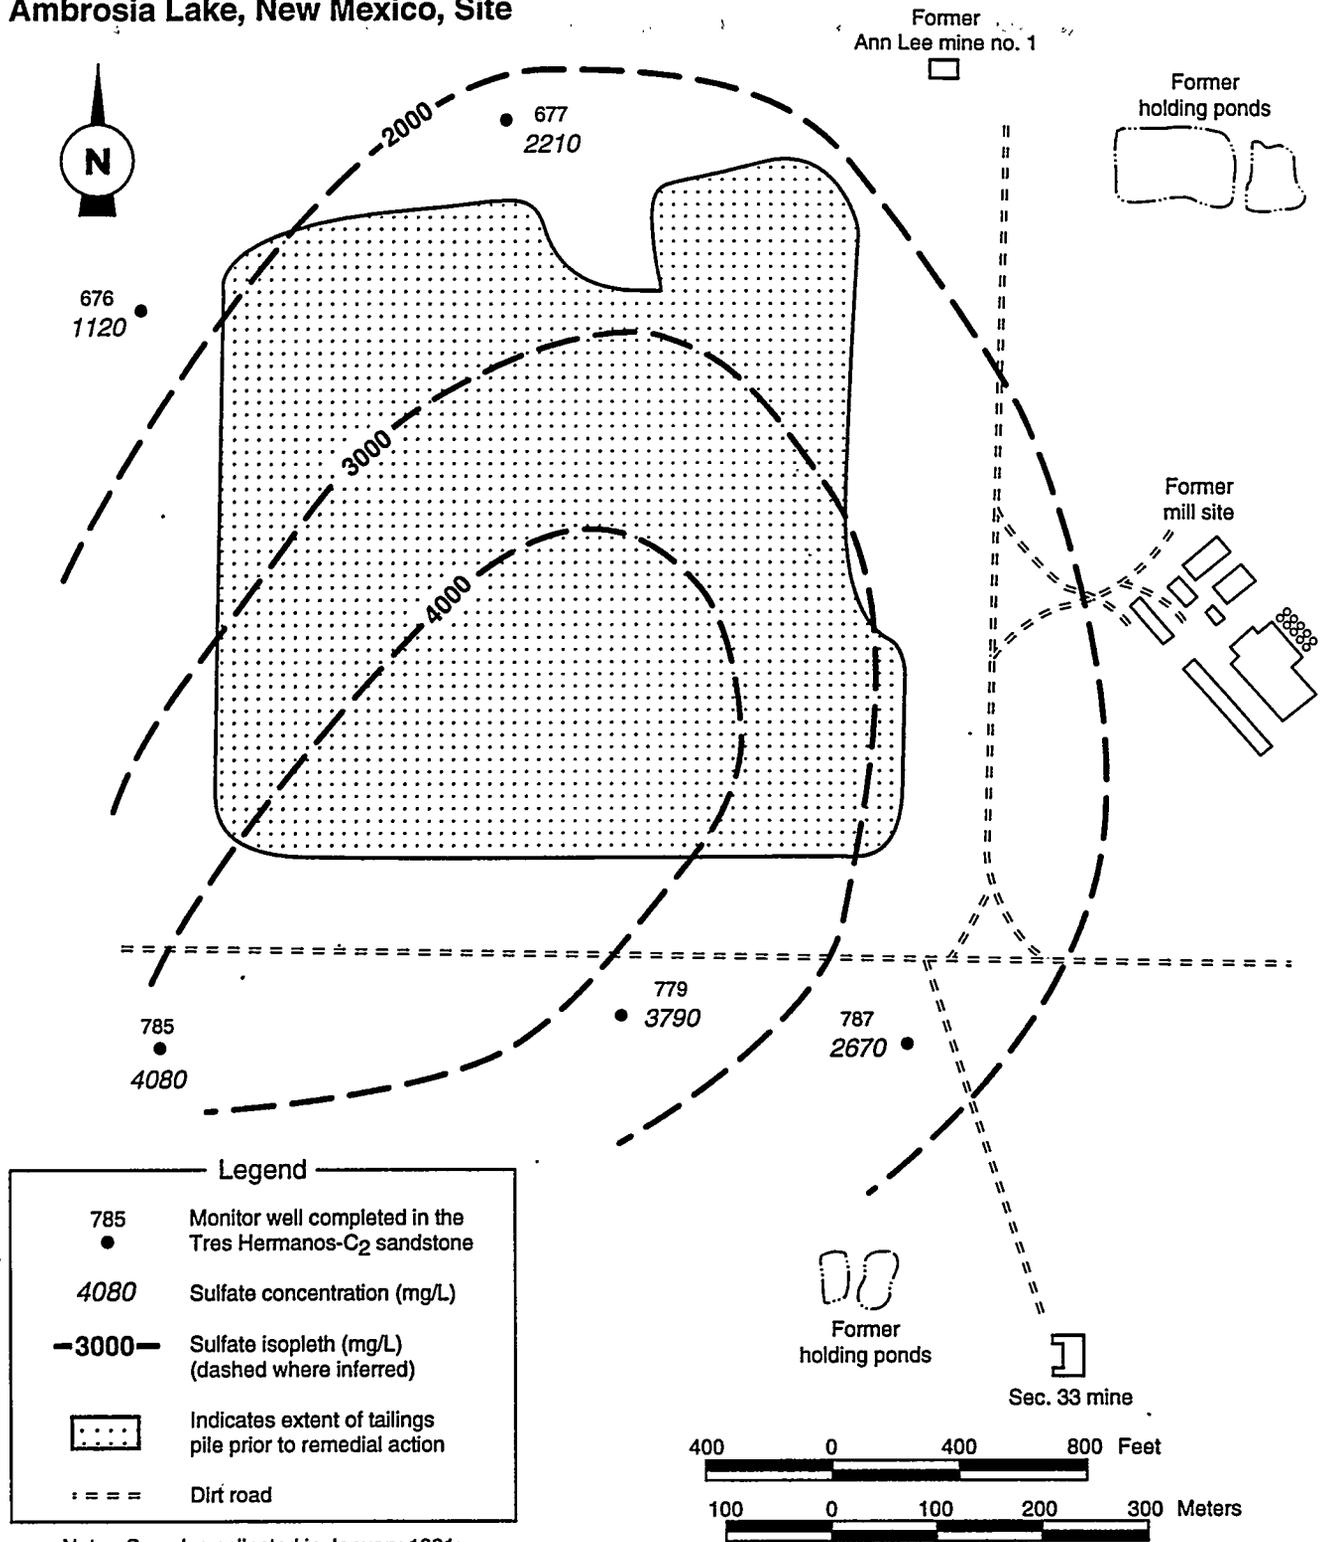
**Figure 5.10**  
**Sulfate Isopleth Map for Ground Water in the Tres Hermanos-C<sub>2</sub> Sandstone**  
**Ambrosia Lake, New Mexico, Site**

Note: Samples collected in January 1991; except for well 779 which was sampled September 1989.
