PHASE I CHEMICAL SOIL INVESTIGATION DATA REPORT FOR THE WELDON SPRING CHEMICAL PLANT/RAFFINATE PITS

DOE/OR/21548-016

PHASE I CHEMICAL SOIL INVESTIGATION DATA REPORT FOR THE WELDON SPRING CHEMICAL PLANT / RAFFINATE PITS

WELDON SPRING SITE REMEDIAL ACTION PROJECT

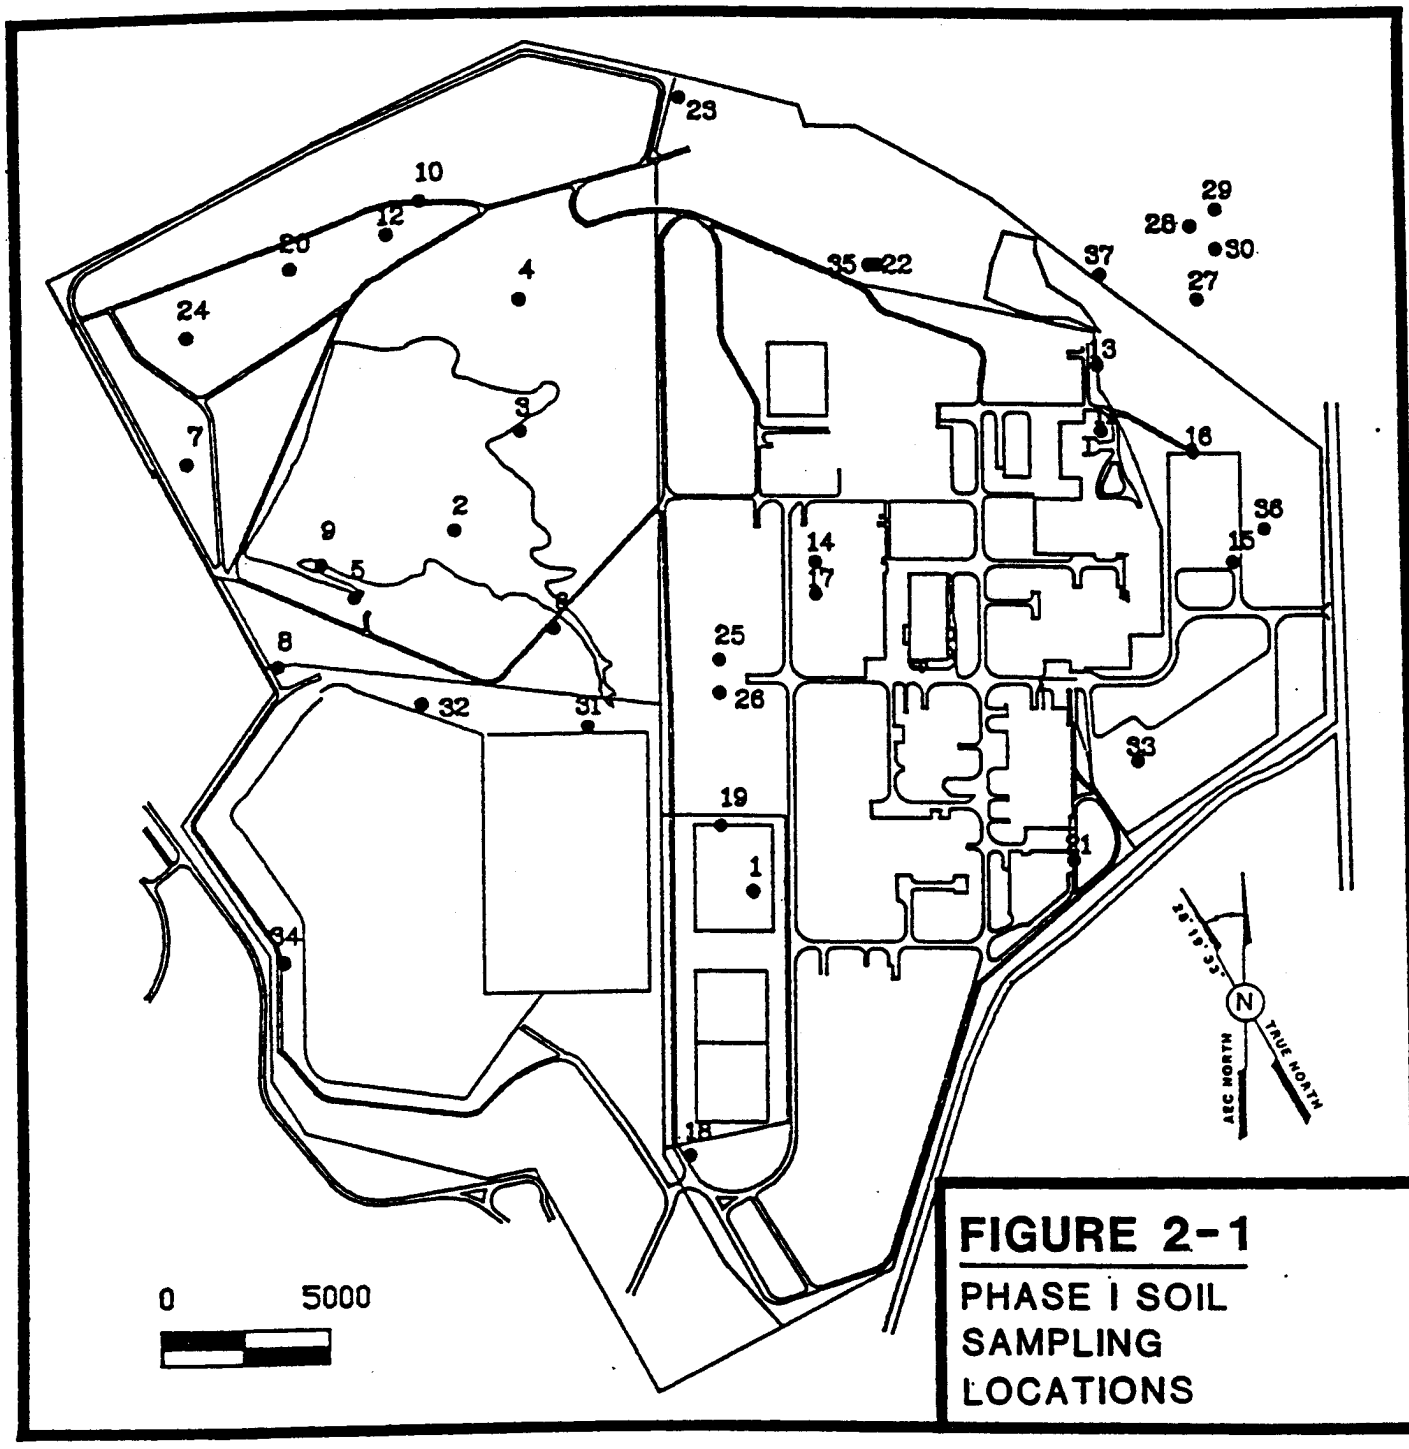
FIGURE 2-1
PHASE I SOIL SAMPLING LOCATIONS

Soil samples were collected from 37 locations at or near the WSCP/WSRP. Figure 2-1 shows the sampling locations. Thirty-two locations were within the fenced WSCP/WSRP boundary. Four of the remaining five boreholes were drilled in WSOW Waste Lagoon

Lead concentrations in the soil at the WSCP ranged from <0.6 ug/Kg to 43,000 ug/Kg. The highest value was observed at Location No. 3 (Figure 2-1) north of Ash Pond in the 2- to 4-foot interval downslope from the final production area of TNT Line No. 2.
