**Post-Closure Monitoring
and Inspection Plan for
Amchitka Island
Mud Pit Release Sites,
Amchitka, Alaska**

May 2016

Legacy
Management

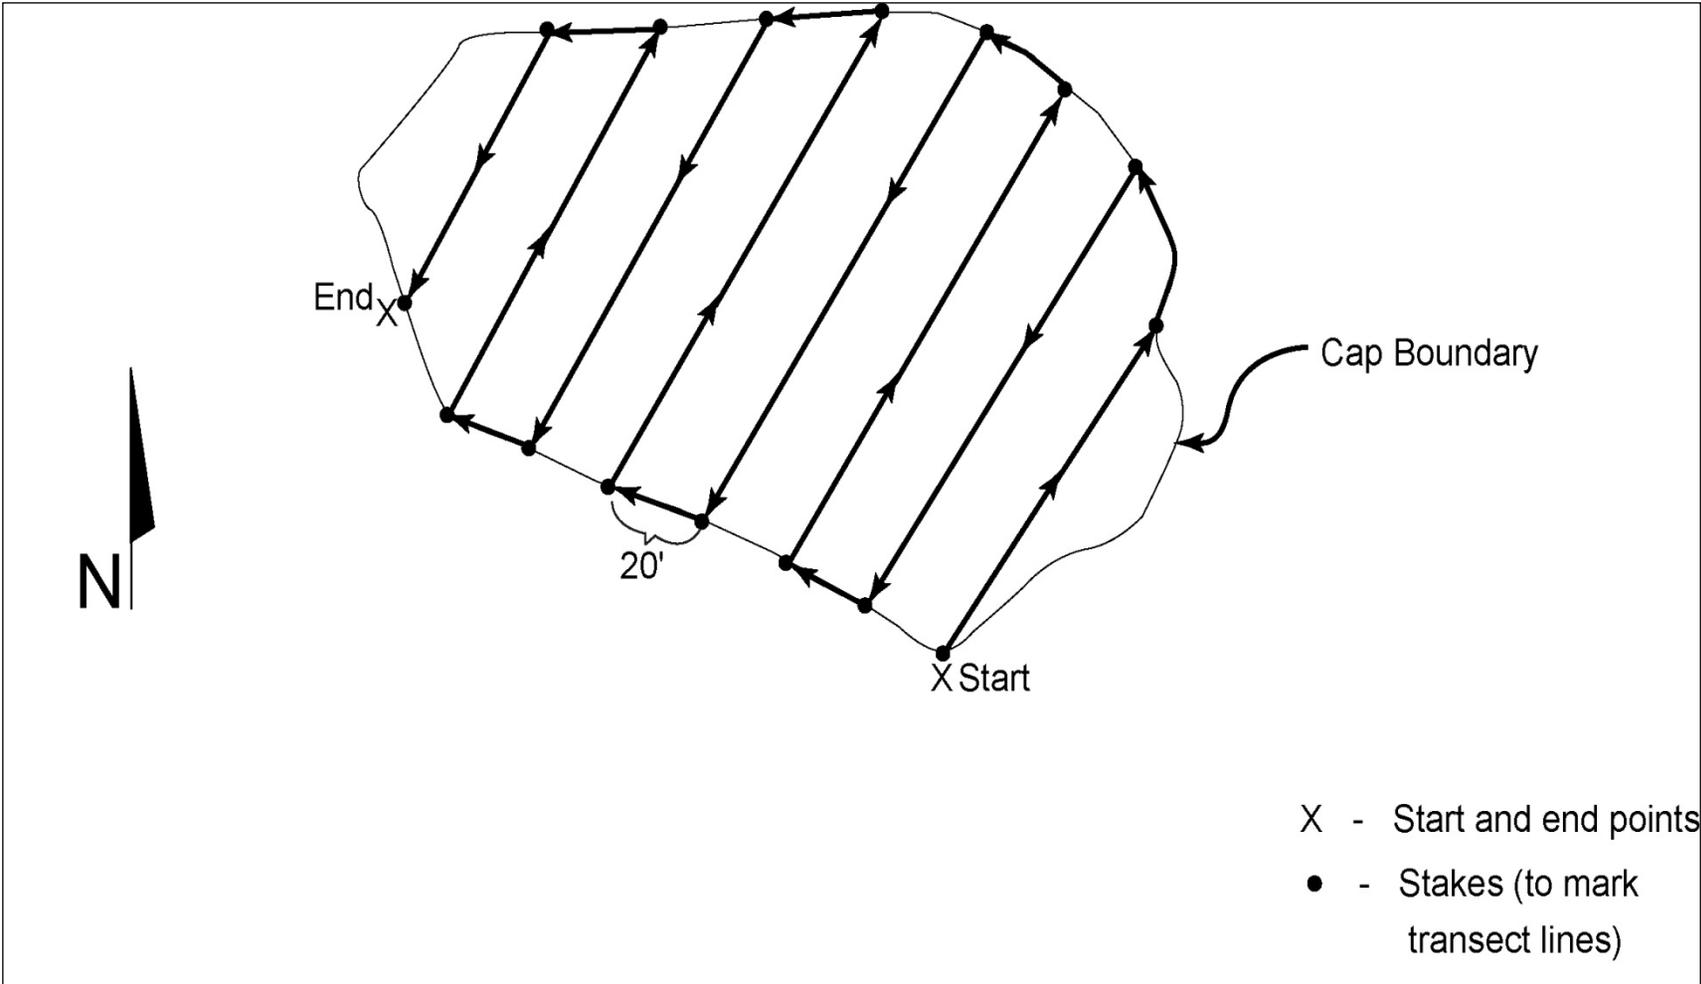
Figure 2. Example of Cap Inspection Pattern on 20-foot Transects

Table 3 outlines the proposed inspection specifications for each site. Actual field conditions may dictate a different specification(s) for a given site, and minor modifications to the specifications may be warranted (and documented) at the time of the inspection. Figure 2 provides an example of the proposed cap inspection pattern for each site. The 20-foot (ft) spacing between transect lines is proposed to ensure adequate visual coverage of each cap, but spacing may be adjusted based on site conditions. The use of a GPS unit is proposed to stake the endpoints of the transects. A compass may be used to help the inspector stay on a straight course along each transect.
