**VERIFICATION SURVEY  
OF  
PHASE II REMEDIAL ACTIONS  
ALBANY RESEARCH CENTER  
ALBANY, OREGON**

T. J. Vitkus and P. R. Cotten

Environmental Survey and Site Assessment Program  
Energy/Environment Systems Division  
Oak Ridge Associated Universities  
Oak Ridge, TN 37831-0117

**INTERIM REPORT**

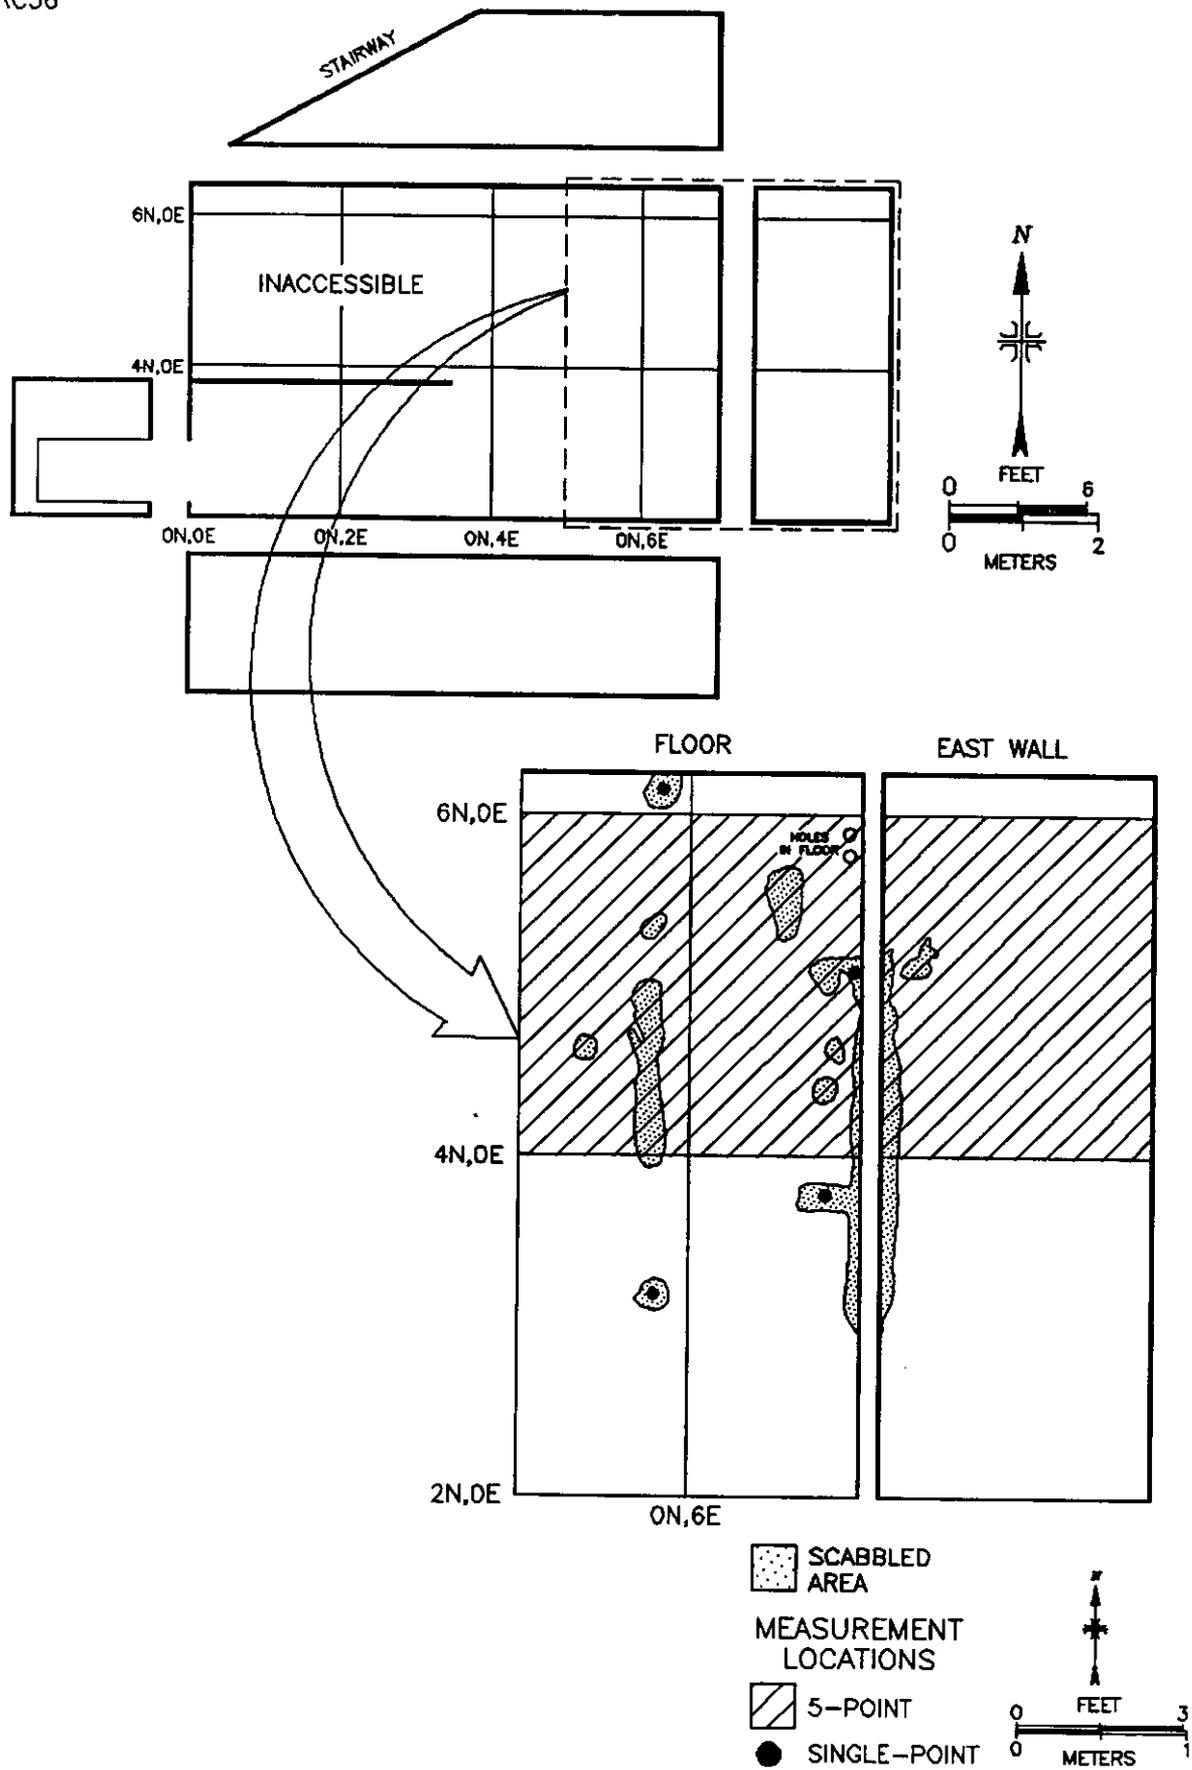
FIGURE 4: Building 1, Room 119, Indicating Measurement Locations on the Floor and East Wall

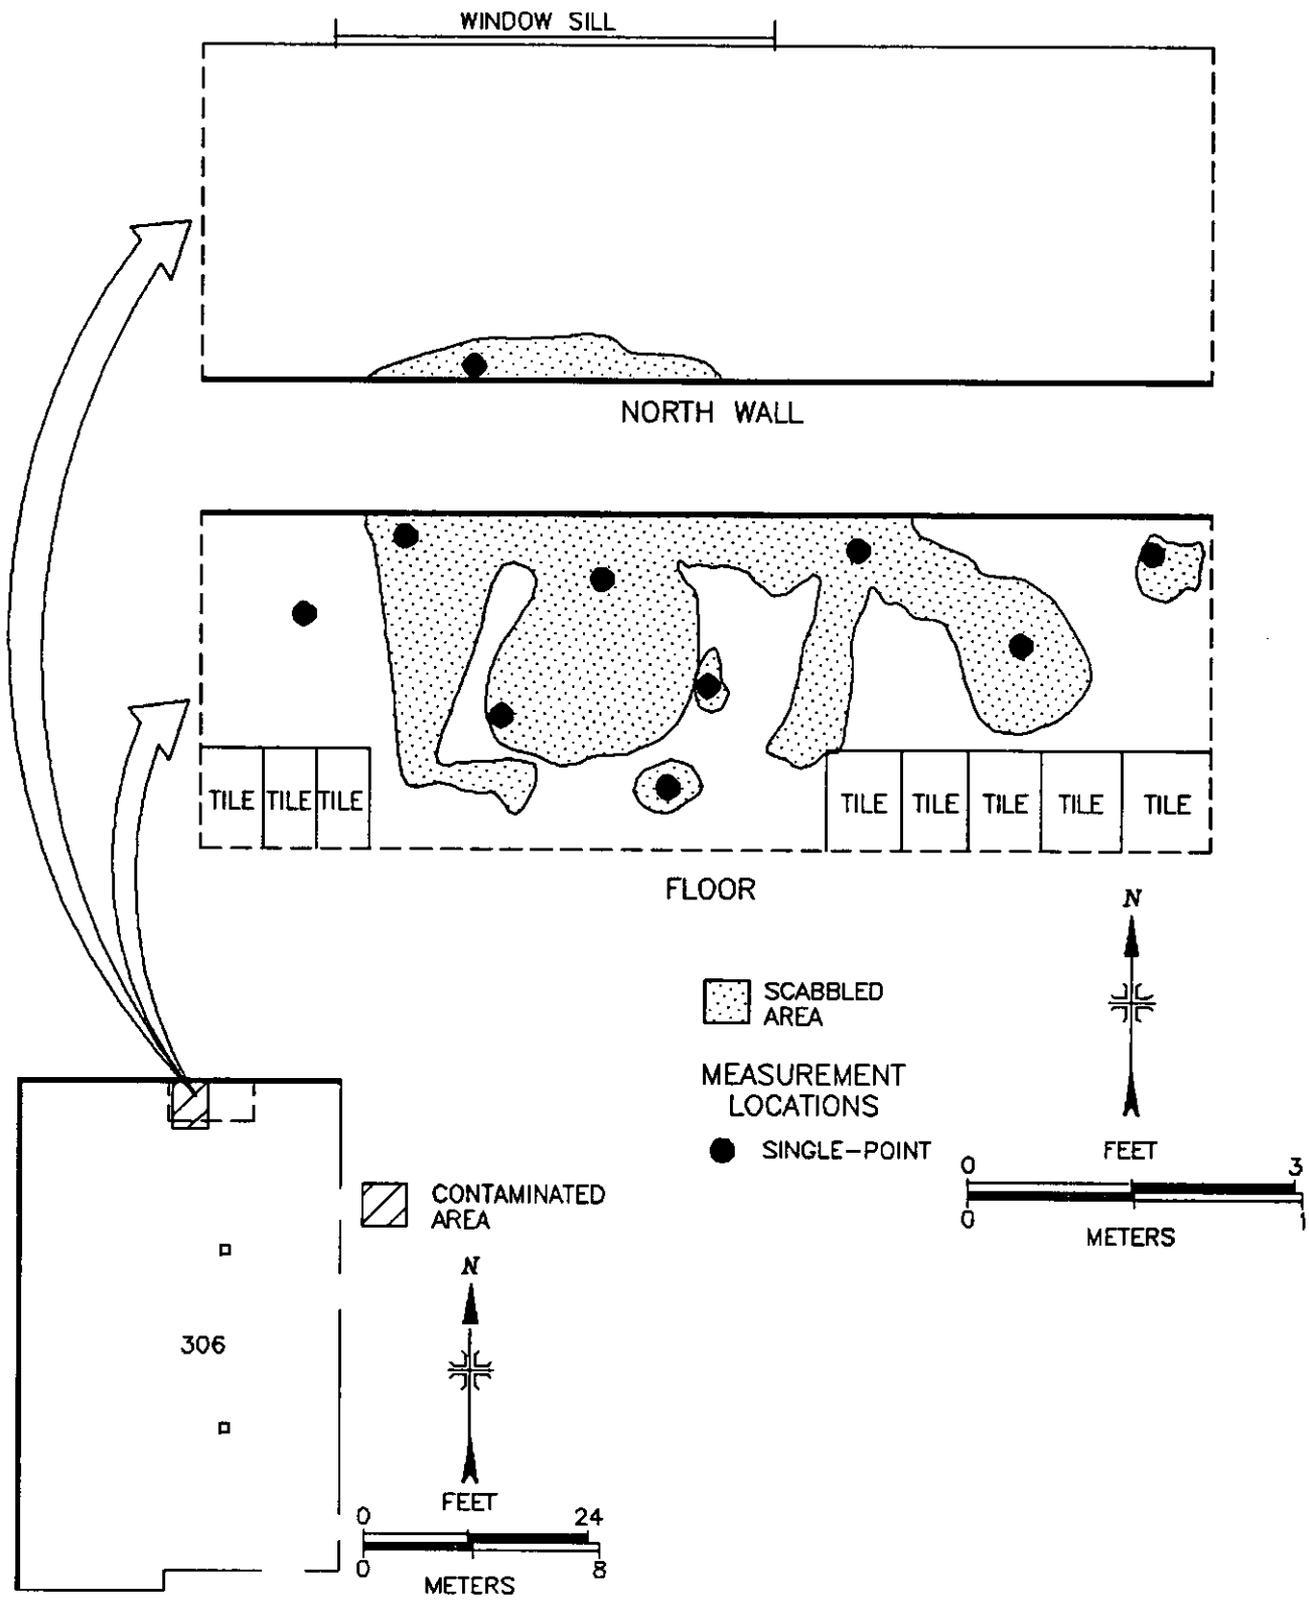
FIGURE 6: Building 1, Room 306, Indicating Measurement Locations on the Floor and North Wall

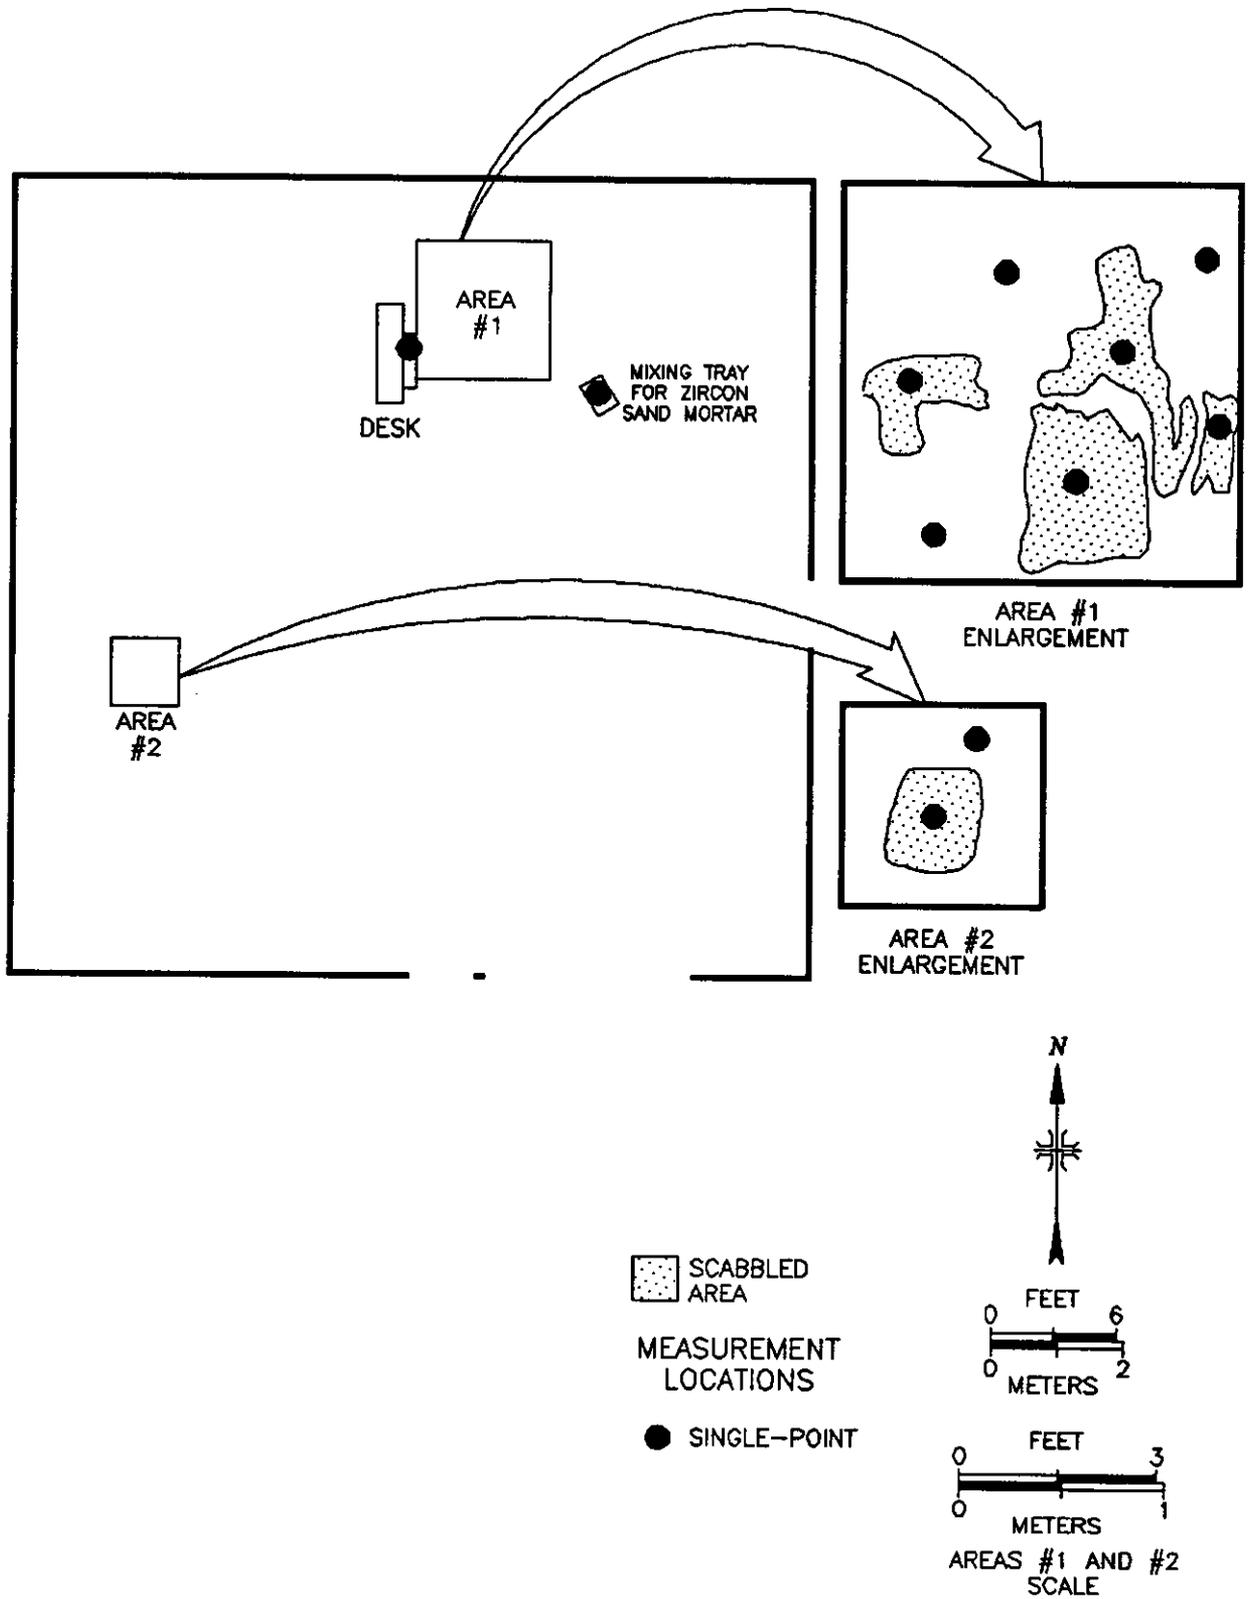
FIGURE 8: Building 3, Room 101, Indicating Measurement Locations on the Floor

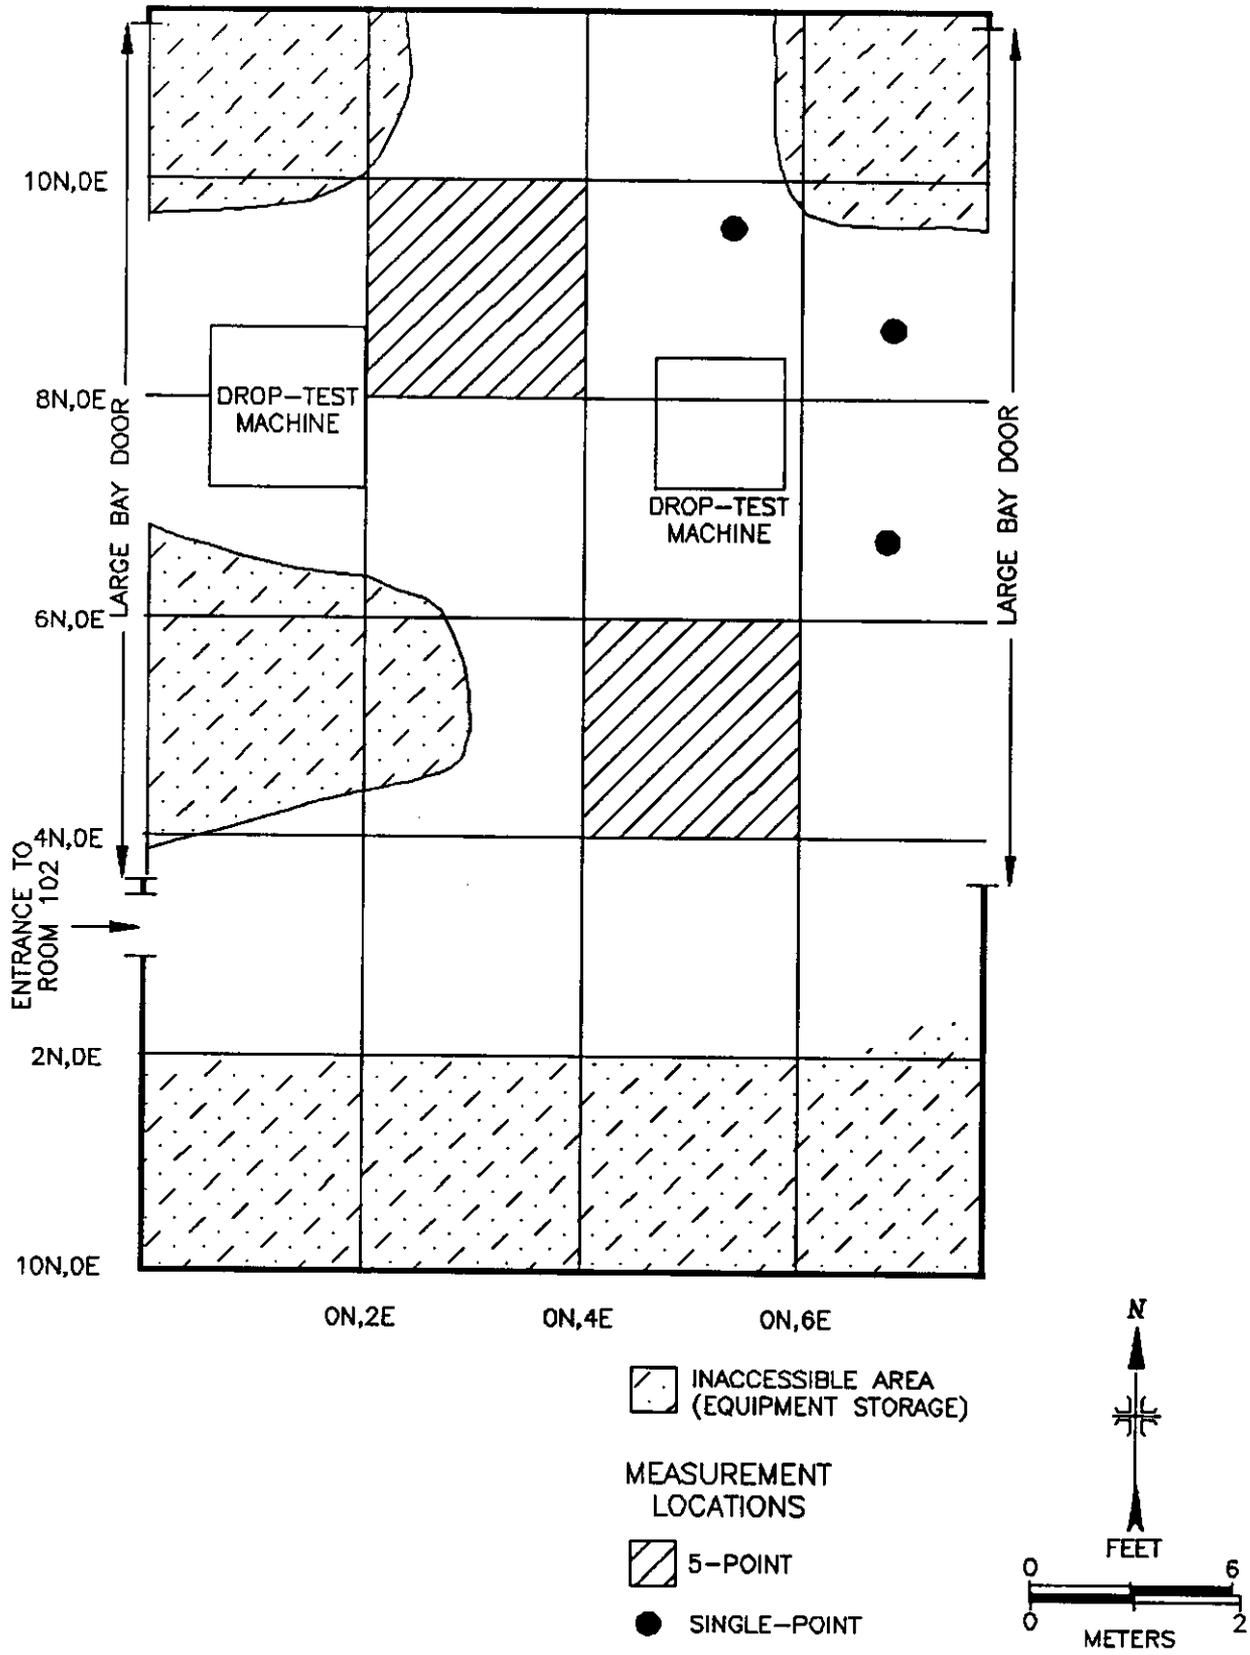
FIGURE 9: Building 3, Room 103, Indicating Measurement Locations on the Floor

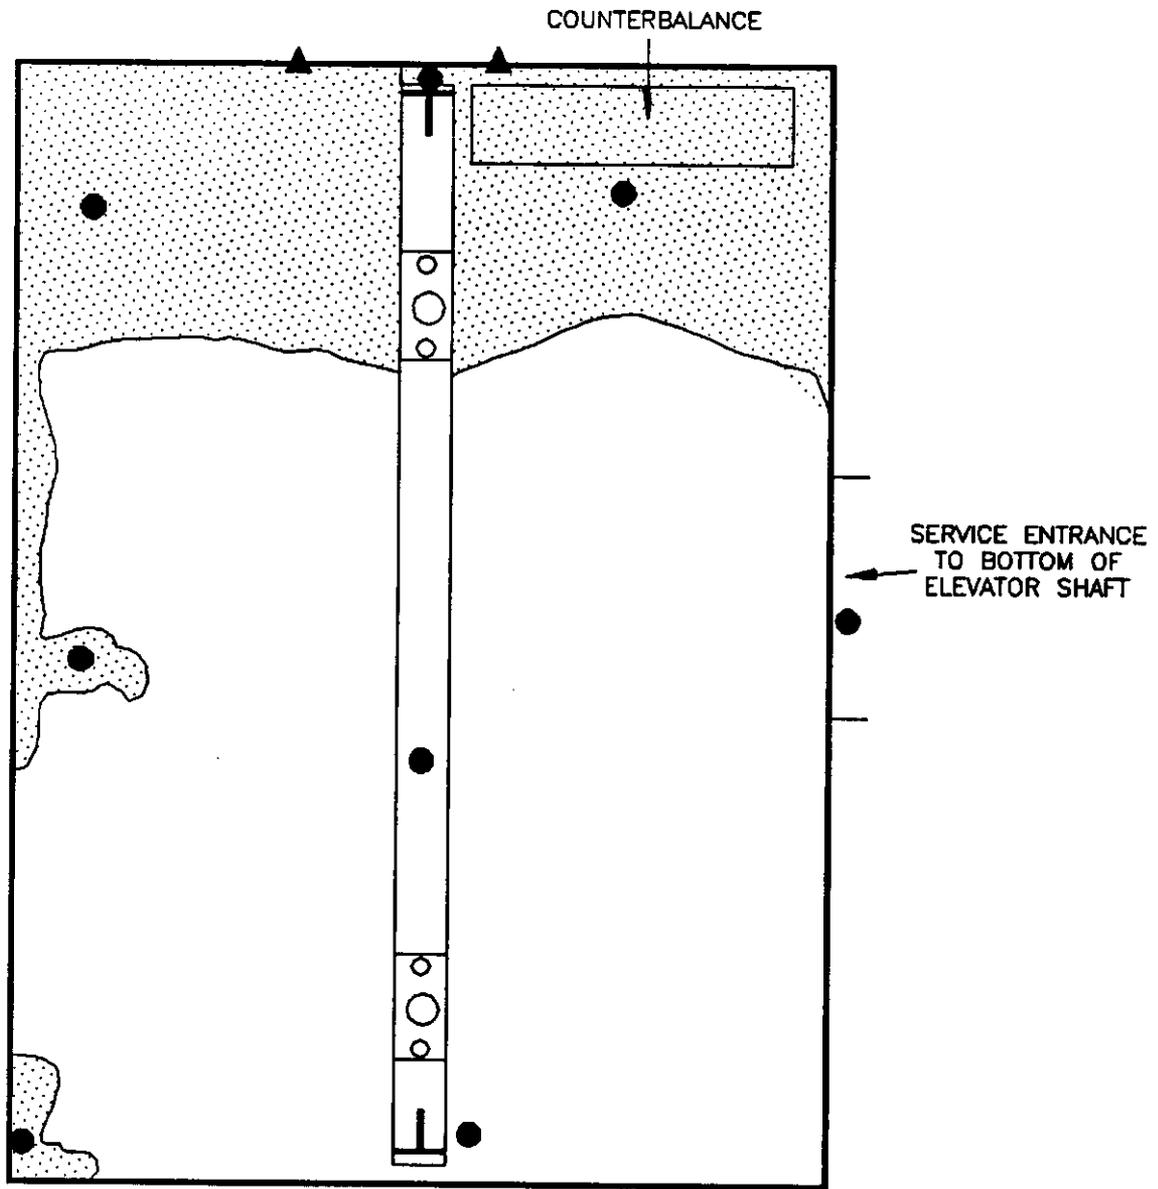
SCABBLED AREA

MEASUREMENT LOCATIONS

- SINGLE-POINT (FLOOR)
- ▲ SINGLE-POINT (LOWER WALL)

FIGURE 13: Building 23 Basement, Southeast Corner, Indicating Measurement Locations on the Elevator Shaft-Floor and Lower Wall

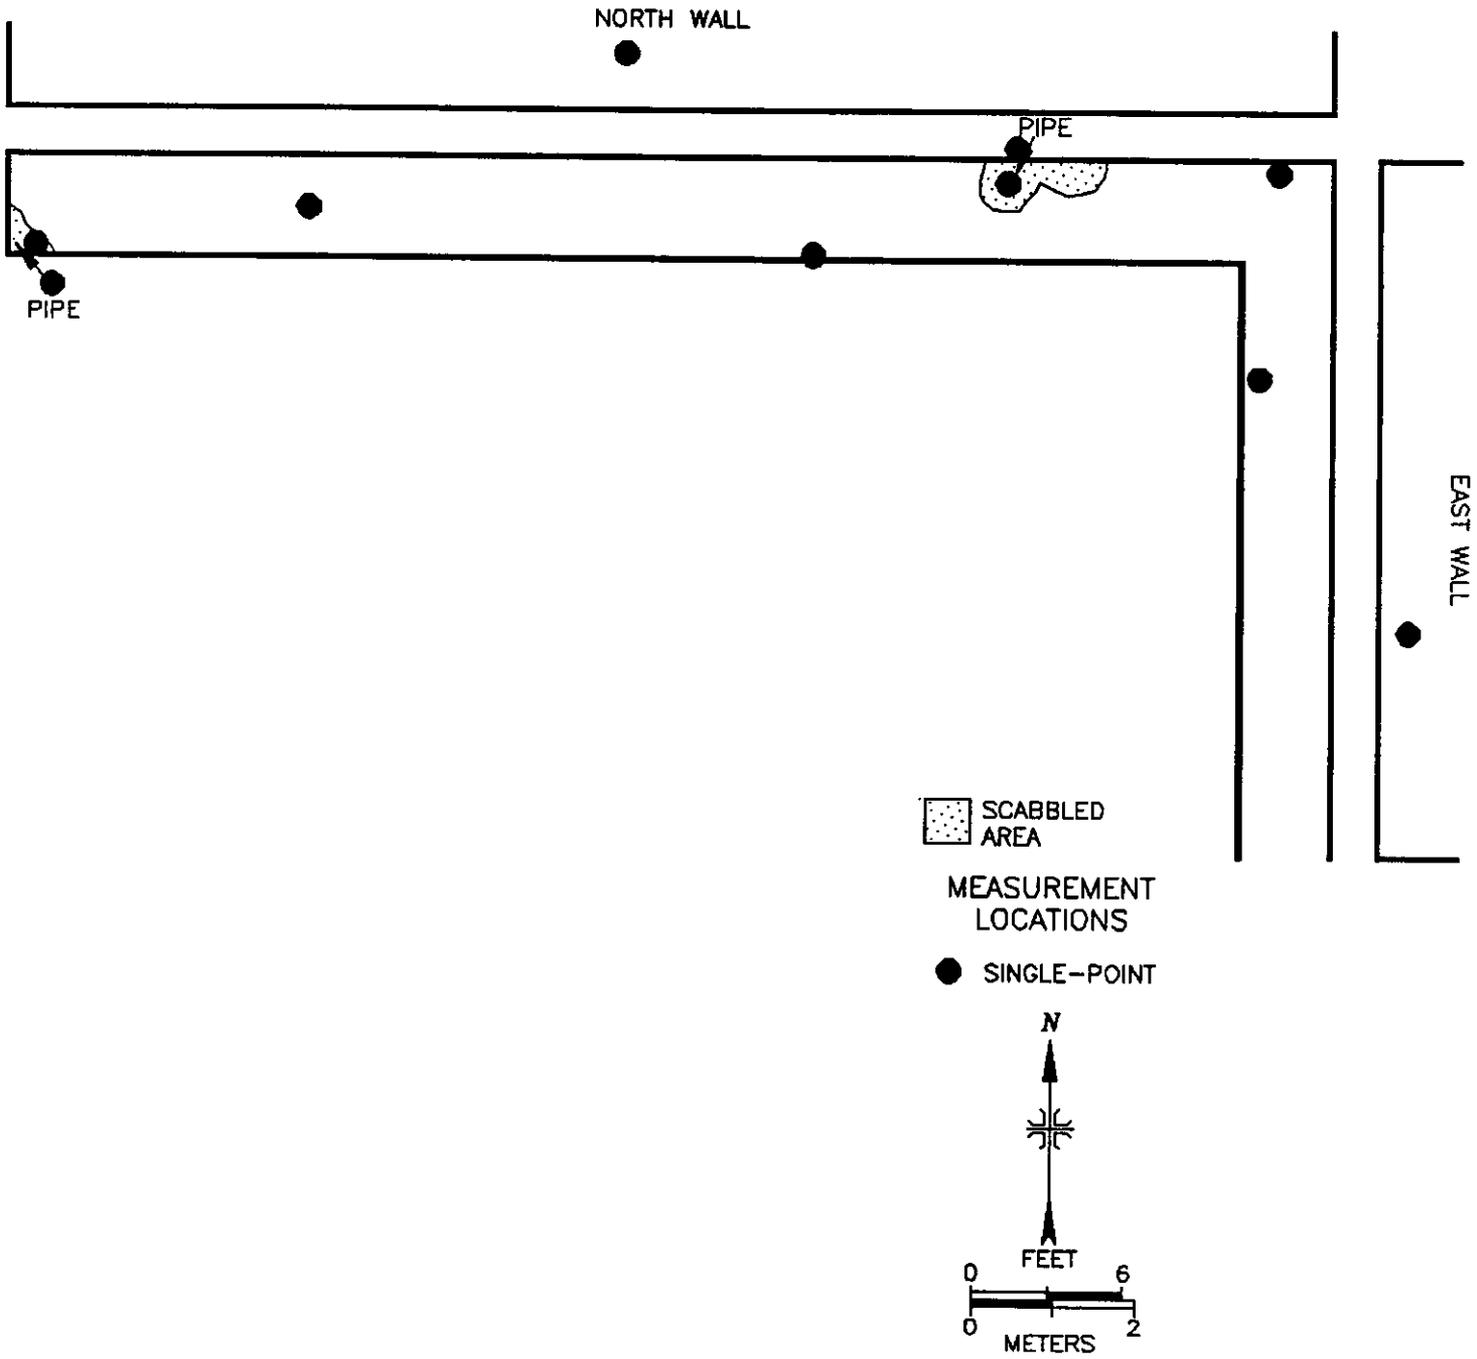
FIGURE 14: Building 23, Basement Tunnel, Indicating Measurement Locations

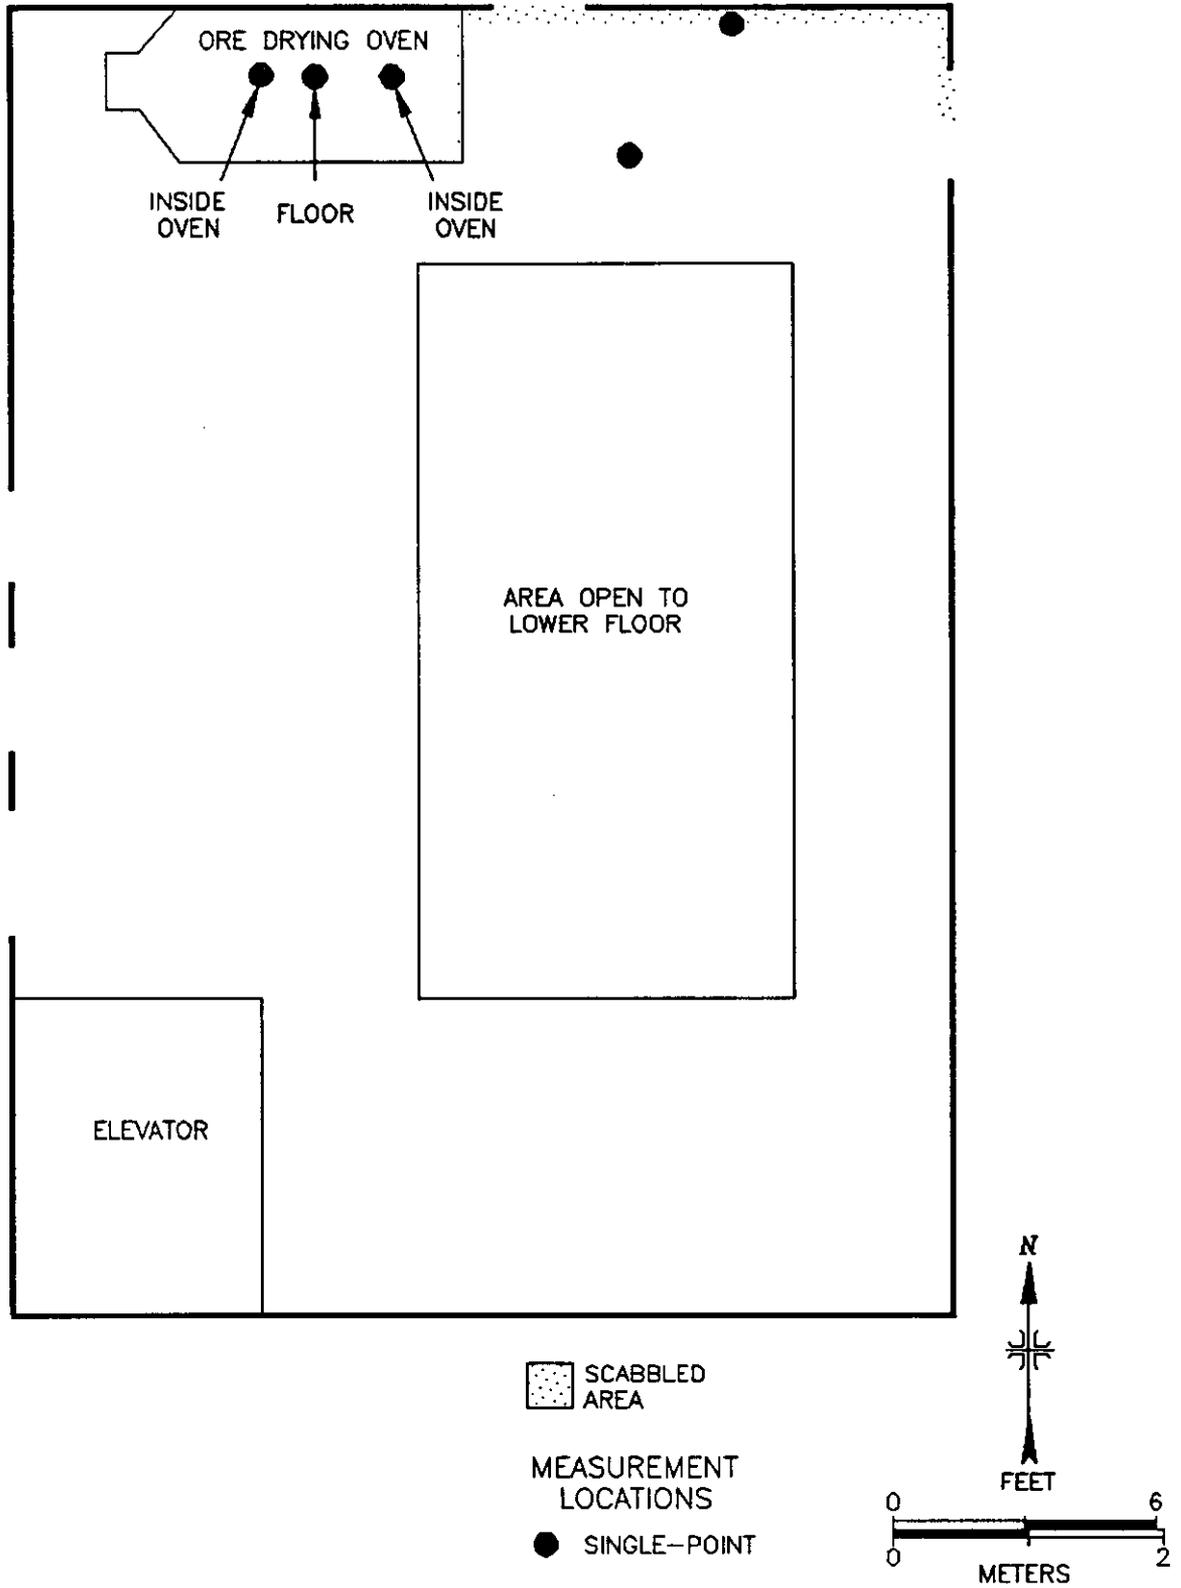
FIGURE 16: Building 23, Crusher Room, Second Floor, Indicating Measurement Locations

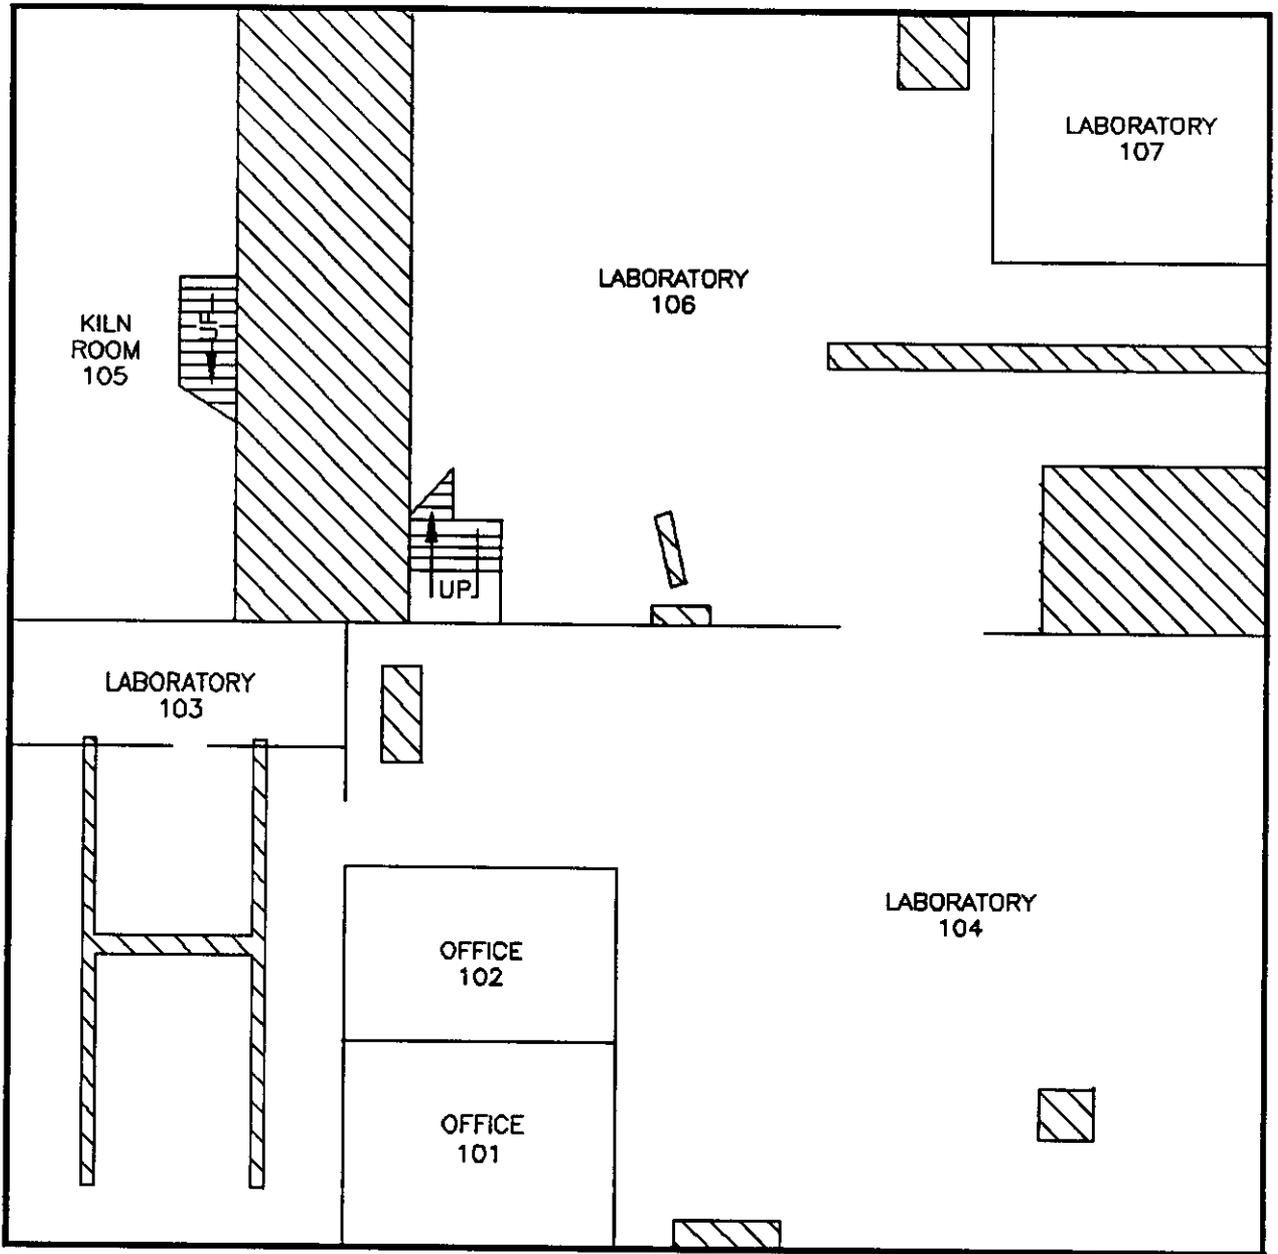
FIGURE 17: Plot Plan of Building 24

CONTAMINATED AREA

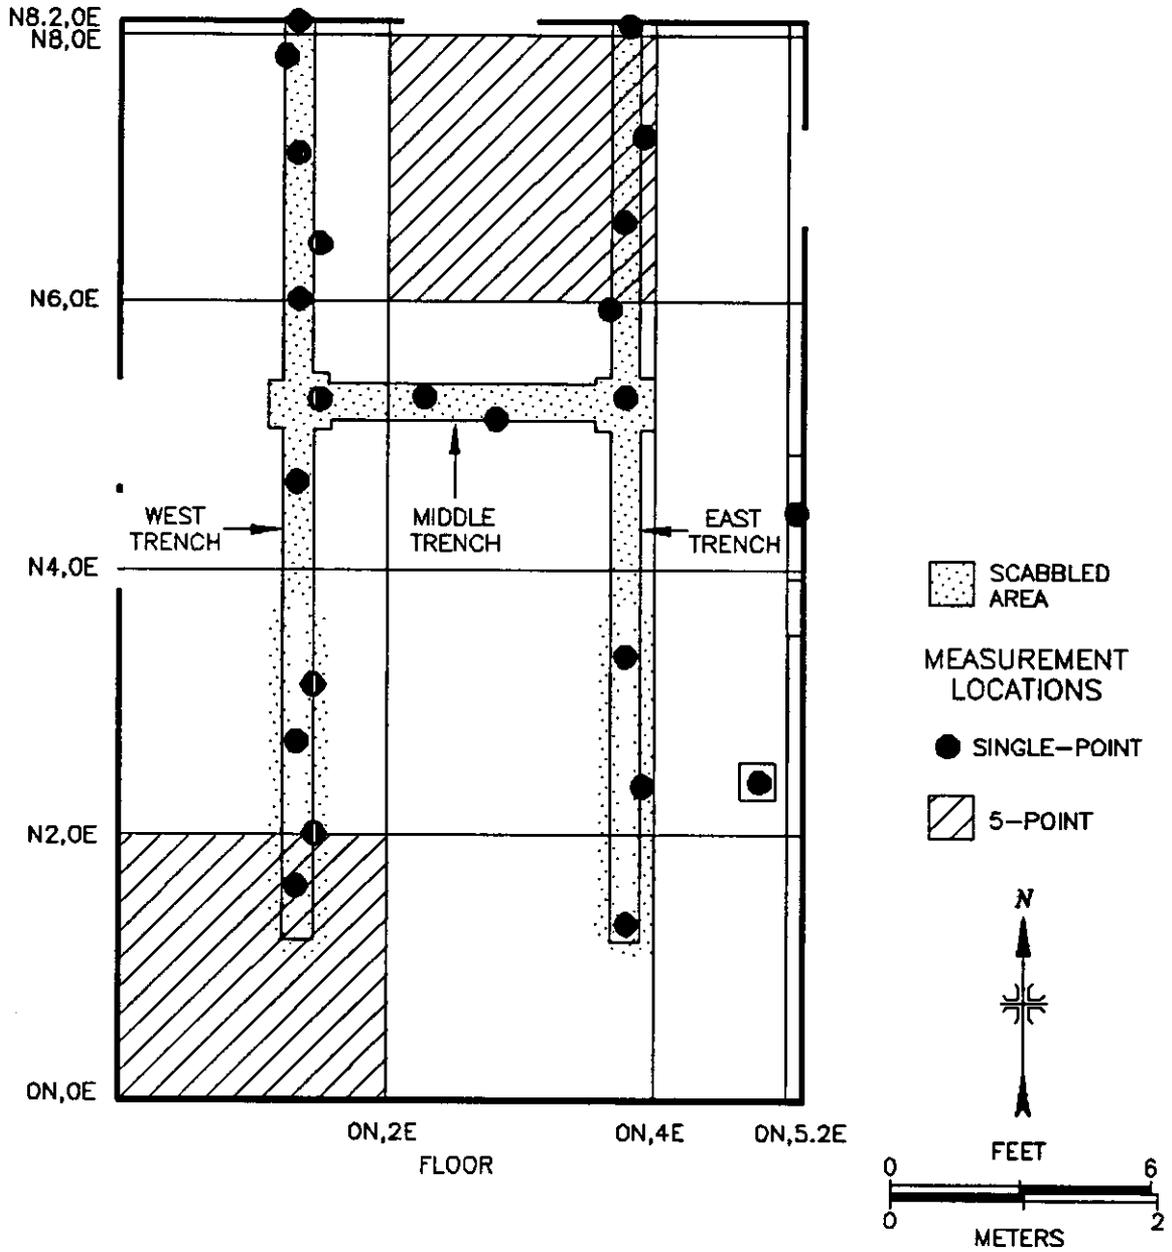
FIGURE 18: Building 24, Room 103, Indicating Measurement Locations on the Floor and in the East, West and Middle Trenches

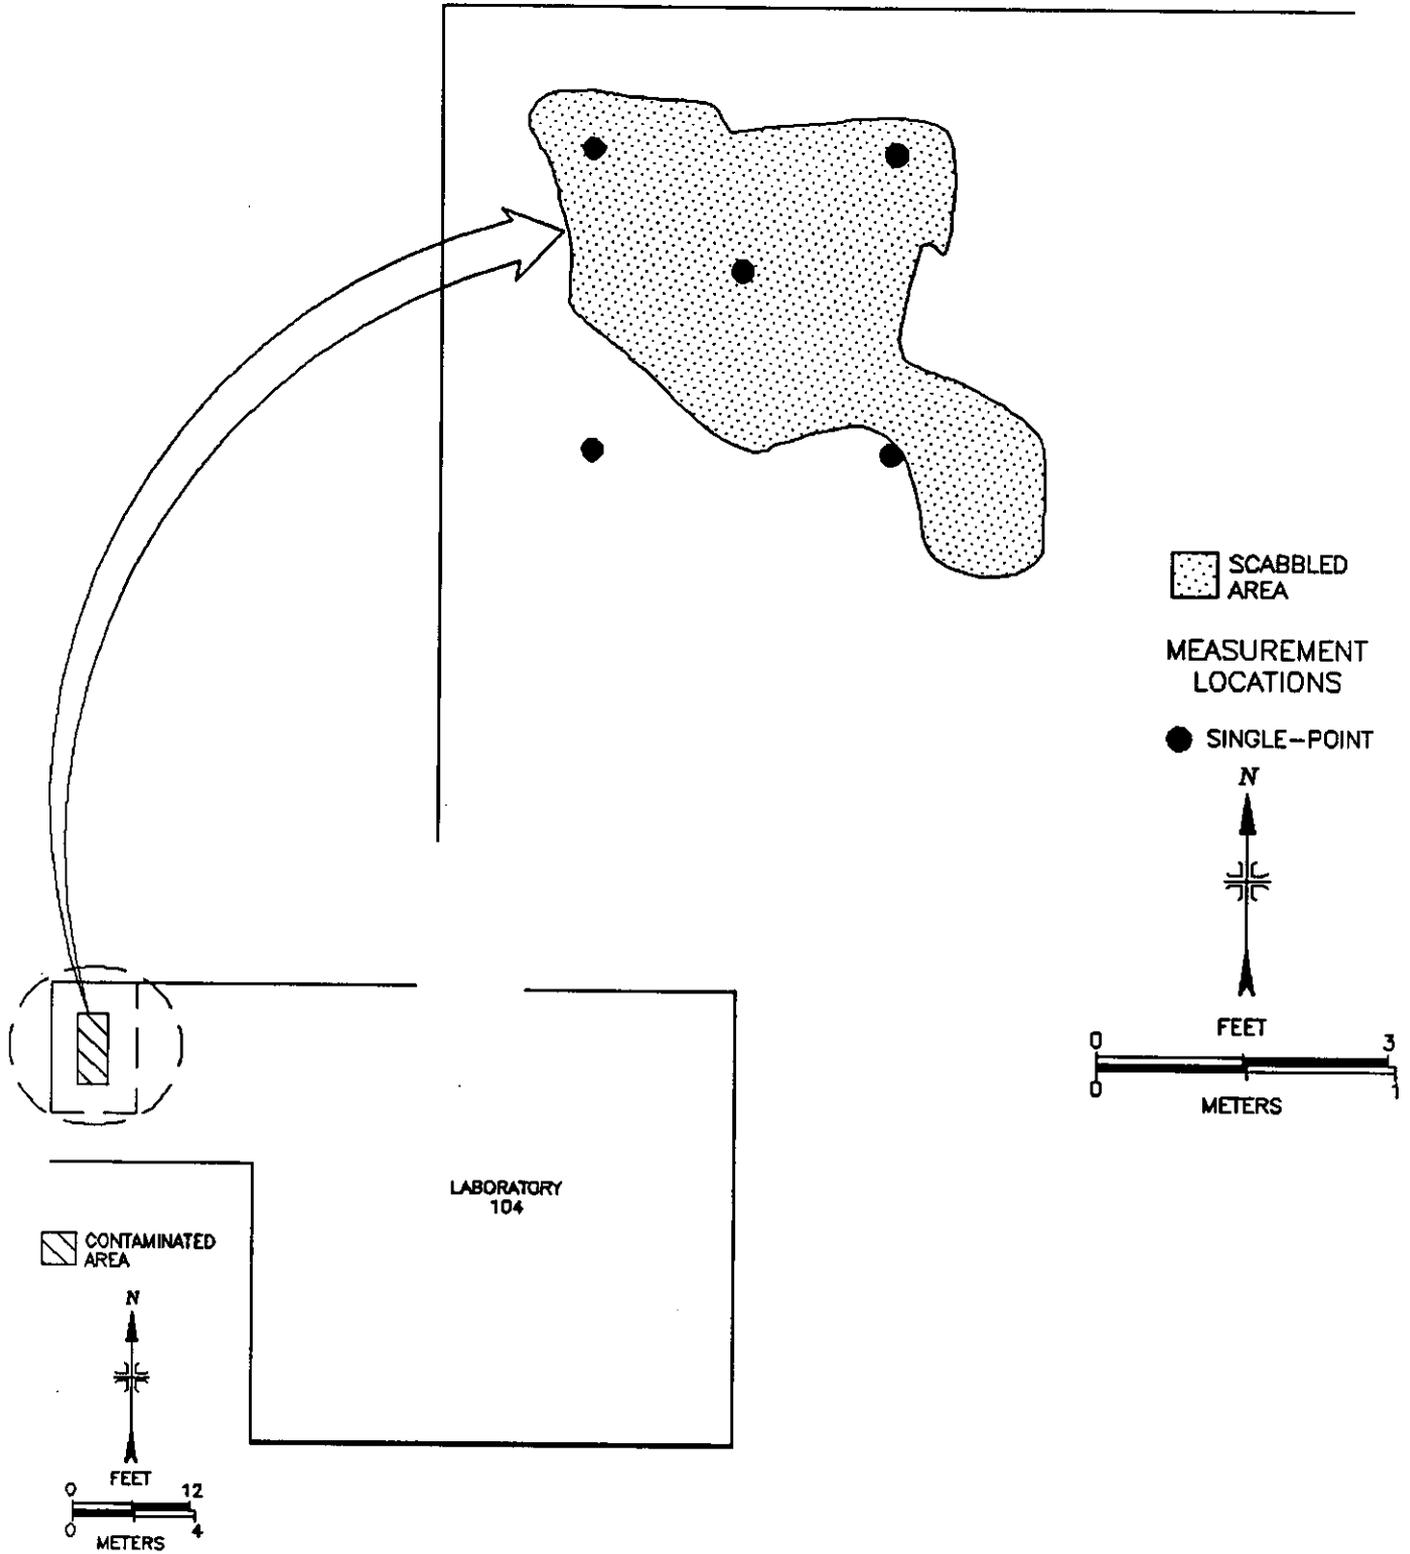
FIGURE 19: Building 24, Room 104, Indicating Measurement Locations on the Northwest Corner of the Floor

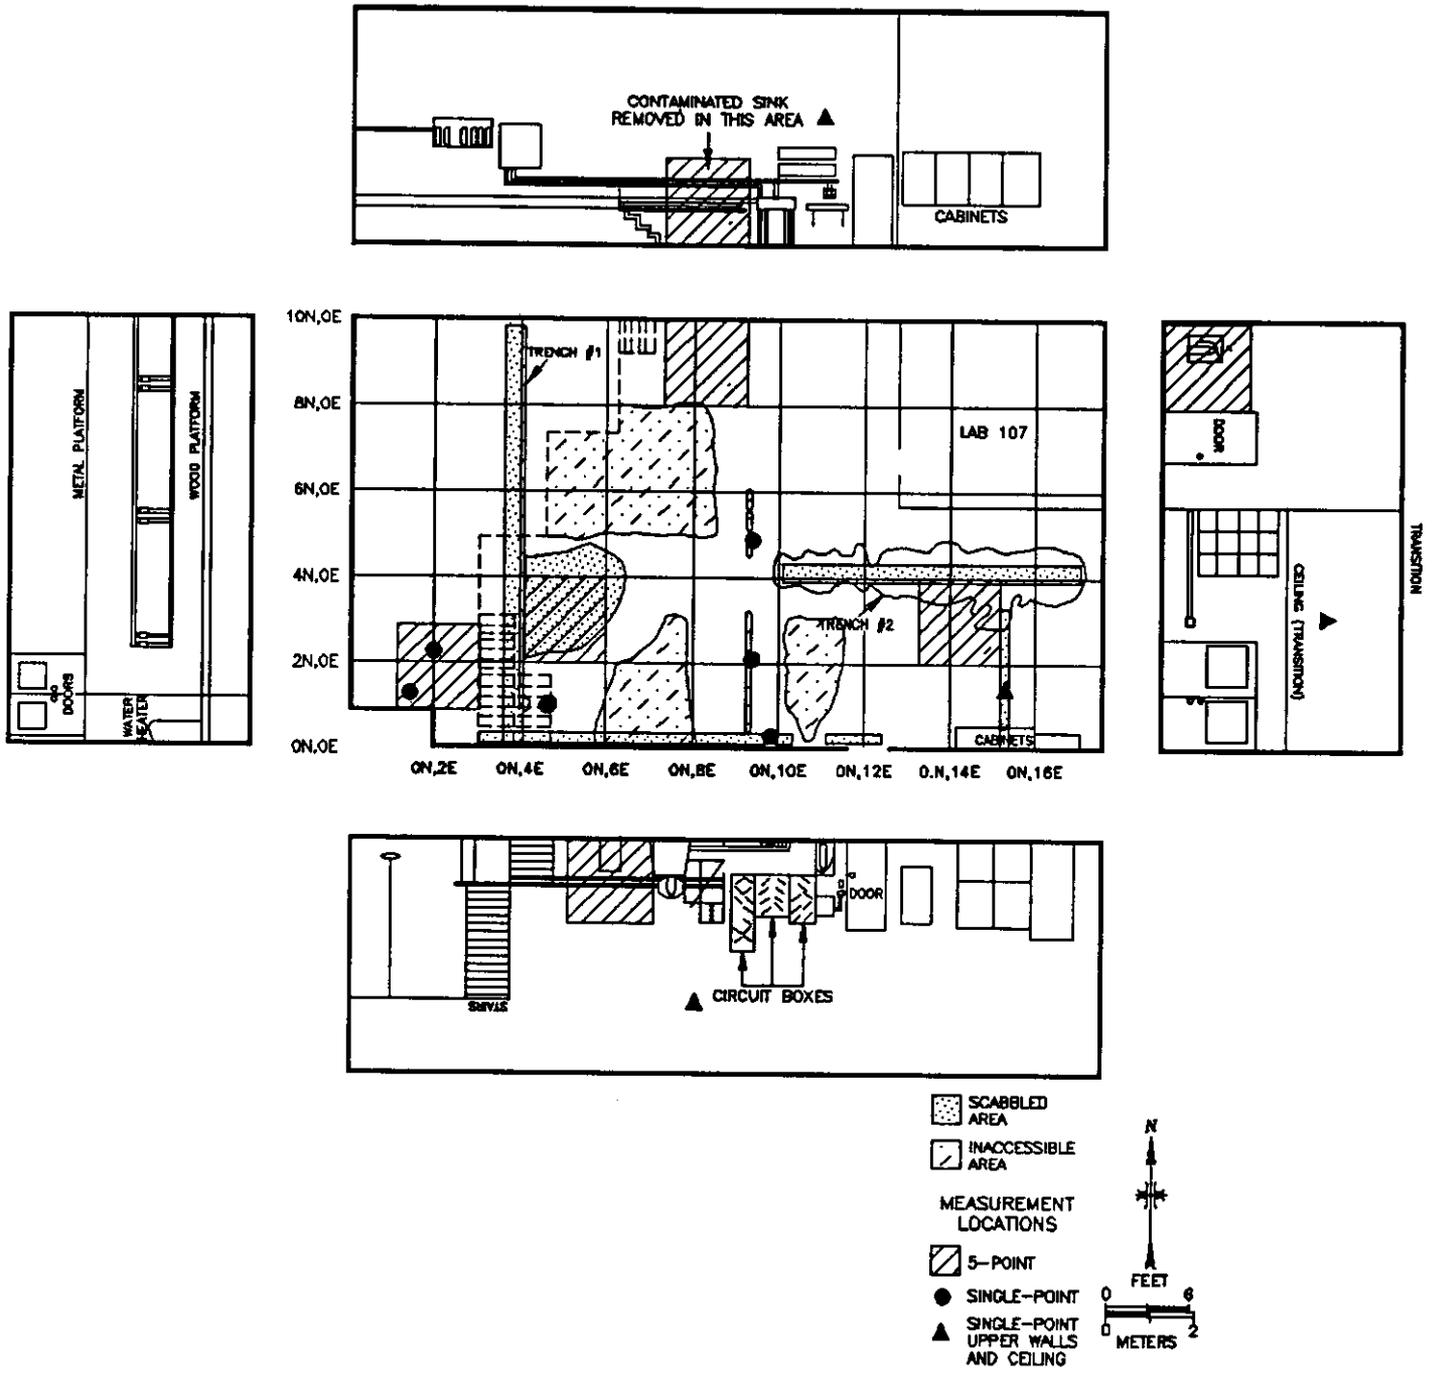
FIGURE 20: Building 24, Room 106, Indicating Measurement Locations on the Floor, Lower Walls, and Upper Walls

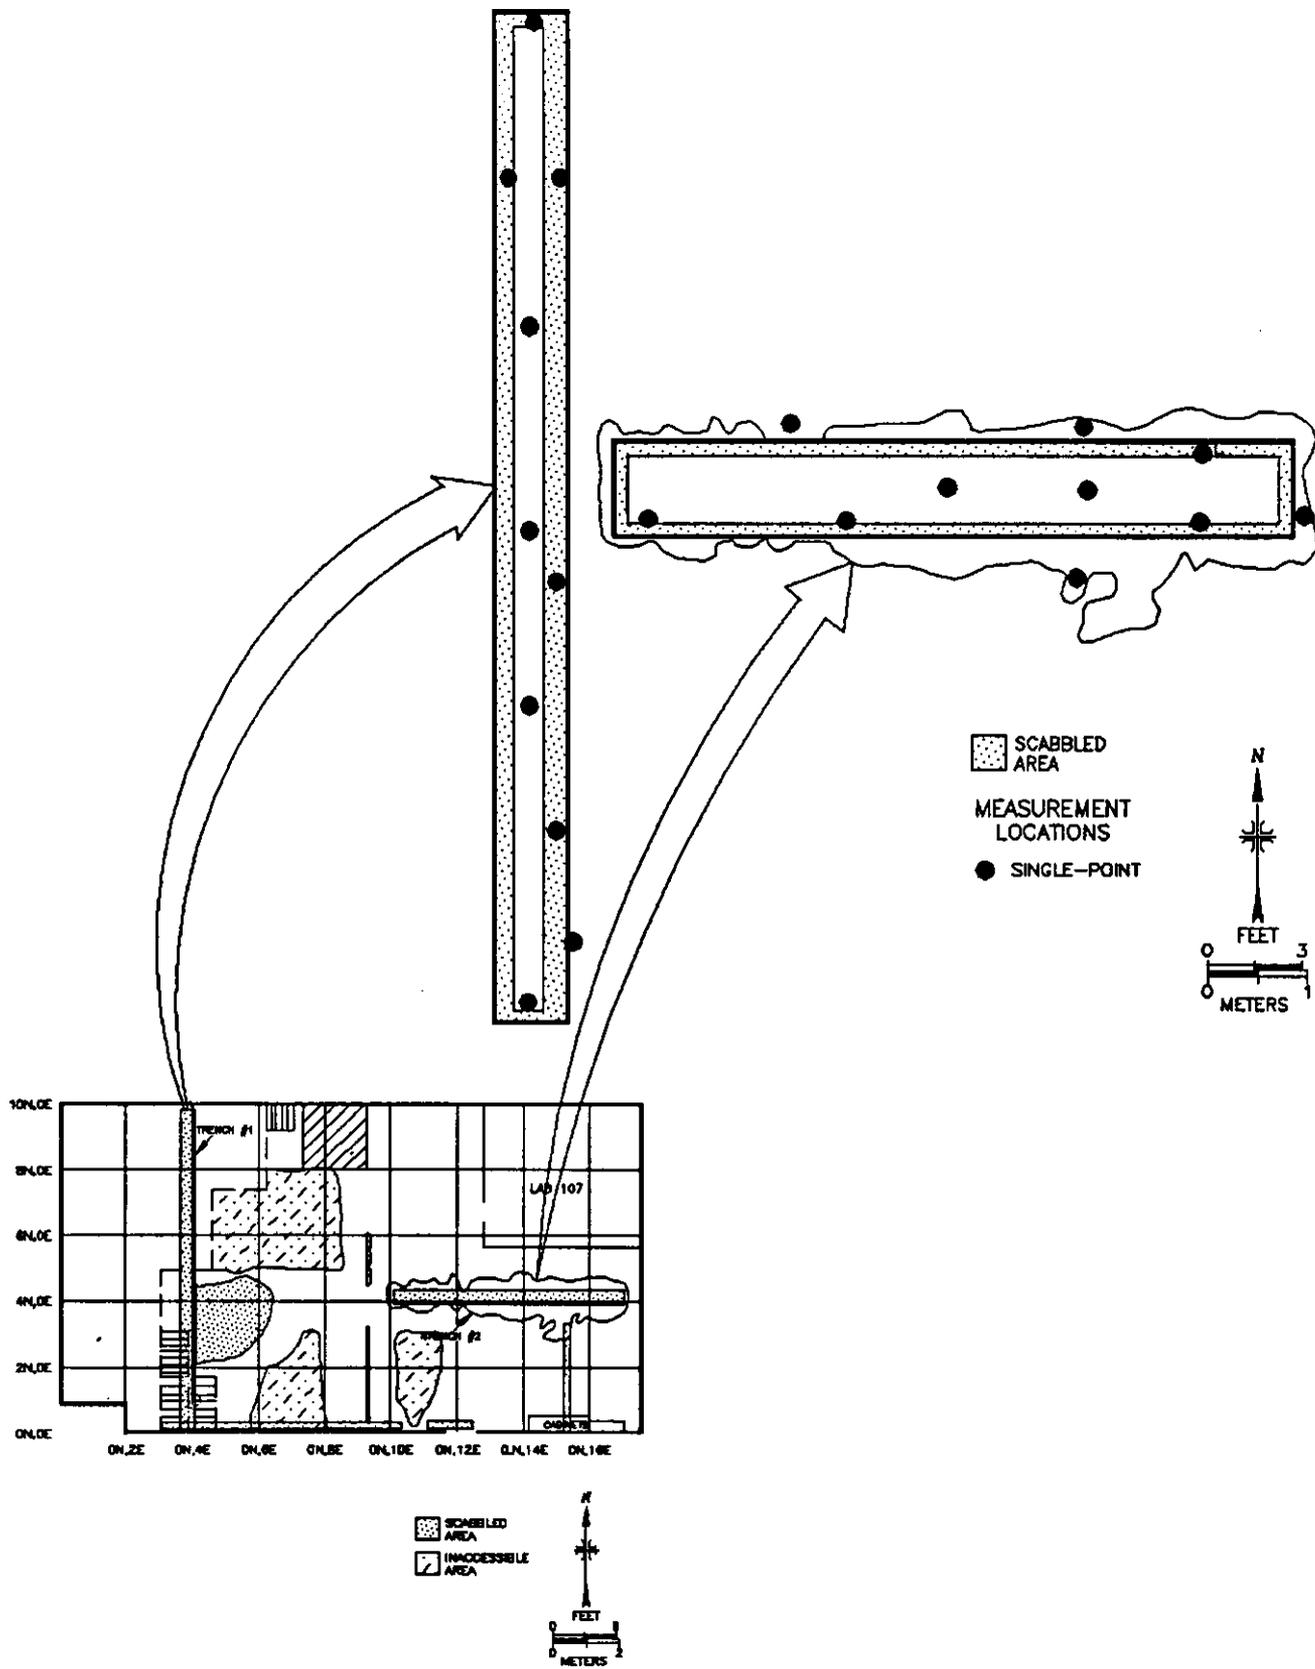
FIGURE 21: Building 24, Room 106, Indicating Measurement Locations in Trenches 1 and 2
