PHASE I CHEMICAL SOIL INVESTIGATION DATA REPORT FOR THE WELDON SPRING CHEMICAL PLANT/RAFFINATE PITS

DOE/OR/21548-016

PHASE I CHEMICAL SOIL INVESTIGATION DATA REPORT FOR THE WELDON SPRING CHEMICAL PLANT / RAFFINATE PITS

WELDON SPRING SITE REMEDIAL ACTION PROJECT

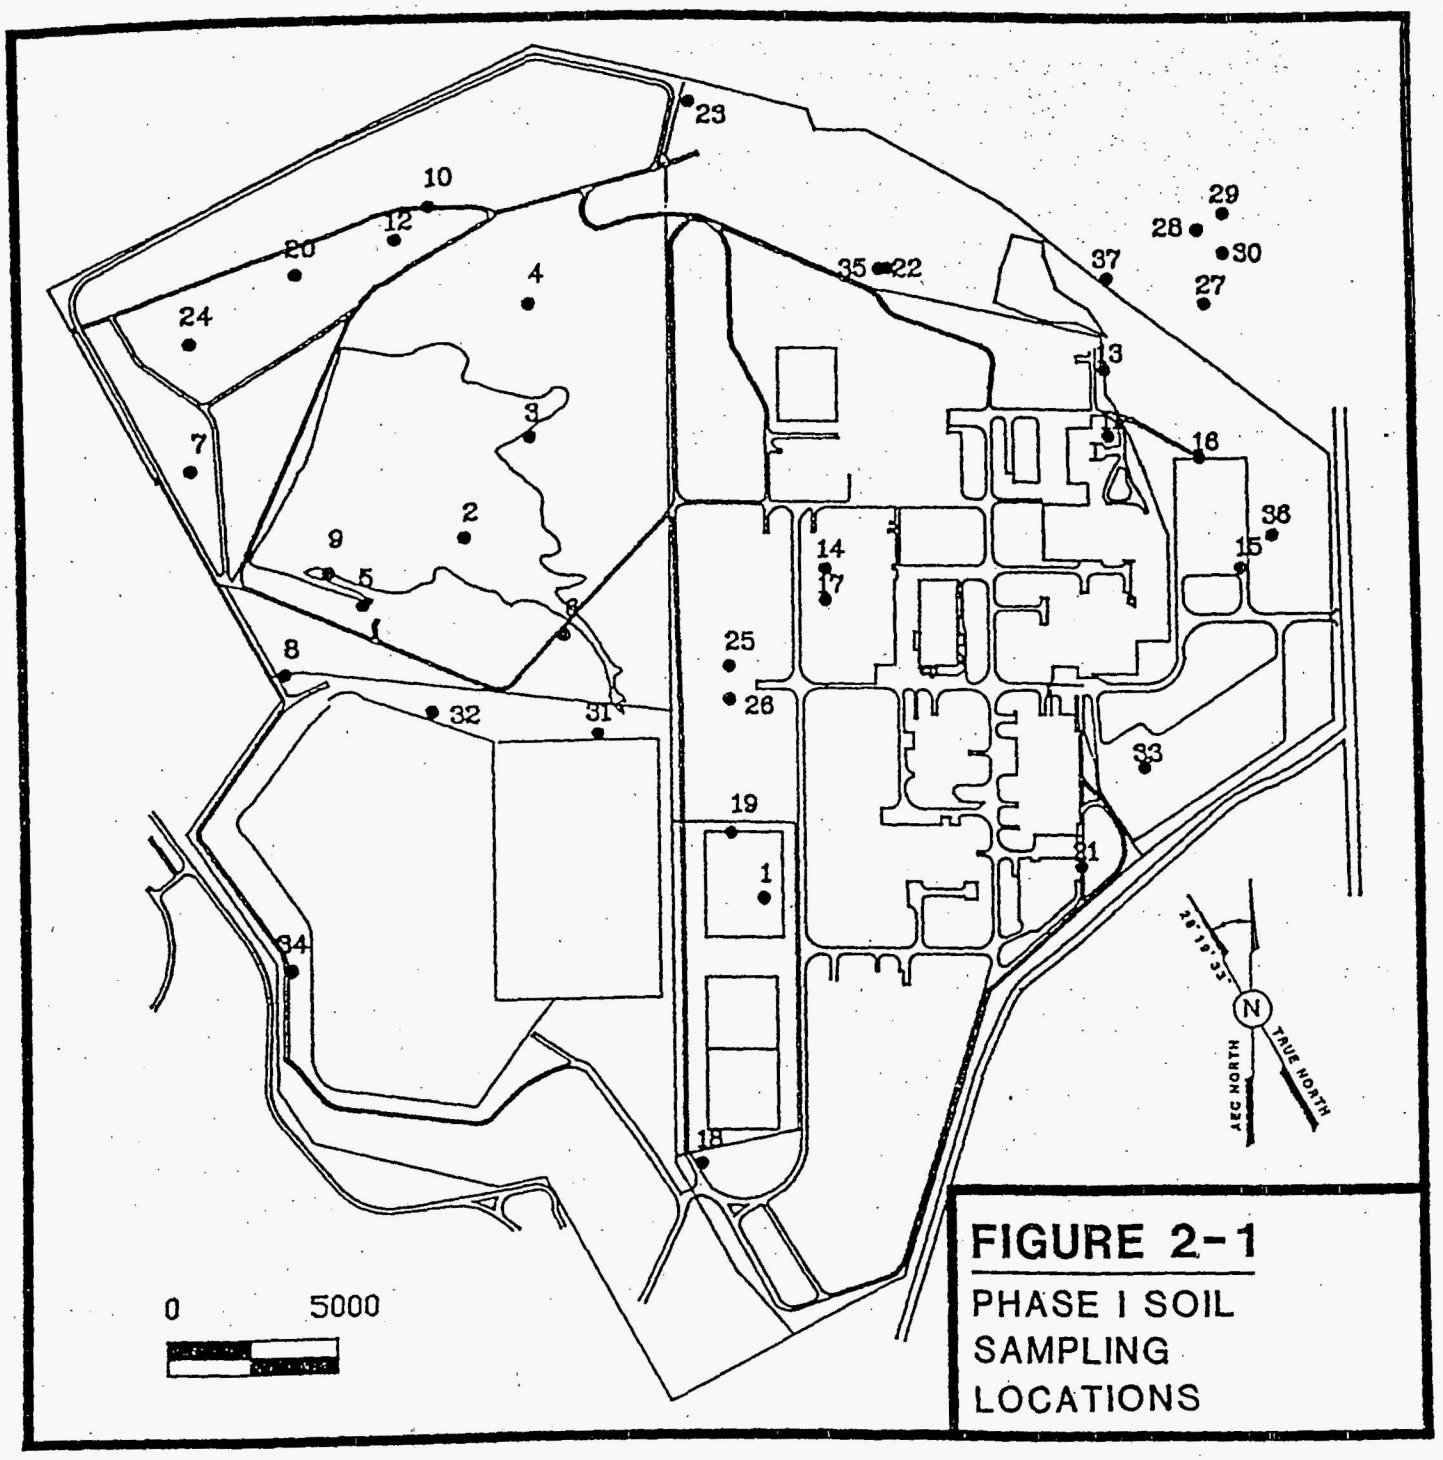
FIGURE 2-1

Soil samples were collected from 37 locations at or near the WSCP/WSRP. Figure 2-1 shows the sampling locations. Thirty-two locations were within the fenced WSCP/WSRP boundary. Four of the remaining five boreholes were drilled in WSOW Waste Lagoon

PHASE I SOIL SAMPLING LOCATIONS

ead concentrations in the soil at the WSCP ranged from <0.6 ug/Kg to 43,000 ug/Kg. The highest value was observed at Location No. 3 (Figure 2-1) north of Ash Pond in the 2- to 4-foot interval downslope from the final production area of TNT Line No. 2.
