**VERIFICATION SURVEY  
OF  
PHASE II REMEDIAL ACTIONS  
ALBANY RESEARCH CENTER  
ALBANY, OREGON**

T. J. Vitkus and P. R. Cotten

Environmental Survey and Site Assessment Program  
Energy/Environment Systems Division  
Oak Ridge Associated Universities  
Oak Ridge, TN 37831-0117

**INTERIM REPORT**

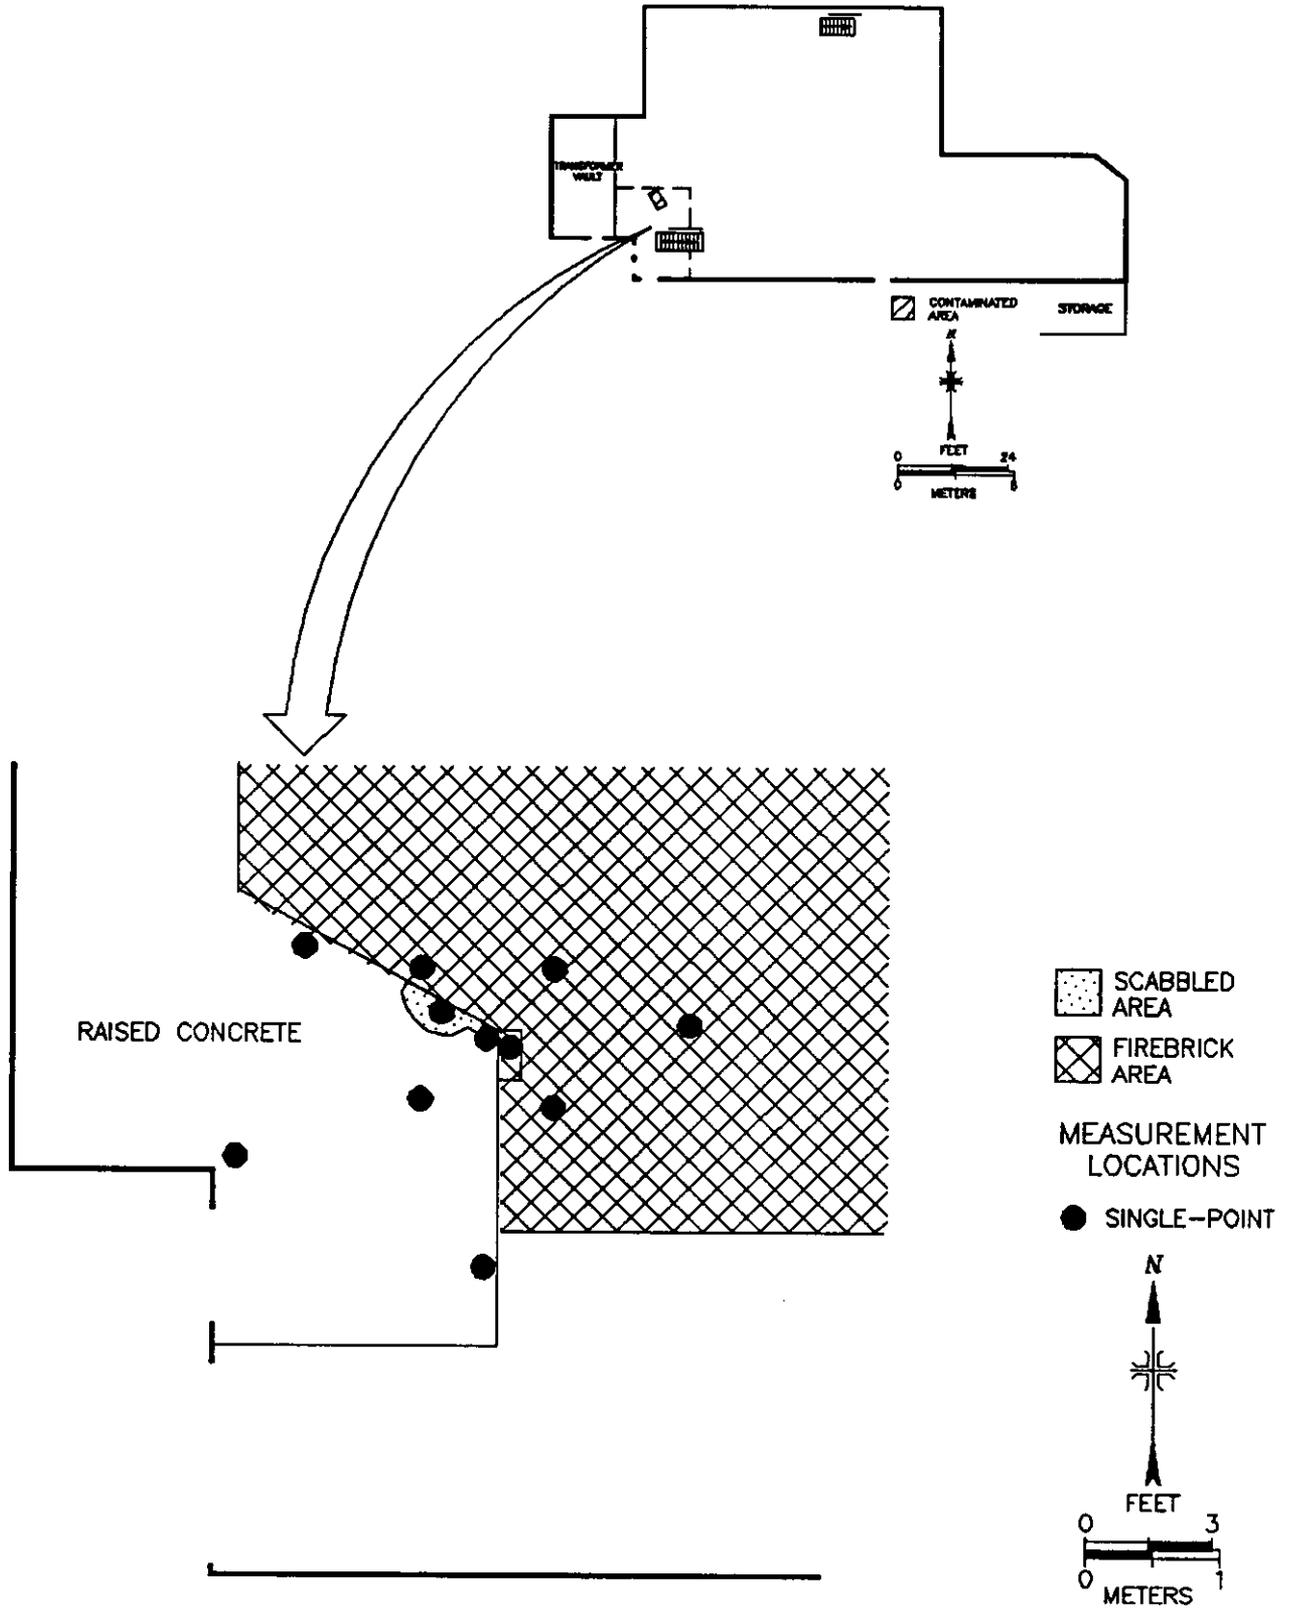
FIGURE 23: Building 25, First Floor, Indicating Measurement Locations on the Floor in the Southwest Corner

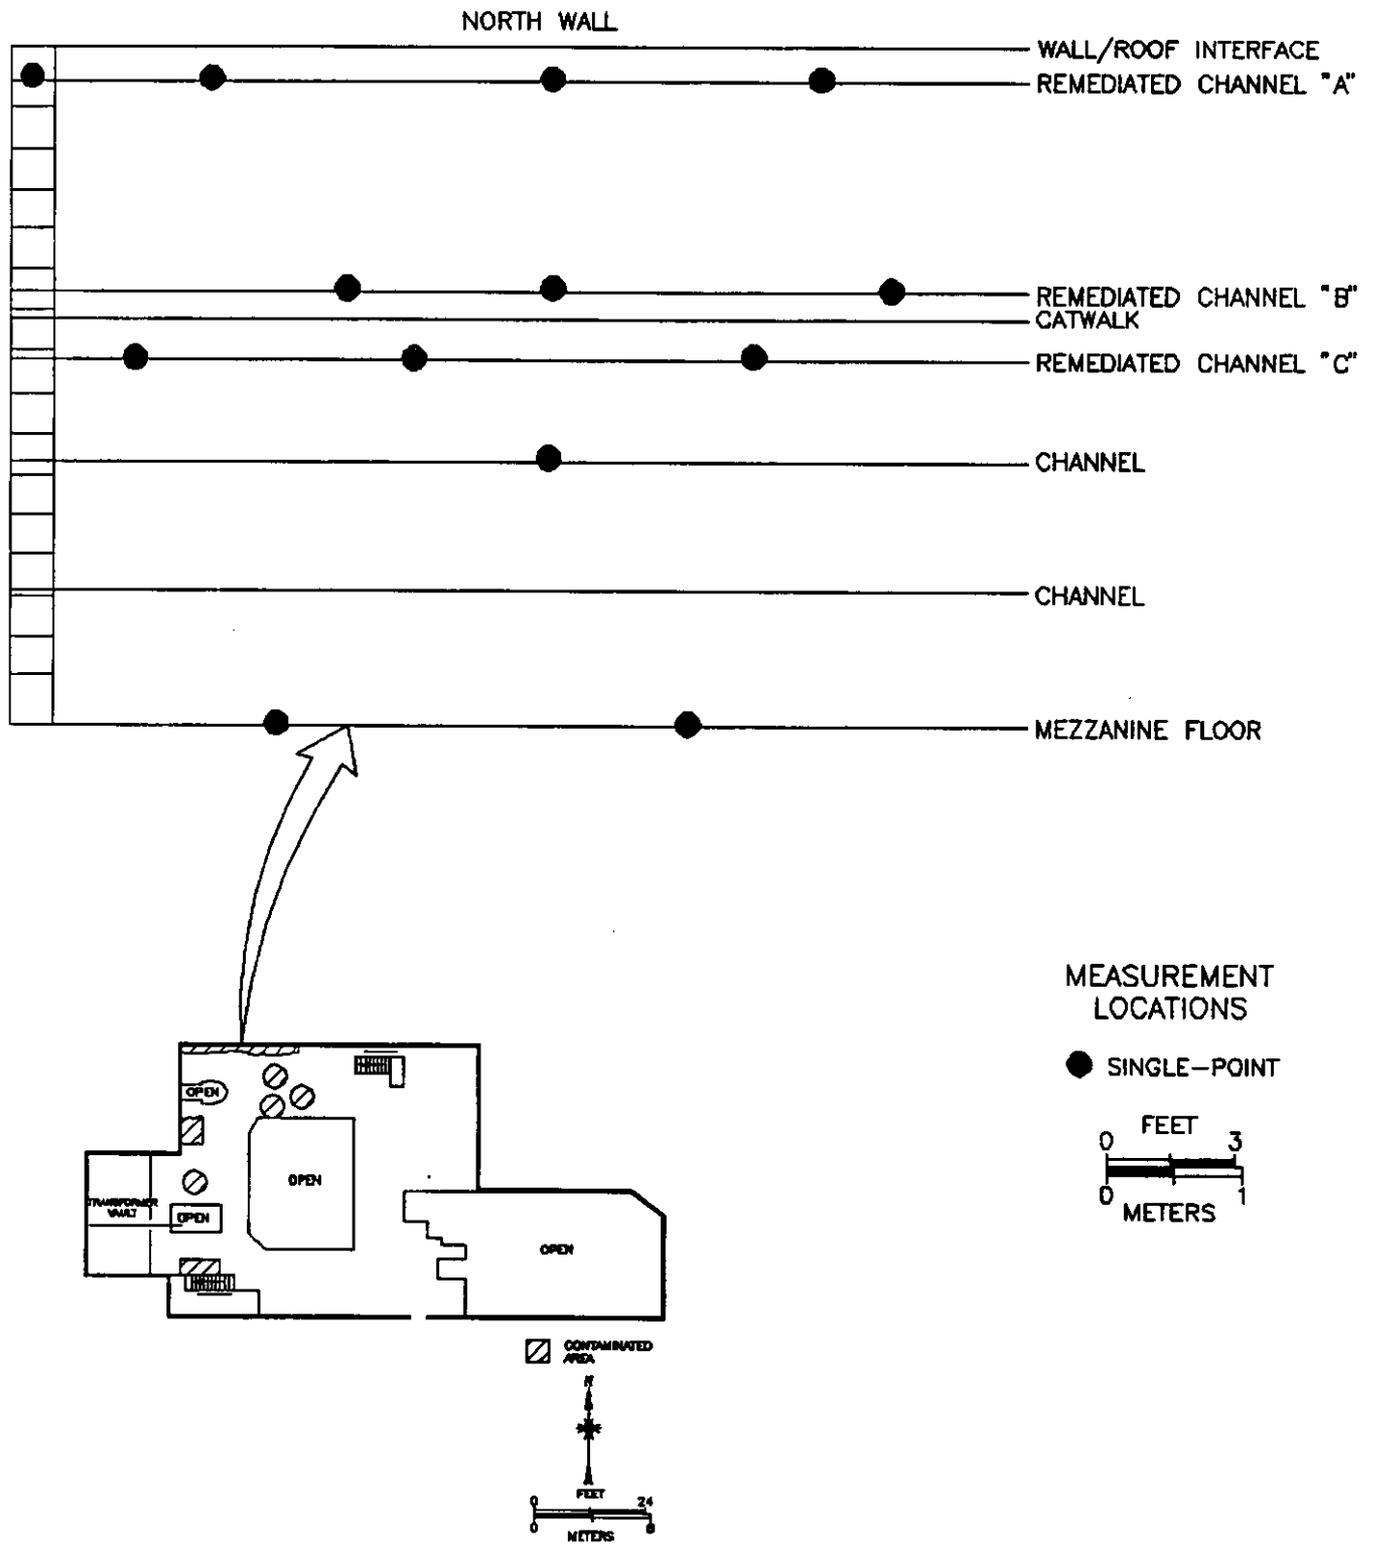
FIGURE 25: Building 24, Mezzanine, Indicating Measurement Locations in the Northwest Corner of the North Wall

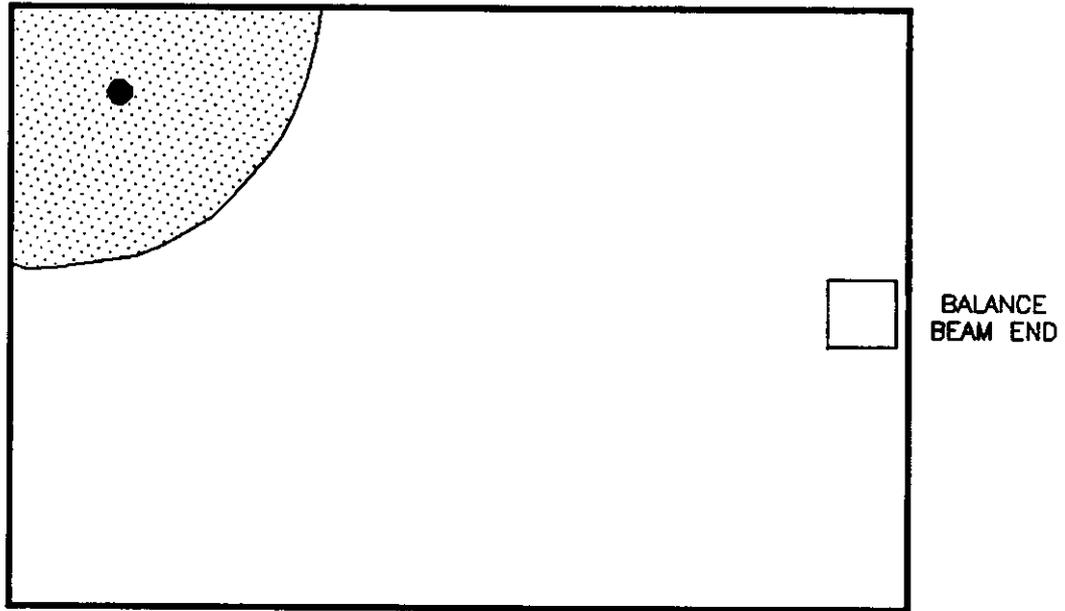
SCABBLED AREA  
MEASUREMENT LOCATIONS  
● SINGLE-POINT

FIGURE 26: Building 25, Indicating Measurement Locations on the Scale Platform Located on the Mezzanine

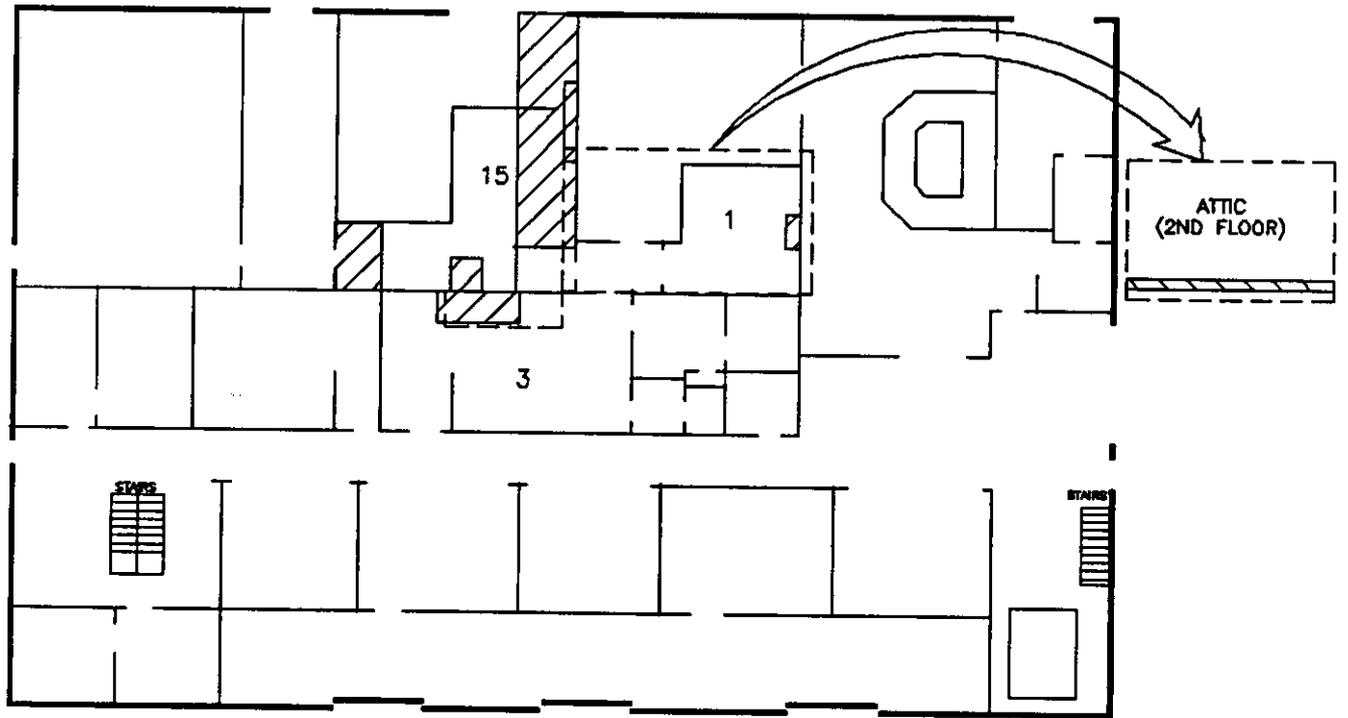
FIGURE 27: Plot Plan of Building 28, First Floor

CONTAMINATED AREA

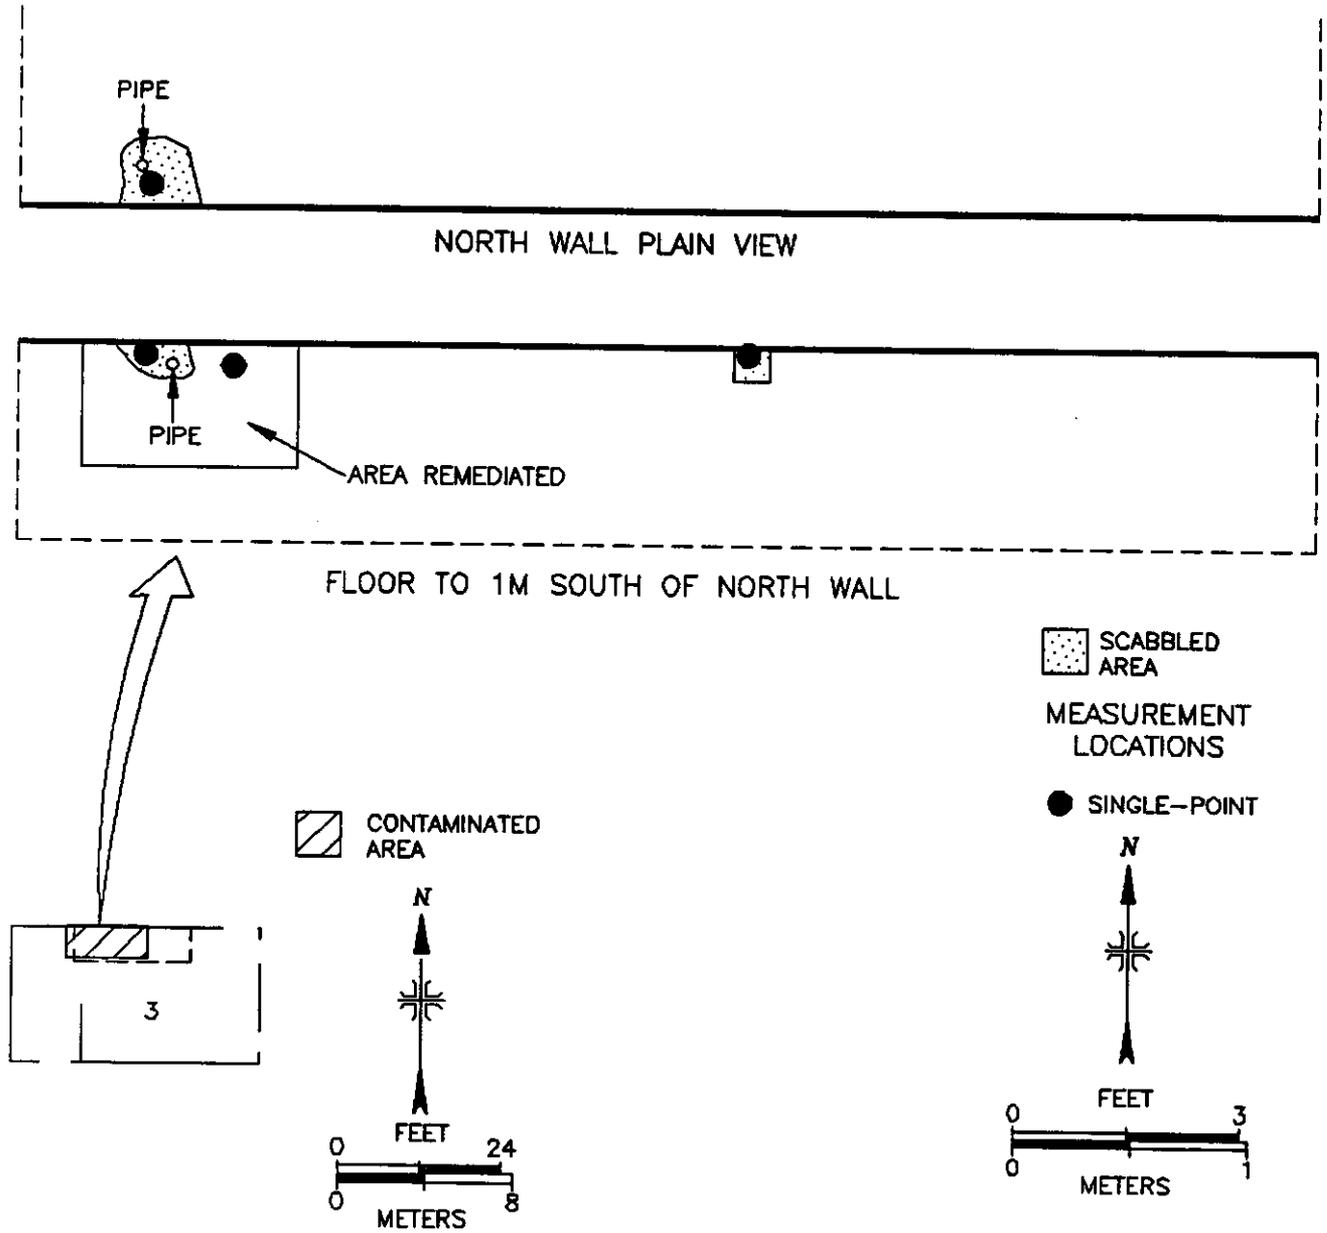
FIGURE 28: Building 28, Room 3, Indicating Measurement Locations on the Floor and North Wall

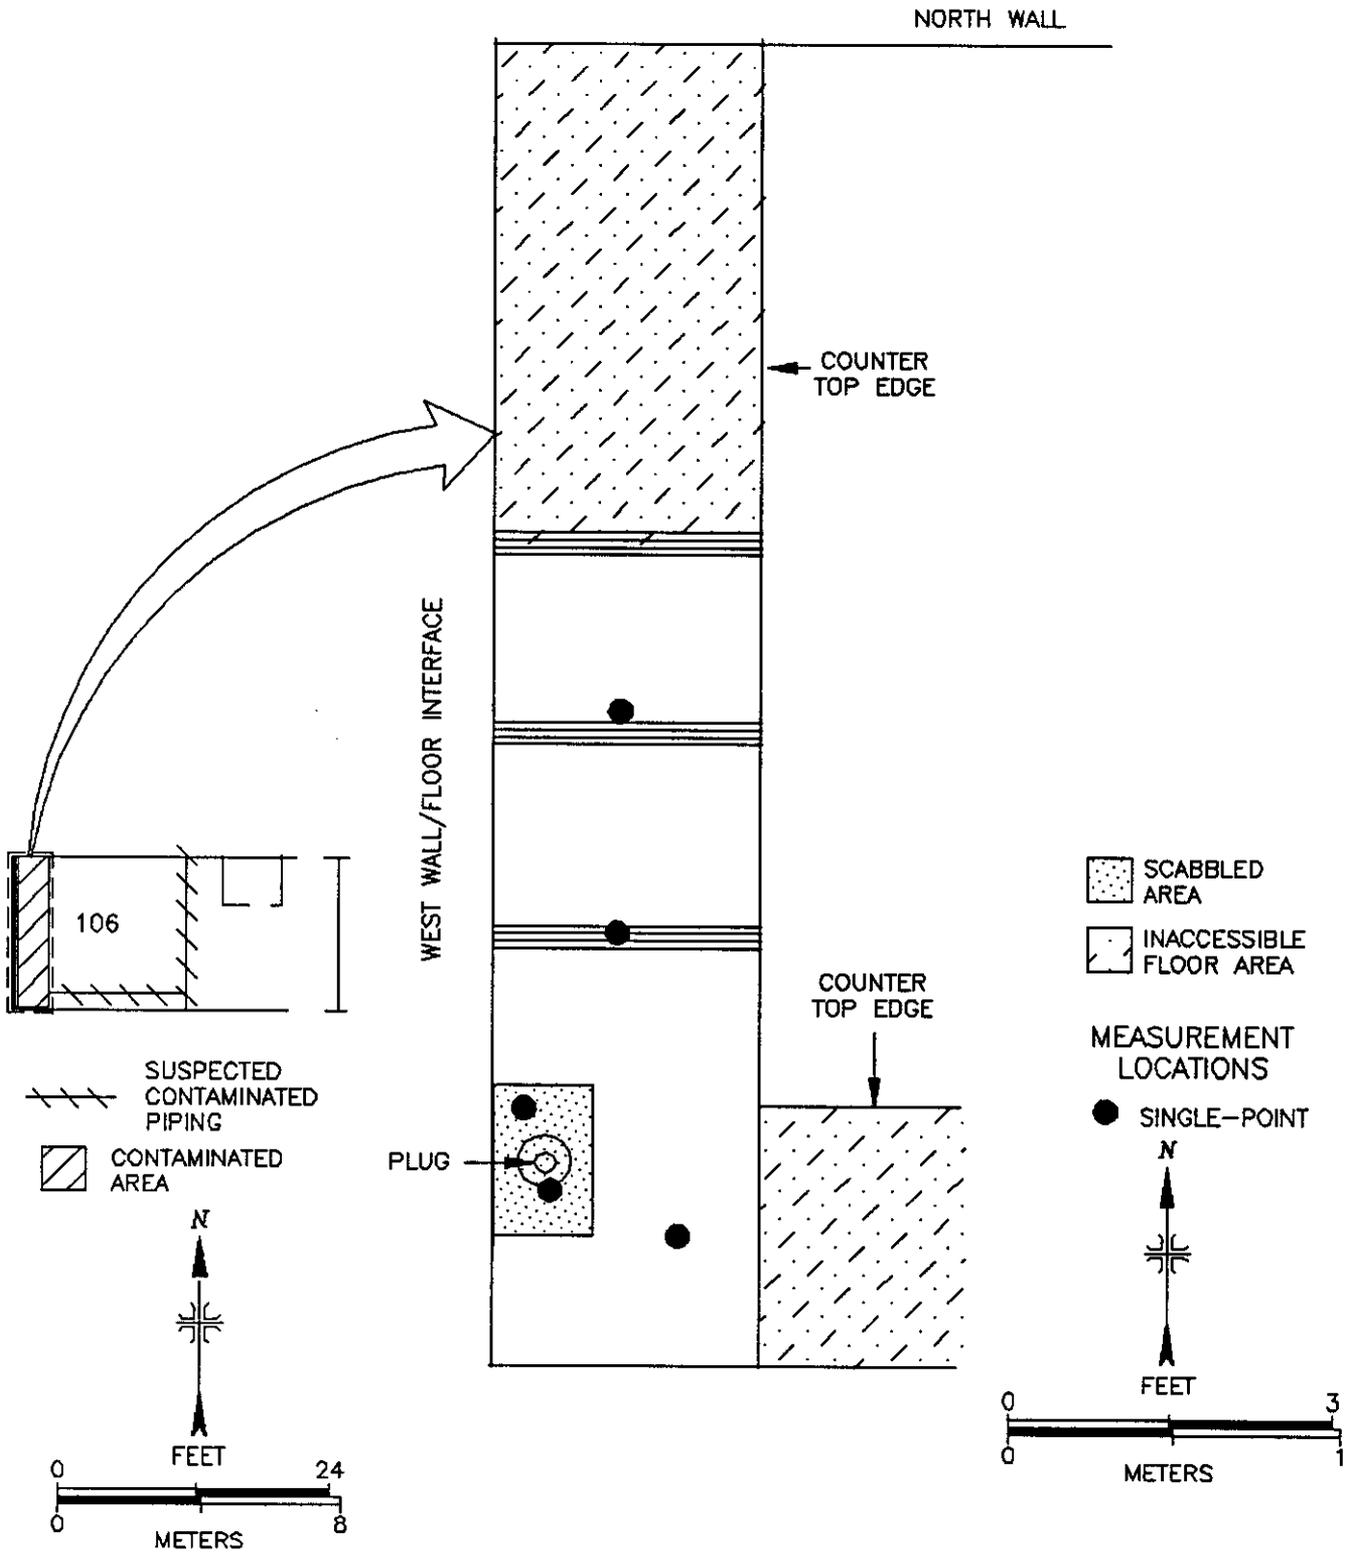
FIGURE 30: Building 29, Room 106, Indicating Measurement Locations on the Floor Beneath Counters

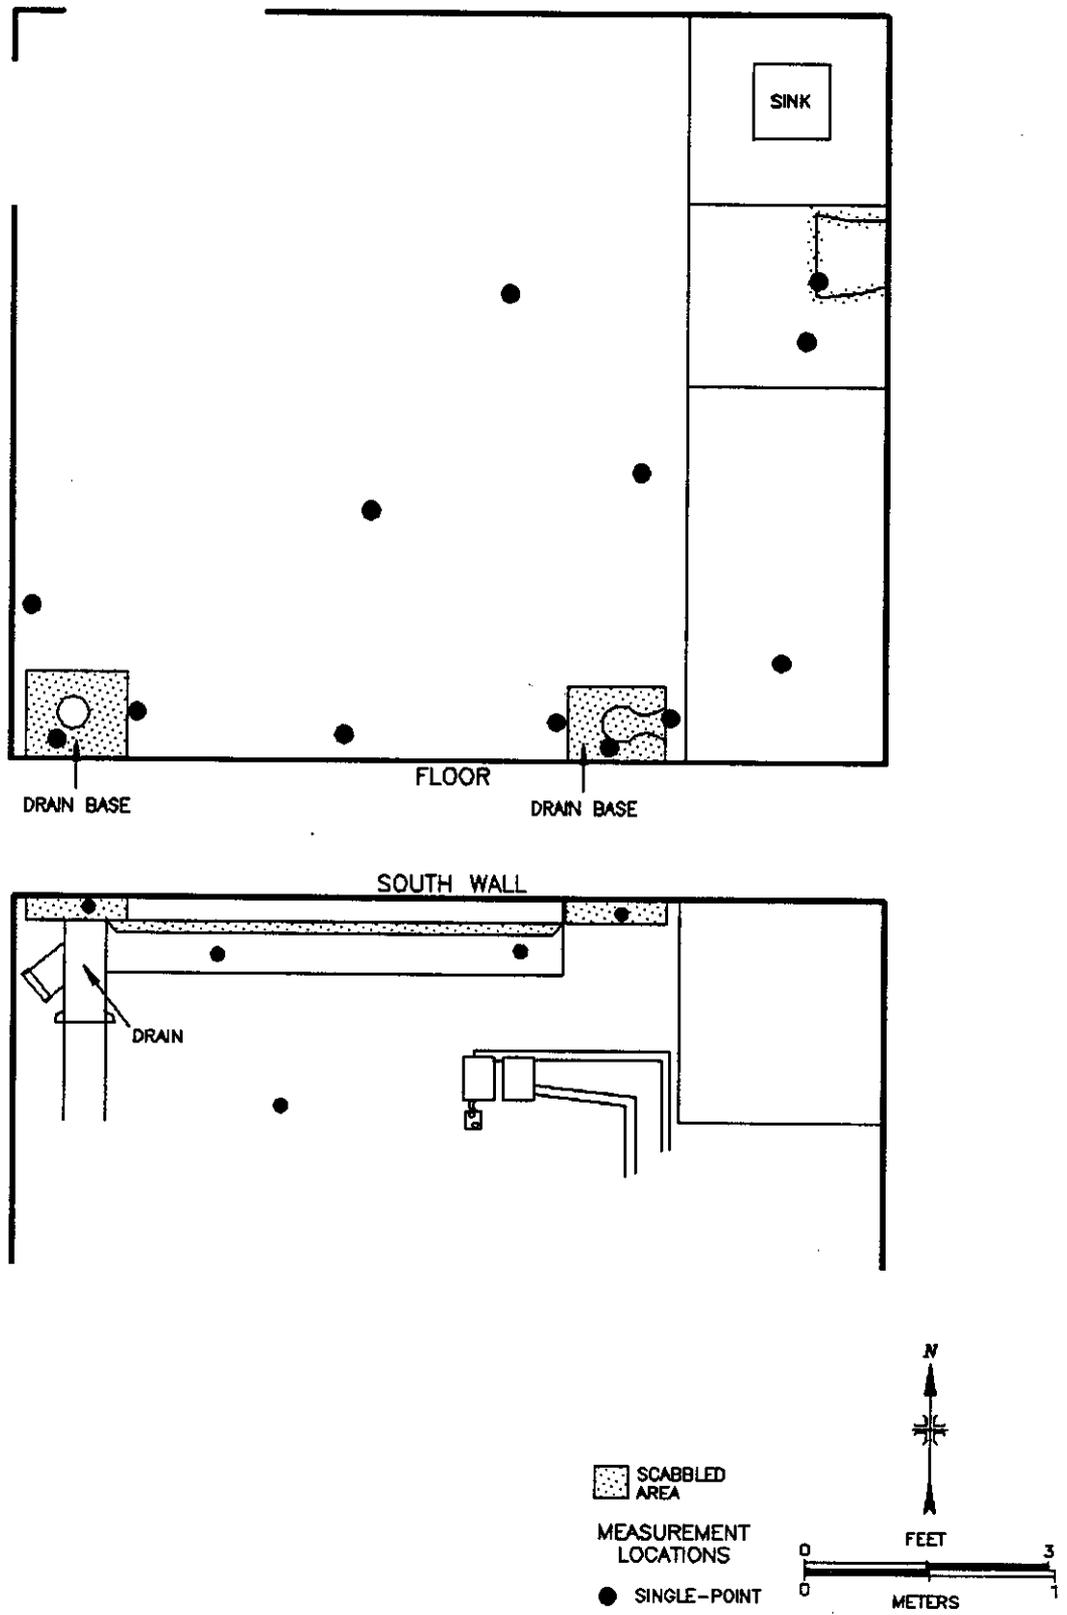
FIGURE 31: Building 29, Room 109, Indicating Measurement Locations on the Floor and South Wall

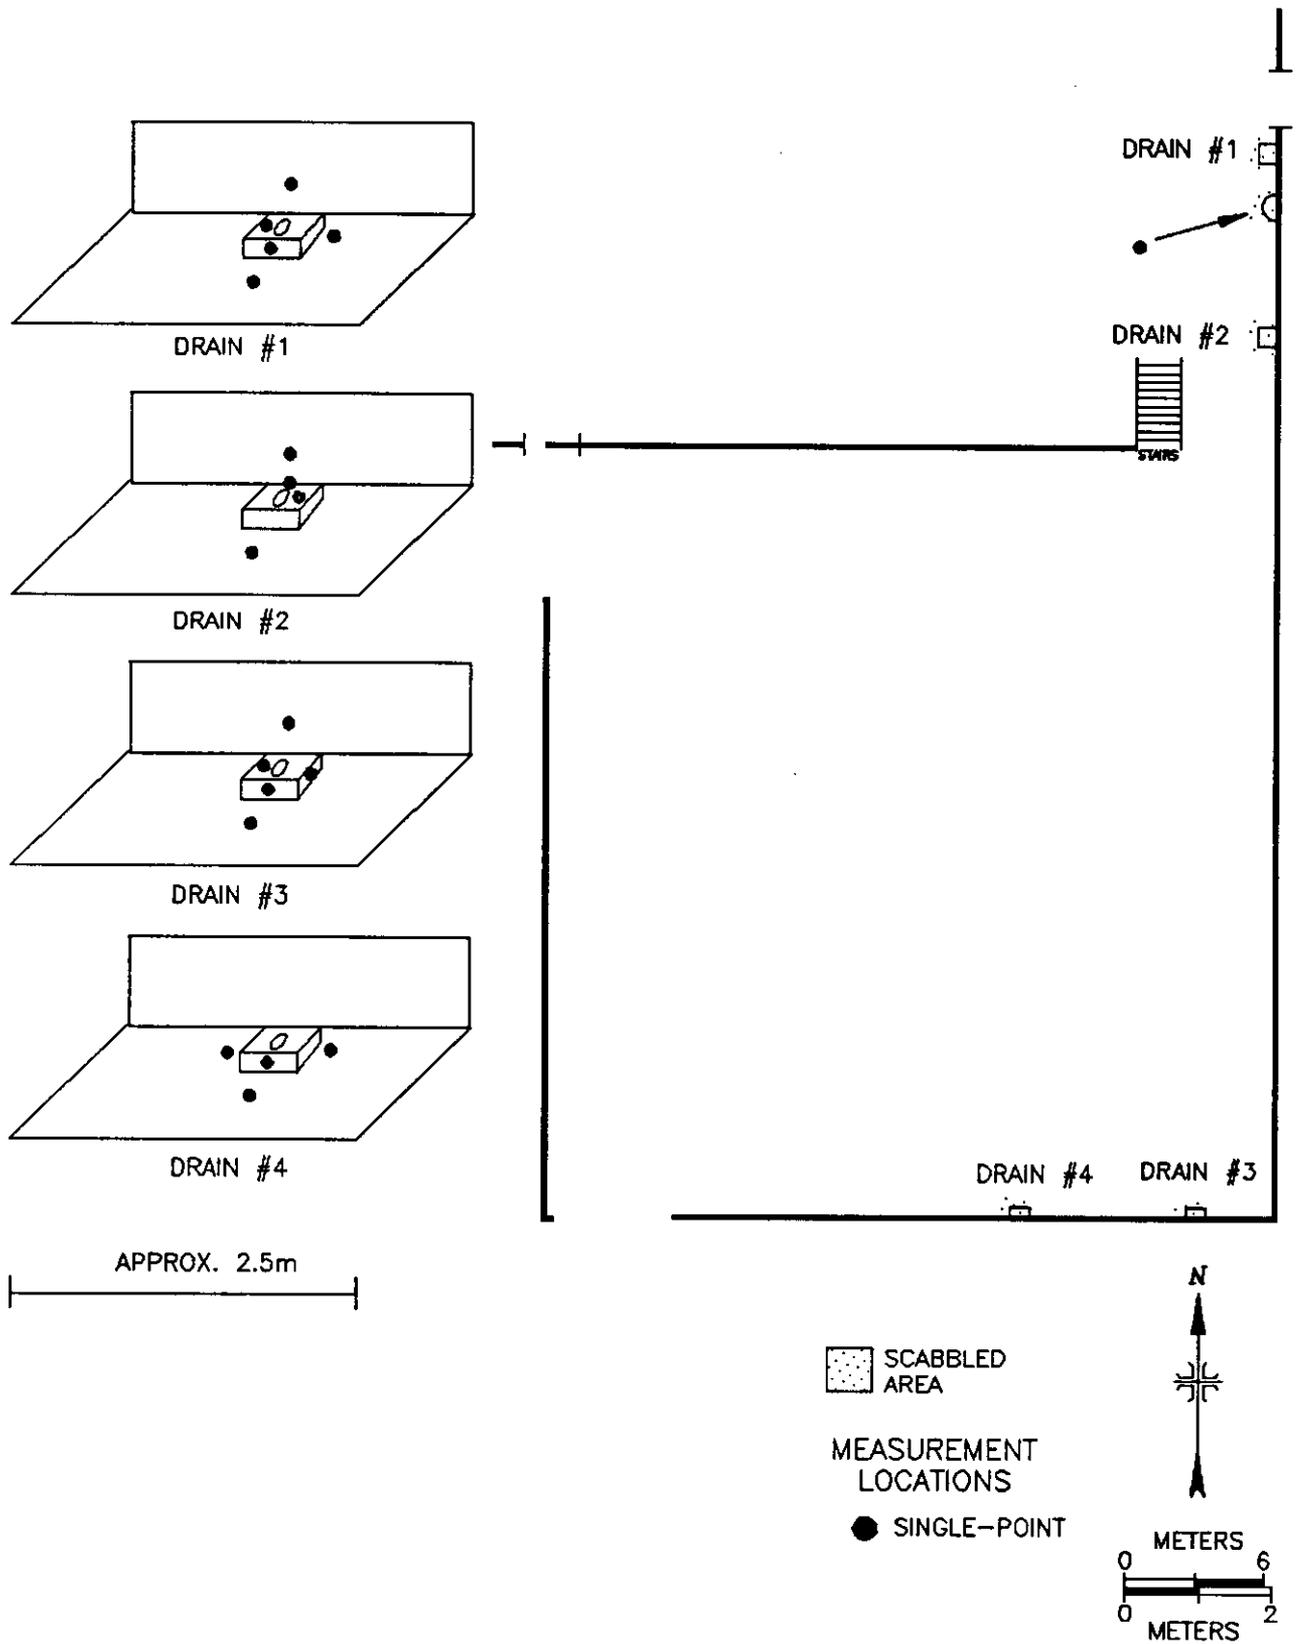
FIGURE 32: Building 29, Room 111, Indicating Measurement Locations on the Floor and Drain Pedestals

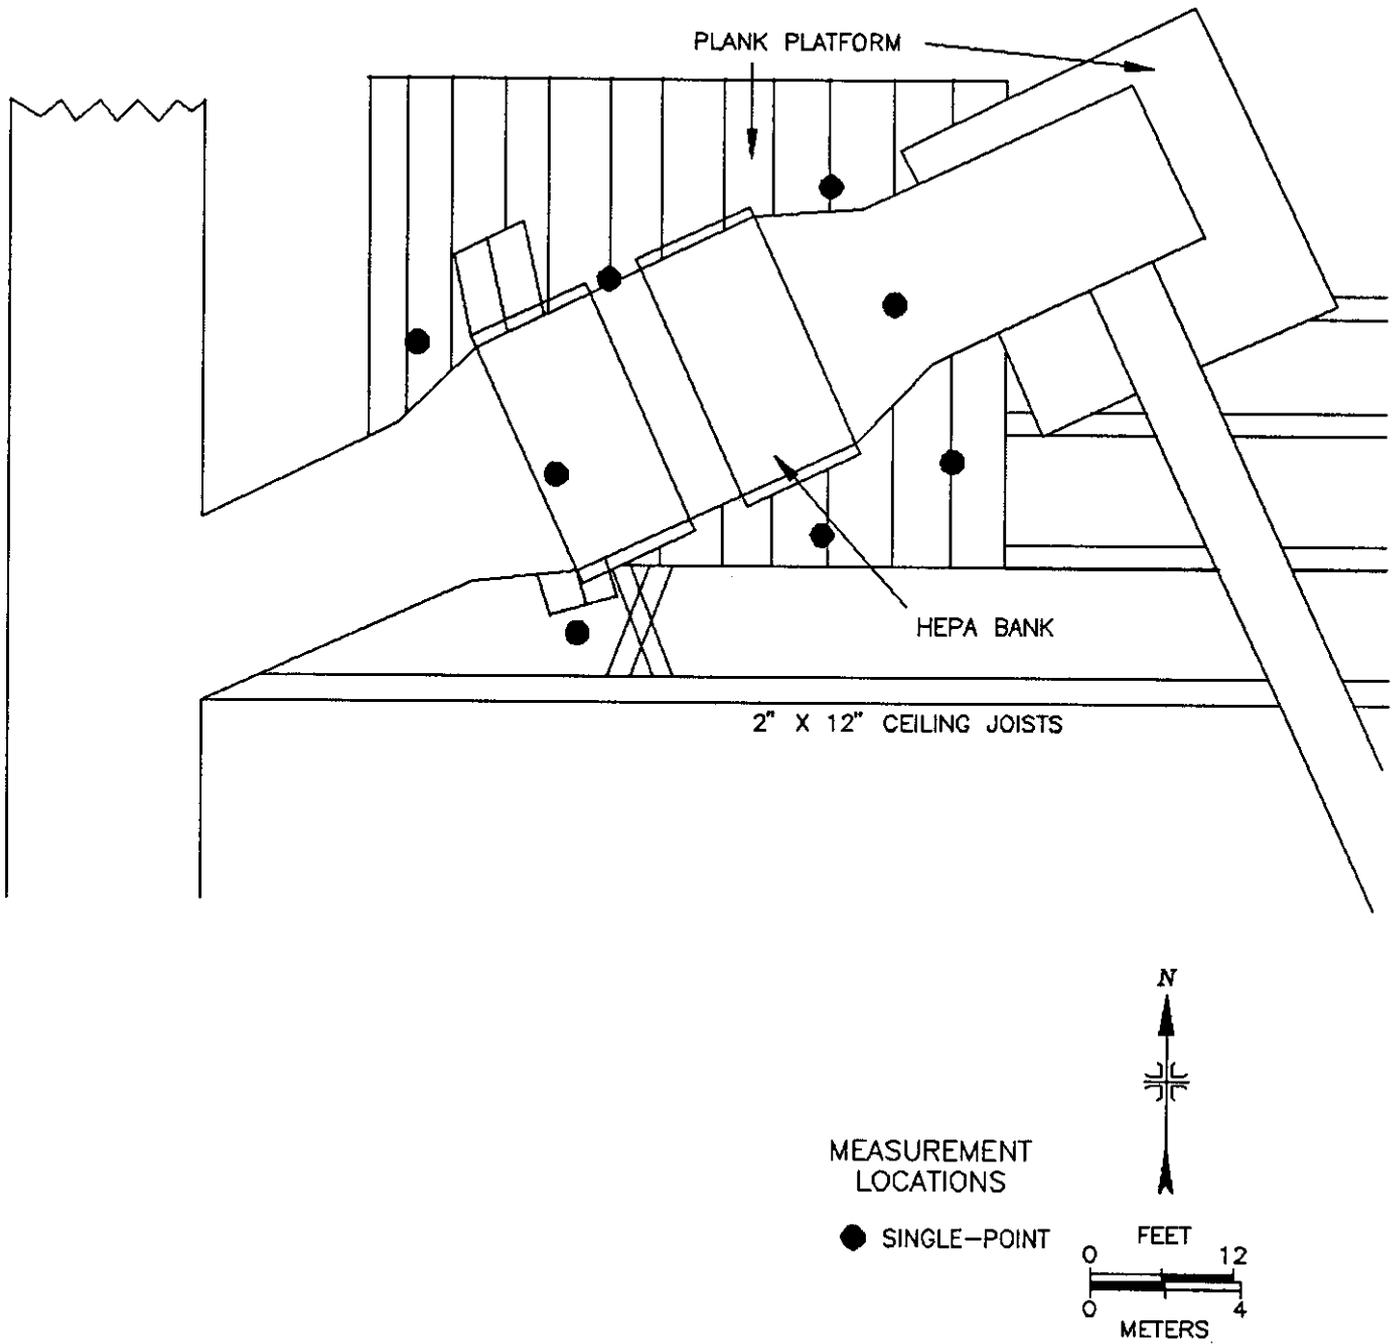
FIGURE 34: Building 29, Room 113, Indicating Measurement Locations on the HEPA Filter Bank

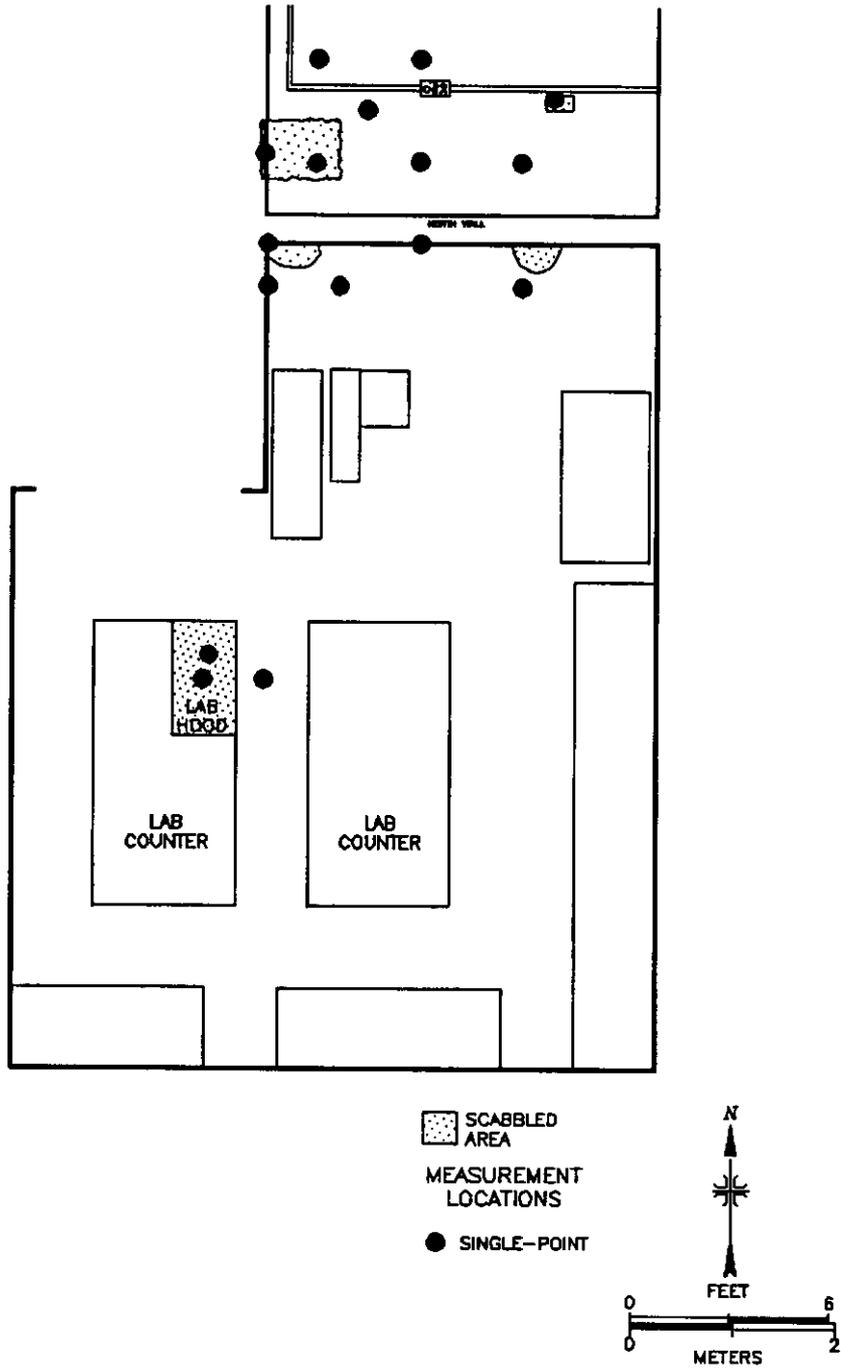
FIGURE 36: Building 31, Room 2, Indicating Measurement Locations on the Floor, North Wall, and Counter Space

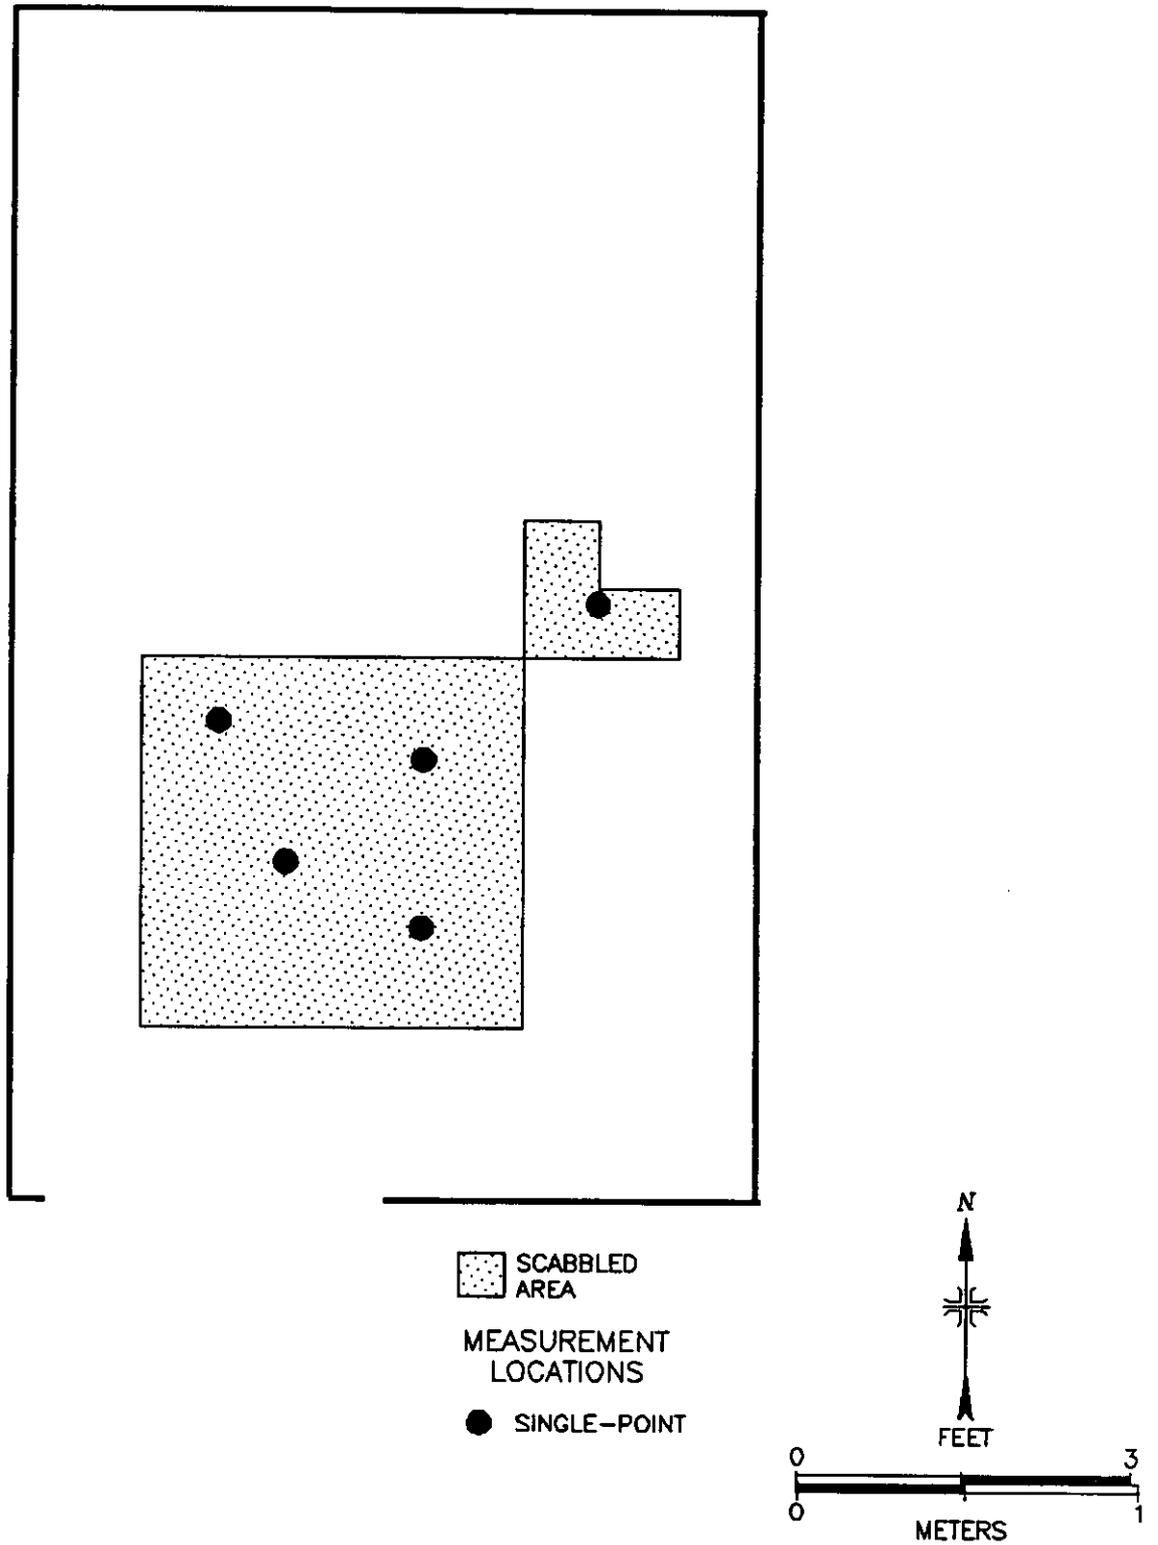
FIGURE 38: Building 33, Room 103, Indicating Measurement Locations on the Floor

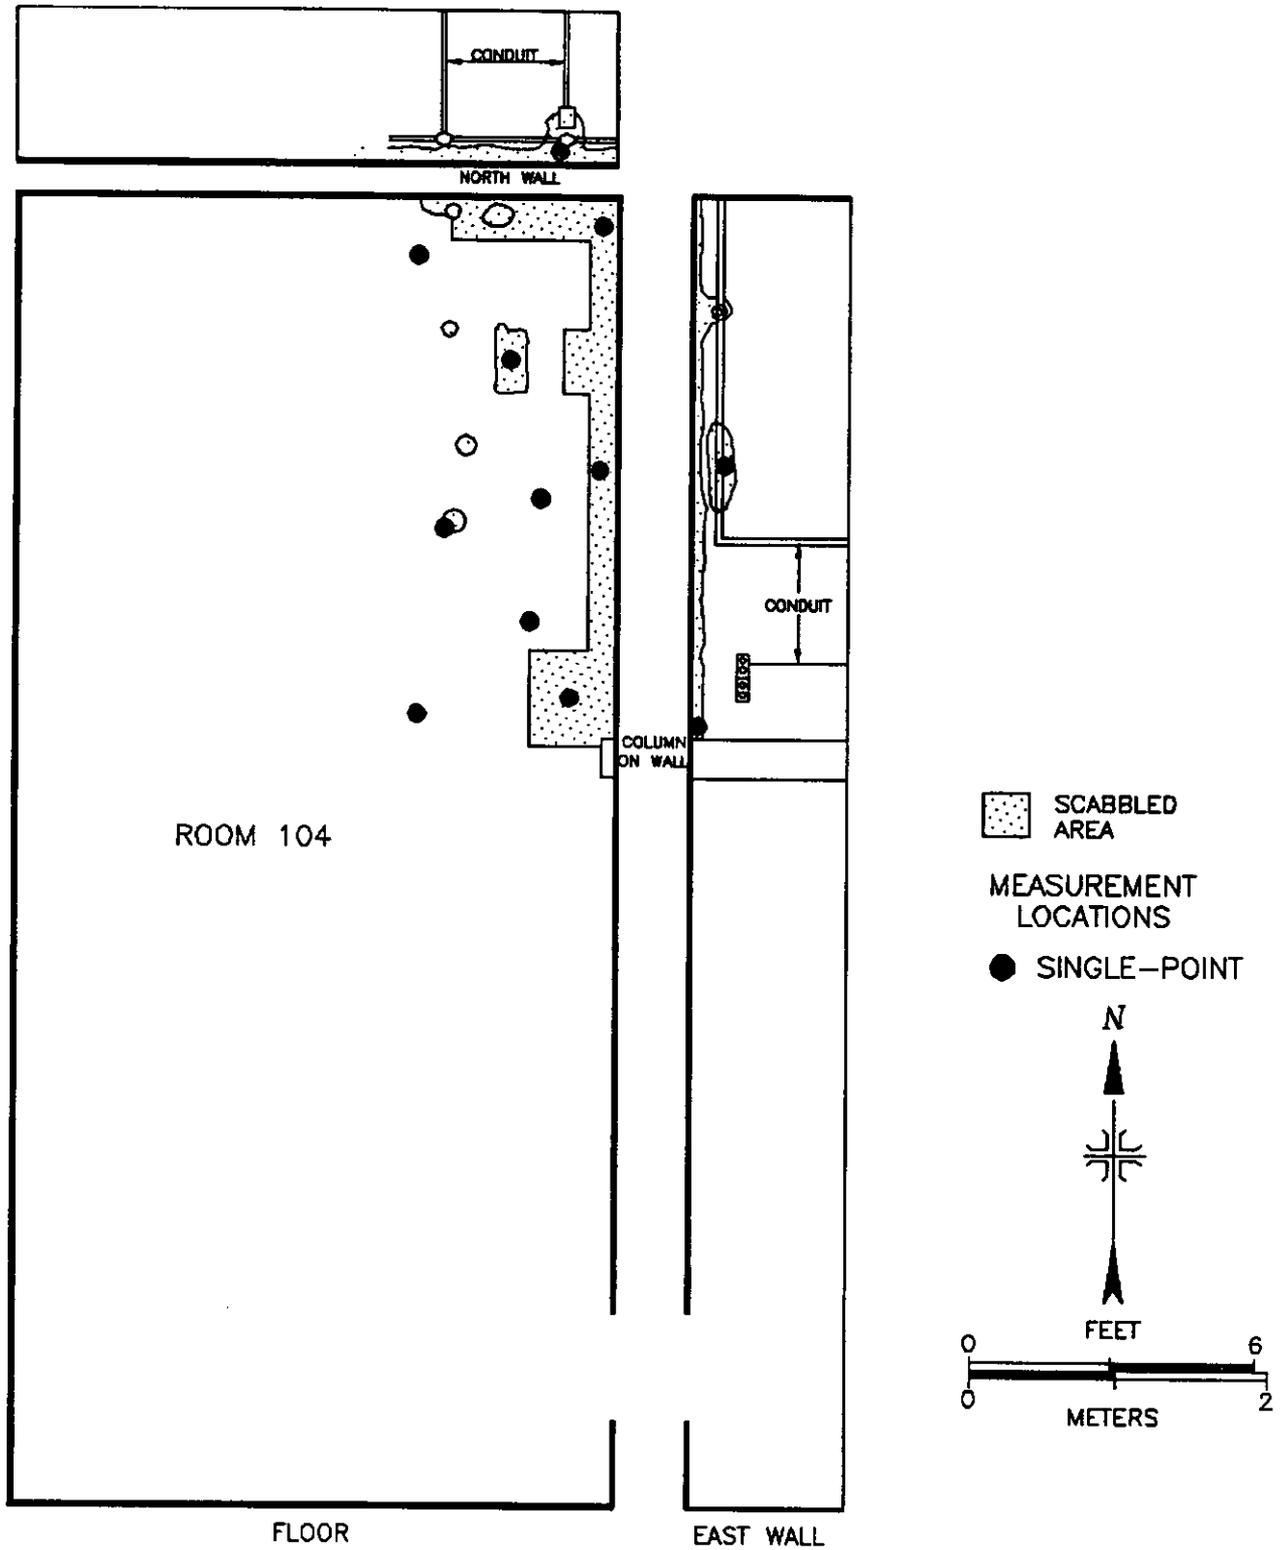
FIGURE 39: Building 33, Room 104, Indicating Measurement Locations on the Floor and Wall in the Northeast Corner
