MOUND PLANT

PRS 93

July 10, 1995

MOUND PLANT
PRS 93
JULY 5, 1995

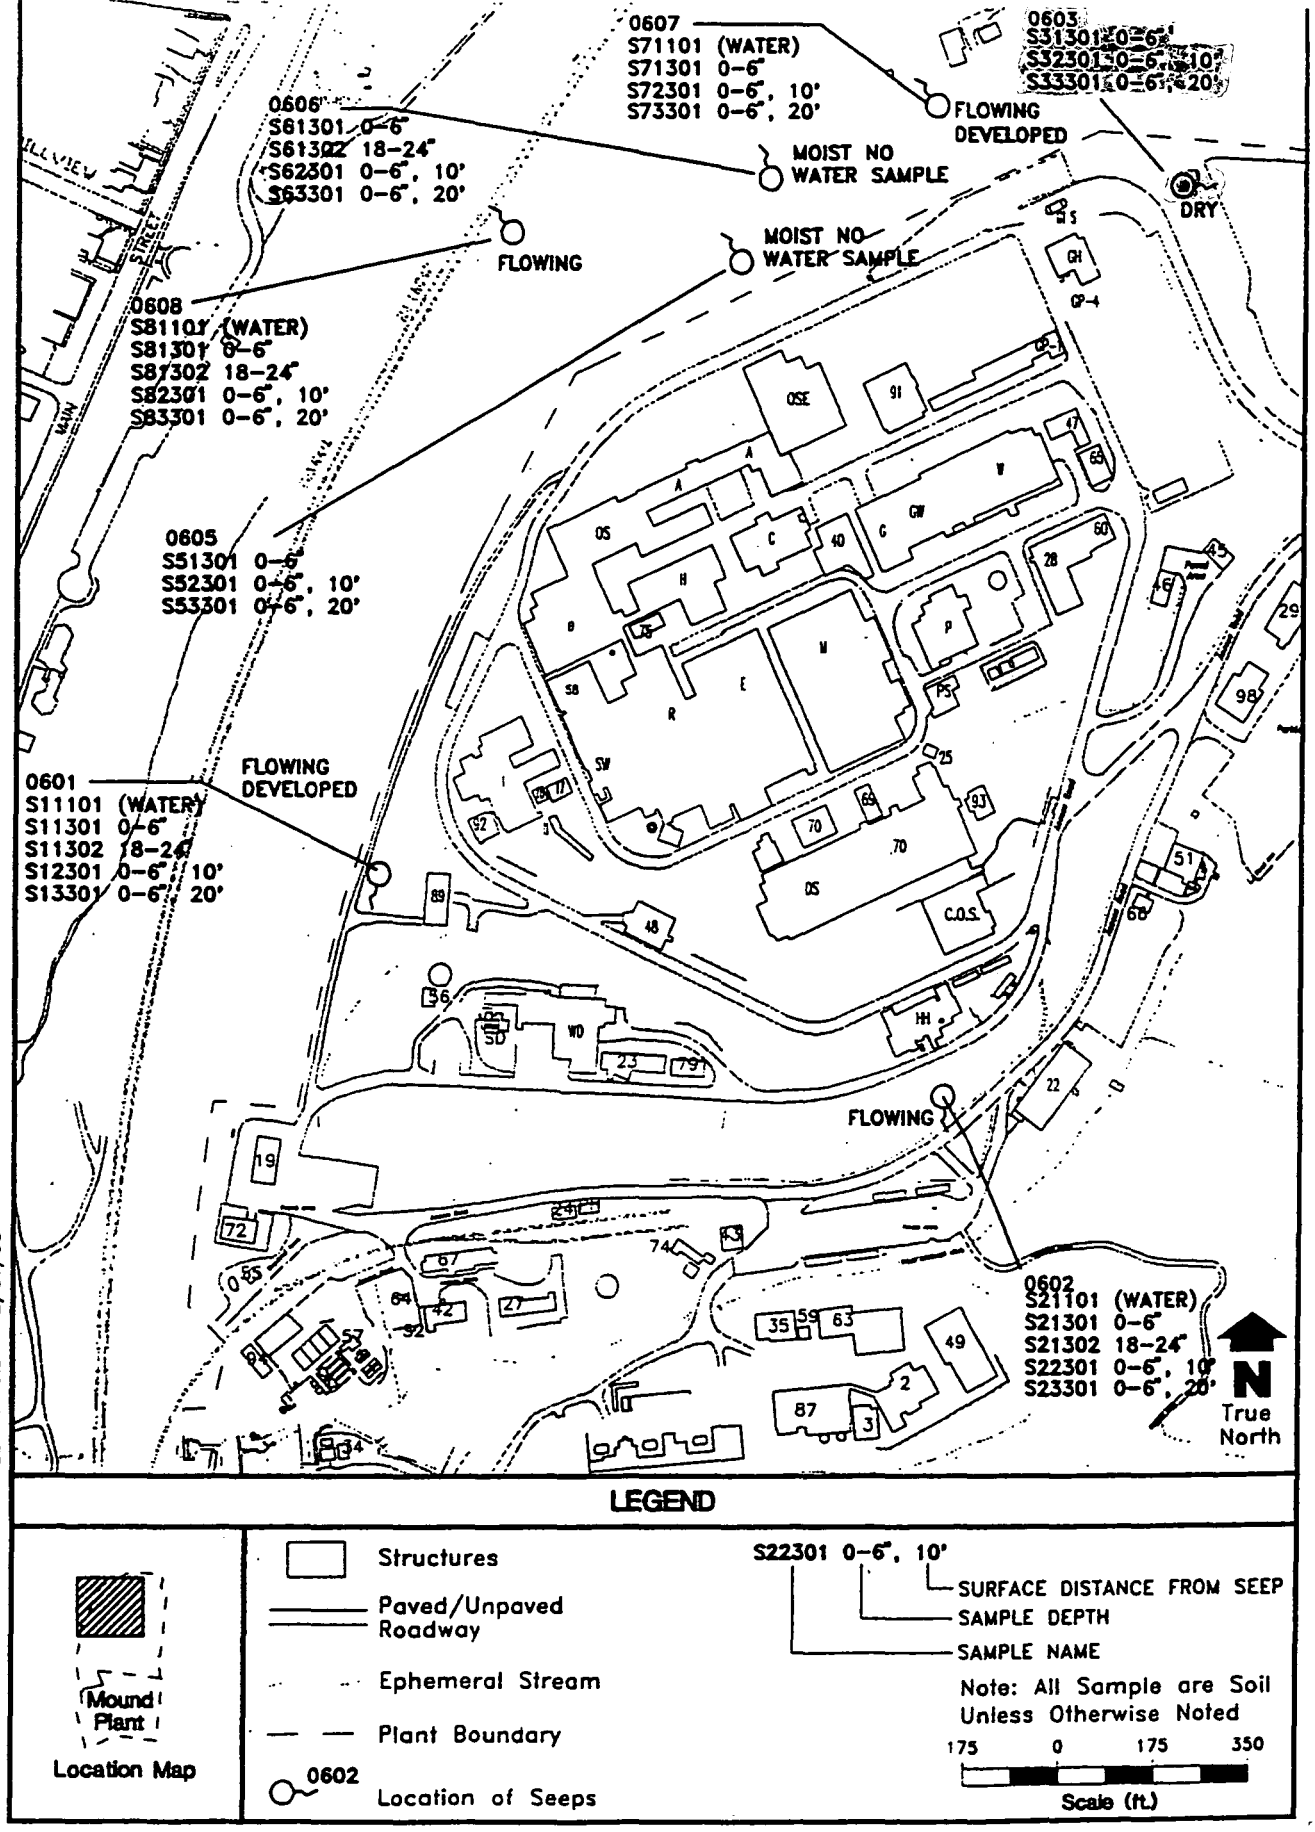
Figure 2.6. Main Hill Seep Sample Locations

Sampling was conducted in accordance with the FSP, with one exception. The FSP indicated that eight sampling locations (601, 602, 603, 604, 605, 606, 607, 608) should be sampled. Upon inspection of the seeps, only seven seeps were identified. One seep was found near the historically represented locations of seeps 604 and 605. Due to the relatively short distance between seeps 604 and 605 on the historical map (Figure 2.6), the field crew arbitrarily identified this "combined" seep as 605.
