MOUND PLANT
Potential Release Site Package
PRS # 105

PRS 105

MOUND PLANT
PRS 105
FORMER SOLVENT STORAGE SITE
E BUILDING SHED

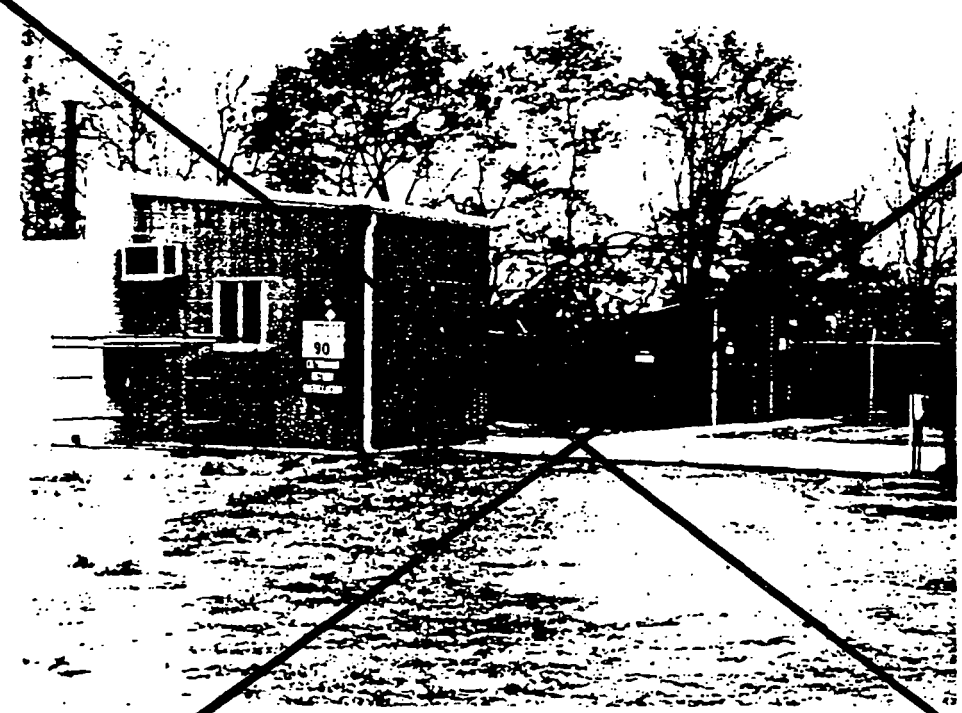
3-10 Former site of E Building Solvent Storage Shed (SWMU CS-2). Shed had been dismantled a short time before the VSI.
