Bechtel*Interoffice Memorandum*

To	File	File No.	113/1300
Subject	B&T Metals Site Scoping Trip Report	Date	November 22, 1995
		From	J.G. Braun
		Of	FUSRAP - Geotech
Copies To	Distribution	At	4D12
		Ext	241-5296

This trip report summarizes the information obtained by both the New York and Missouri/Ohio Teams during visits to the B&T Metals site. The scoping trips were performed to provide information to aid in the detailed planning, design, and preparation for site characterization and remedial action. The scoping trips included a site walkover, library research to investigate historic Sanborn maps and newspaper articles, an interview with a retired B&T Metals employee who was involved with the former MED/AEC activities, coordinating with the property owner in preparation for characterization and remedial action, locating original design drawings, and identifying safety and health hazards.

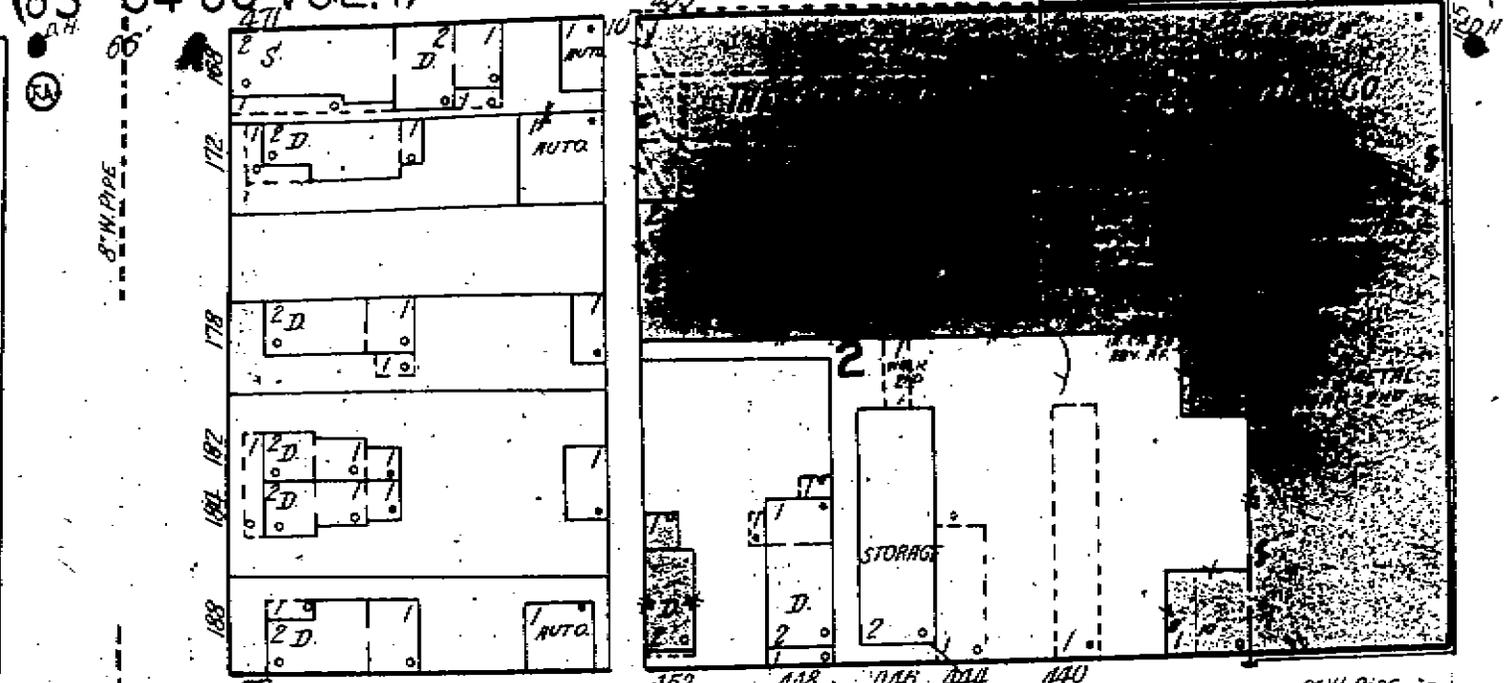
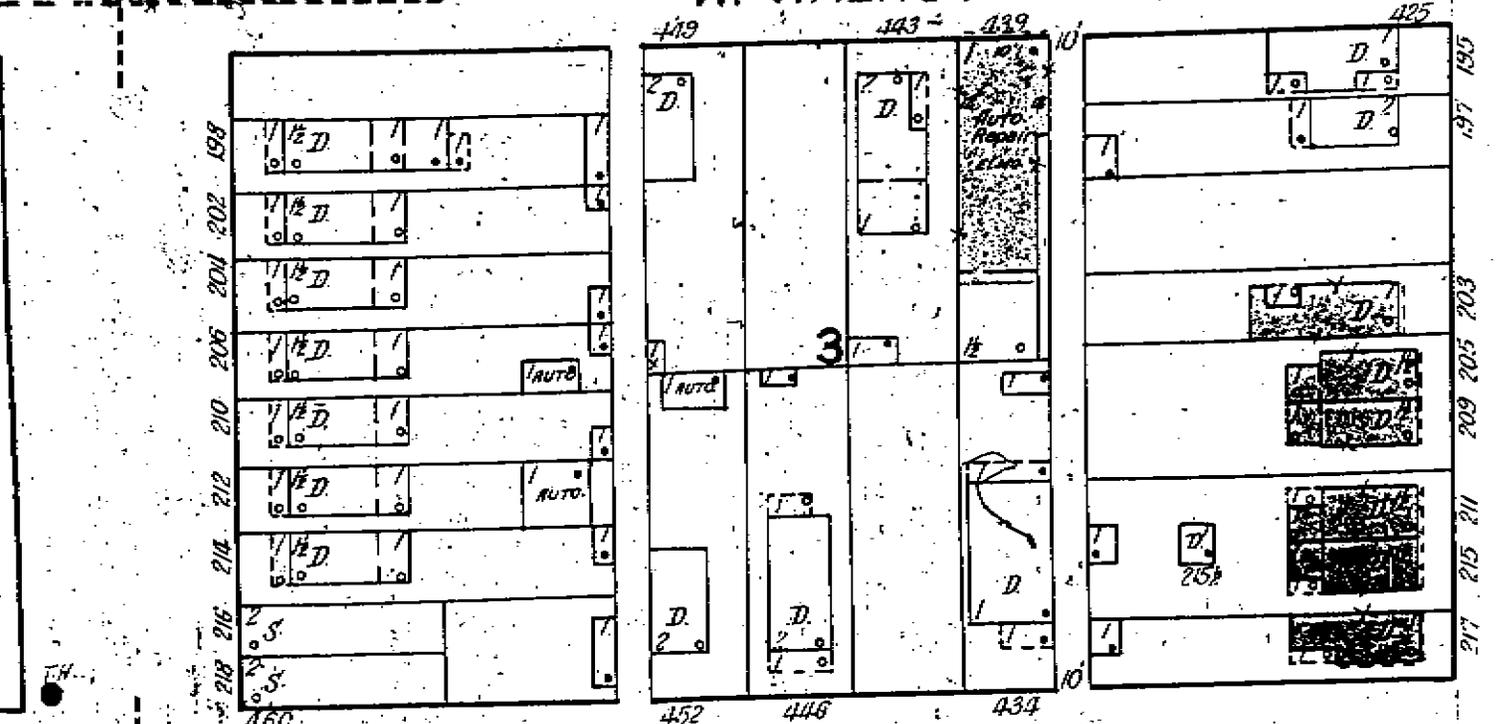
(83-84-90 Vol. 1)

Research was performed at the Columbus public library to investigate historic Sanborn maps and to look for newspaper articles related to the B&T Metals site. Sanborn maps of the B&T Metals site were found for 1891, 1901, 1922, and 1941 (see attached). The maps for 1891 and 1901 show a few frame dwellings and stables. In 1922, the Columbus Heating and Ventilating Company building was in place (currently the main office building for B&T Metals). This building was constructed with concrete floors and wood posts and was used for sheet metal work. By 1941, B&T Metals Company occupied the main building, the southwest addition to the building was in place, the extrusion building had been constructed with a concrete slab floor and steel columns and beams, and the current storage building had been constructed with a concrete floor and was being used for galvanizing.

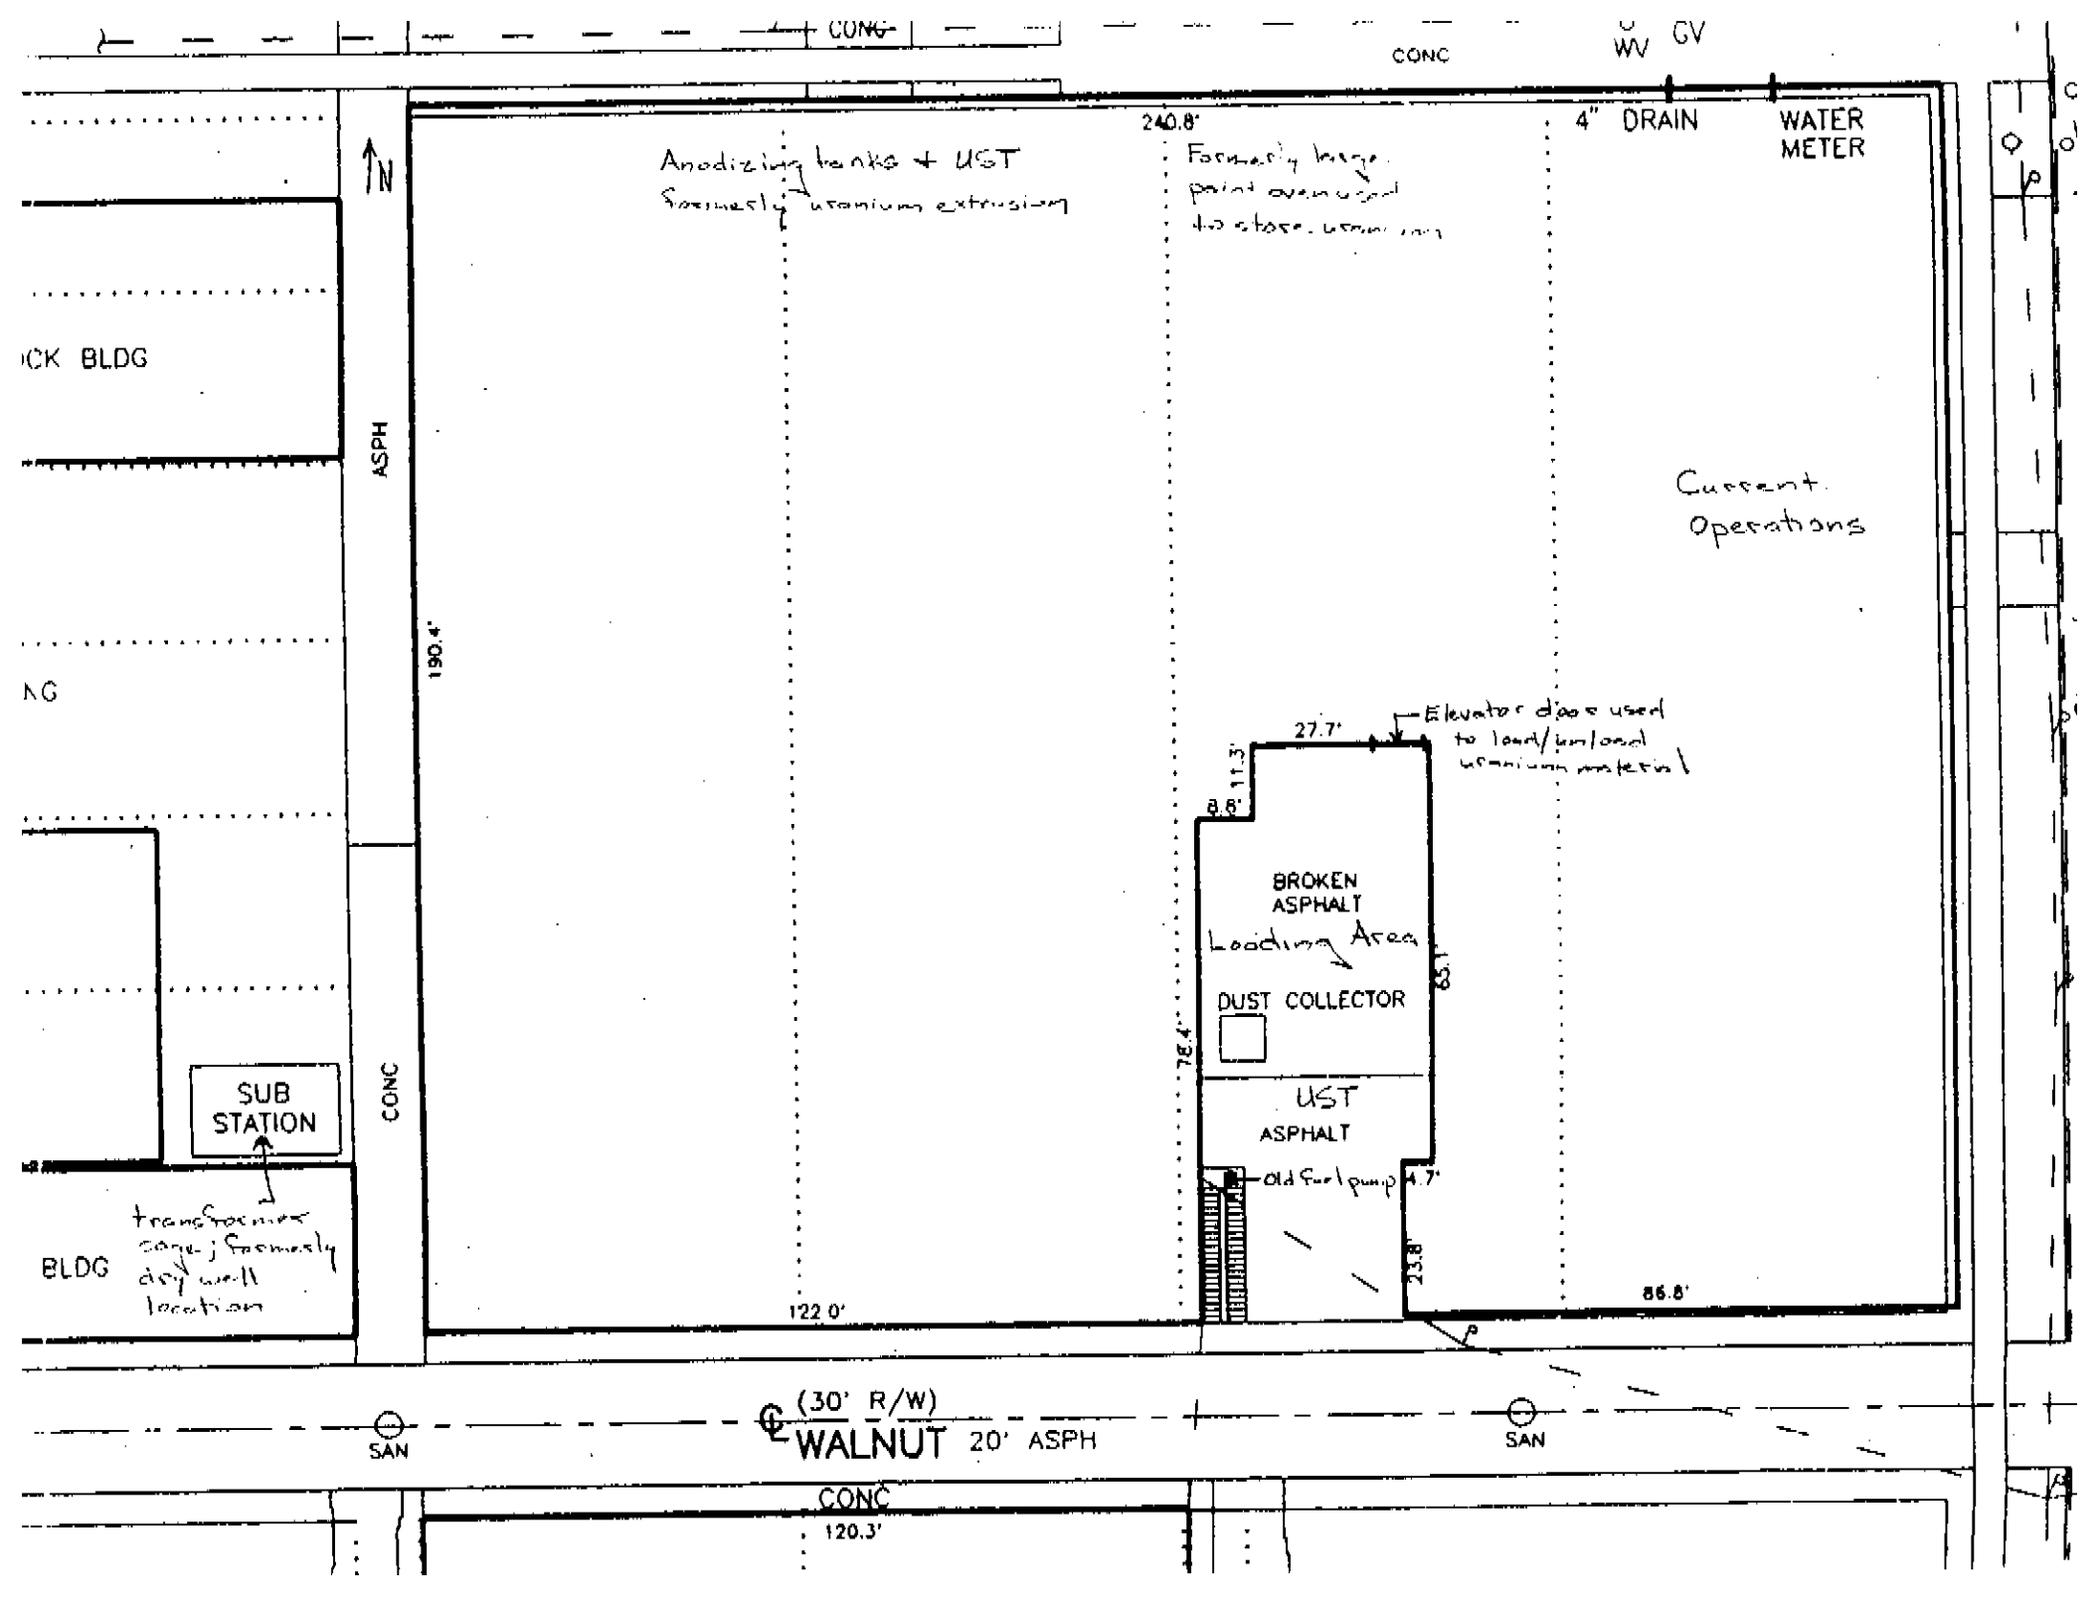
Main office building showing areas of interest

The first floor of the main office building has a small area currently being used by the 2 remaining workers. The majority of the floor contains old equipment and stored furniture. A few office areas are also found on this floor. One restroom facility (no longer in use) is located on this floor. The northwest area of the floor that was used during the MED/AEC activities has been largely cleared of the furniture storage boxes but still contains an old automobile and several anodizing tanks.

Old floor tiles are located throughout the main office building and due to their age, are suspected of being asbestos tiles. Suspected asbestos insulating material is also found under and around the anodizing tanks.

The second floor of the main office building has wood and carpeted floors and contains offices with office furniture and supplies. One large area contains many boxes of office material and personal items. Water damage is extensive due to a leaky roof. Another side of the second floor may have been used for machining or assembly. This side has a lot of water standing on the floor.
