SUBJECT: **Contract No. DE-AC24-03OH20152:** Deliverable #36 Building Data Package; Section C.2.1.1 Facility Demolition; Building WD Structure OSC Report, Final

BUILDING WD STRUCTURE REMOVAL ACTION

OSC REPORT

Final

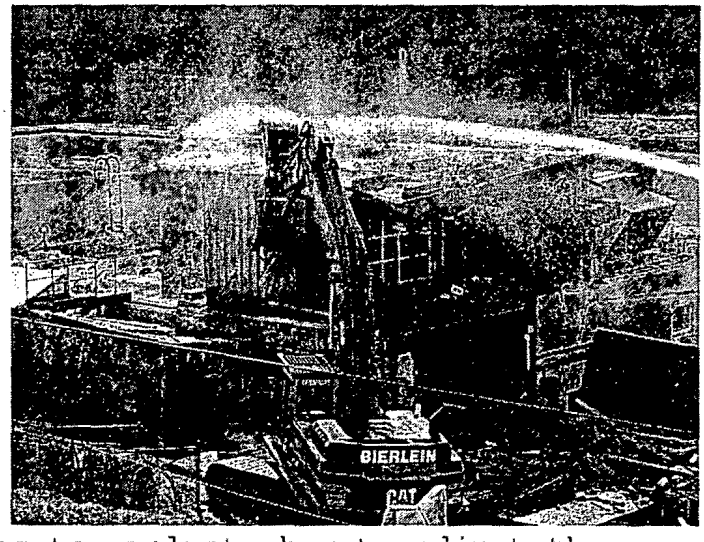
Discussion: On Wednesday March 10, 2004 while performing demolition of the WD facility, the supporting structure for the penthouse unit on the west side of the facility 2 stories above grade buckled causing the penthouse to react unexpectedly. The operator compensated for the reaction by pulling the corner of the penthouse to the ground swiftly causing visible dust to be emitted. The operator secured the penthouse and immediately stopped demolition activities. At the time of this drop, adequate radiological controls were in place and there was no release of contamination outside of controlled areas, and there were no personnel contamination or uptakes. Air samples were counted and notifications made. A briefing was held with all affected parties to evaluate how to adjust the work planning documents to remove the remaining penthouse. The plan was implemented and the remaining penthouse was removed. Additional control measures were put in place to avoid further visible dust issues by utilizing 2 more water sources for dust suppression.

Operator pulls penthouse down

Lessons Learned: Despite good planning and a sound demolition work package, unexpected things can occur. Being prepared for the unexpected and stopping work immediately when the work doesn't go as expected prove time and time again the right thing to do. The only safe way to do work.

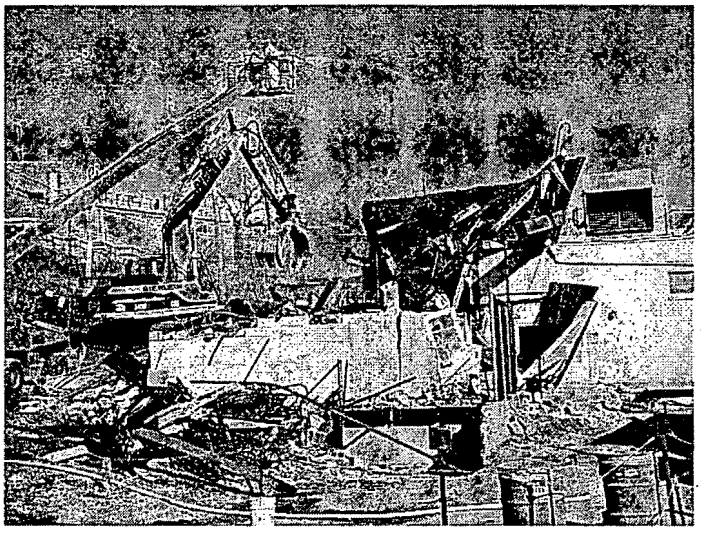
Penthouse in WD Basement
