SMO-344-05
September 21, 2005

SUBJECT: **Contract No. DE-AC24-03OH20152:** Deliverable #36 Building Data Package; Section C.2.1.2 Facility Transfer; Building 45, Building Data Package, Final

Miamisburg Closure Project
Potential Release Site Package

PRS 101/102

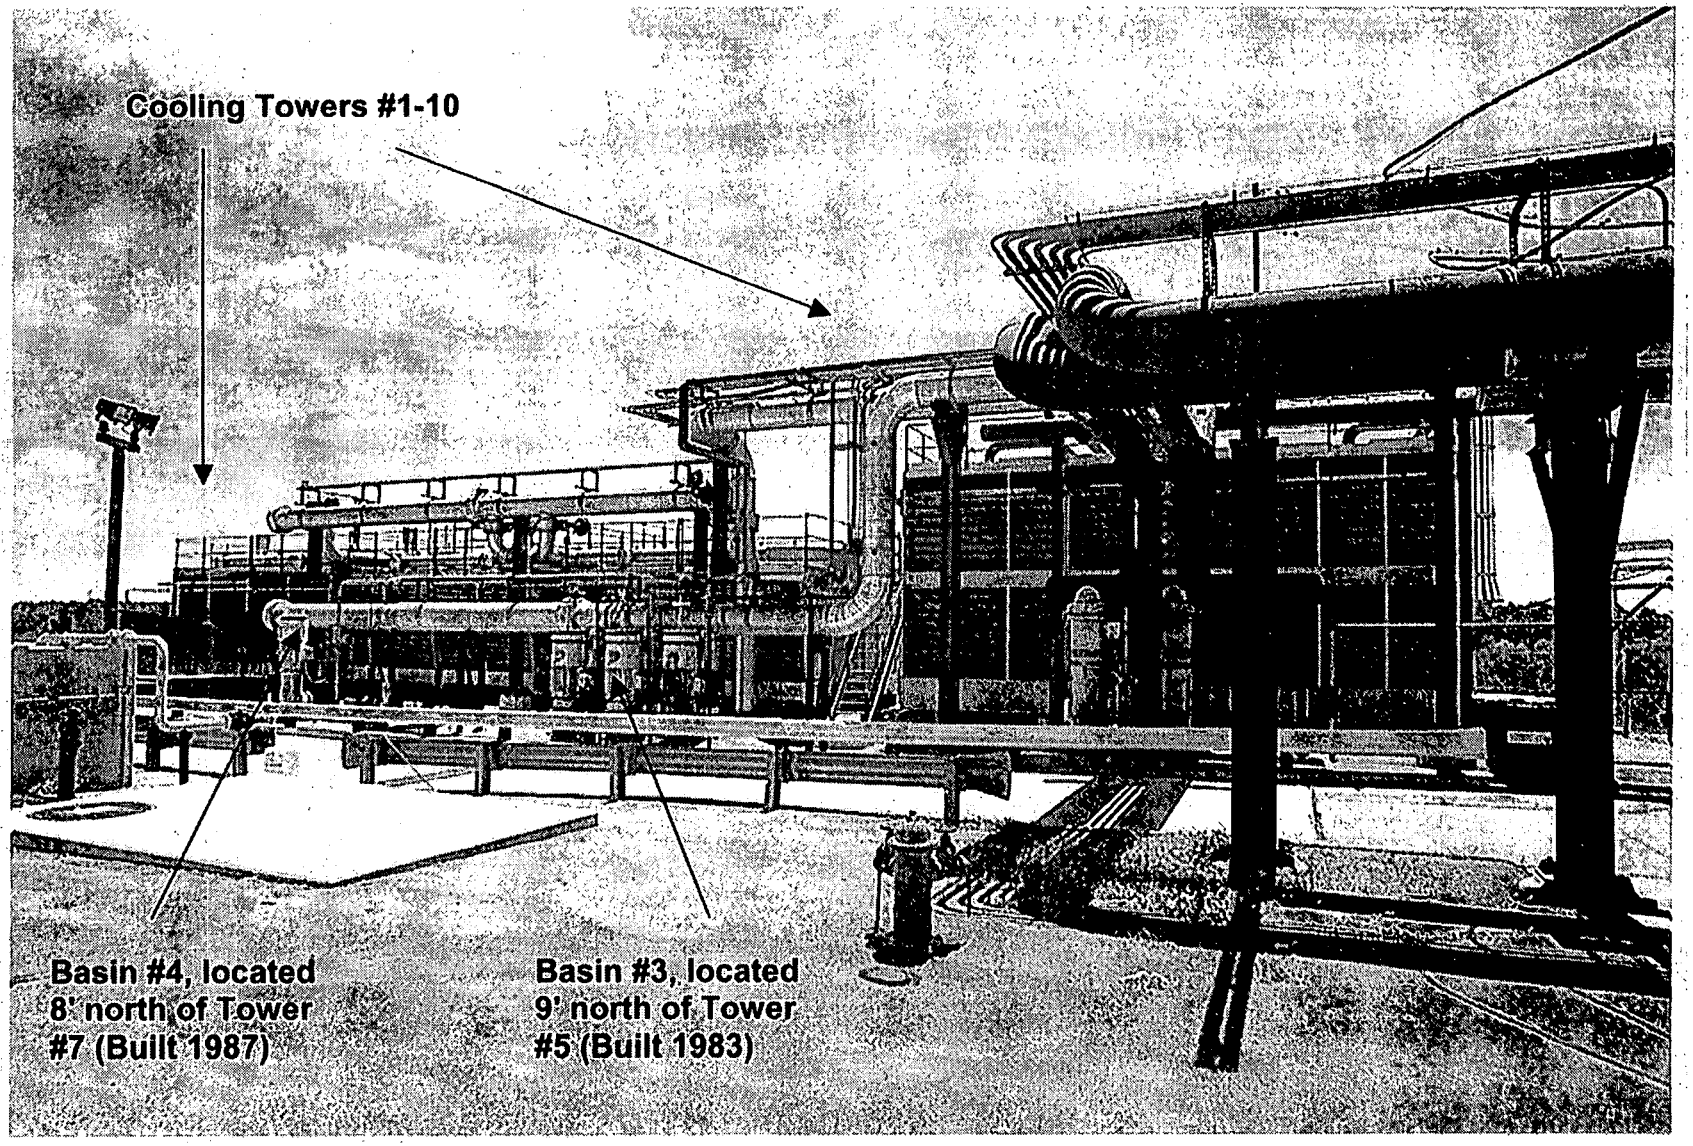
FIGURE 2: PRS 101, historical (2000) view of Cooling Towers #1-10, and Cooling Tower Basins #3 & #4 (looking south)

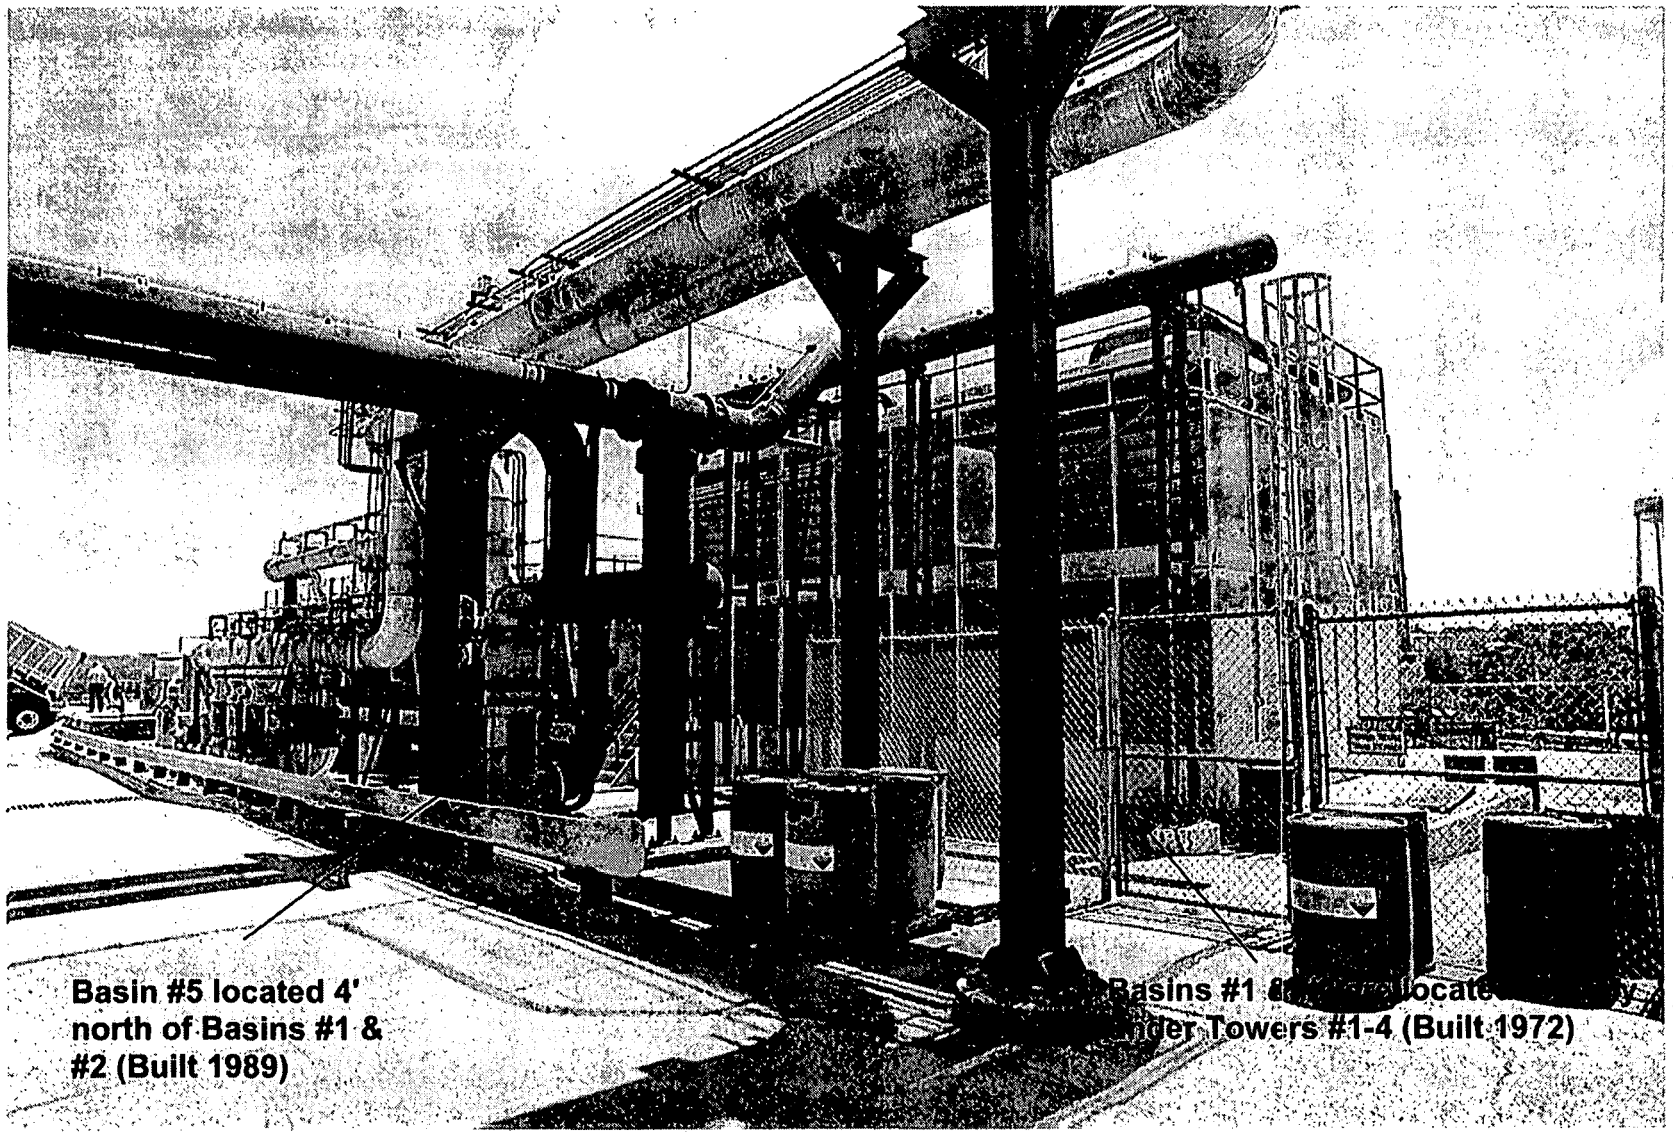
FIGURE 3: PRS 101, historical (2000) view of Cooling Towers #1-4 (looking southeast), and Cooling Tower Basins #1, #2 & #5

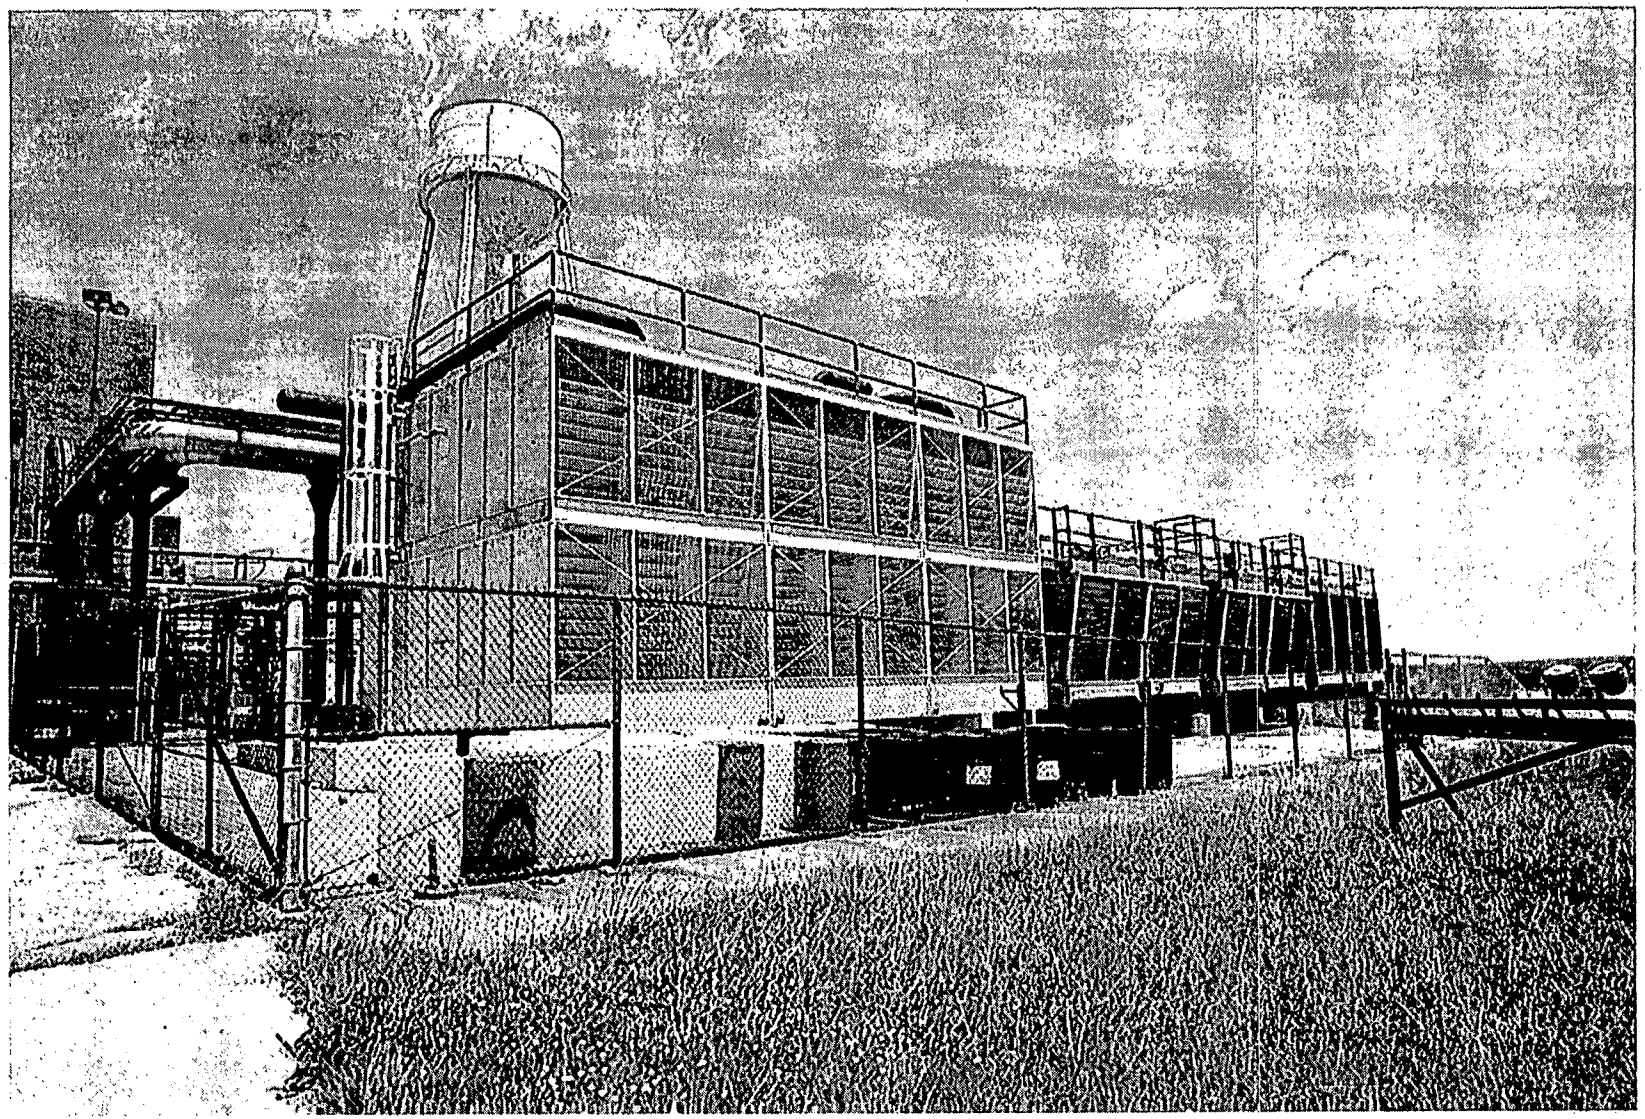
FIGURE 5: PRS 102 historical (2000) view of Cooling Tower Drum Storage Area (looking northeast)

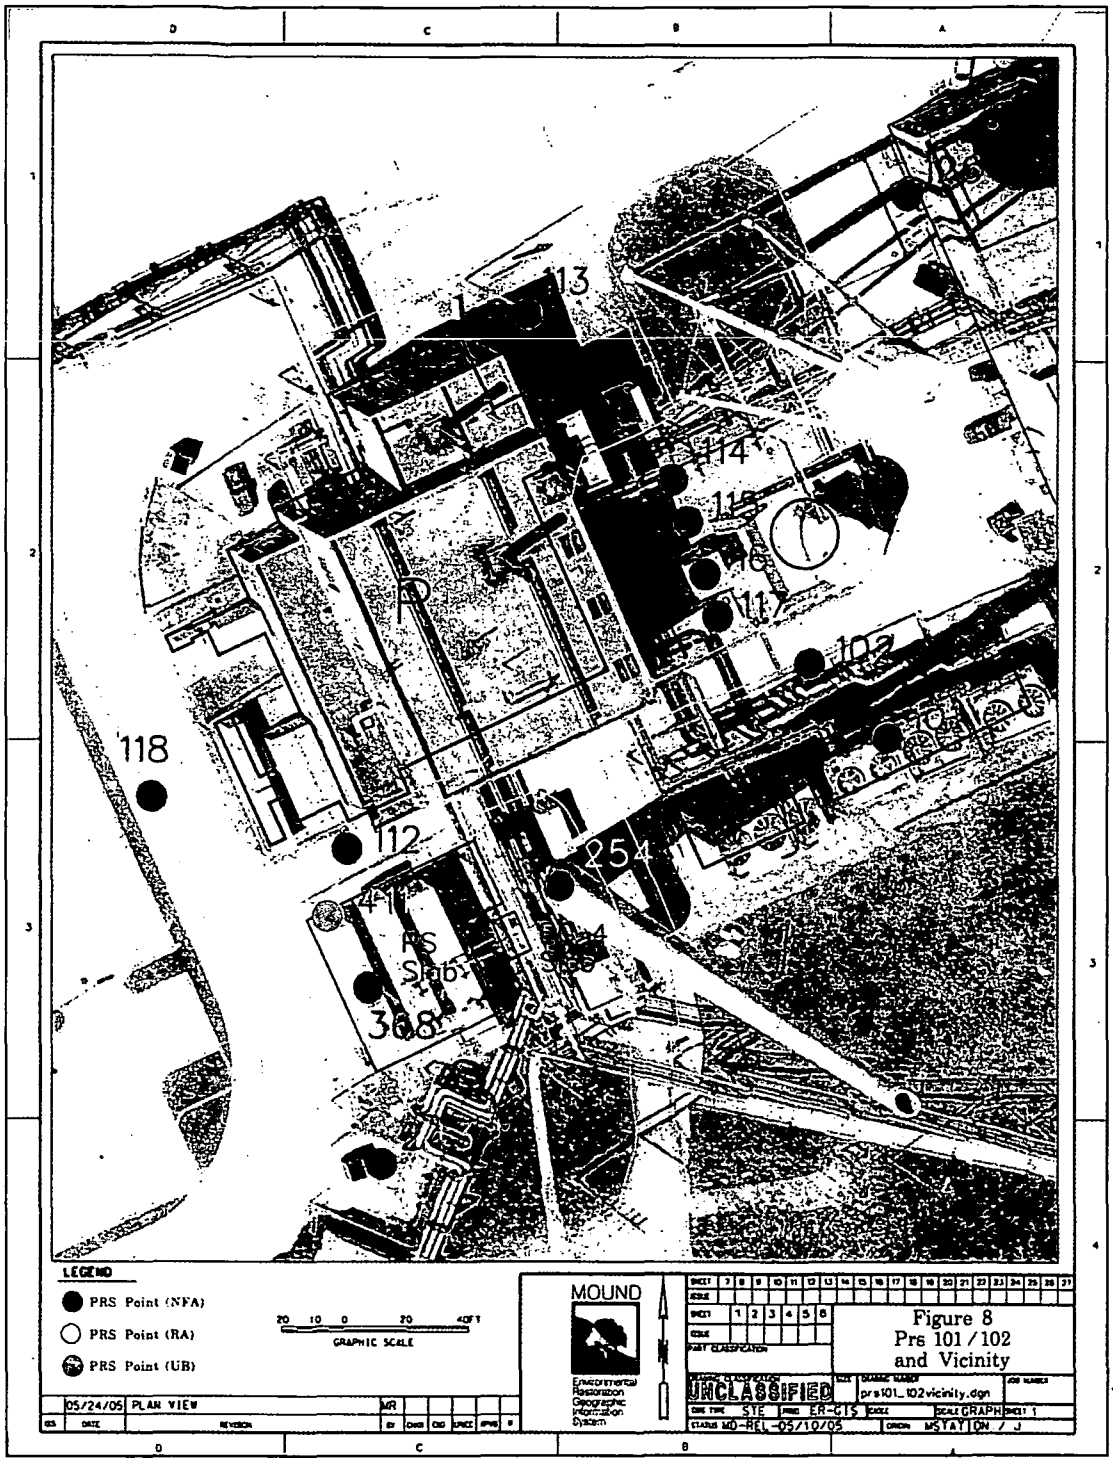
FIGURE 8: PRS 101/102 & Vicinity

Figure 8 has been added to the package to show the locations and current status of the PRSs in the vicinity. No other PRSs overlap the area designated as PRSs 101 and 102.
