Miamisburg Closure Project
Building Data Package

P Building
(Demolition)

Final
April 2005

Building P (Power House)

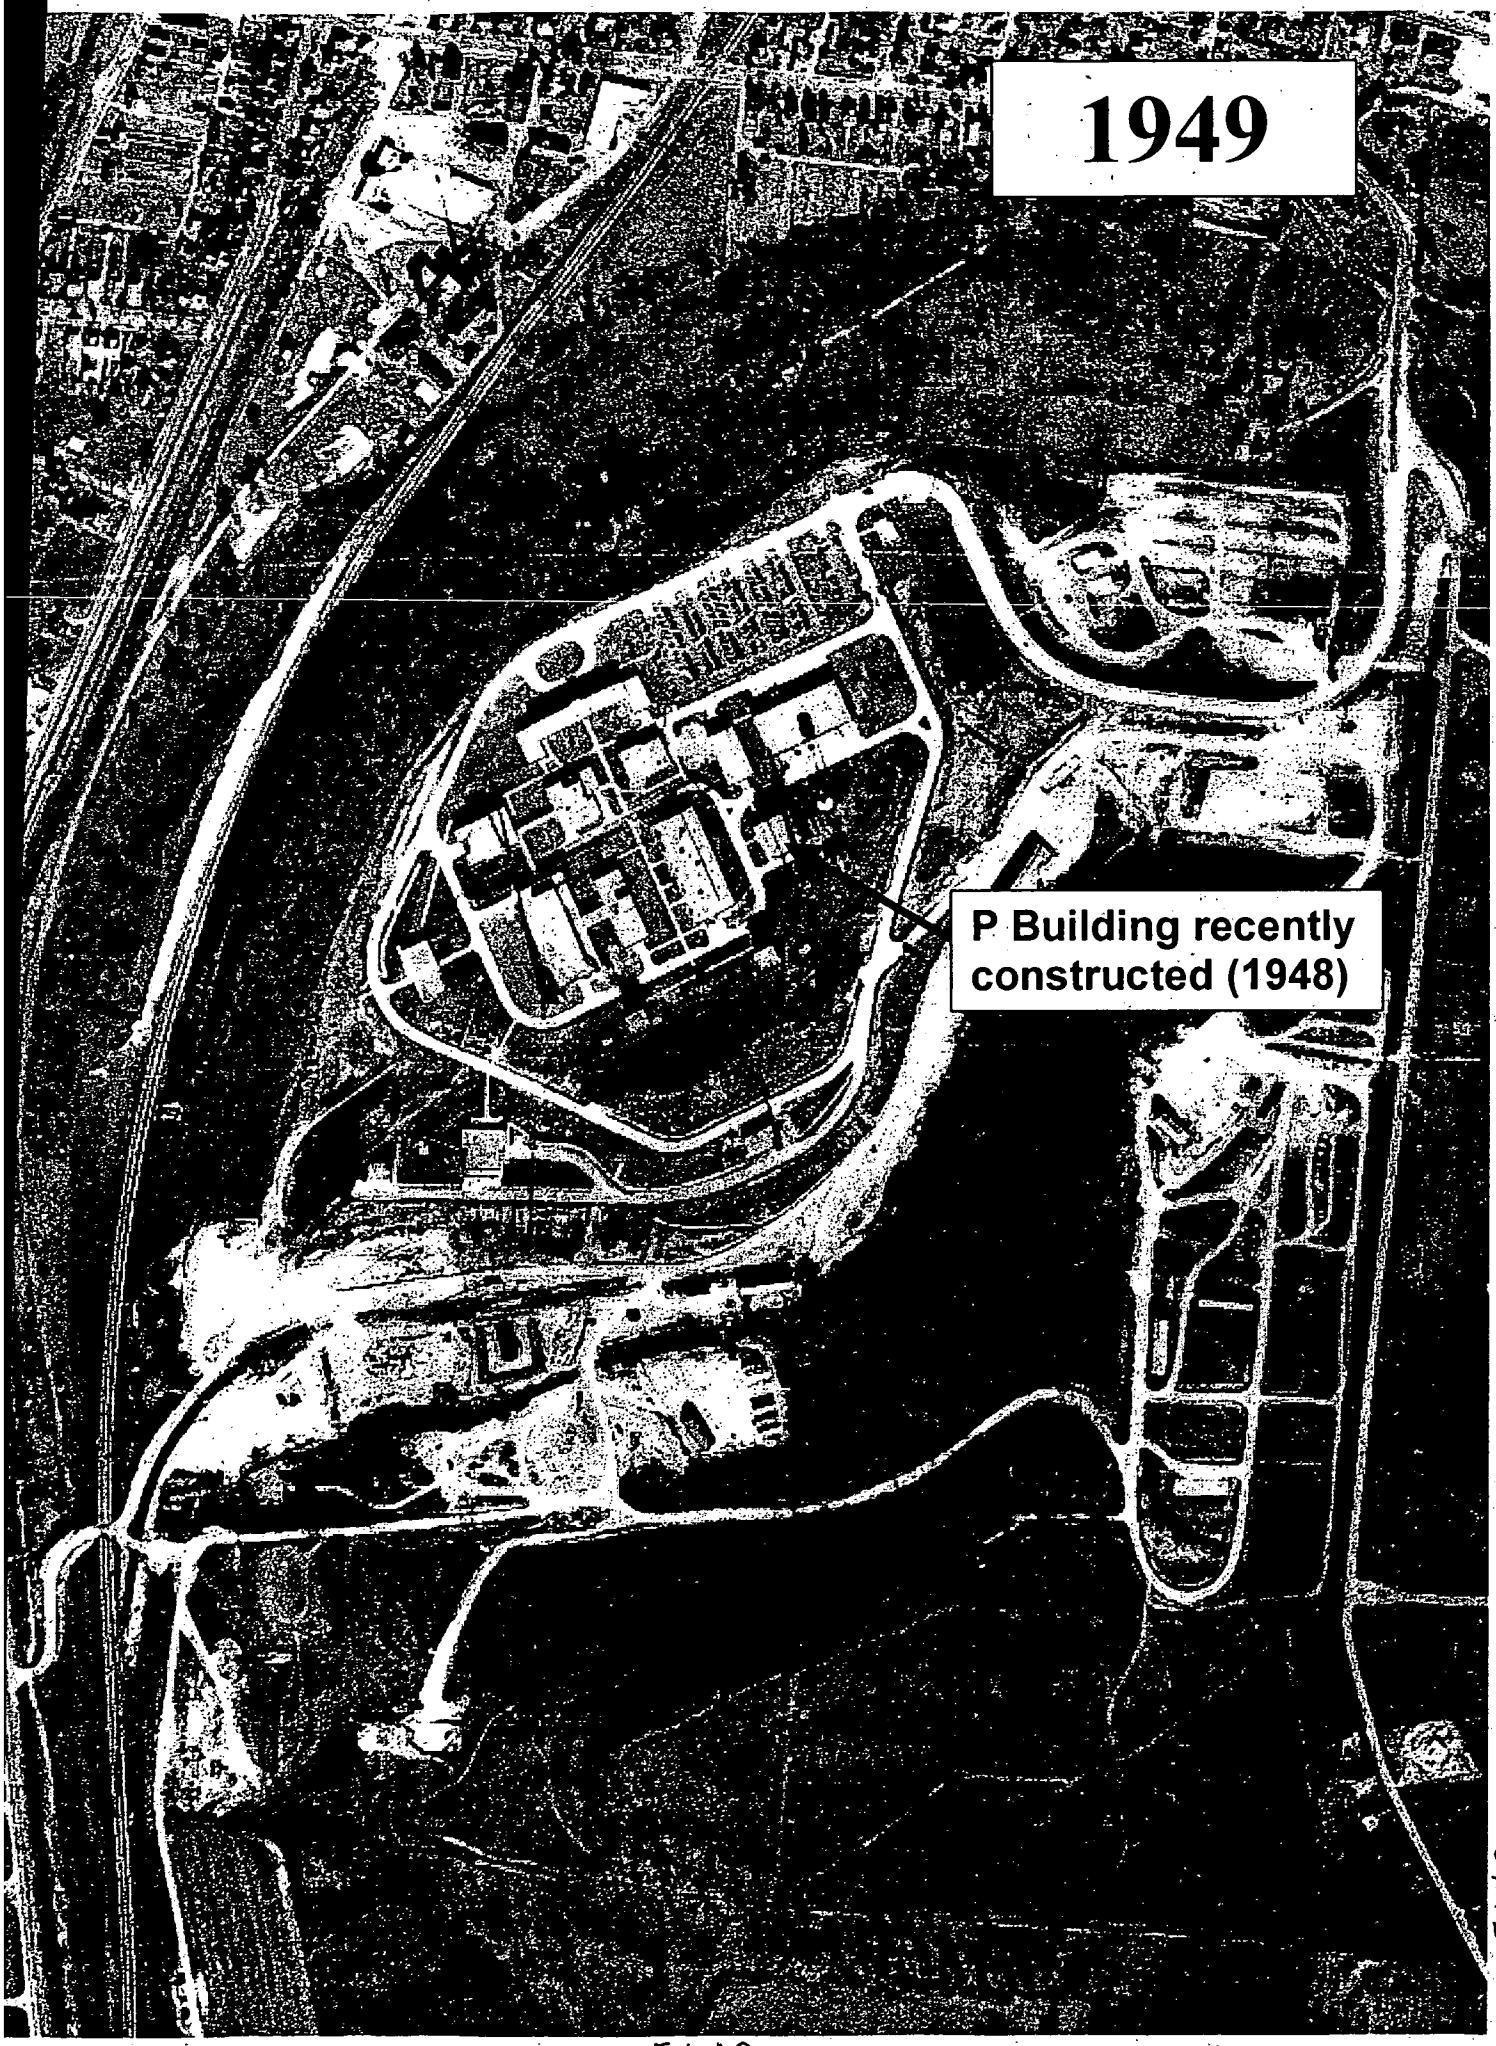
1949
P Building recently constructed (1948)

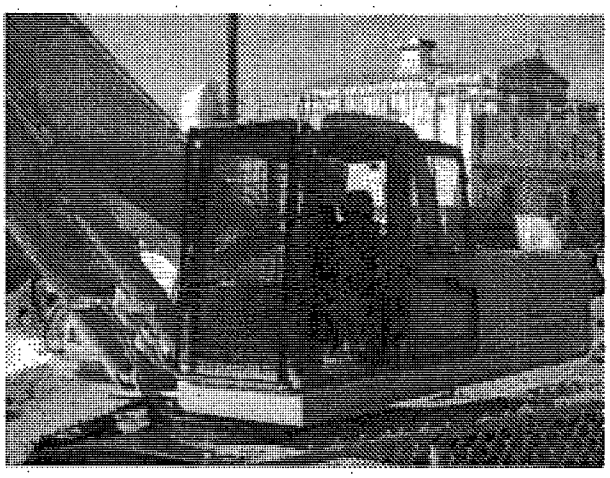
Discussion: On Thursday, April 22, 2004, in the early afternoon, a scrap piece of 2" copper piping apparently became caught in the track of an excavator and rotated up and struck the windshield. There were no injuries as a result of this incident, the operator had on a hard hat, safety glasses, and safety toed shoes. This piece of equipment is leased and came with an operator from the Equipment Rental Company.

The equipment operator had just finished refueling the Komatsu PC 400 Track Hoe and was in the process of tracking back to the active demolition area of HH Building. While tracking, apparently a section of 2" copper pipe became entangled in the track and suddenly flipped up and struck the lower section of the windshield, breaking the safety glass. Operation of the track hoe was suspended immediately and the operator was checked to ensure that he was OK. The track hoe was taken out of service until that evening when a replacement windshield and guard was installed. There is no OSHA requirement for this piece of equipment to have a windshield guard but it is a good safety practice to do so.

Lessons Learned: During demolition activities, heavy equipment used for demolition should have guarding on the windshield to protect from debris. When tracking an excavator, beware of the potential for scrap items to become caught in the track and rotate up to the cab.

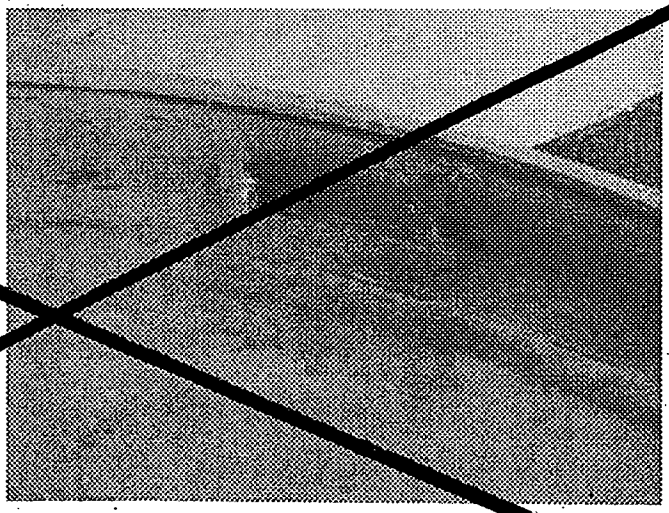
Title: Damaged Waste Drum Sent to NTS **Date: April 19, 2004**

Discussion: On April 15, 2004, a shipment destined for NTS containing eight drums and seven boxes departed Mound. Upon arrival at NTS on April 19, NTS personnel discovered 3 holes in the drum lid lip of drum SD000051. Drum SD000051 contained a Cobalt 60 source and a Cesium 137 source. The encapsulated sources had been placed in an aluminum "rabbit" and were shielded by sealing in an epoxy-lead shot matrix. The resulting 55-gallon drum was dose rated at 4 mrem/hr at 1 meter and **weighed in excess of 800 pounds**, two factors

Lessons Learned: Use of the incorrect tools for a job can result in damage to waste containers.

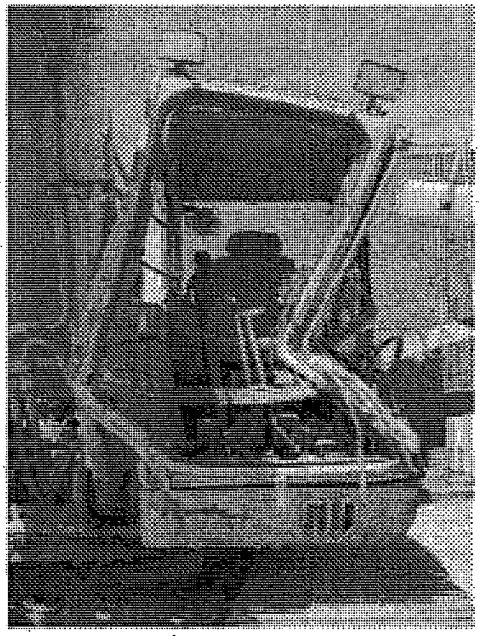
Project: BOSS **Location:** R Building Breezeway

Discussion: On Thursday, April 29, 2004, during the start of demolition to the R-breezeway (a structure approximately 8 feet high), to separate the breezeway from the R-annex, a Heavy Duty Operator cut two points on the south end of the breezeway roof where it was connected to the R-annex. Reaching across the breezeway to complete the separation, the HD operator noticed the roof start to move. As the operator began to move the excavator away from the breezeway it collapsed. The breezeway overhang struck the cab of the excavator. The cab frame was bent and the windshield broken. The operator sustained a minor first aid injury to his left index finger.

Lessons Learned: During demolition activities, heavy equipment used for demolition should have guarding on the windshield to protect from debris. Legacy issues regarding configuration control management deficiencies continue to create potential hazards due to drawings not reflecting as built conditions.

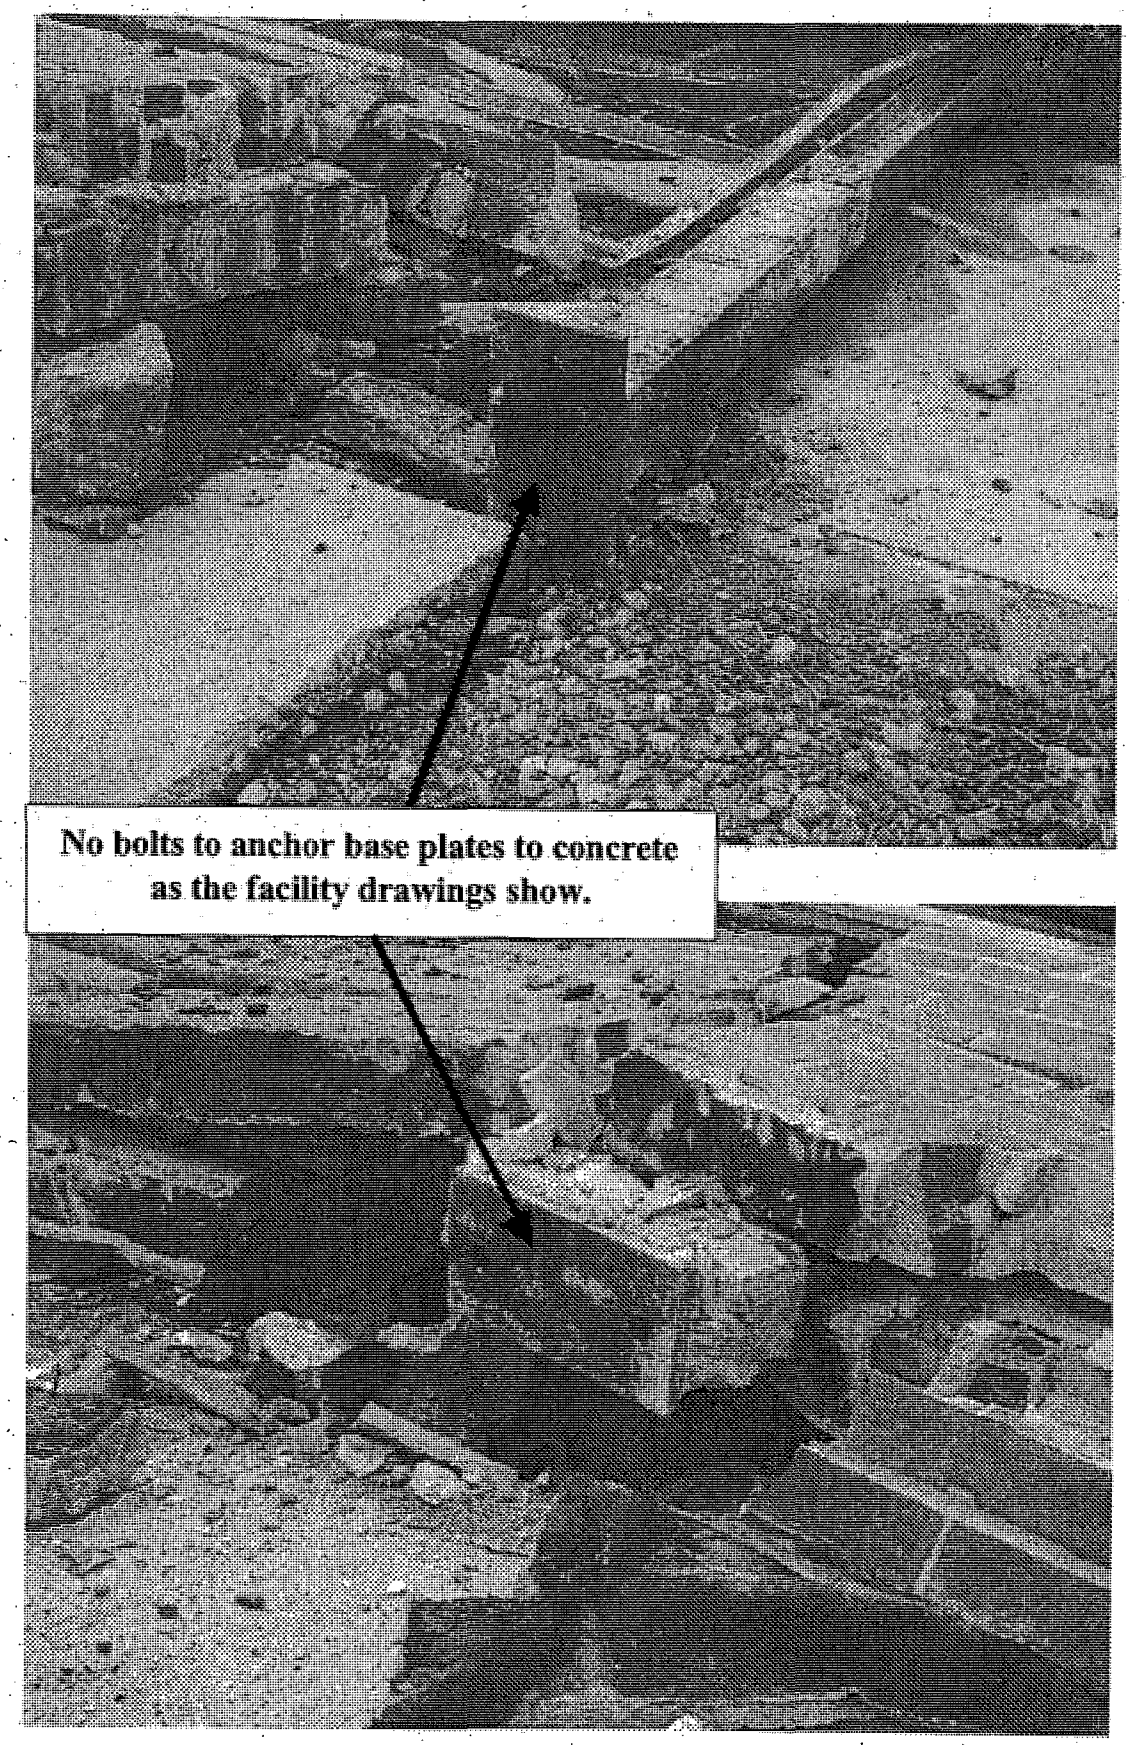
No bolts to anchor base plates to concrete
as the facility drawings show.
