Miamisburg Closure Project
CLOSEOUT REPORT

P Building

(Demolition included PS Building slab,
EG-4 slab, and Bulk Gas Tank Slab)

Final
November 2005

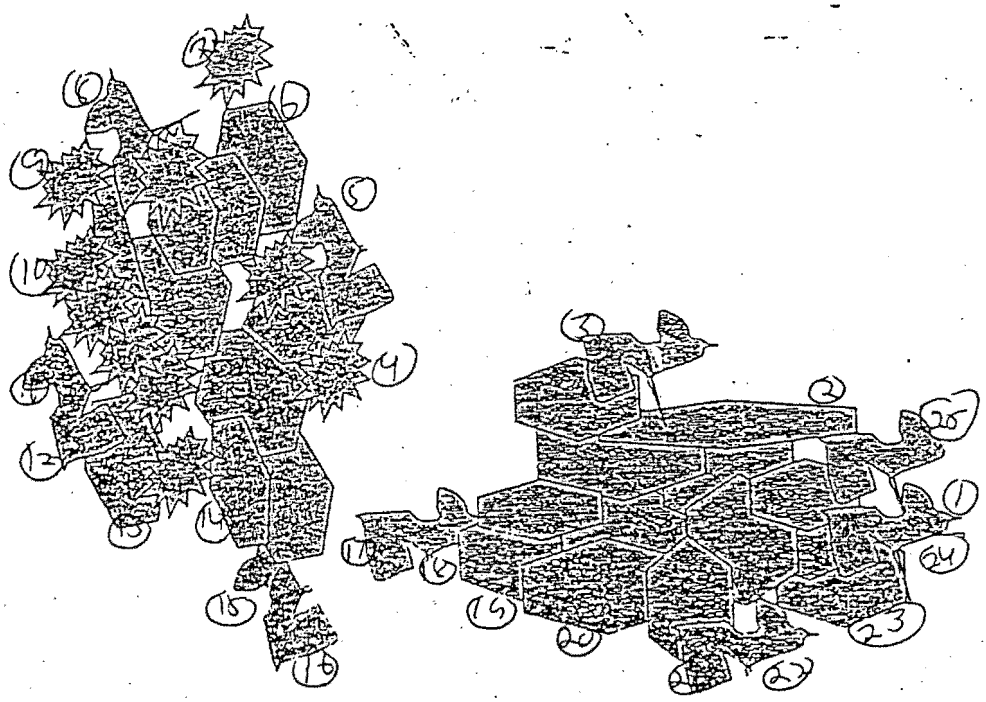
Survey No. 05-TF-0124

LOCATION: (BLDG/AREA/ROOM) Power House	SURVEY NO. 05-TF-0124
PURPOSE: Characterization of concrete debris pile from Power House demolition	RWP NO. N/A
	DATE: 3-21-05
	TIME: 0900

Scan and house survey conducted
NO audible clicks

Integrated count taken IF audible detected. NO audible detected.
ALL direct readings <100dpm/100cm2 Alpha and <5000dpm/100cm2 Beta

COMMENTS: Characterization of power house. Concrete deans ok. Paused scan 2360 no audible chirps. all is well. Field check prior to setting empty bags.

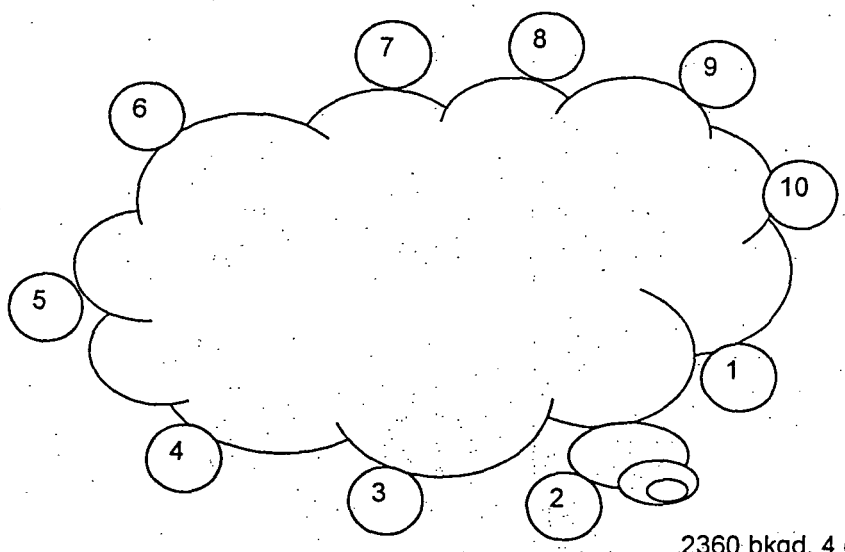
LOCATION: (BLDG./AREA/ROOM) Across from Powerhouse	SURVEY NO. 05-TF-0182
PURPOSE: Debris pile survey of Emergency Generator #4 concrete pad	RWP NO. N/A
	DATE: 4/27/05
	TIME: 13:30

* Scan and pause survey performed no audible clicks detected, therefore no intergrates performed
