Phase I RFI/RI Report
Operable Unit No. 15
Inside Building Closures

U.S. Department of Energy
Rocky Flats Plant
Golden, Colorado

August 1994

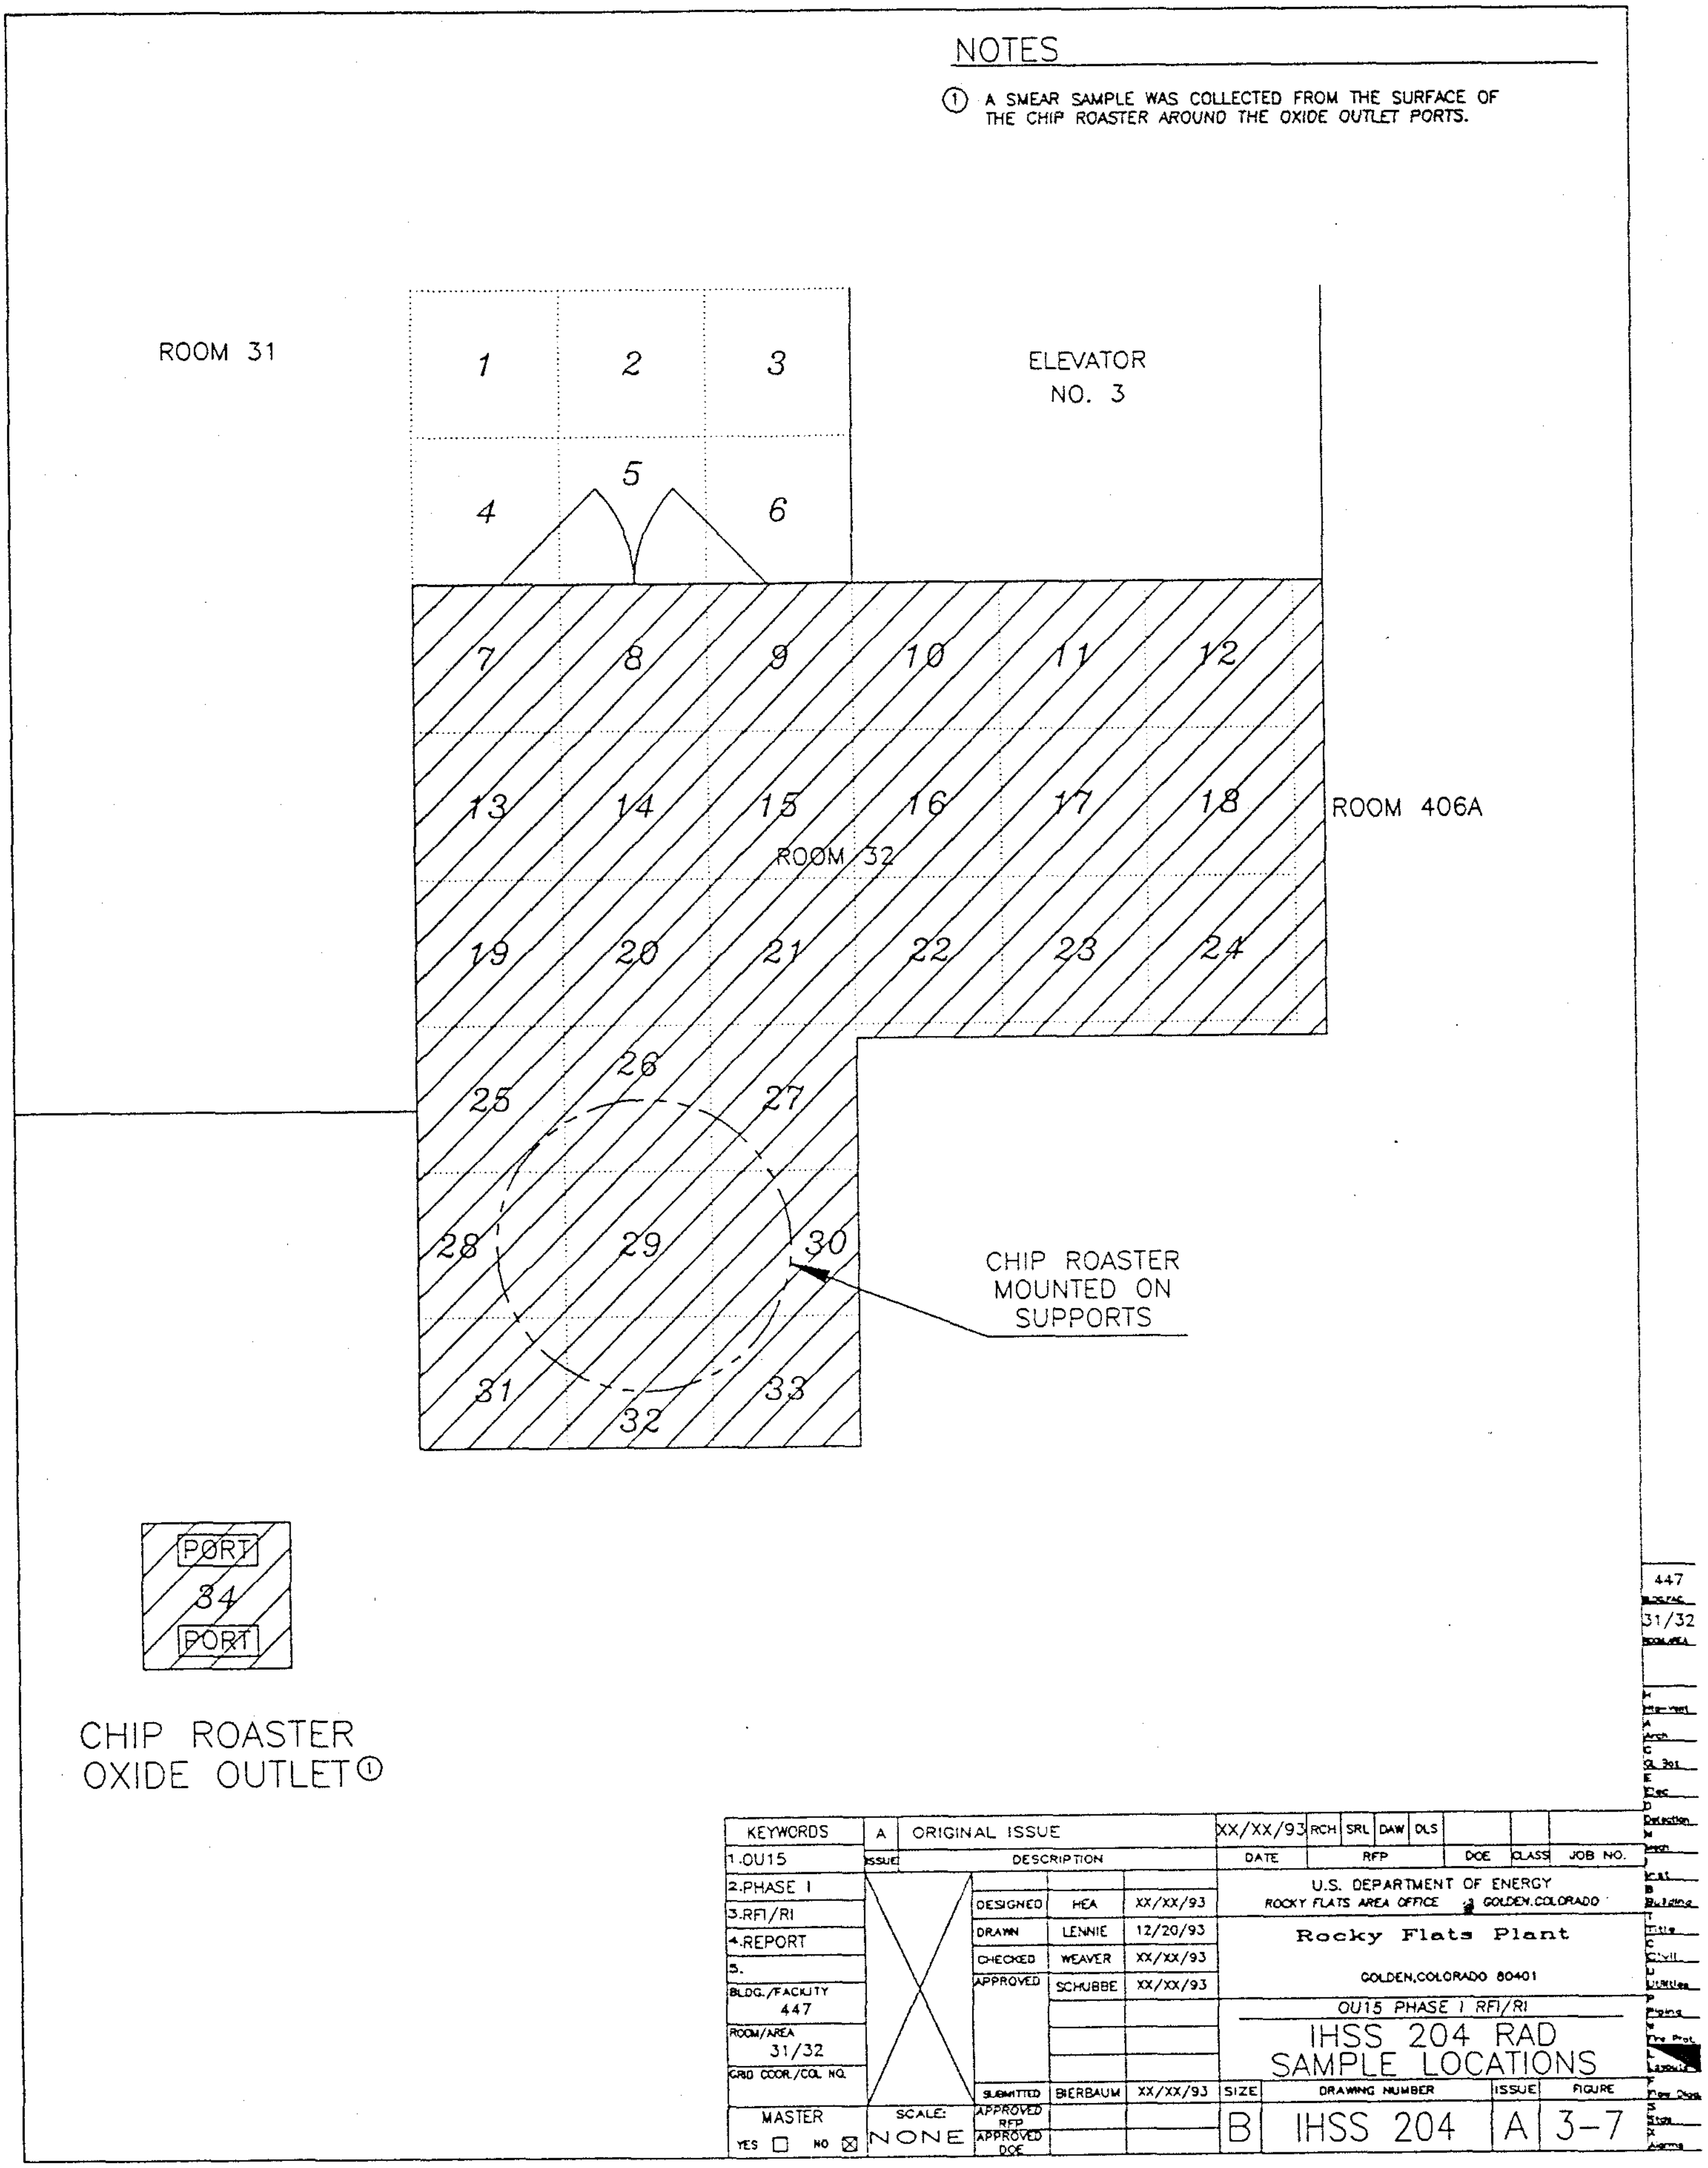
NOTES
① A SMEAR SAMPLE WAS COLLECTED FROM THE SURFACE OF THE CHIP ROASTER AROUND THE OXIDE OUTLET PORTS.
ROOM 31
ELEVATOR NO. 3
1
2
3
4
5
6
7
8
9
10
11
12
13
14
15
16
17
18
ROOM 32
ROOM 406A
19
20
21
22
23
24
25
26
27
28
29
30
CHIP ROASTER MOUNTED ON SUPPORTS
31
32
33
PORT
34
PORT
CHIP ROASTER OXIDE OUTLET ①
KEYWORDS
1.OU15
2.PHASE I
3.RFI/RI
4.REPORT
5.
BLDG./FACILITY 447
ROOM/AREA 31/32
GRID COOR./COL NO.
MASTER
YES NO
SCALE: NONE
A
ORIGINAL ISSUE
XX/XX/93
RCH
SRL
DAW
DLS
ISSUE
DESCRIPTION
DATE
RFP
DOE
CLASS
JOB NO.
DESIGNED HEA XX/XX/93
DRAWN LENNIE 12/20/93
CHECKED WEAVER XX/XX/93
APPROVED SCHUBBE XX/XX/93
SUBMITTED BIERBAUM XX/XX/93
APPROVED RFP
APPROVED DOE
U.S. DEPARTMENT OF ENERGY
ROCKY FLATS AREA OFFICE GOLDEN,COLORADO
Rocky Flats Plant
GOLDEN,COLORADO 80401
OU15 PHASE I RFI/RI
IHSS 204 RAD SAMPLE LOCATIONS
SIZE B
DRAWING NUMBER IHSS 204
ISSUE A
FIGURE 3-7

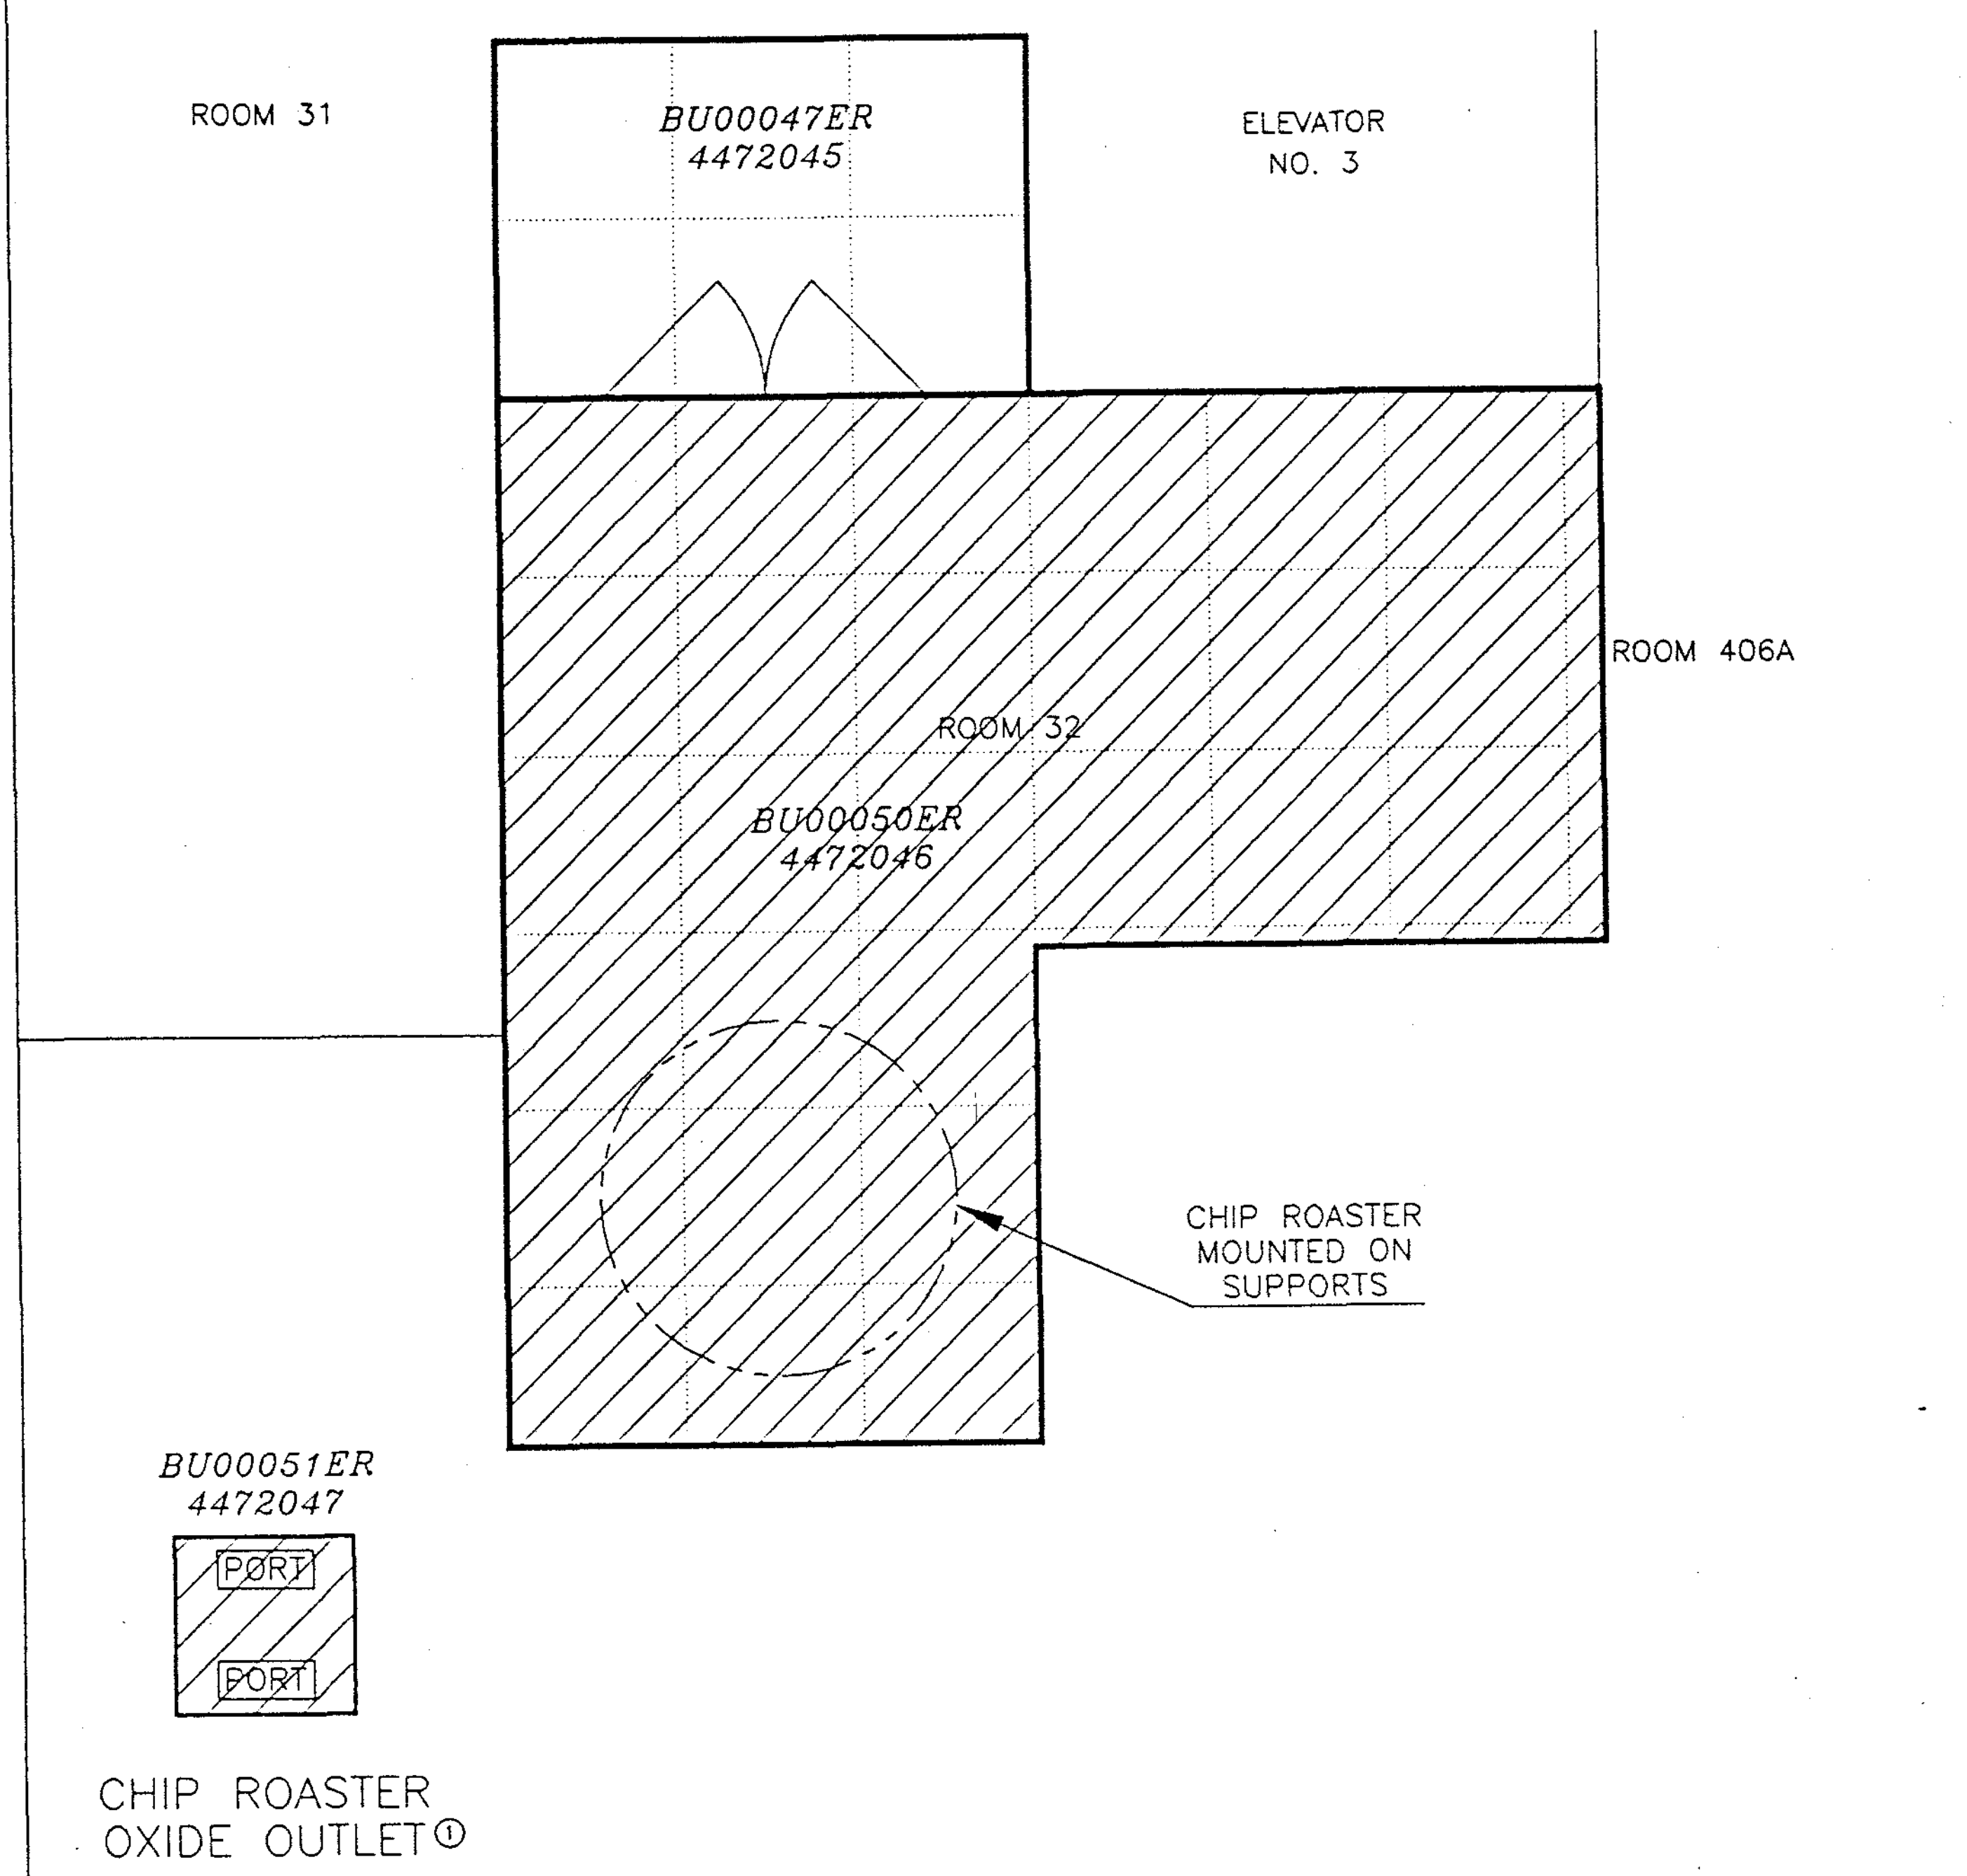
(1) A RINSATE SAMPLE WAS COLLECTED FROM THE SURFACE OF THE CHIP ROASTER AROUND THE OXIDE OUTLET PORTS.

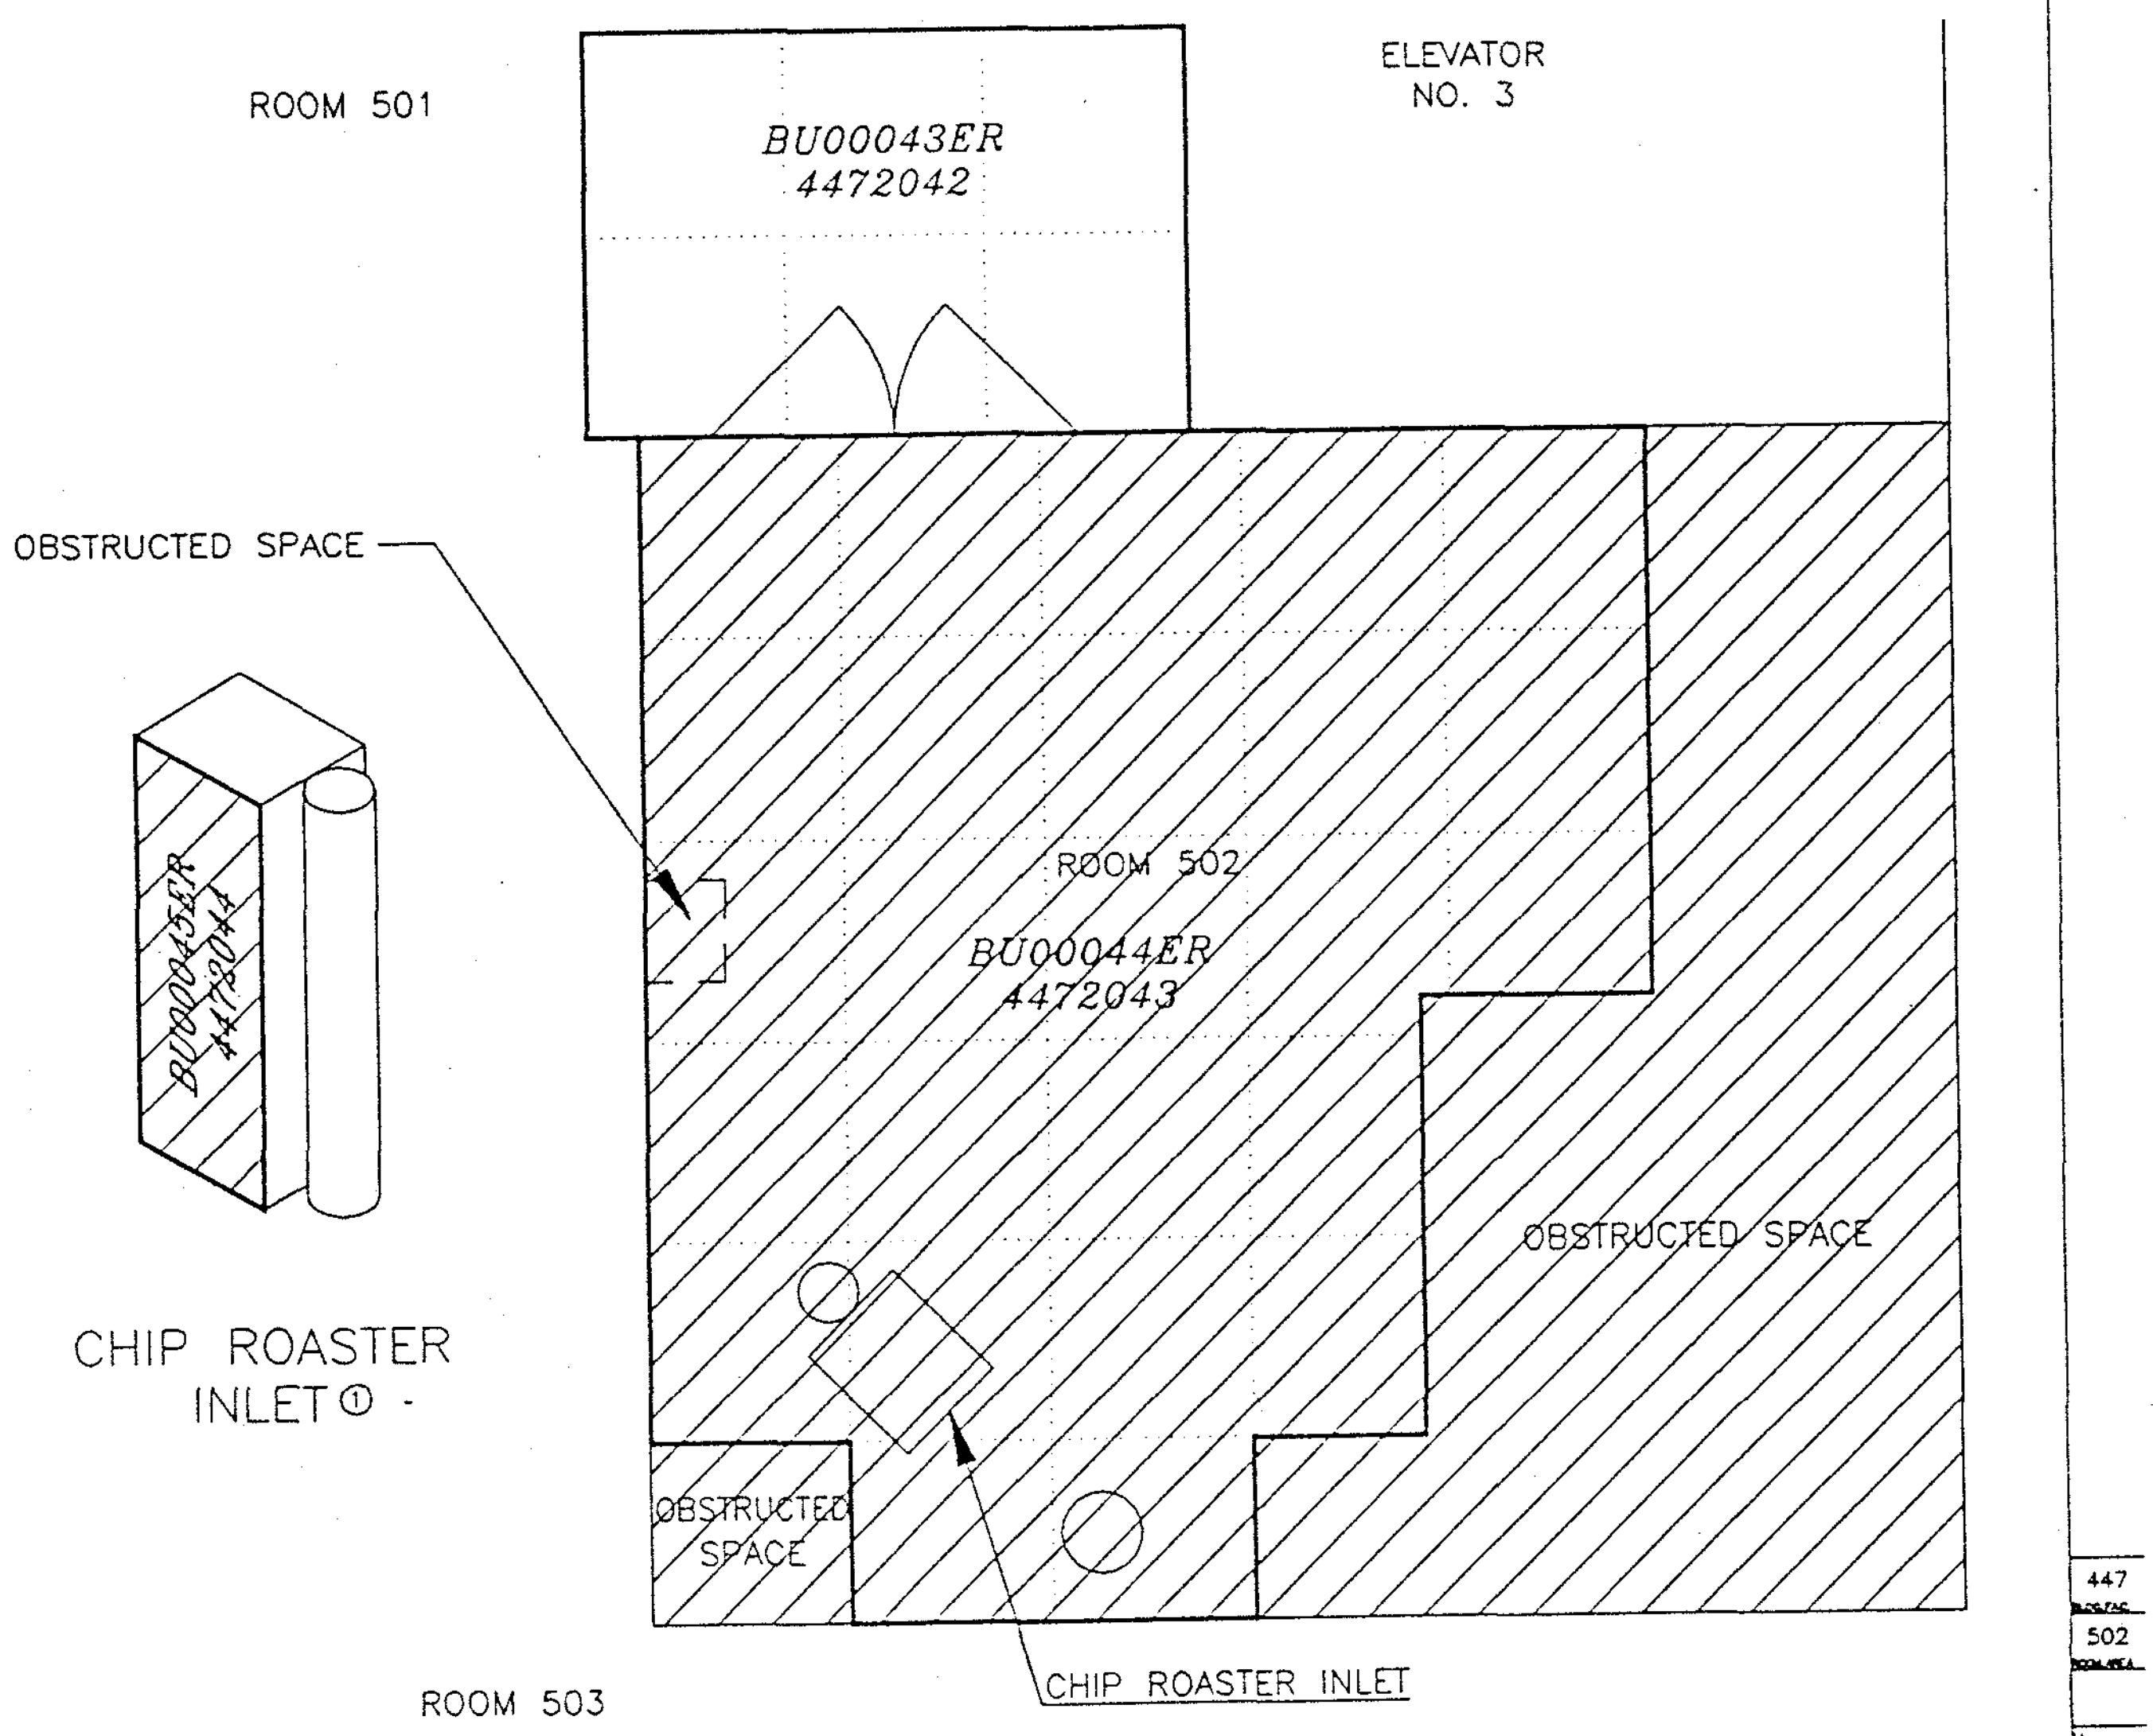
① A RINSATE SAMPLE WAS COLLECTED FROM THE SURFACE OF THE CHIP ROASTER INLET.

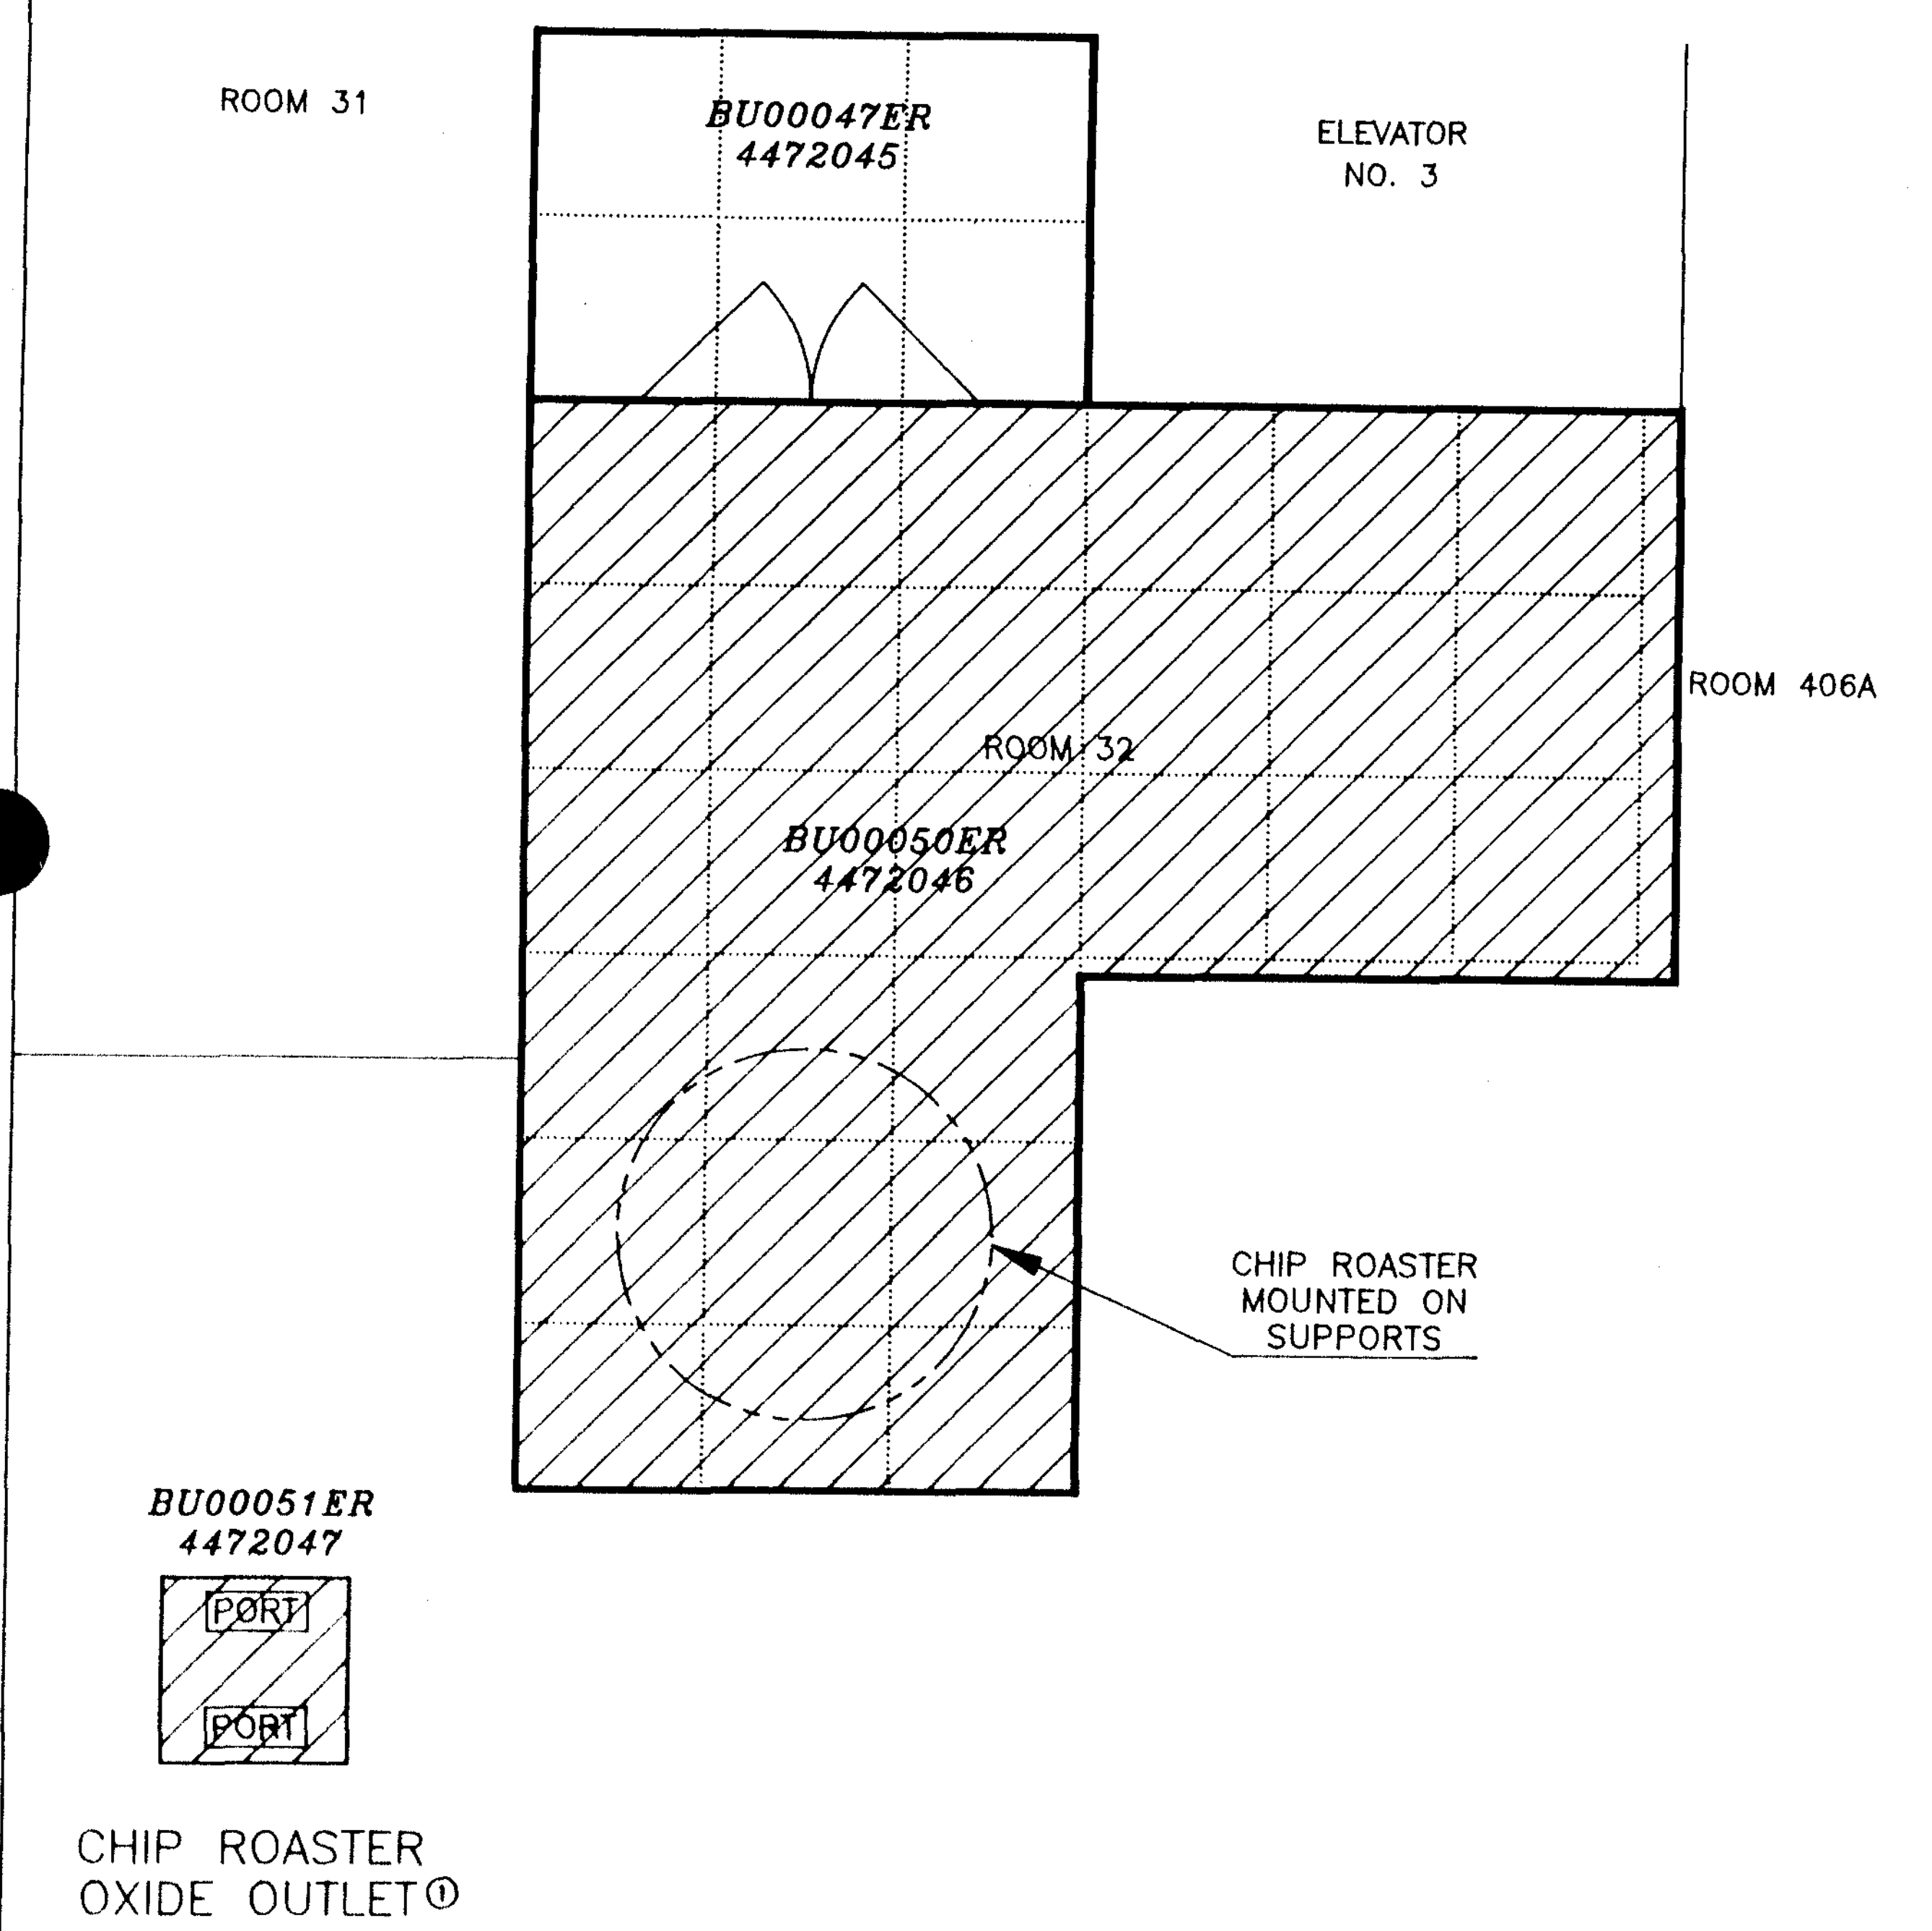
① A RINSATE SAMPLE WAS COLLECTED FROM THE SURFACE OF THE CHIP ROASTER AROUND THE OXIDE OUTLET PORTS.

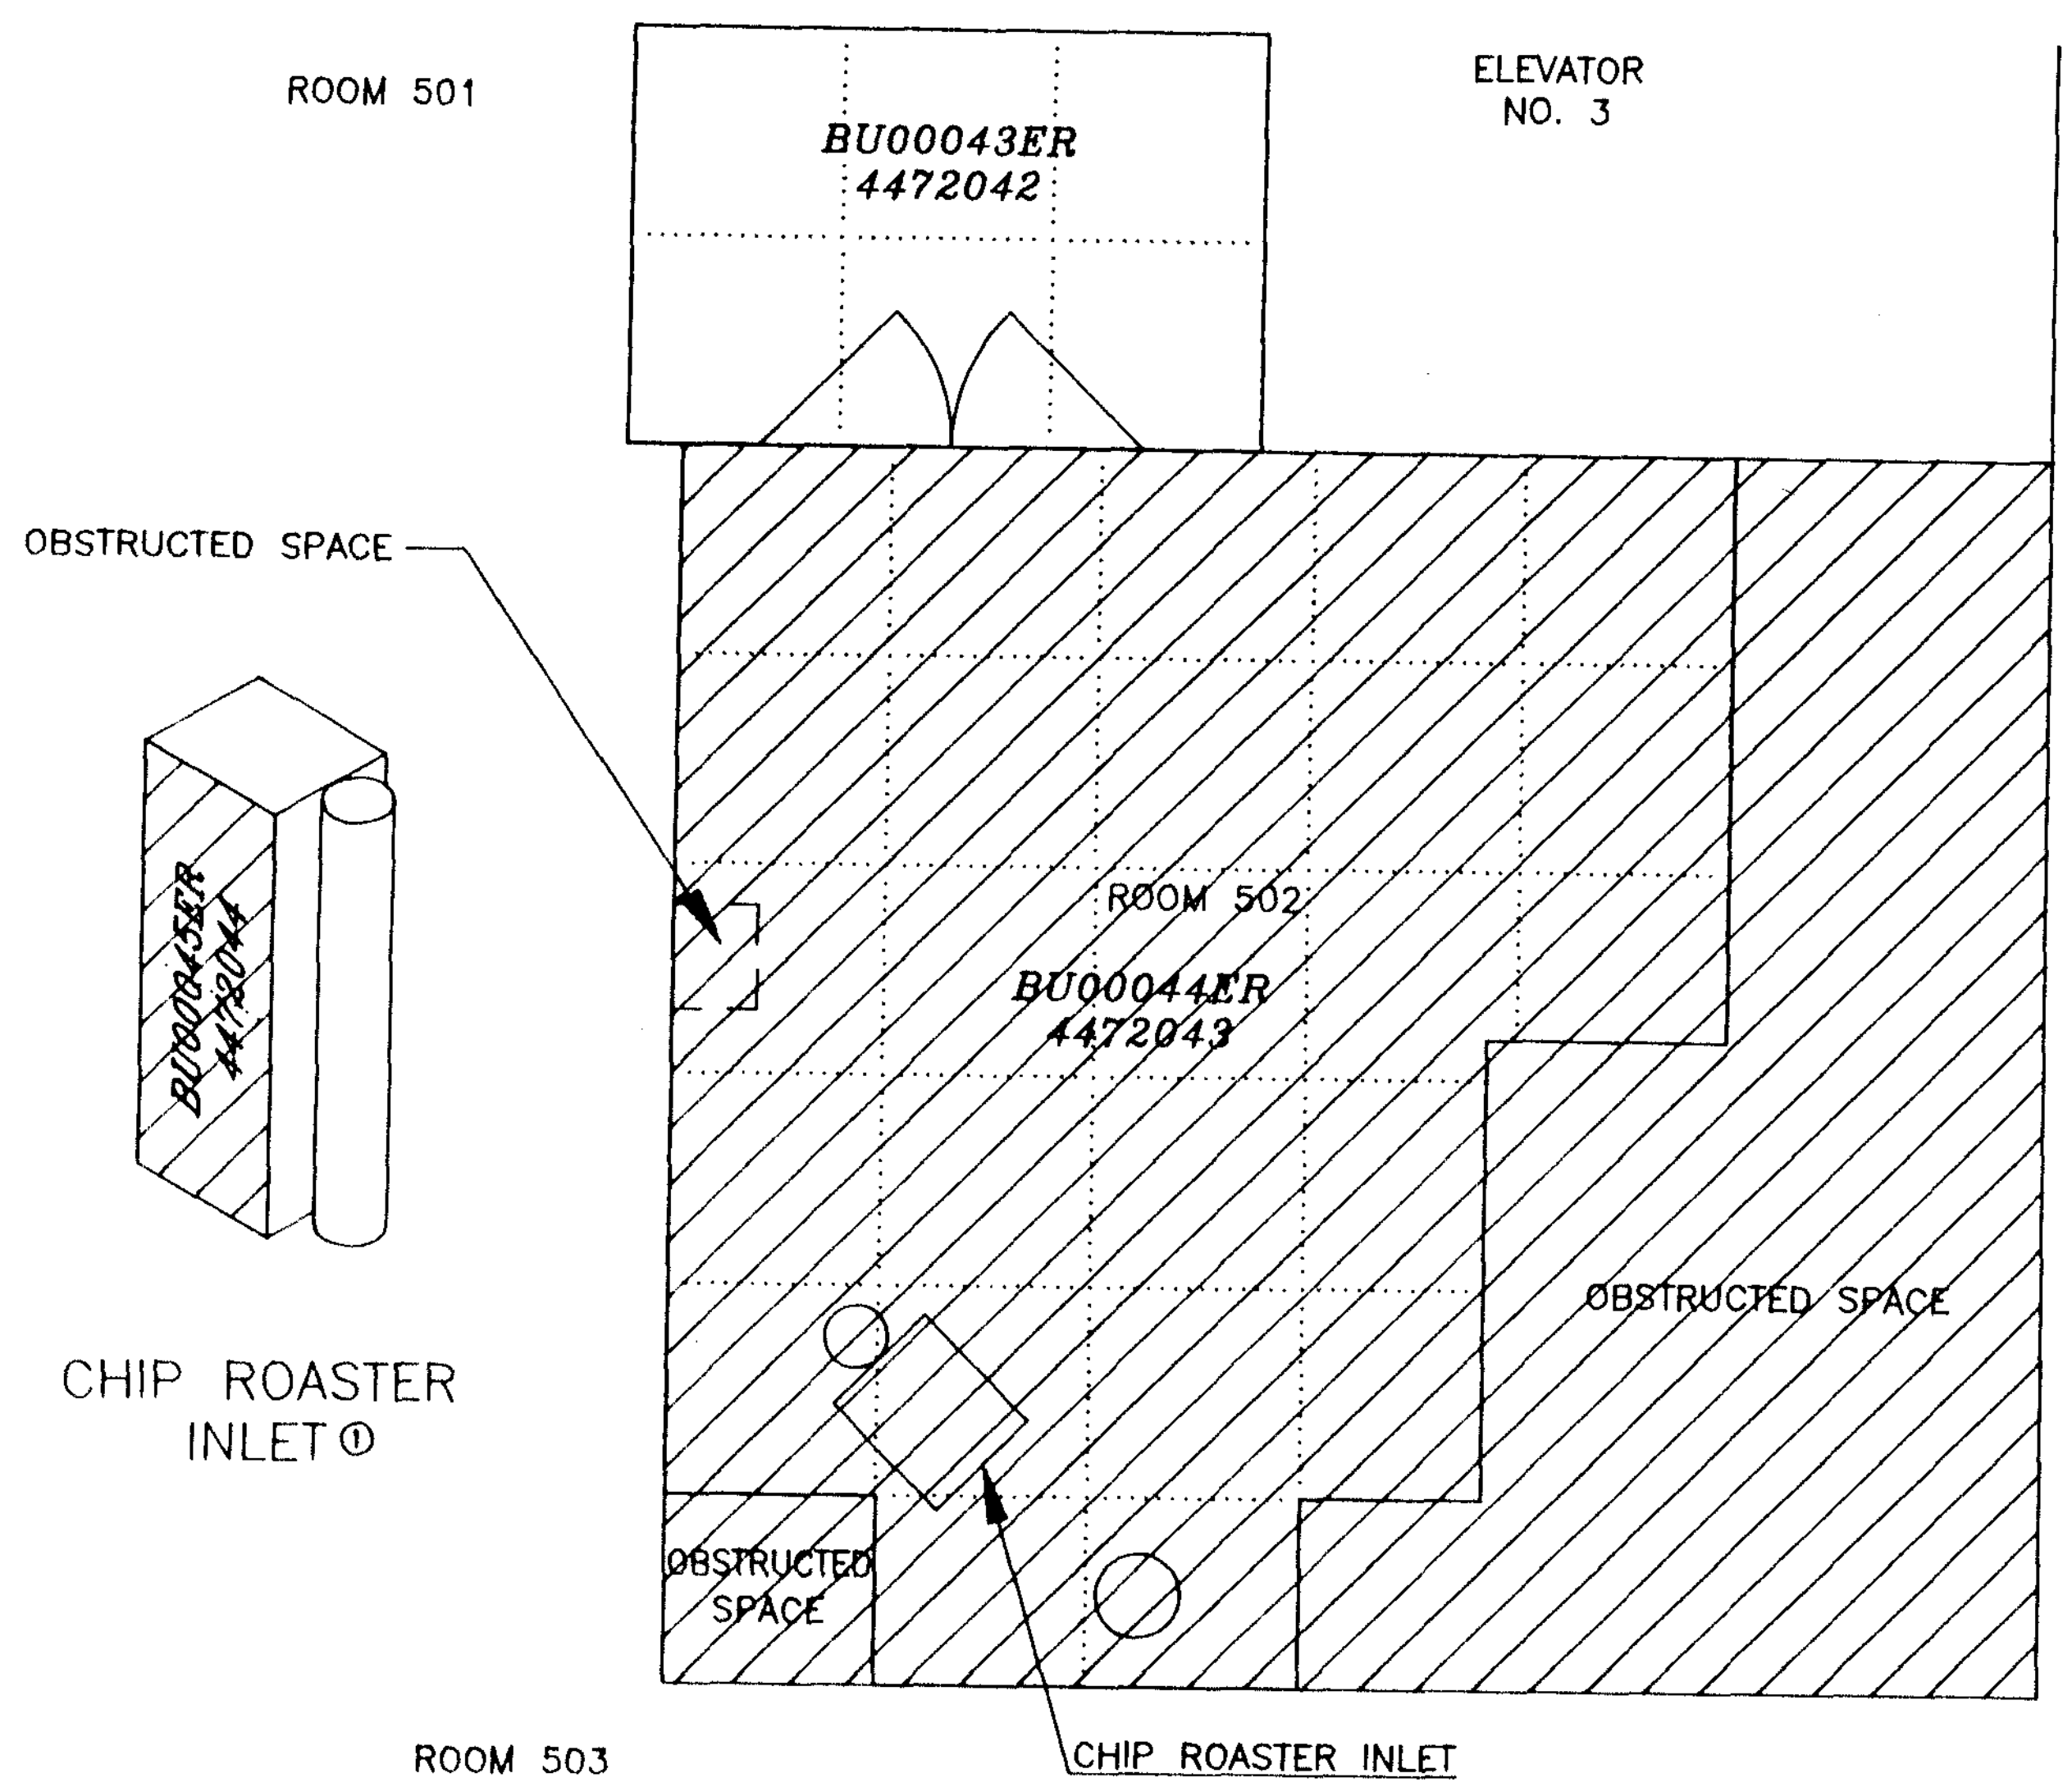
① A RINSATE SAMPLE WAS COLLECTED FROM THE SURFACE OF THE CHIP ROASTER INLET.

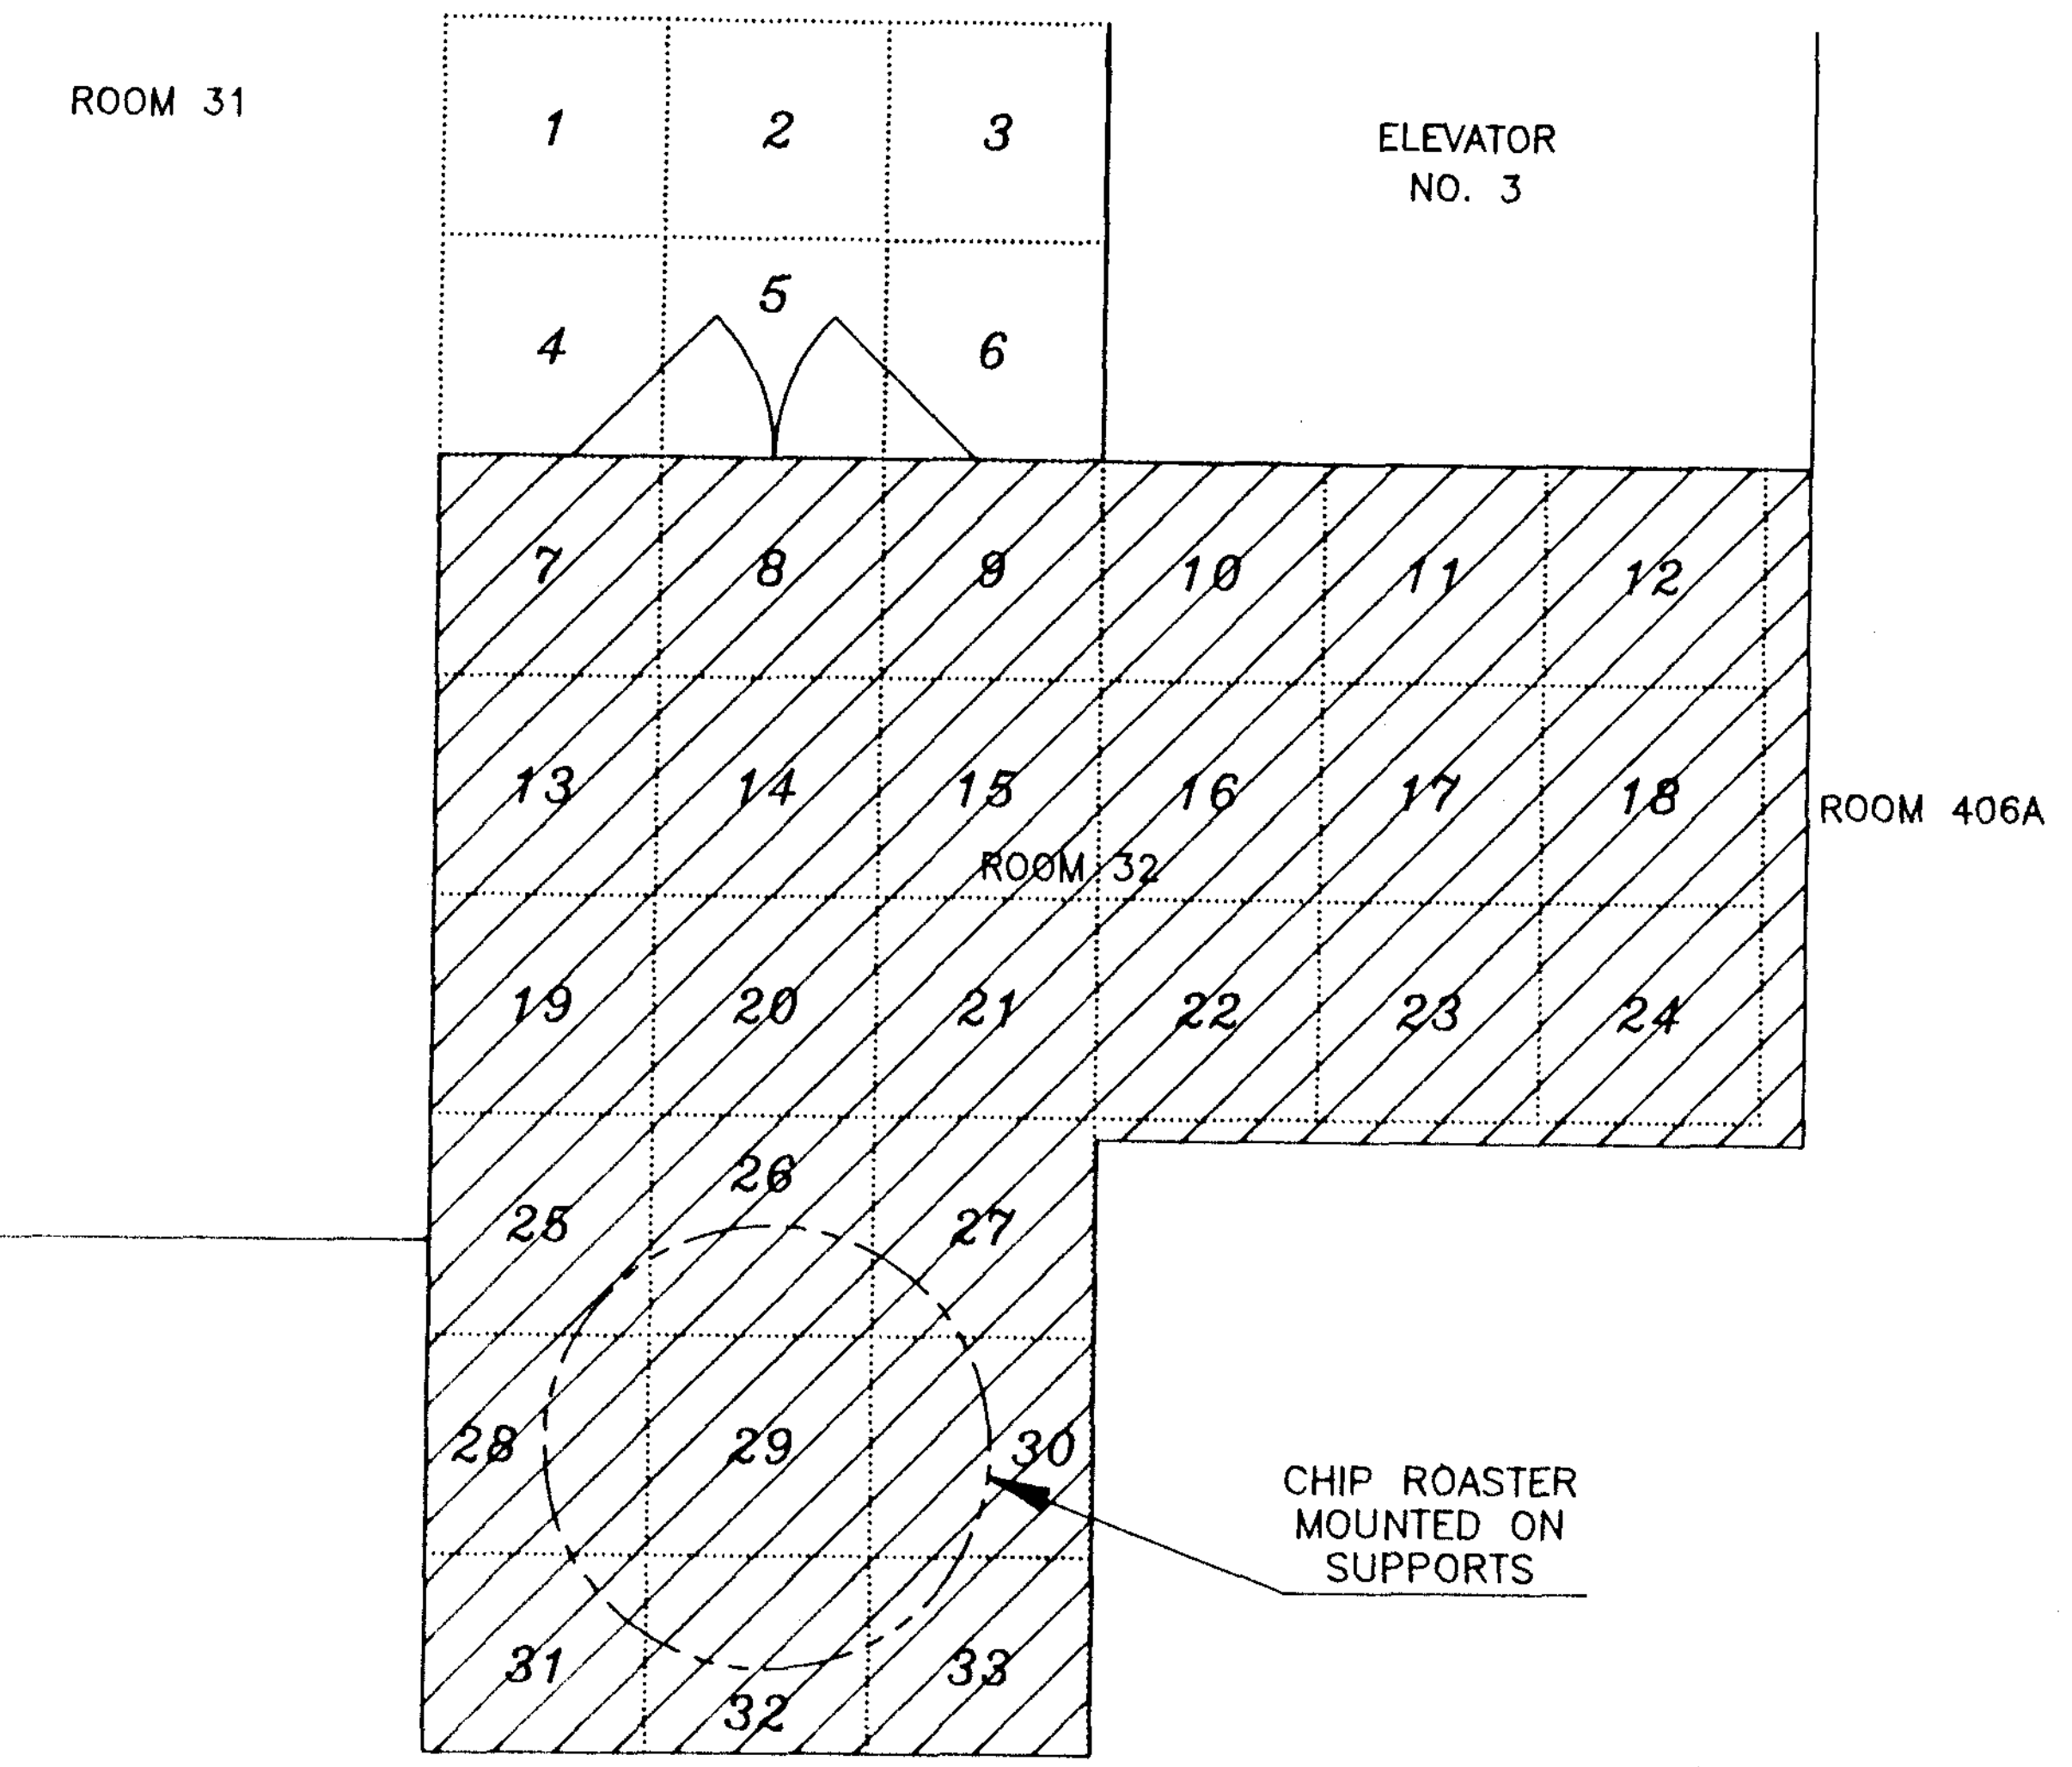
① A SMEAR SAMPLE WAS COLLECTED FROM THE SURFACE OF THE CHIP ROASTER AROUND THE OXIDE OUTLET PORTS.
