Phase I RFI/RI Report
Operable Unit No. 15
Inside Building Closures

U.S. Department of Energy
Rocky Flats Plant
Golden, Colorado

August 1994

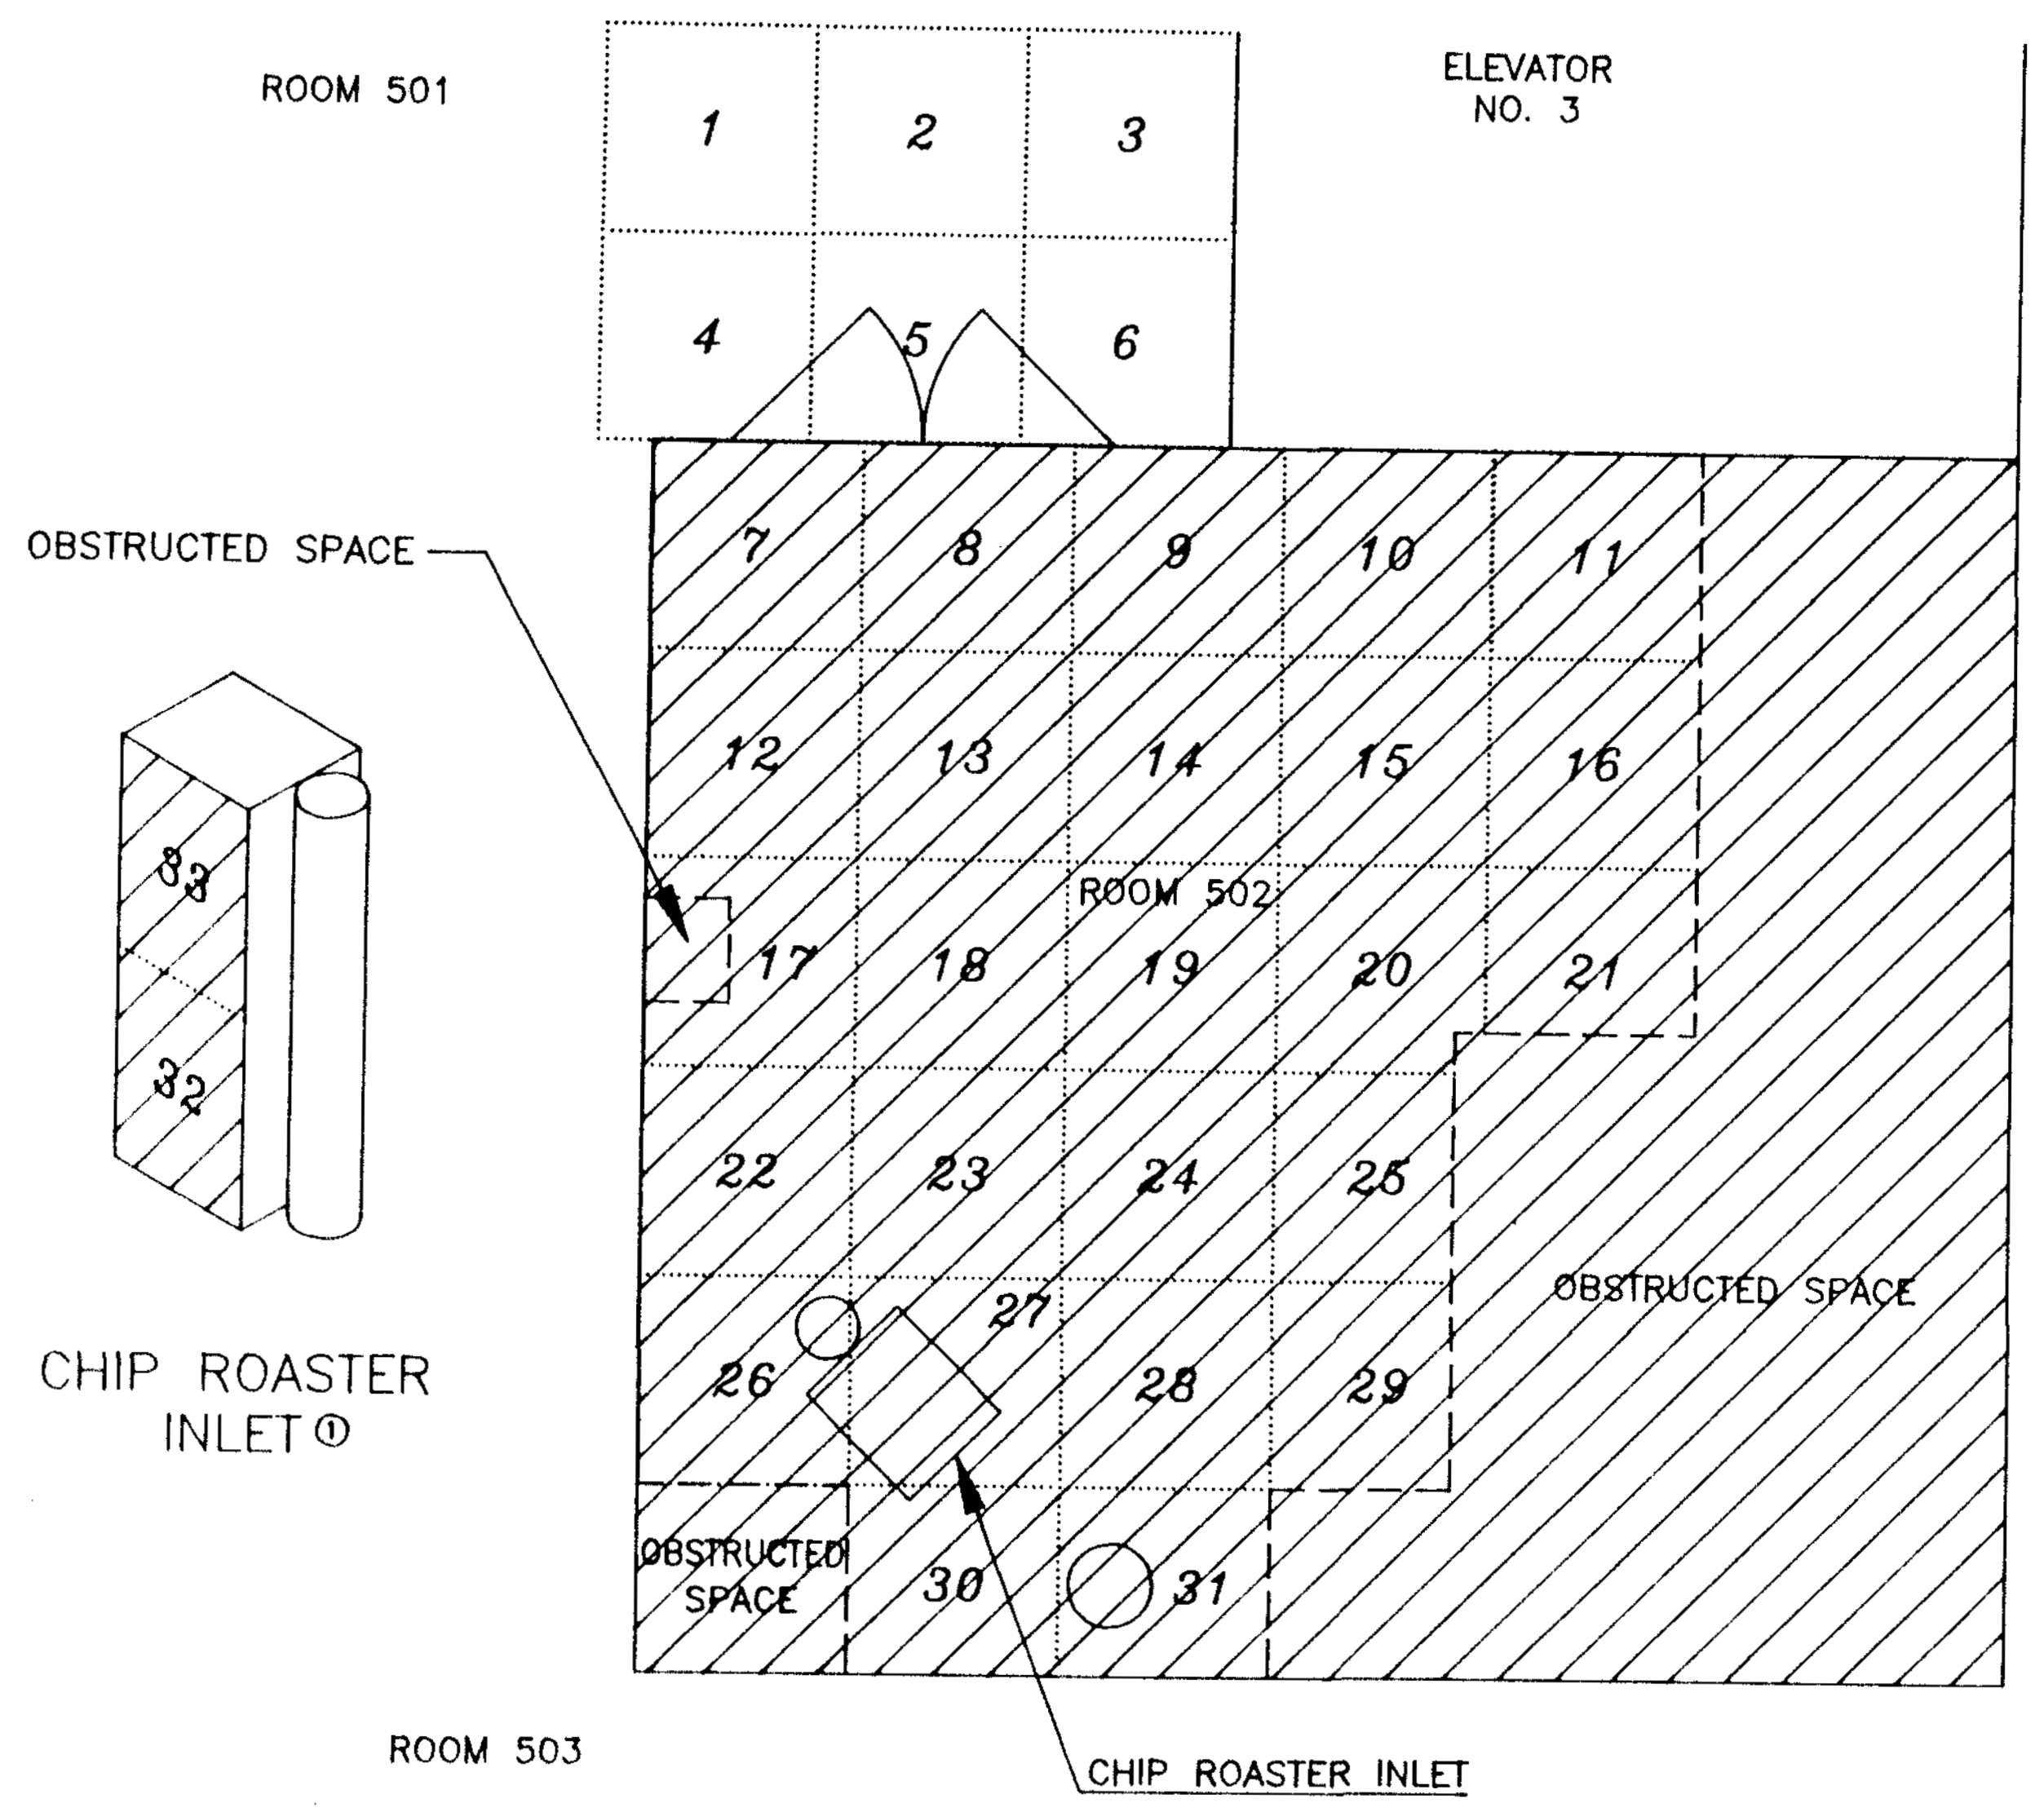
① TWO SMEAR SAMPLES WERE COLLECTED FROM THE SURFACE OF THE CHIP ROASTER INLET.

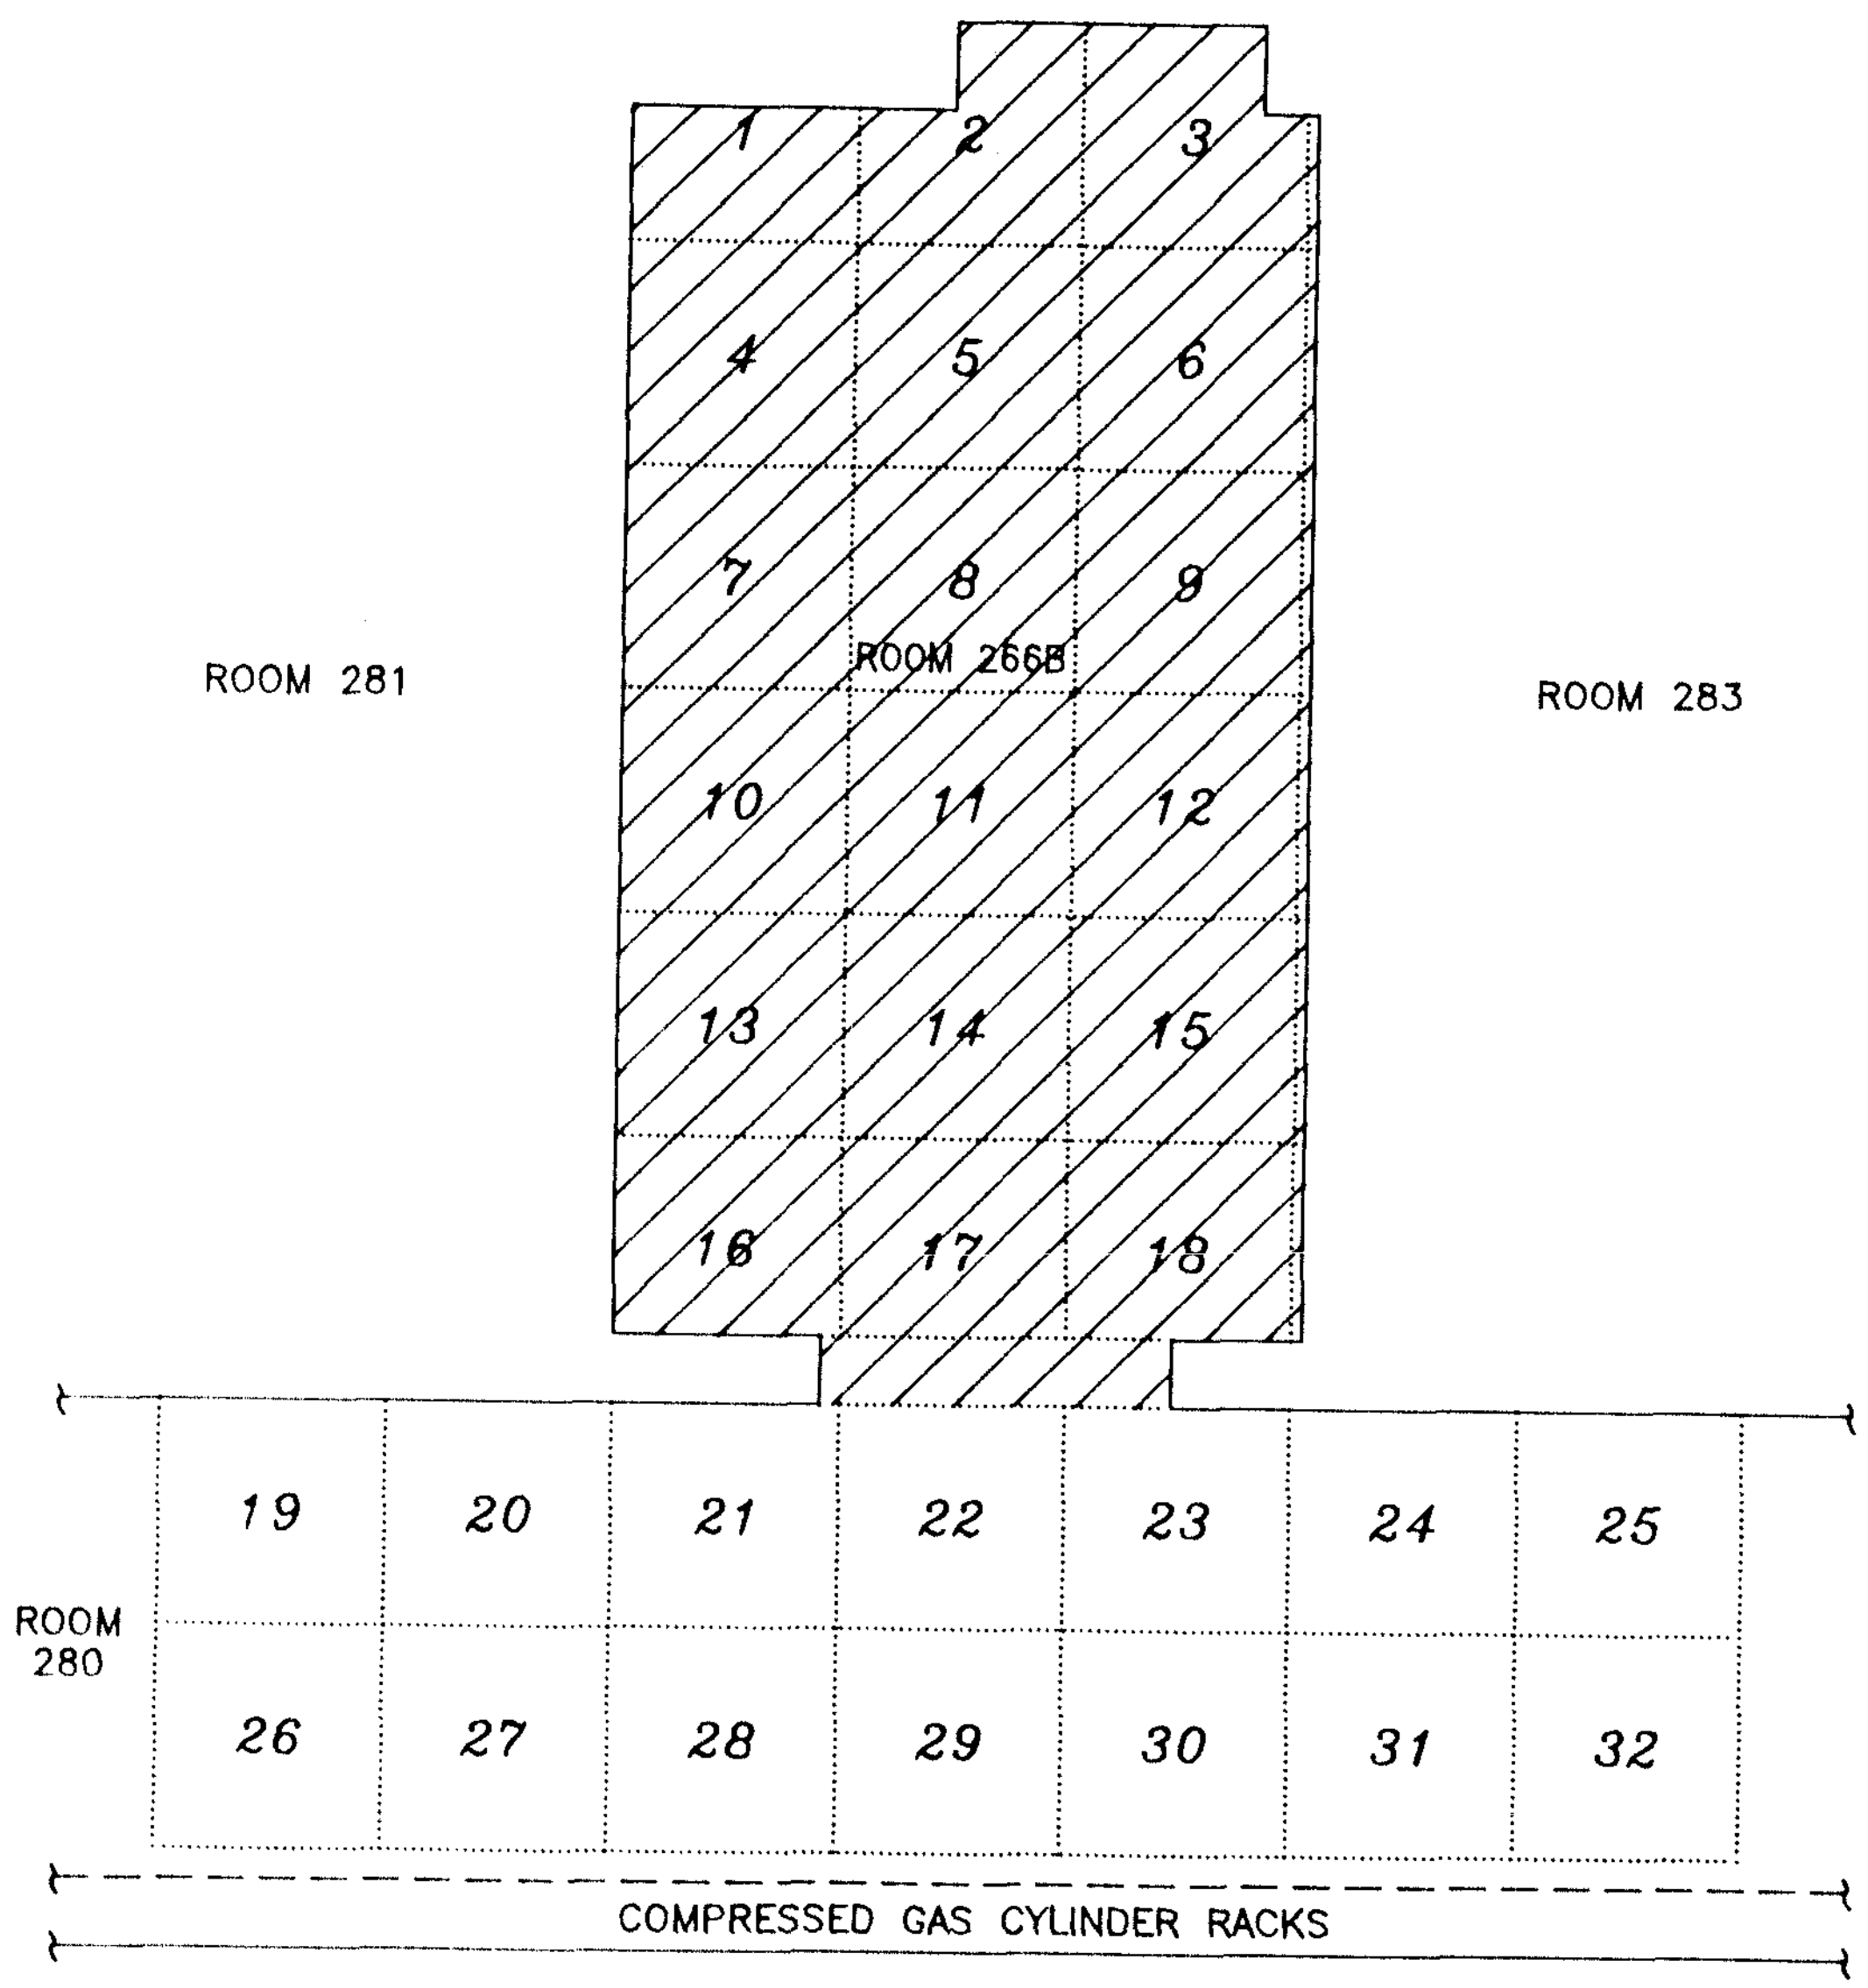
SIZE B | DRAWING NUMBER IHSS 211 | ISSUE A | FIGURE 5-22

The analytical results for the hot water rinsate samples, alpha and beta smear samples, and beta and gamma dose-rate surveys for IHSS 211 are provided in Tables 5-25 through 5-27. Figures 5-22 and 5-23 present the radiological results plotted on drawings of IHSS 211.
