MOUND PLANT
Potential Release Site Package
PRS # 237

PRS 237: Soil Contamination - B Area North of I Bldg.

MOUND PLANT
PRS 237
Soil Contamination B Area North of I Building

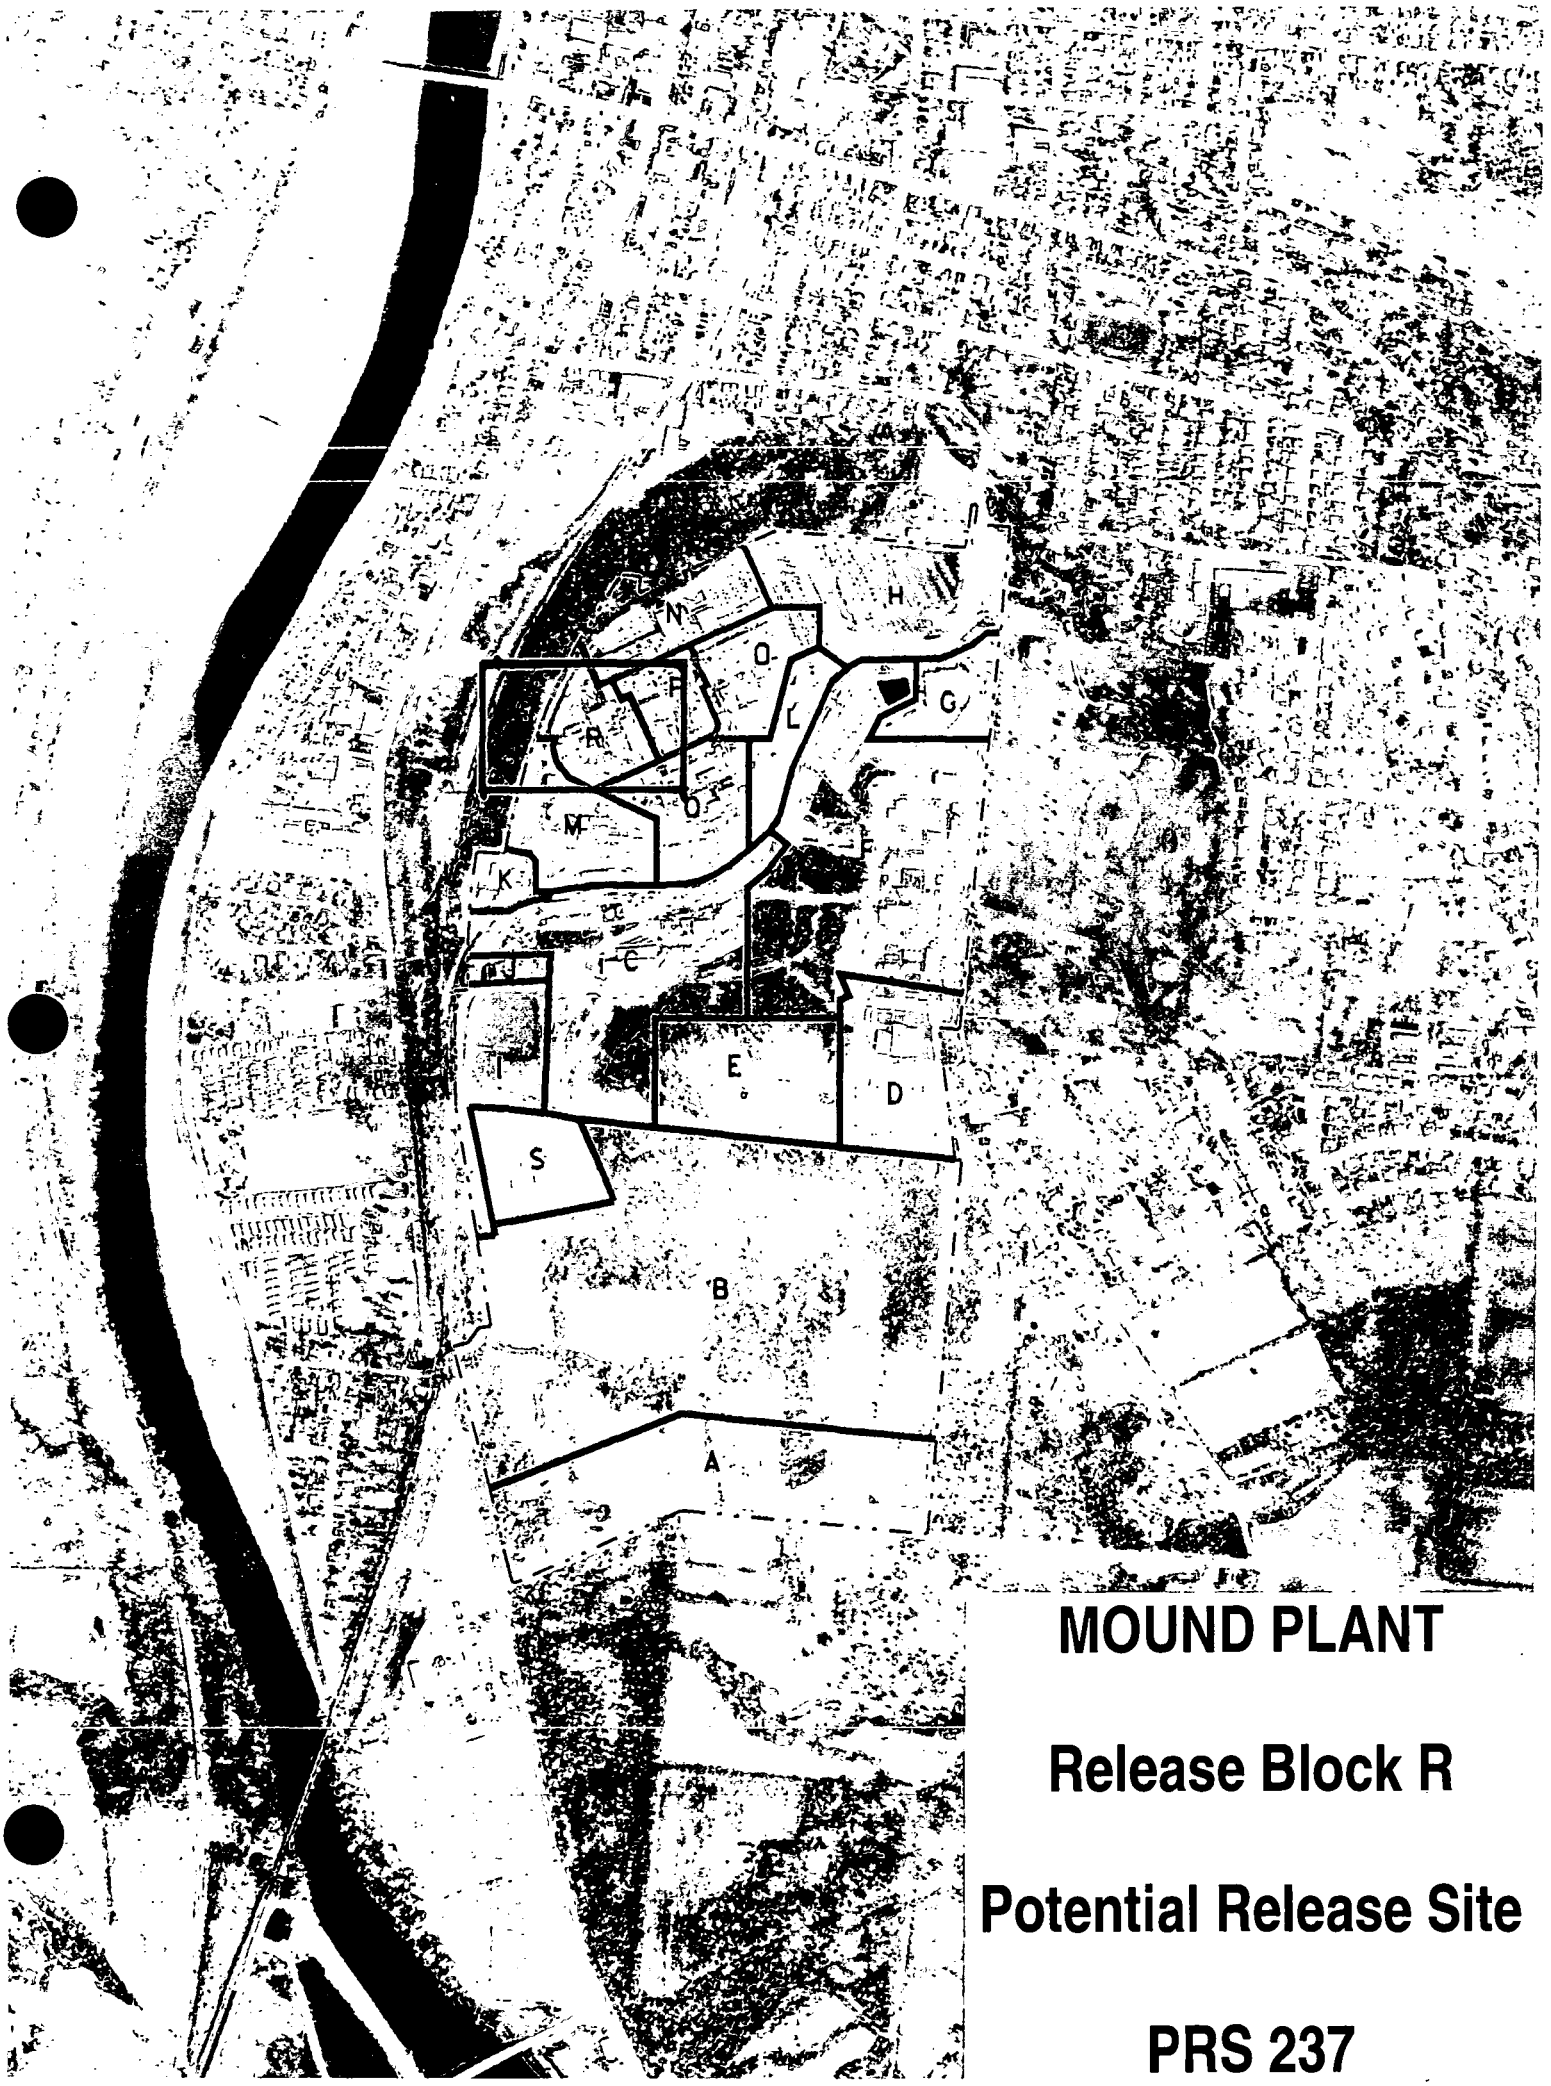
Potential Release Site (PRS) 237 became a PRS due to the elevated detections of cesium-137 and cobalt-60 found during the Site Survey Project.[2] PRS 237 is located approximately 100 feet northwest of I Building.

The Core Team originally recommended Further Assessment for PRS 237. Subsequently, the cost of further investigation versus the cost of removing the potentially contaminated soils was evaluated. Cost estimates indicate that the cost of removal is not significantly greater than the cost of further assessment at PRS 237. Additionally Further Assessment findings may indicate the need for a Response (removal) Action, resulting in costs associated with both Further Assessment and Response Action. Therefore, the Core Team recommends a RESPONSE ACTION as a more cost-effective course of action for PRS 237.
