**MOUND PLANT
POTENTIAL RELEASE
SITE PACKAGE**

**Potential Release Site 99/100:
Area 6, WD Building Filter-Cleaning Waste/Area F, Chromium Trench**

**Potential Release Site Package
PRS # 99/100**

MOUND PLANT
Potential Release Site Package
PRS #99/100
Addendum 1

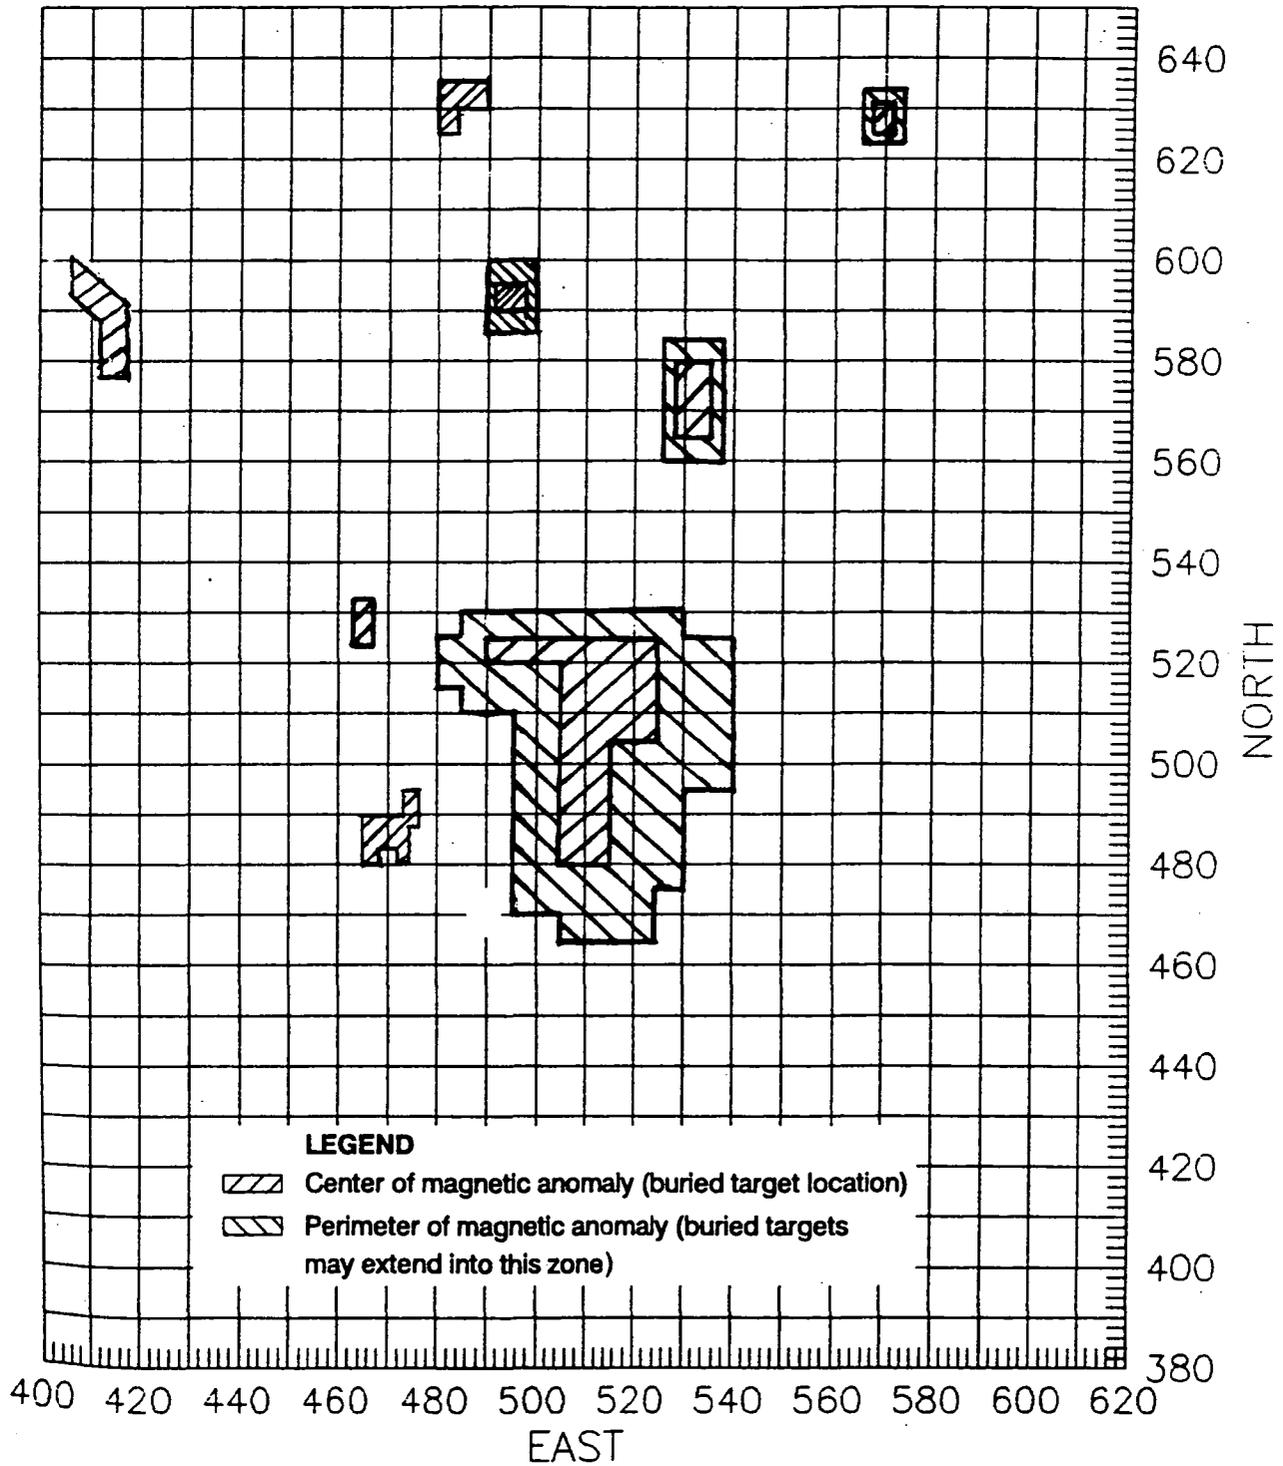
Figure 9. Interpretive map of magnetic anomalies in Area 6.

AREA 6 - Interpreted Magnetic Anomaly Map

Figure 9 is an interpretive map of magnetic anomalies in Area 6. A relatively large anomaly exists between approximately 490 and 525 east and between 480 and 525 north. This anomaly is interpreted to be related to buried ferrous materials beneath the parking lot. Eight additional small anomalies are present throughout the area that are interpreted to represent buried ferrous objects. The interpretive map does not include anomalies that are related to surface cultural features identified in the field. The locations of the centers of the eight areas and the approximate areal coverage of the anomalous zones are listed in Table 1.

^aGeophysical grid coordinates are shown on Figure 9.

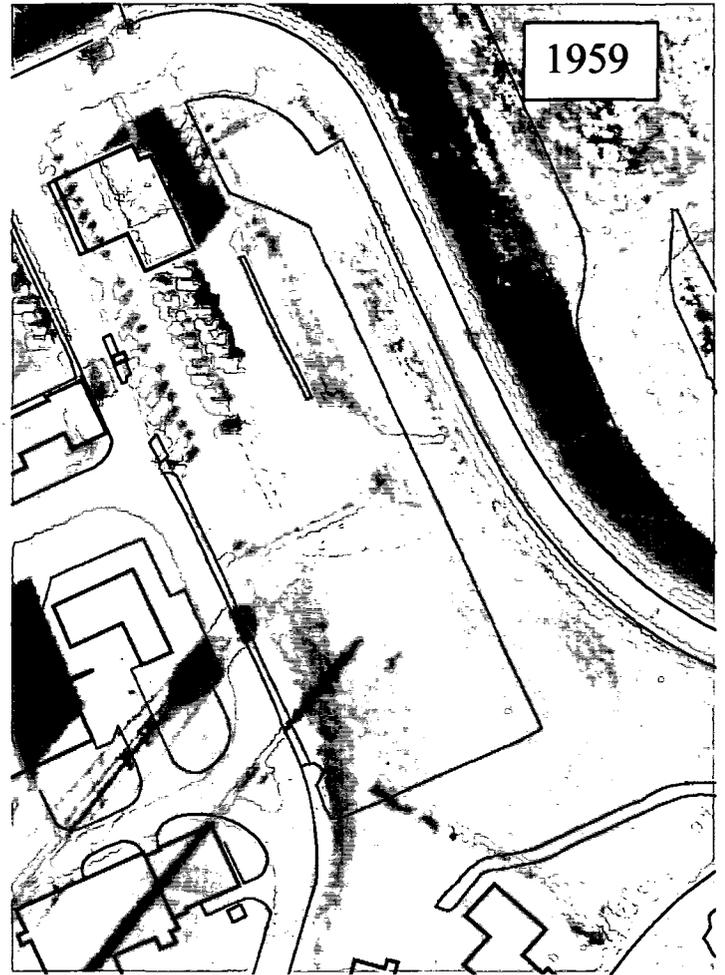
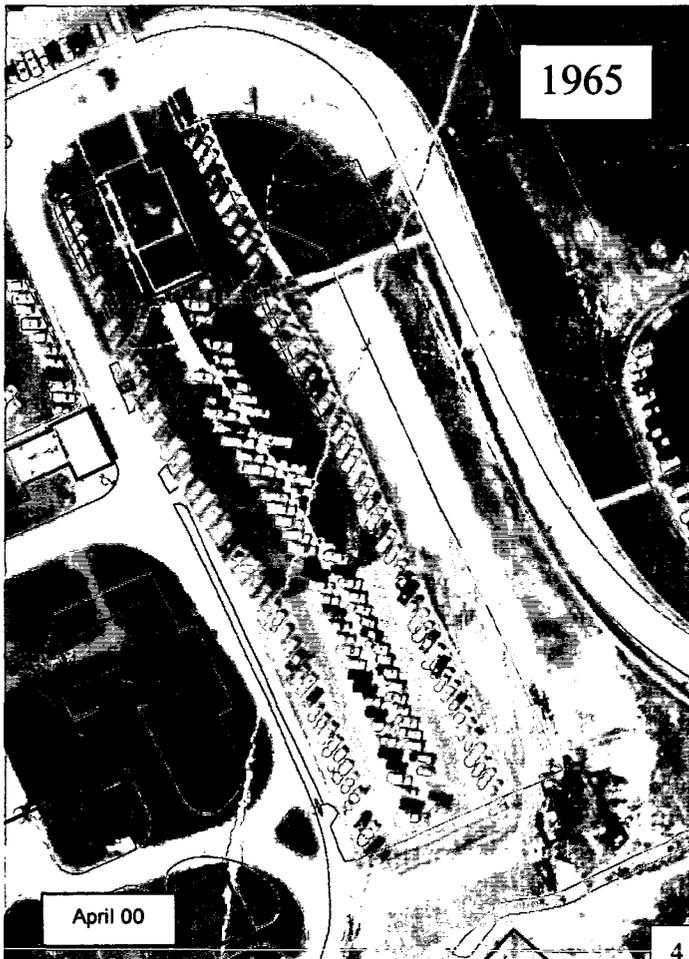
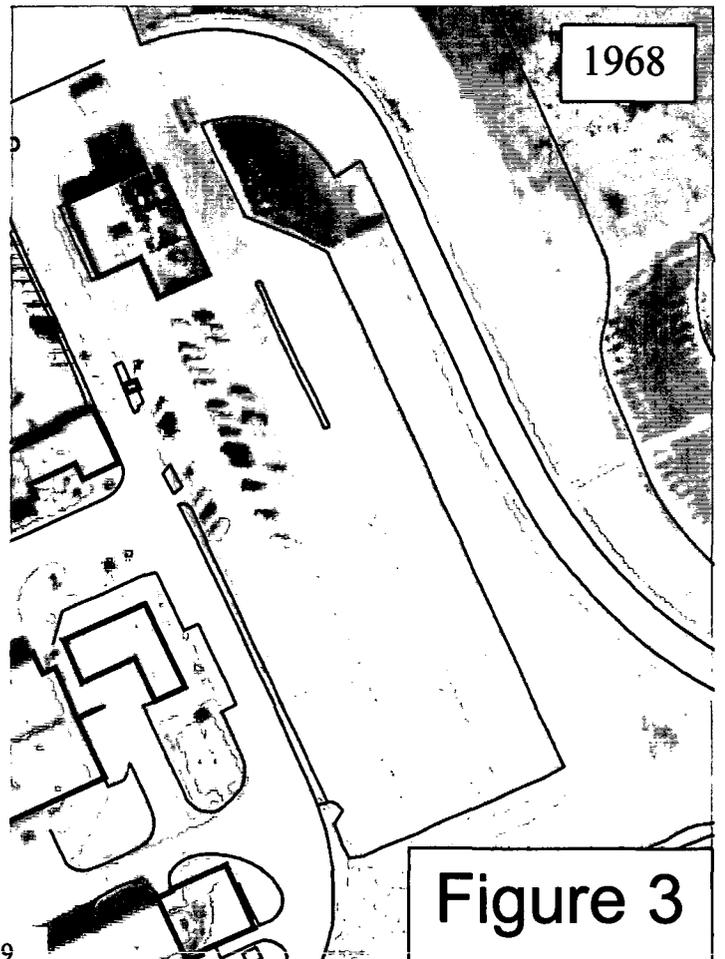
Figure 3

1968 aerial photo

The horizontal extent of the entire area suspected as containing waste (PRS 100) was generated as presented herein based on the reported dates of disposal (1963-64) and the largest area that could have included disposed of material. Aerial photographs dated closest to the reported disposal events in 1963-64 were for 1959 and 1965 (Figure 3). The area encompassed by the GH Lot as photographed in 1959 was not included as a potential release site because it predates the reported disposal period. The area encompassed by the last expansion of the lot (between 1965 and 1968) post-dates the disposal period and was not characterized but was included herein to provide a complete chronology of expansions to the parking lot relative to the disposal period.

The original GH Lot was very small and located northeast of the GH Building, as shown on the 1949 aerial photograph in Figure 3. The 1959 aerial photograph shows the first construction of a

parking lot south of the GH Building. The 1959 parking lot was much shorter and narrower than the current dimensions. Area next to the lot (southeast) was used for waste disposal, but specific location(s) were not documented. In 1963-64, prior to an expansion of the GH Parking Lot, waste was disposed of in a trench(es) dug next to the GH Lot. By 1965, the lot was expanded south to its current length, burying the trench(es). By 1968, the lot was expanded to its current width.
