Main Hill Project

CLOSE OUT REPORT

Demolition of PS Building (Phase I)

MOUND PLANT

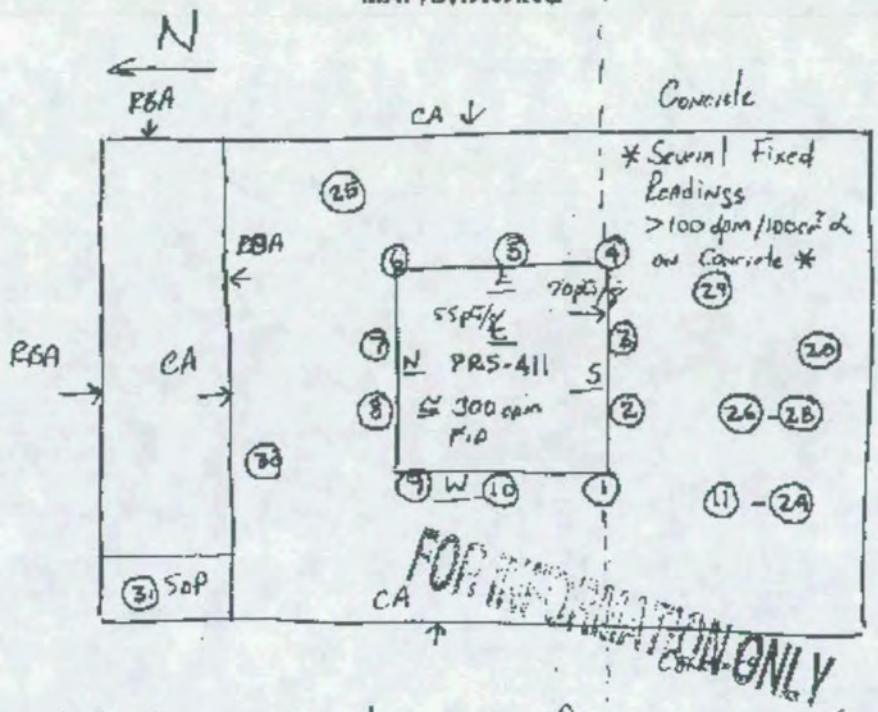
MAP/DRAWING

LOCATION: (BLDG./AREA/ROOM) PAINT SHOP (PRS 411)	SURVEY NO. 99-LS-088
PURPOSE: F.C.A. REMOVAL Contamination Survey	RWP NO. LS-010-99
	DATE: 05/11/99
	TIME: 1000

Direct Reading on Asphalt
(< 100 dpm/100cm² α)
(< 5000 dpm/100cm² β-γ)

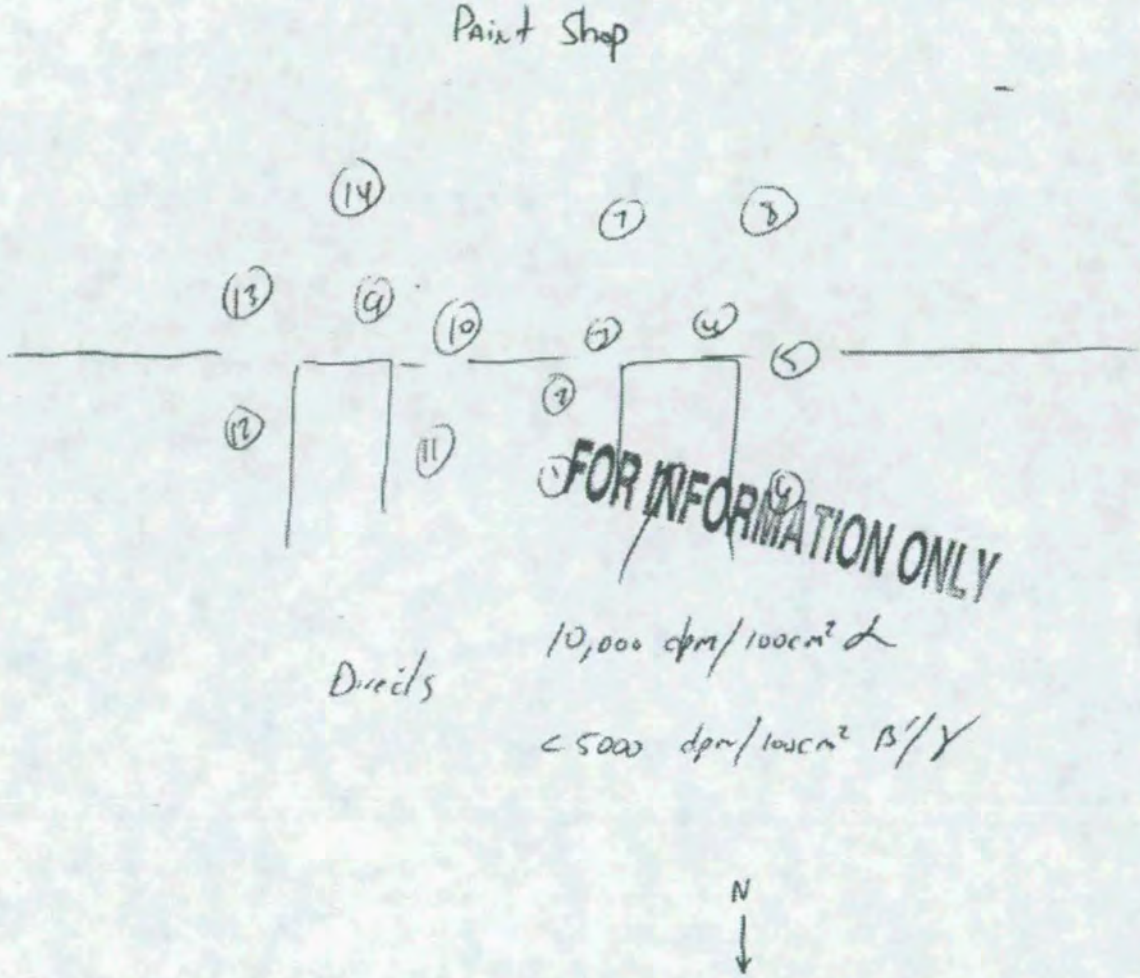
MAP/DRAWING

LOCATION: (BLDG/AREA/ROOM) PS Bldg	SURVEY NO. 99-CS-79
PURPOSE: Contamination Survey	RWP NO. CS-009-99
	DATE: 4/28/99
	TIME: 1200

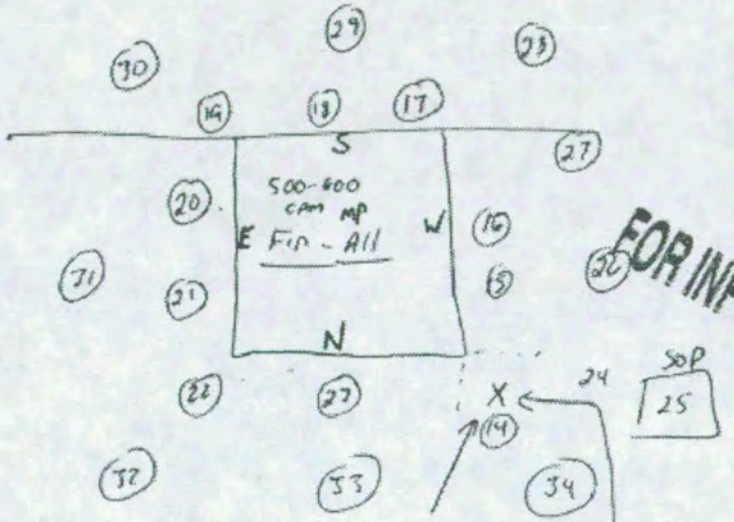
MAP/DRAWING

LOCATION: (BLDG./AREA/ROOM) Paint Shop	SURVEY NO. 99-LS-084
PURPOSE: Release Items + Concrete	RWP NO. LS-011-99
	DATE: 5/4/99
Contamination Survey	TIME: 1400

Directs 350 dpm/100cm² α - <5000 dpm/100cm² β/γ
60,000 cpm F.D
