# MOUND PLANT

## Potential Release Site Package

### PRS # 405

**MOUND PLANT  
PRS 405  
Soil Contamination – Building 23**

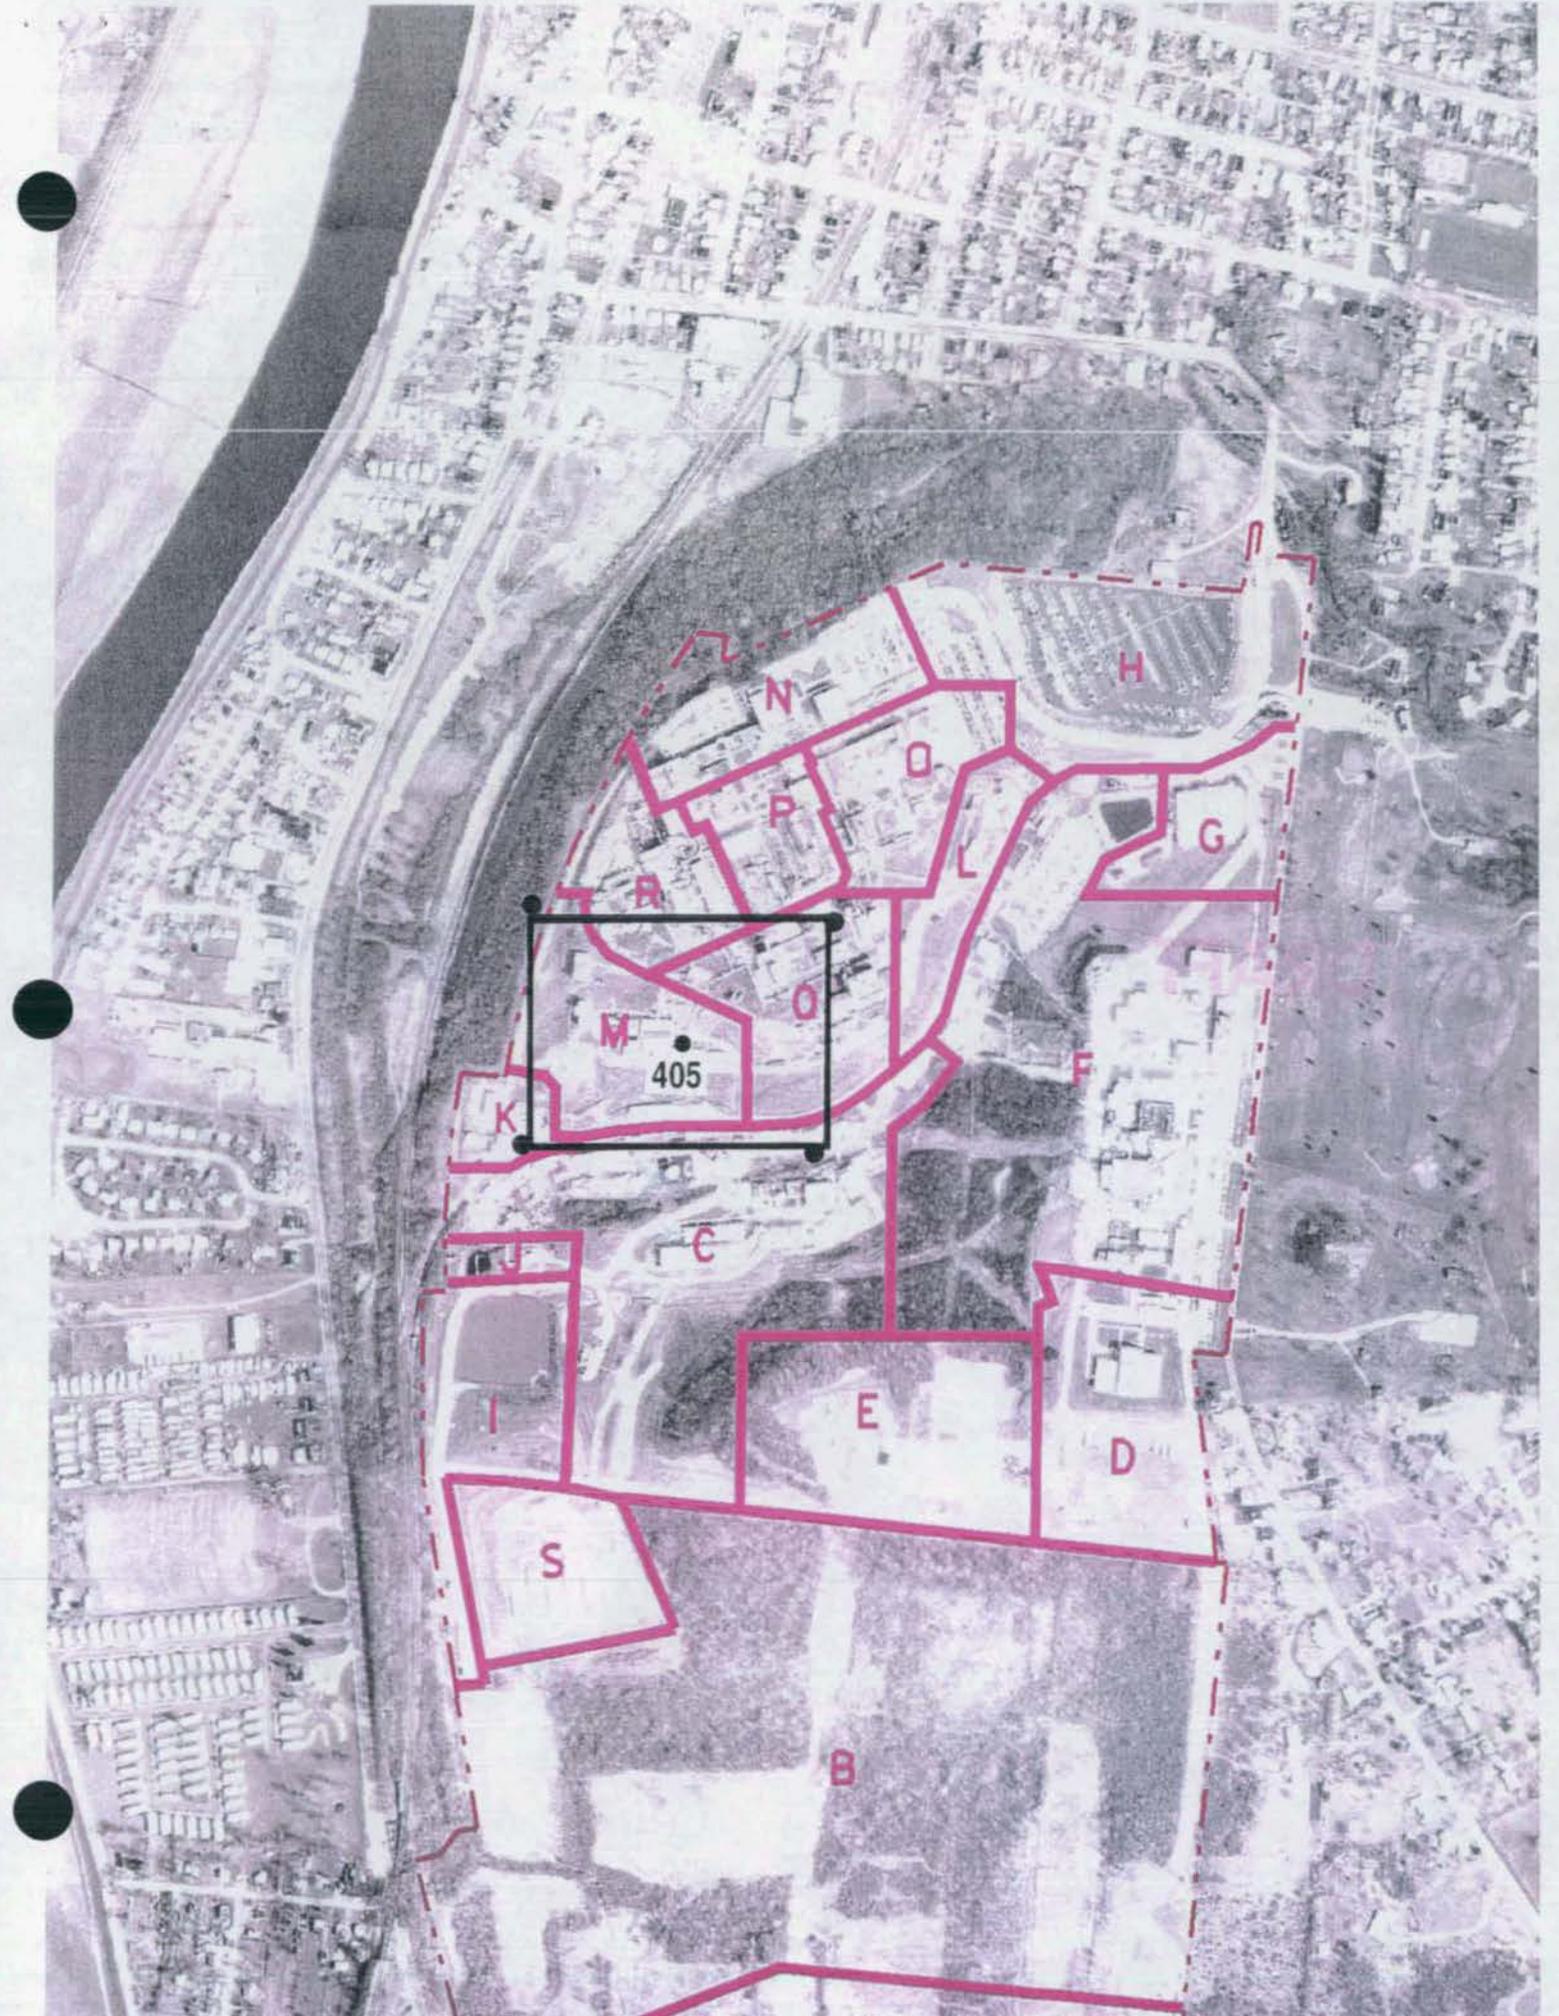
**PRS 405**

**MOUND PLANT**

**Release Block M**

**Potential Release Site**

Potential Release Site (PRS) 405 is a soil area located approximately 5 feet north of Building 23 (Waste Management Facility) at the east end of that building. PRS 405 was identified during construction activities in June 1994.<sup>2</sup> The contaminant of concern during construction was an oily substance.

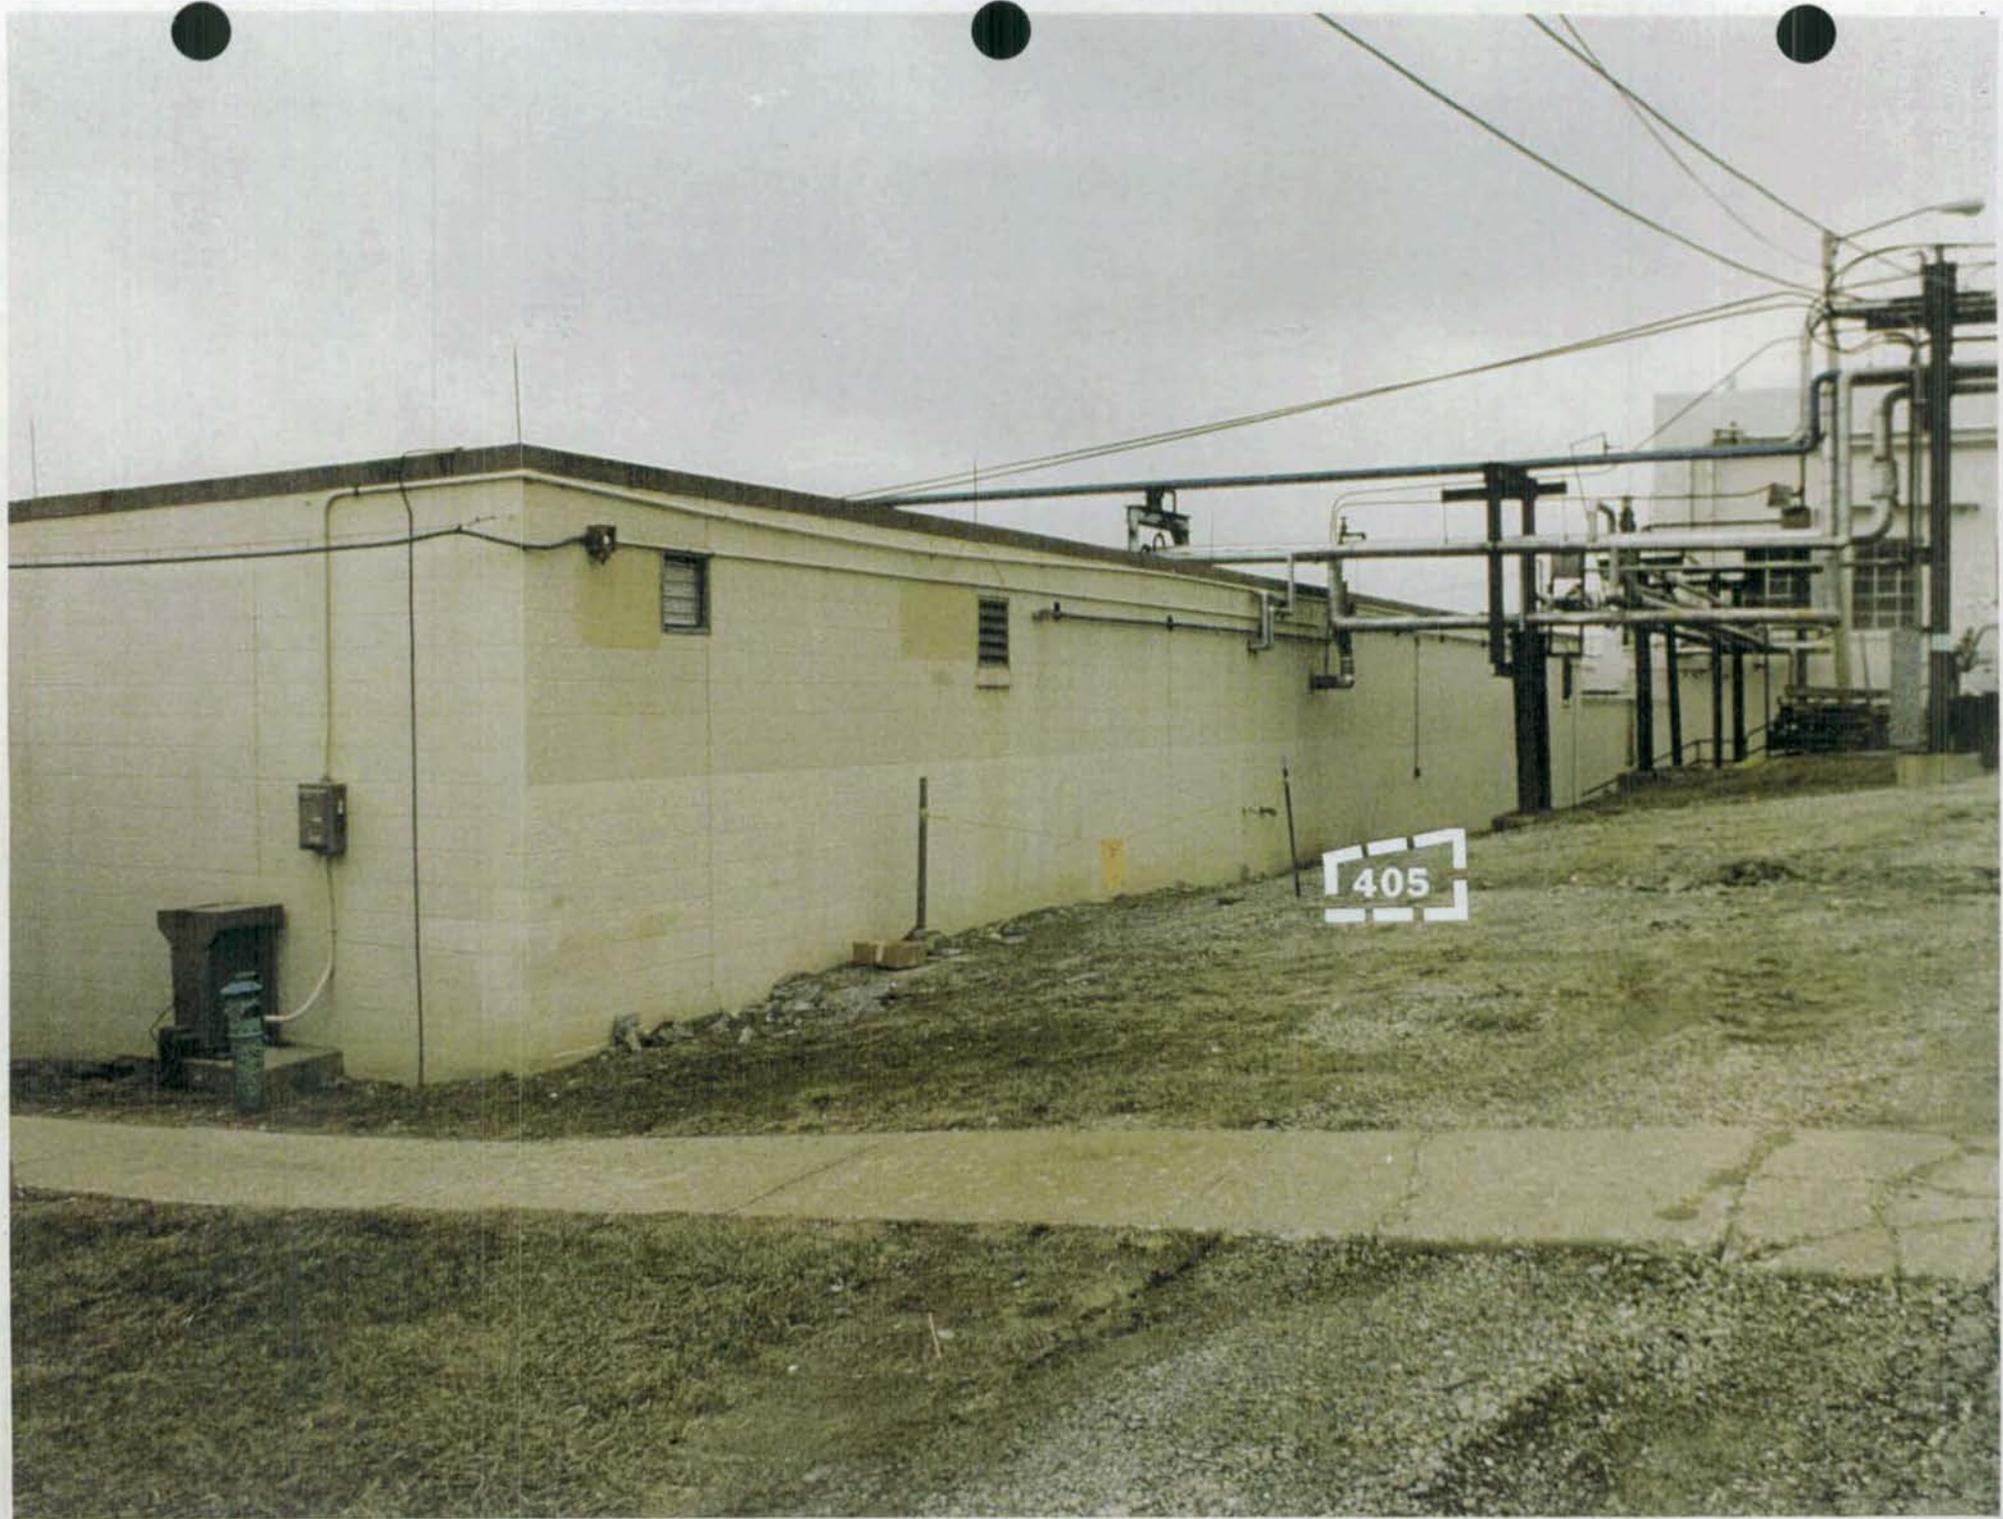
# Mound Plant

## Release Block M

Potential Release Site

### PRS 405
