RF/RMRS-96-0071

**Reconnaissance Level Characterization Report
For The 779 Cluster**

October 1997

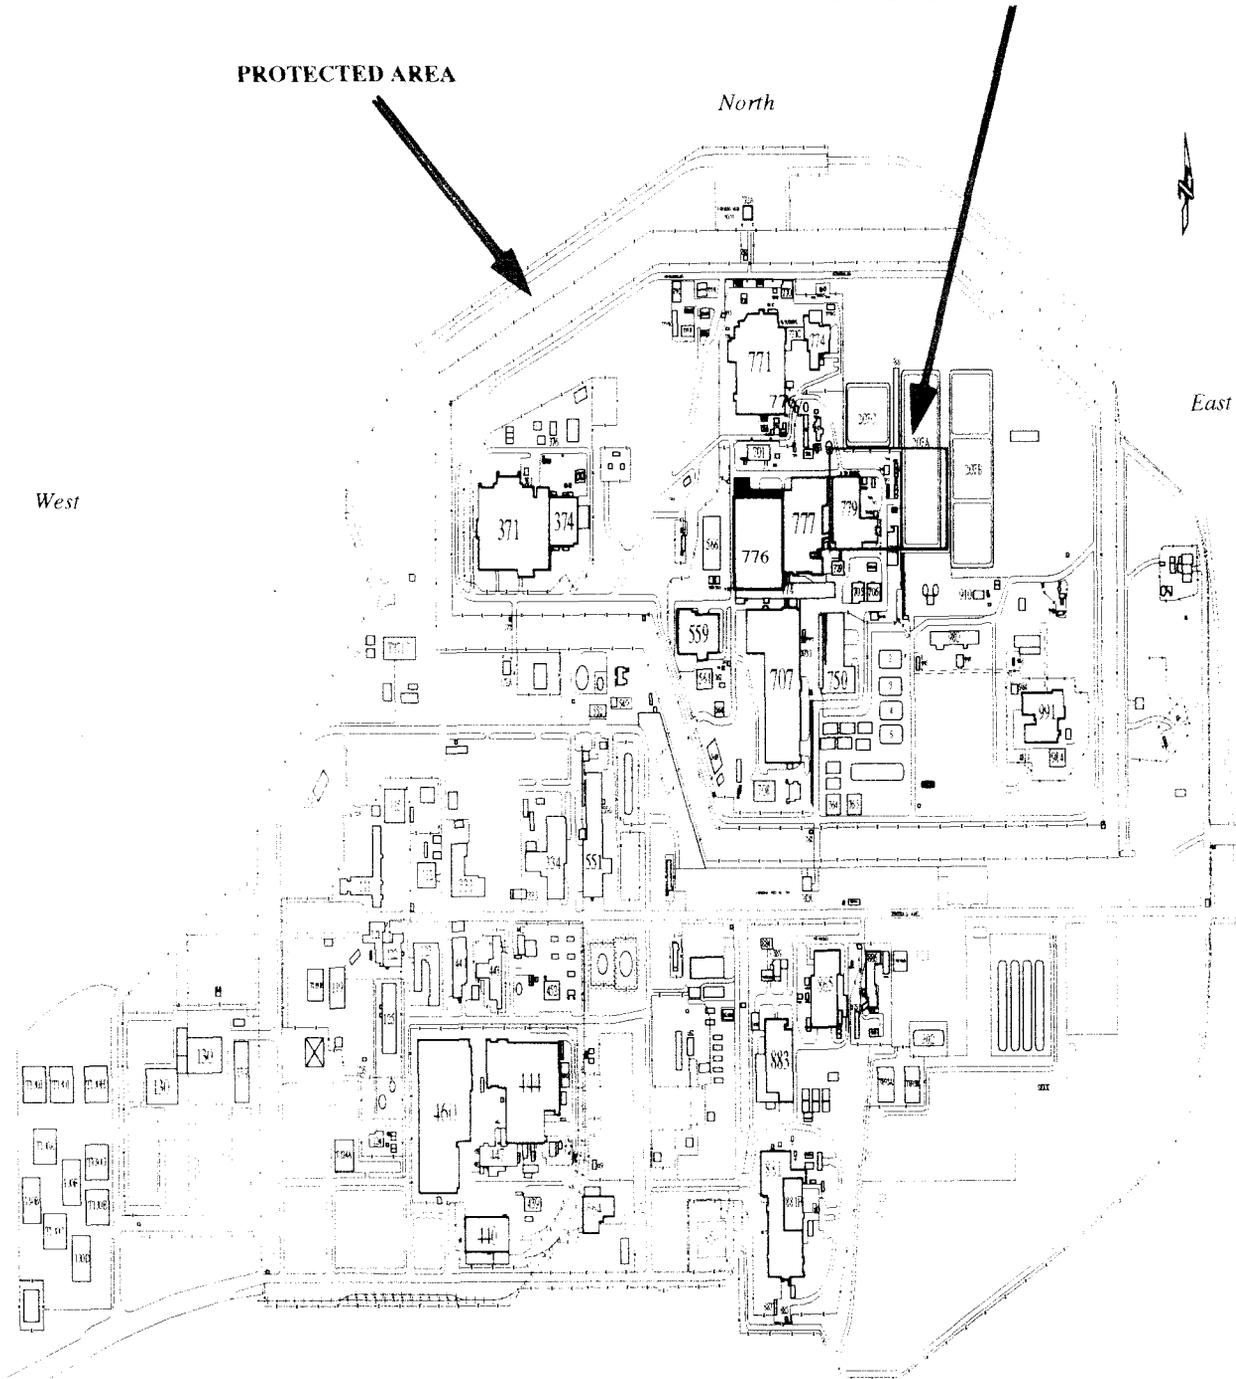
This report is prepared in support of the Building 779 Cluster characterization and decommissioning for the DOE at the RFETS located near Golden, Colorado. Figure 1-1 shows the location of the Building 779 Cluster facilities.

Due to the change in mission of the RFETS from the production of nuclear components to environmental cleanup and shutdown, Building 779 and its associated facilities have no identified mission after FY96. Therefore, the 779 Cluster is being decommissioned to reduce operating costs and to eliminate hazards within the Cluster's buildings. The 779 Cluster consists of Buildings 727, 729, 779, 780, 780A, 780B, 782, and 783 through 787 in the RFETS Protected Area (PA) (see Figure 1-1).
