TRANSMITTAL OF RESPONSE TO COLORADO DEPARTMENT OF HEALTH AND ENVIRONMENT (CDPHE) ADDITIONAL COMMENTS OF DECOMMISSIONING CLOSEOUT REPORT FOR THE 881 CLOSURE PROJECT – DWF-105-05

Enclosed are the responses to CDPHE additional comments on the Final Decommissioning Closeout Report for the 881 Closure Project. Also enclosed are five color copies of revised drawings to accompany copied reports.

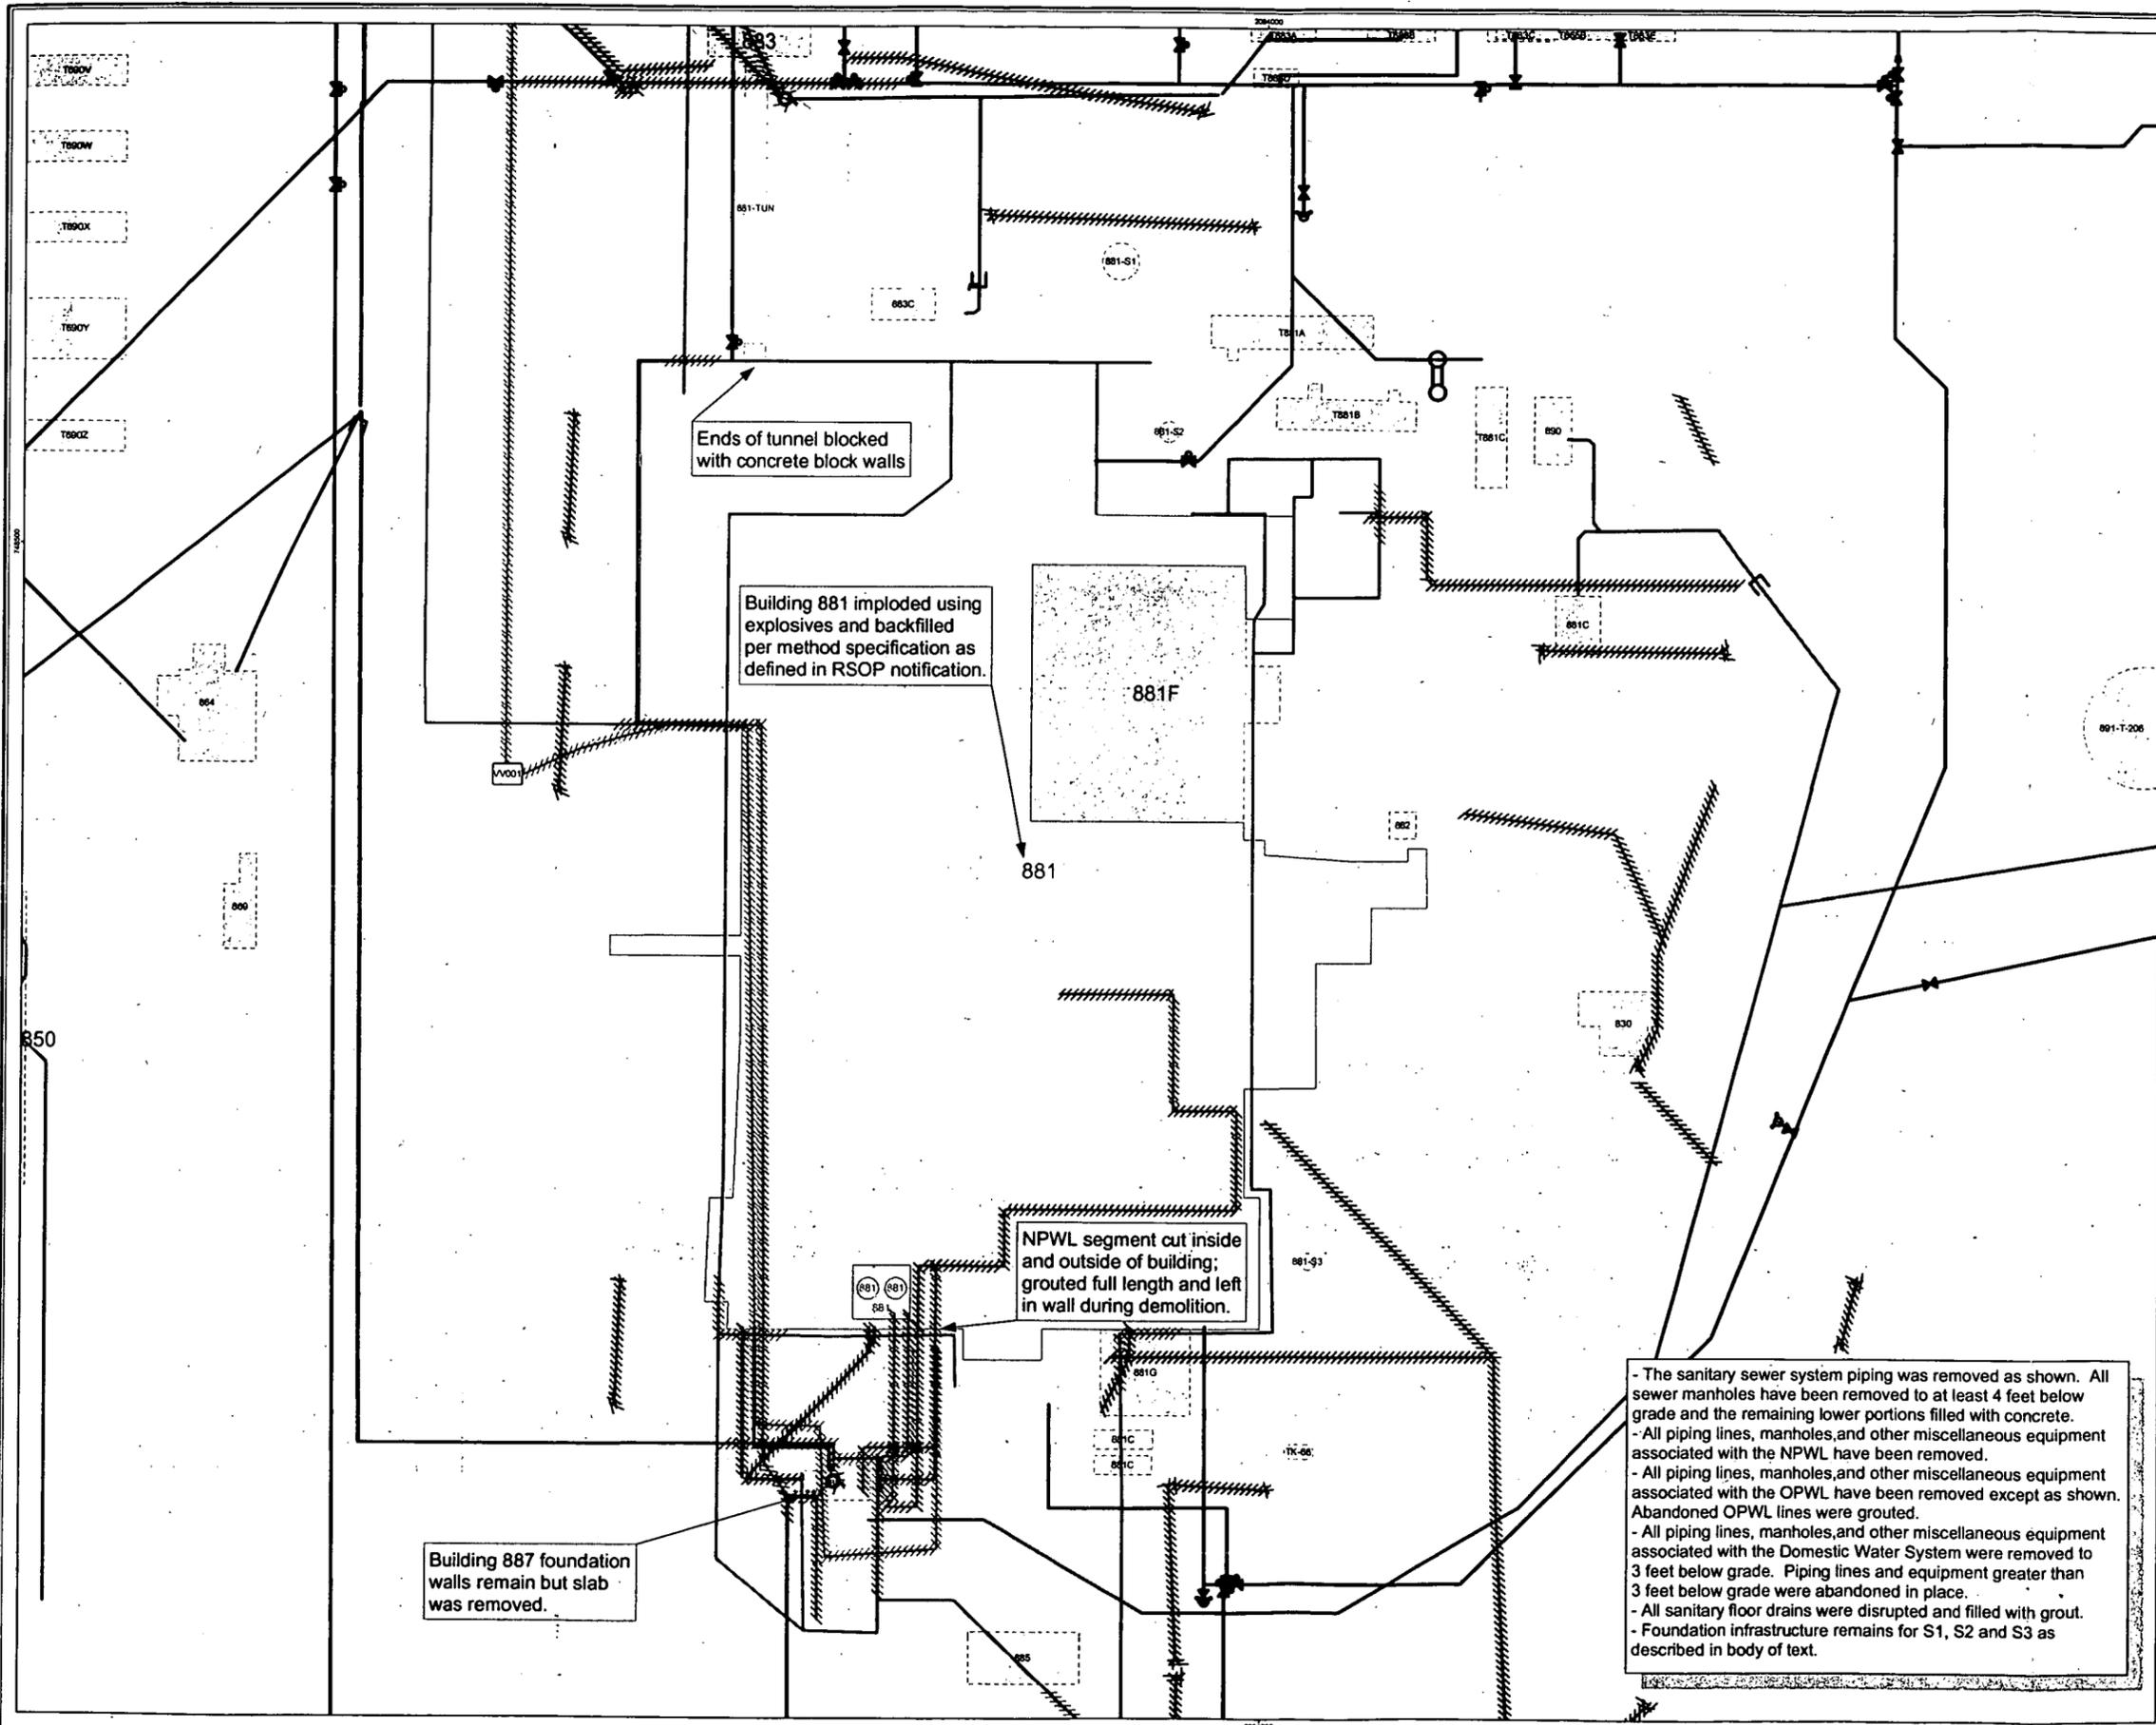
## Standard Map Features

- Remaining Structure
- Removed Structure

- The sanitary sewer system piping was removed as shown. All sewer manholes have been removed to at least 4 feet below grade and the remaining lower portions filled with concrete.  
 - All piping lines, manholes, and other miscellaneous equipment associated with the NPWL have been removed.  
 - All piping lines, manholes, and other miscellaneous equipment associated with the OPWL have been removed except as shown. Abandoned OPWL lines were grouted.  
 - All piping lines, manholes, and other miscellaneous equipment associated with the Domestic Water System were removed to 3 feet below grade. Piping lines and equipment greater than 3 feet below grade were abandoned in place.  
 - All sanitary floor drains were disrupted and filled with grout.  
 - Foundation infrastructure remains for S1, S2 and S3 as described in body of text.

The drawing has been modified to note the remaining foundation walls at B887.

- The boiler tunnel and stack foundation located in the basement was completely backfilled prior to demolition.
- The first floor exhaust stack (S1) tunnel and foundation were left in place. The entrance to the tunnel was blocked with cinder block inside the building, and the stack was demolished to greater than three feet below grade and the remaining infrastructure was backfilled.
- The second floor exhaust stack tunnel (S2) and foundation were left in place. The entrance to the tunnels was blocked with cinder block inside the building, and the stack was demolished to greater than three feet below grade and the remaining infrastructure was backfilled.
- Second floor vaults were left in place. The entrance to the vaults was blocked with cinder block inside the building.
- The tunnel from B881 to B883 was blocked at both ends with cinder block and left in place.

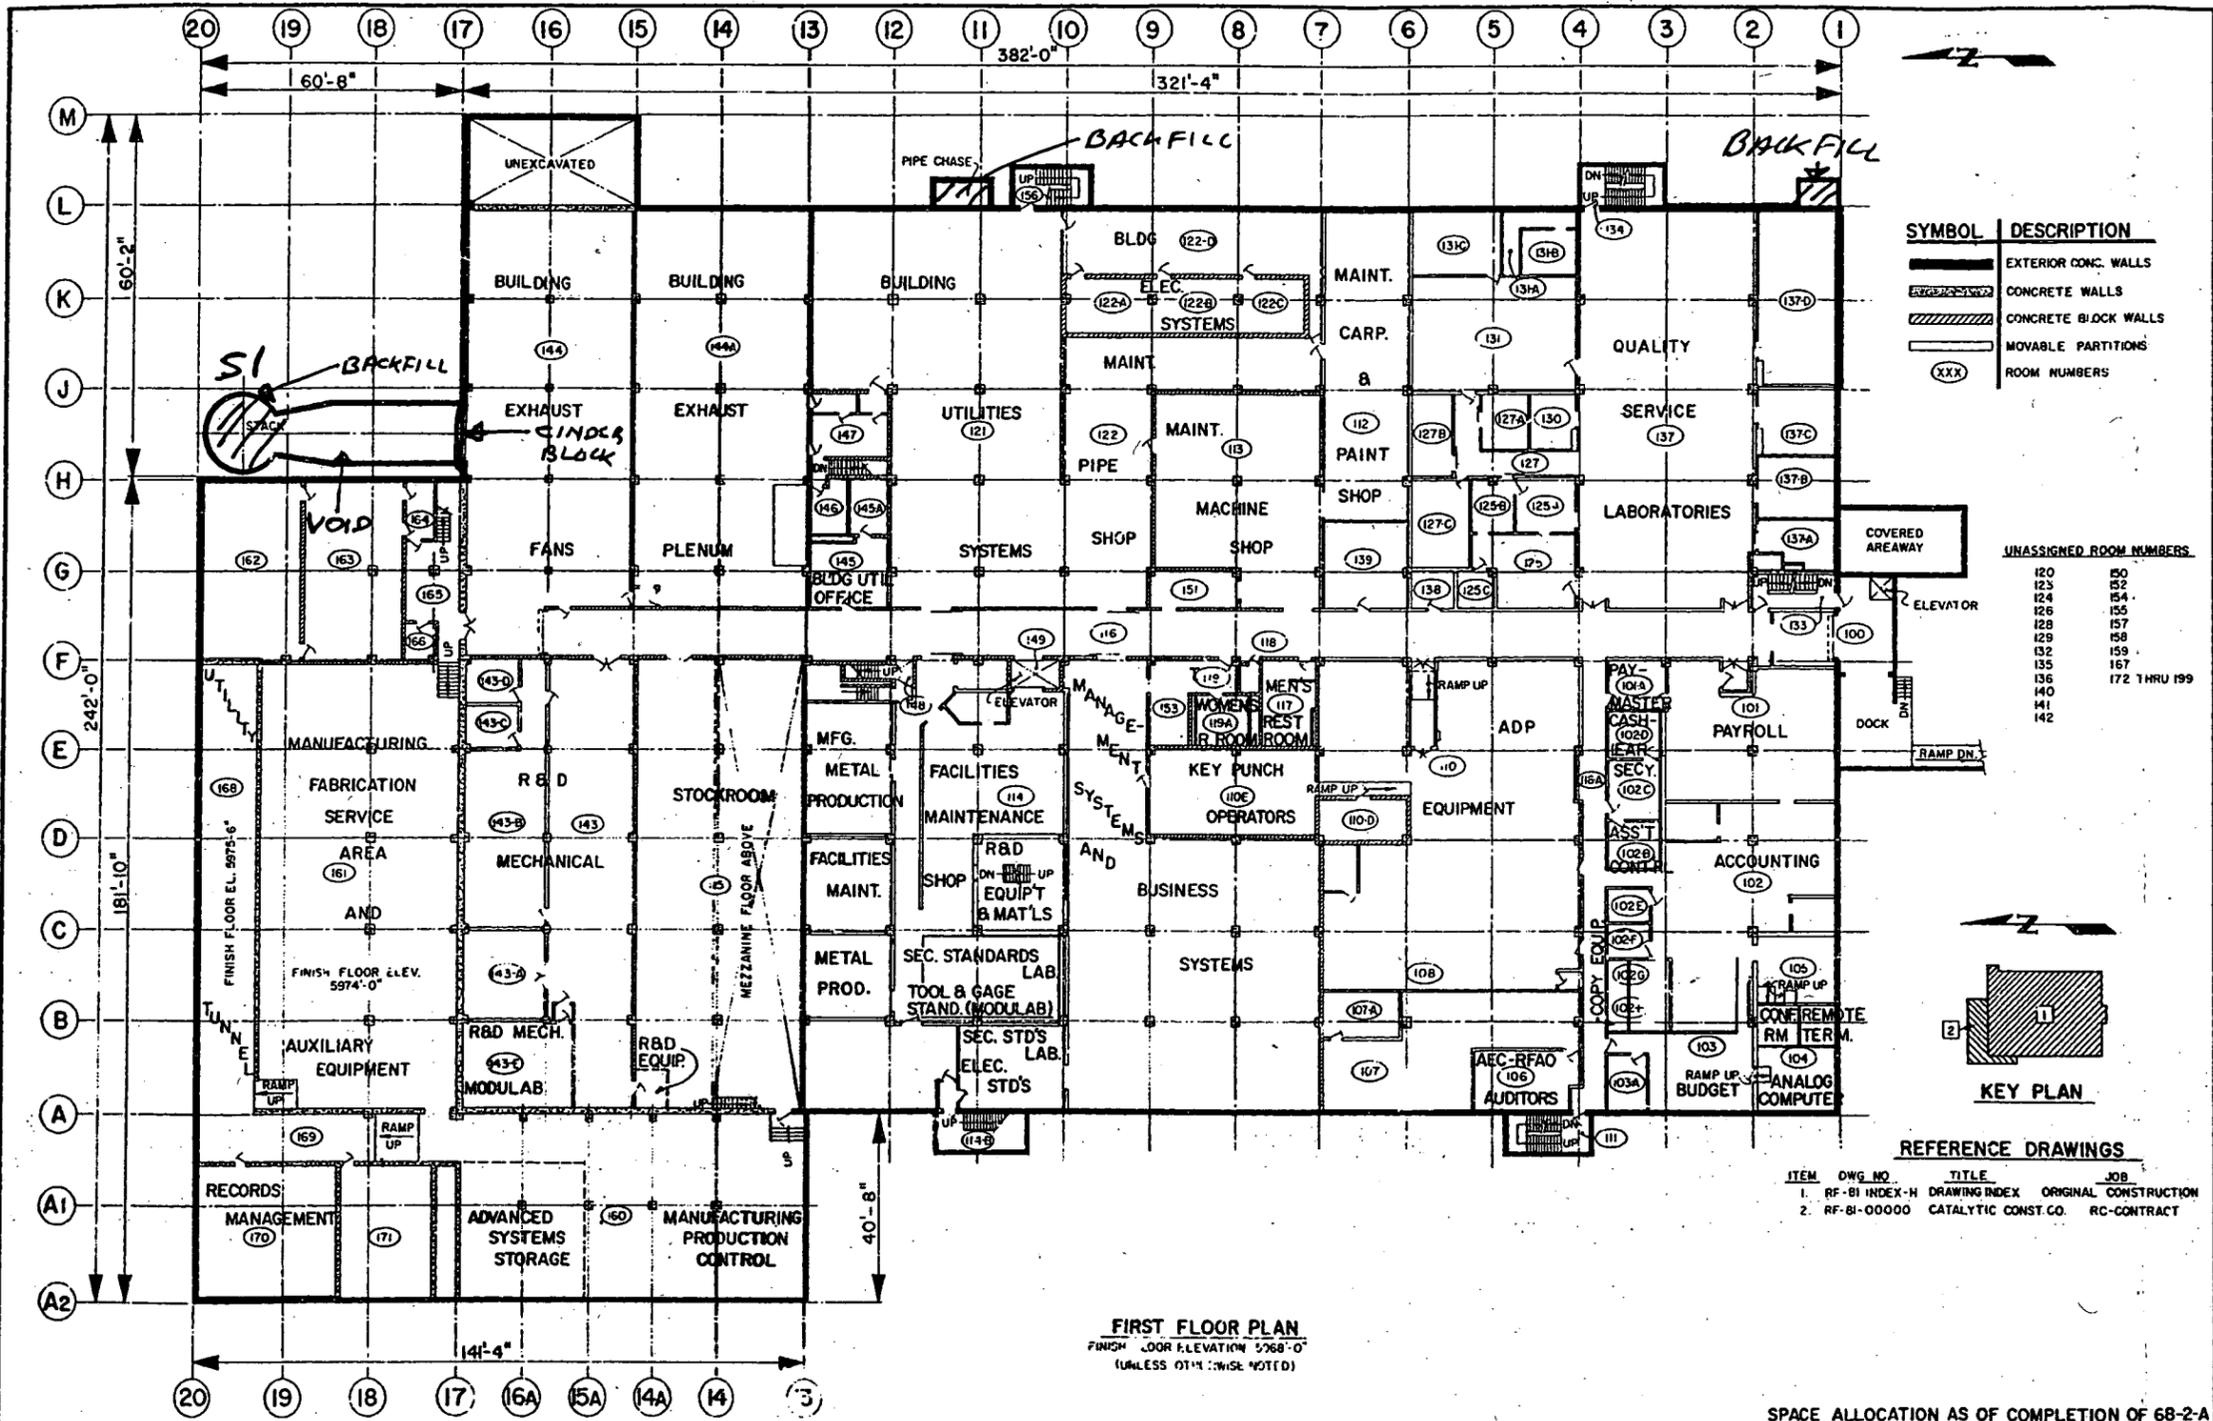
<b>REVISIONS</b> B REDRAWN & RENUMBERED 10-25-68 ACC BY [Signature]		WAC 10-68 O.C.C. 10-24-68	THE DOW CHEMICAL COMPANY 1100 CANTON ST., CANTON, OHIO 44705	BUILDING 881 FIRST FLOOR PLAN	SHEET NO. 18181-1
--	--	------------------------------	---	----------------------------------	-------------------

SYMBOL	DESCRIPTION
(Solid line)	EXTERIOR CONC. WALLS
(Dashed line)	CONCRETE WALLS
(Hatched pattern)	CONCRETE BLOCK WALLS
(Thin solid line)	MOVABLE PARTITIONS
(XXX)	ROOM NUMBERS

SPACE ALLOCATION AS OF COMPLETION OF 68-2-A

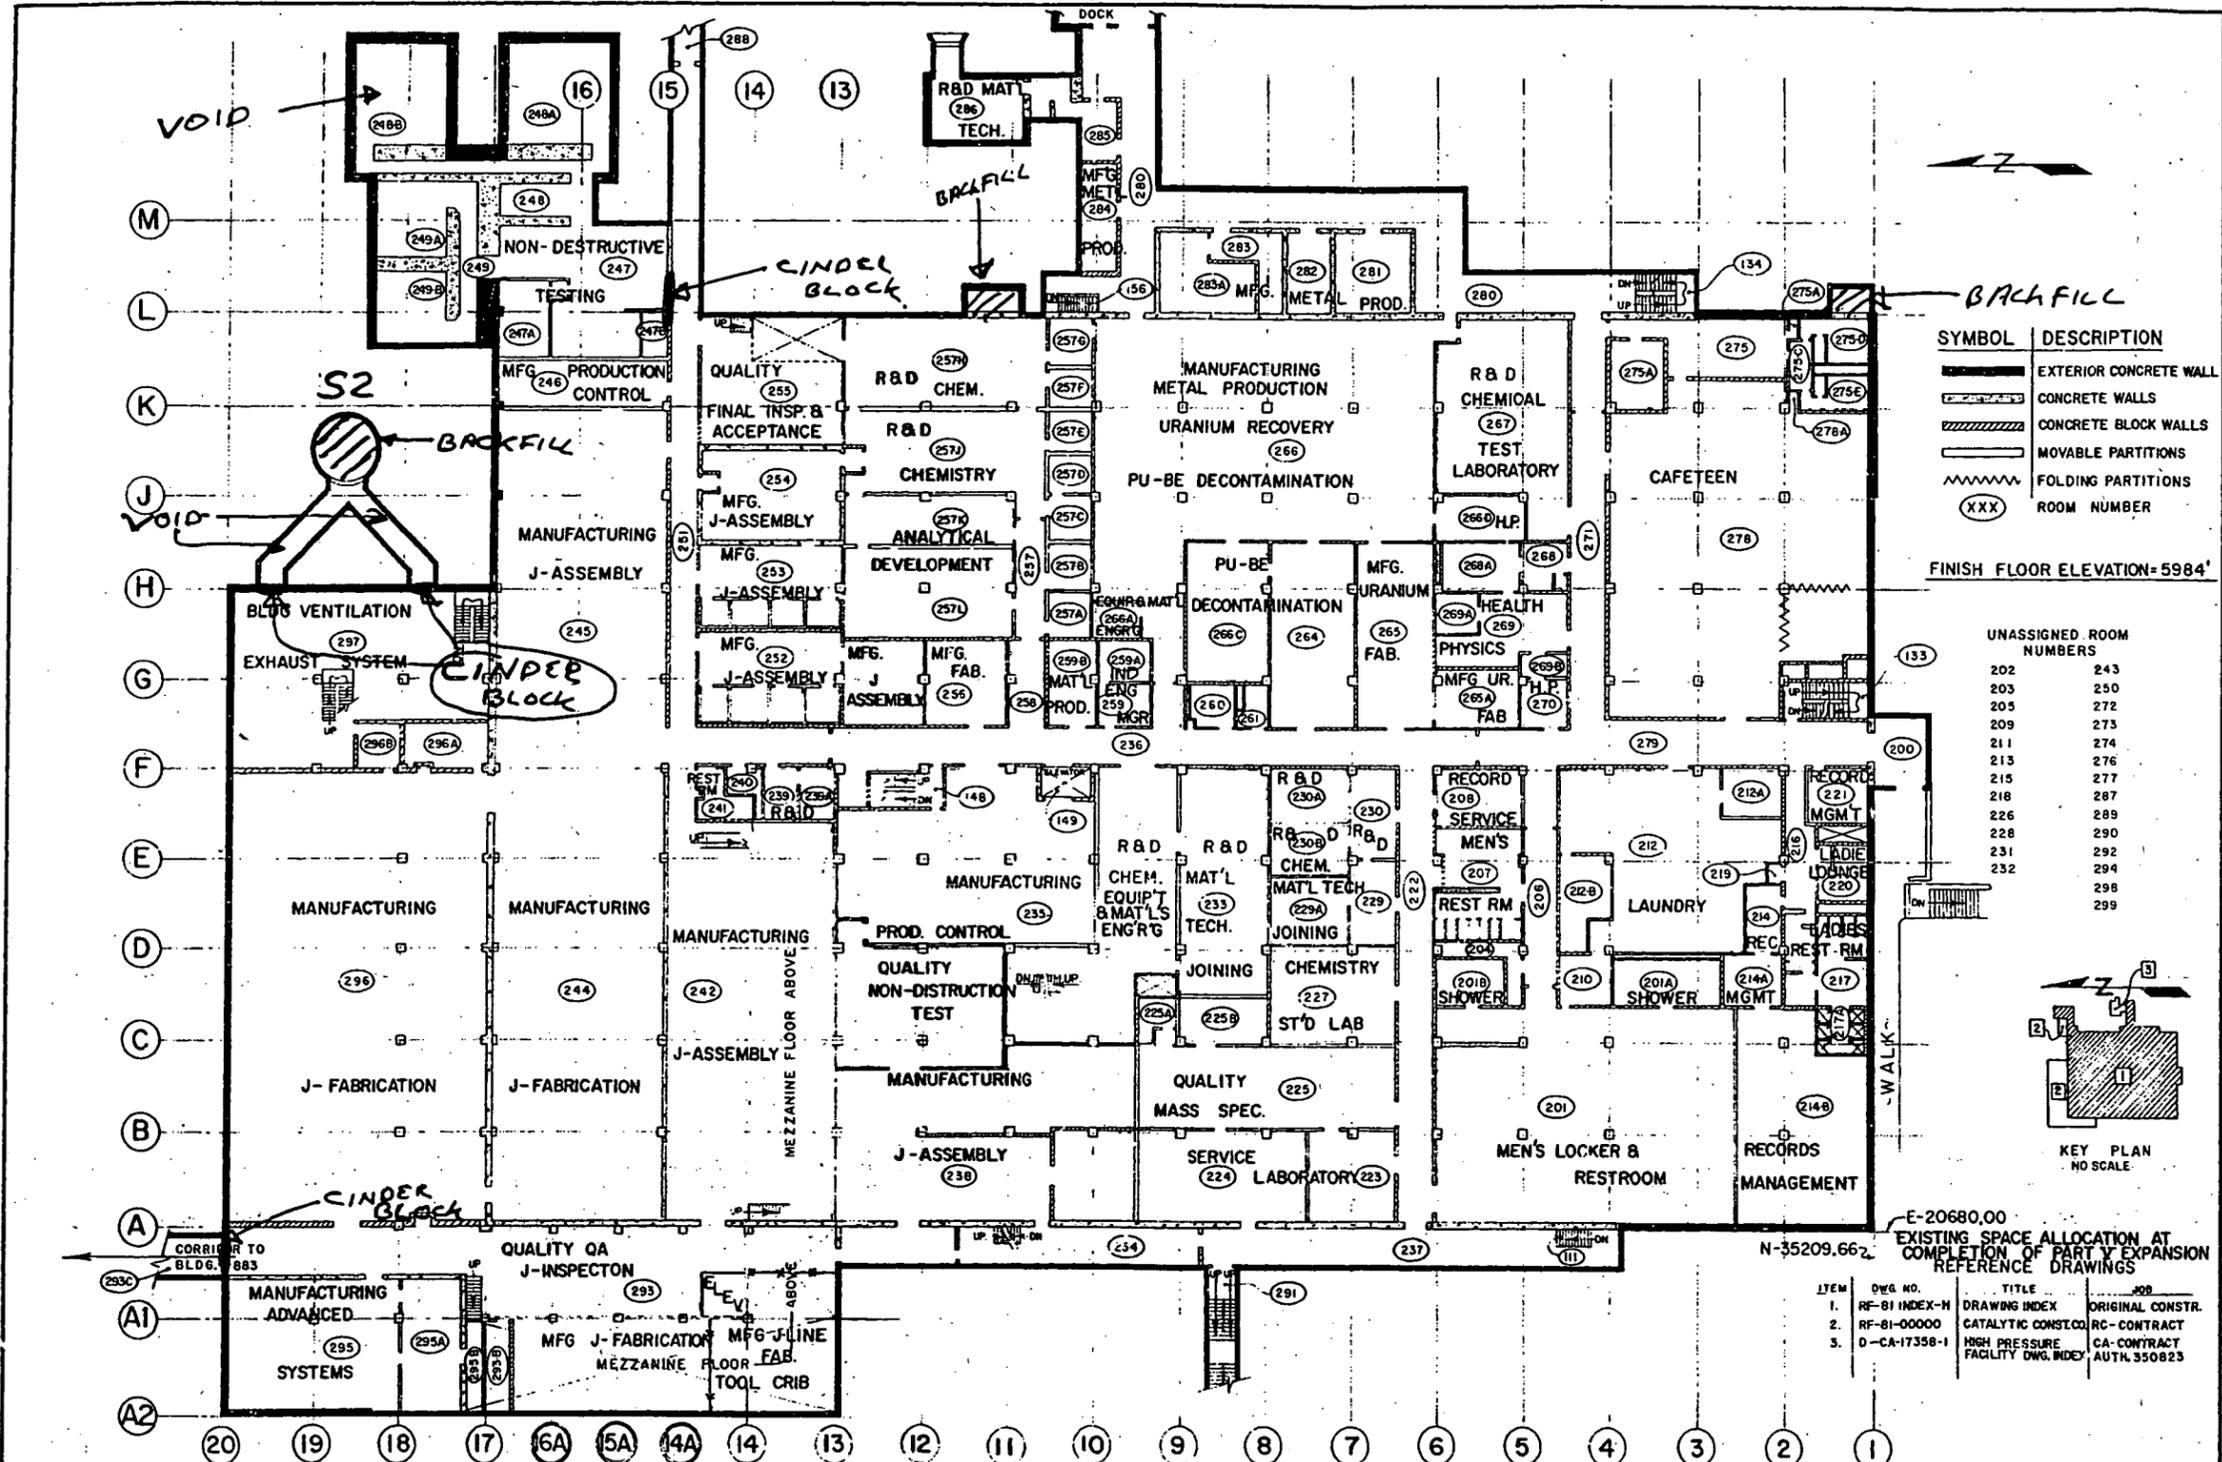
<b>C. Revised</b> D REDRAWN & CHANGED DWG. NO.		3-4-69		THE DOW CHEMICAL COMPANY ALL CONTRACTS ARE SUBJECT TO THE DOW CHEMICAL COMPANY GENERAL CONDITIONS OF CONTRACT	<b>BUILDING 881          SECOND FLOOR PLAN</b>	D 18181-2
---	--	--------	--	--	--	-----------

SYMBOL	DESCRIPTION
(Solid line)	EXTERIOR CONCRETE WALL
(Dashed line)	CONCRETE WALLS
(Hatched pattern)	CONCRETE BLOCK WALLS
(Dotted line)	MOVABLE PARTITIONS
(Wavy line)	FOLDING PARTITIONS
(XXX)	ROOM NUMBER

FINISH FLOOR ELEVATION=5984'

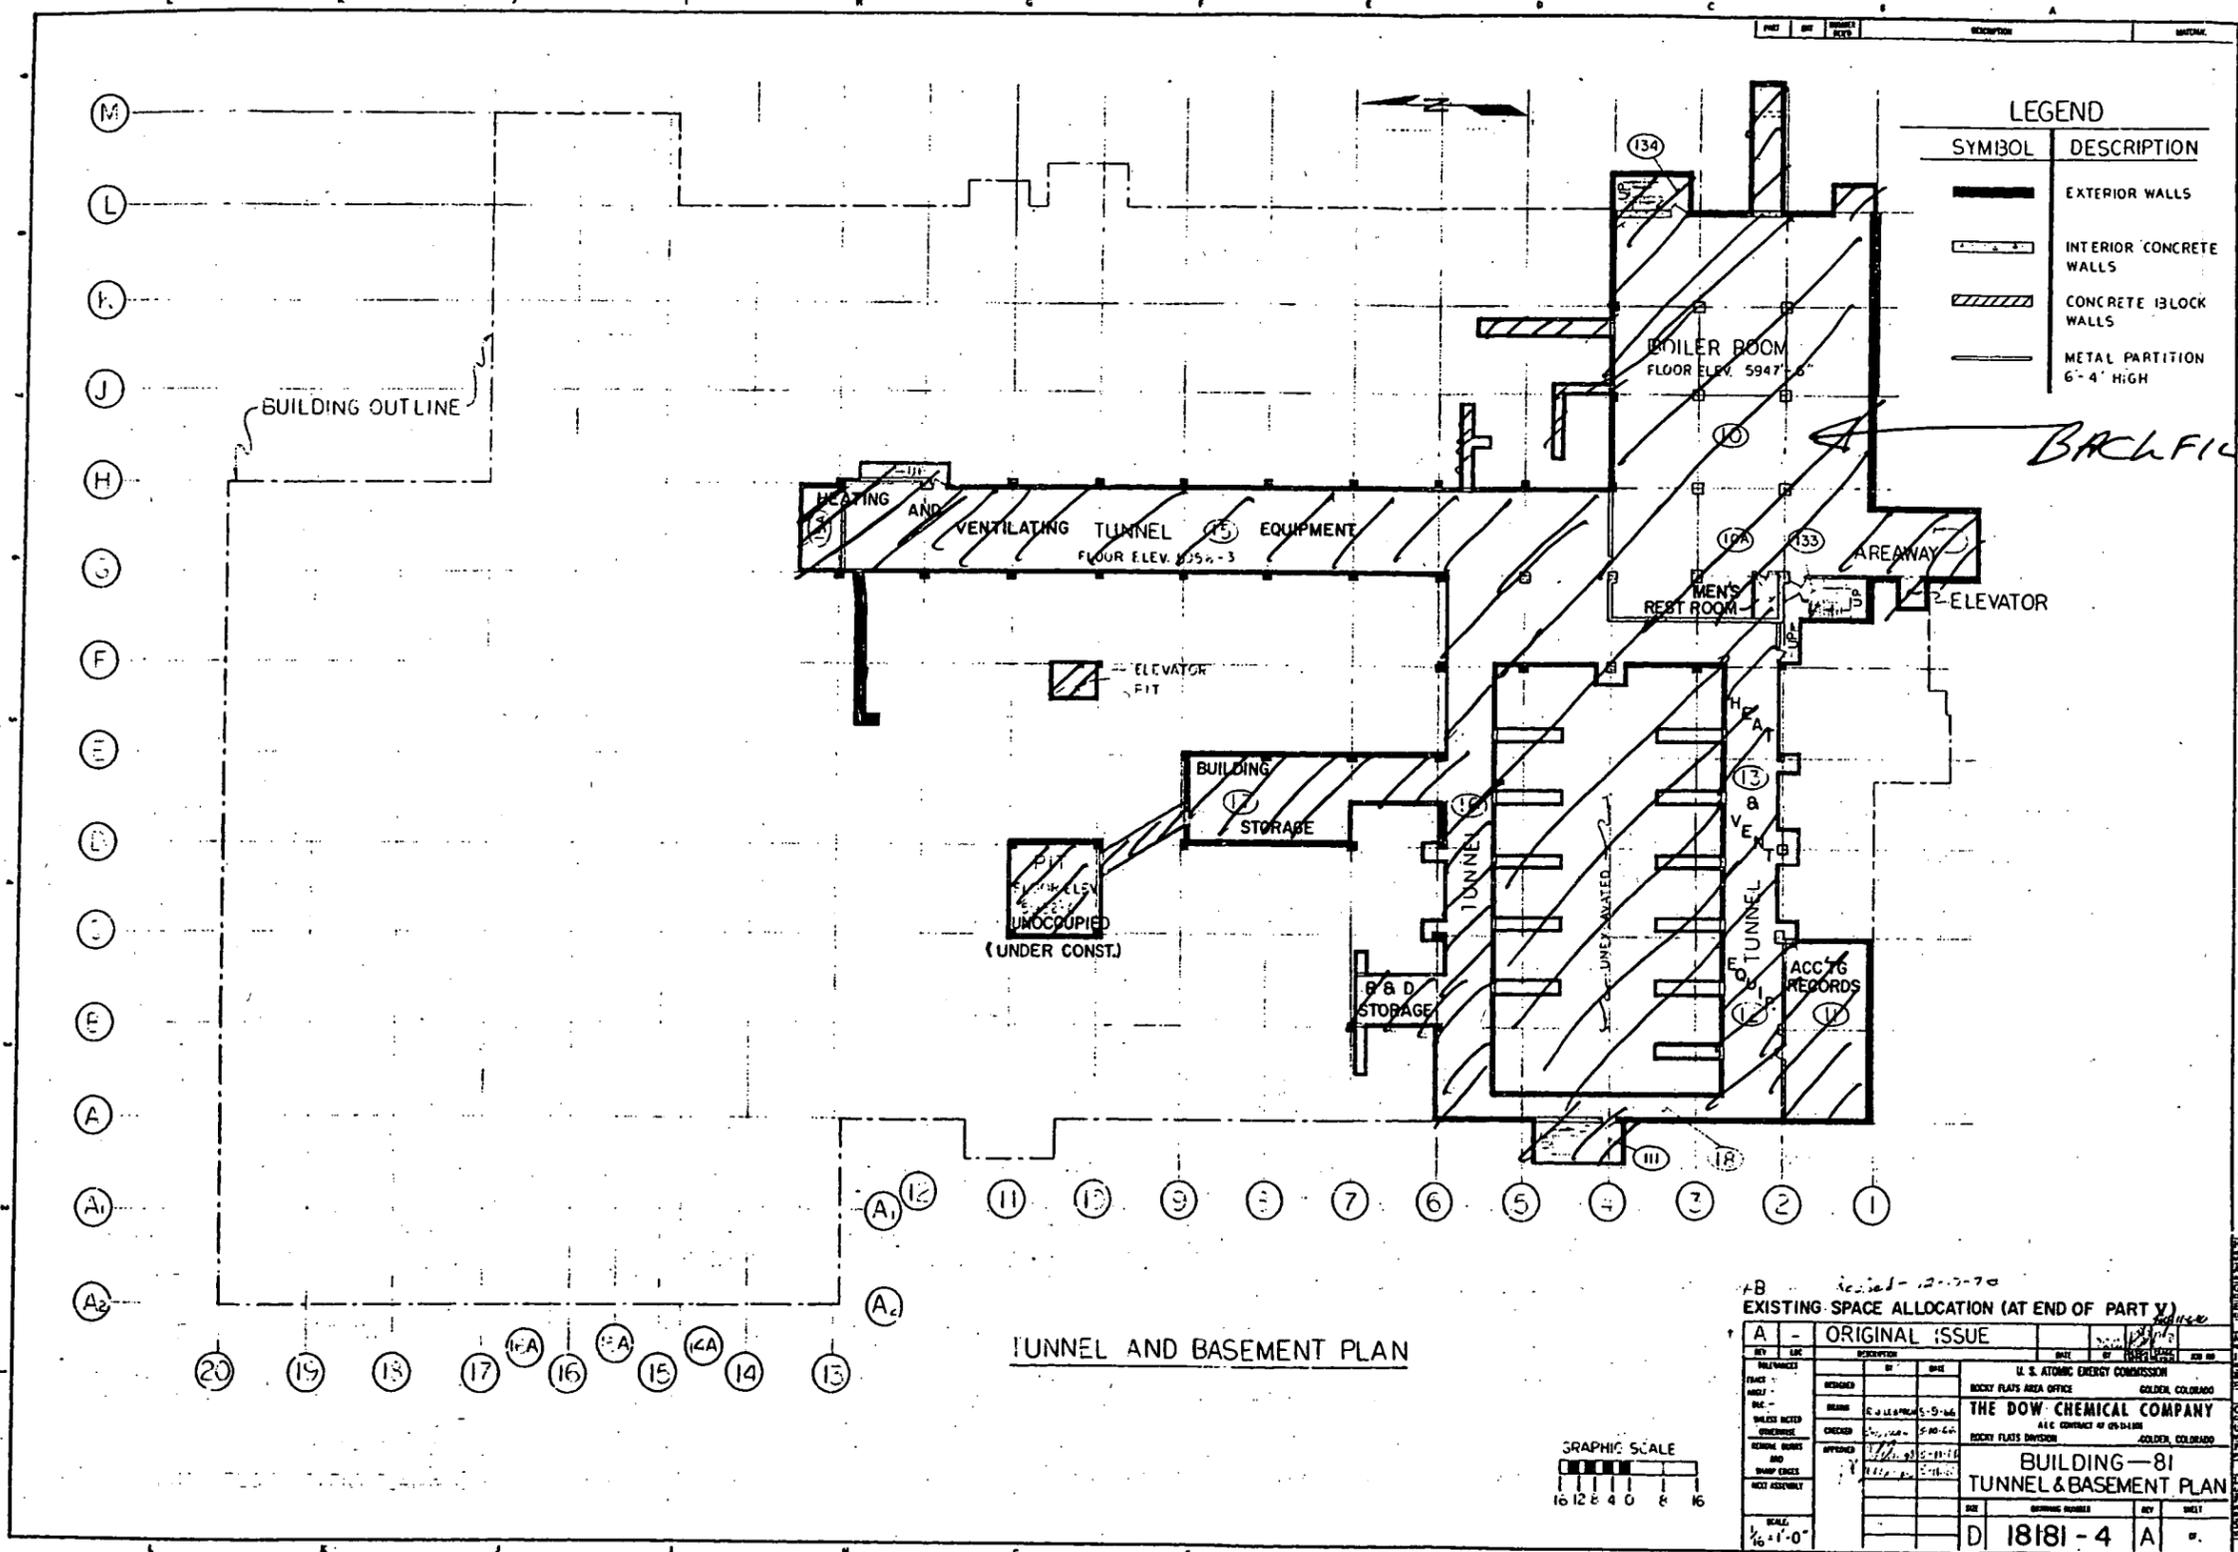
**LEGEND**

SYMBOL	DESCRIPTION
	EXTERIOR WALLS
	INTERIOR CONCRETE WALLS
	CONCRETE BLOCK WALLS
	METAL PARTITION 6'-4" HIGH
