**Closeout Report
for IHSS Group 000-5
(Present Landfill [IHSS 114])**

**Final Closeout Report
for IHSS Group 000-5
Present Landfill (IHSS-114)**

**Environmental Restoration
Rocky Flats Environmental
Technology Site**

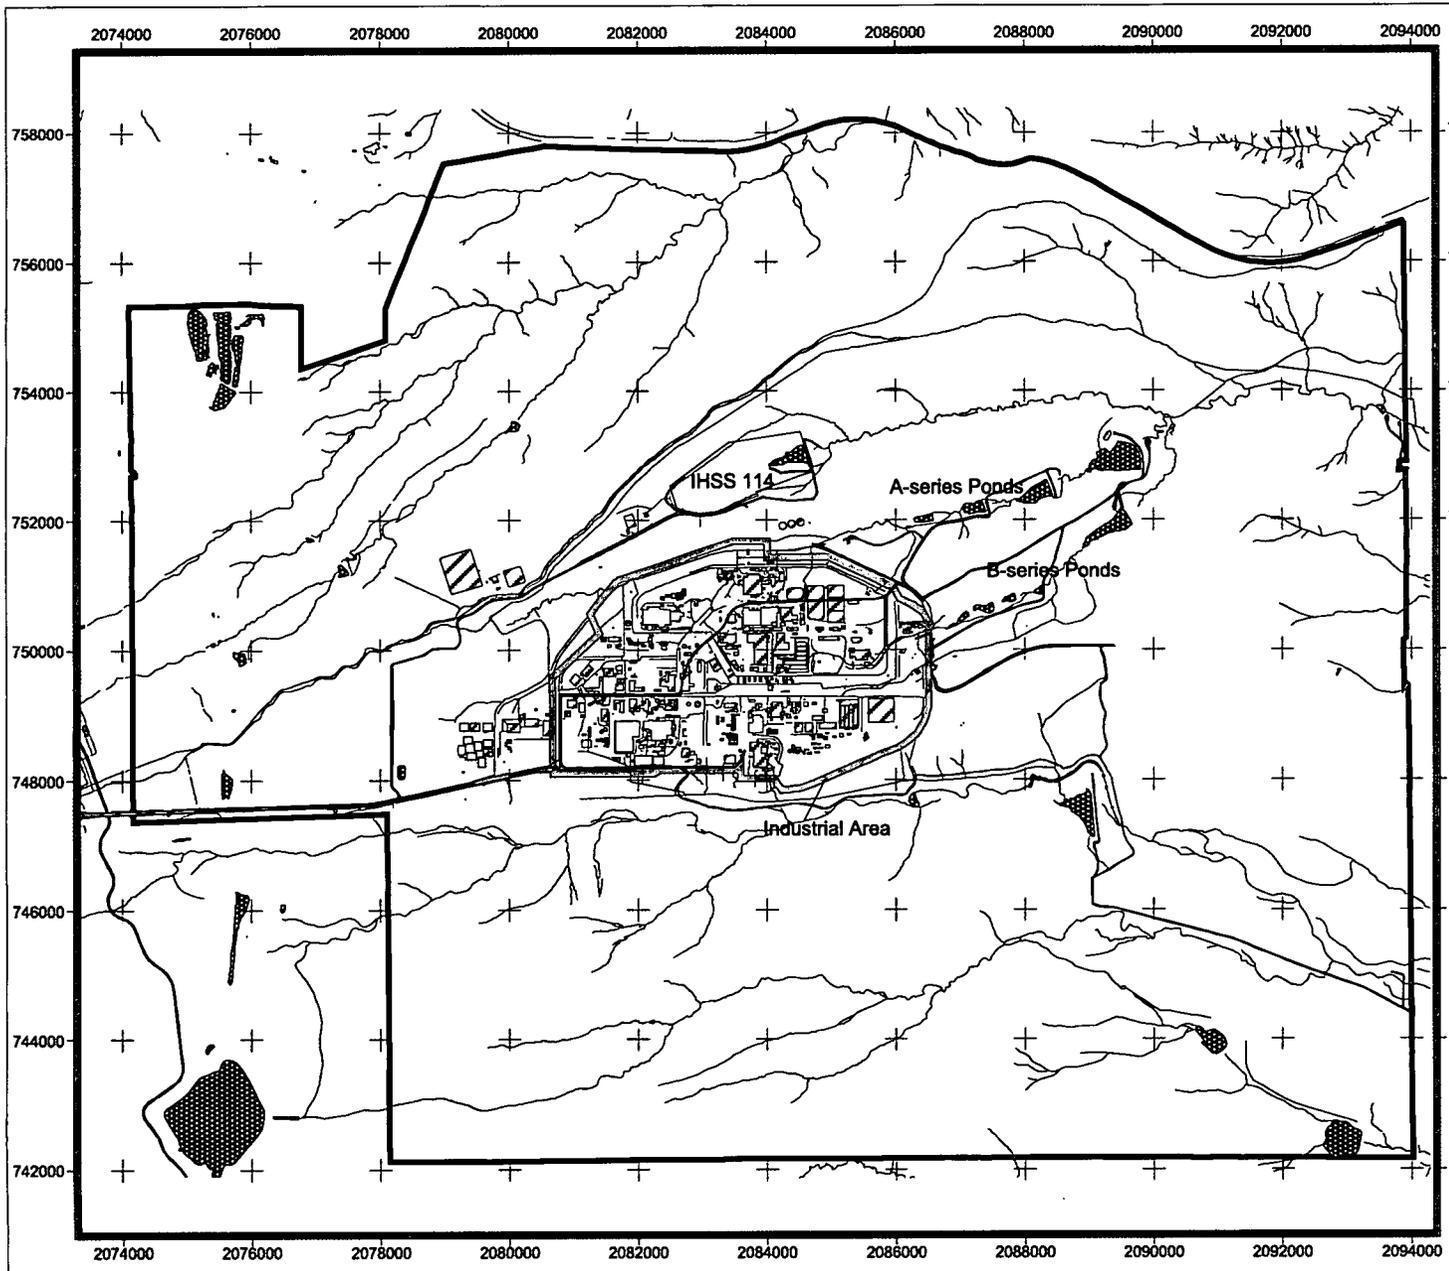
Figure 1
 IHSS Group 000-5
 Present Landfill (IHSS 114)
 Location Map

Figure 1 shows the location of IHSS Group 000-5 and Figure 2 gives a more detailed look at the Present Landfill.

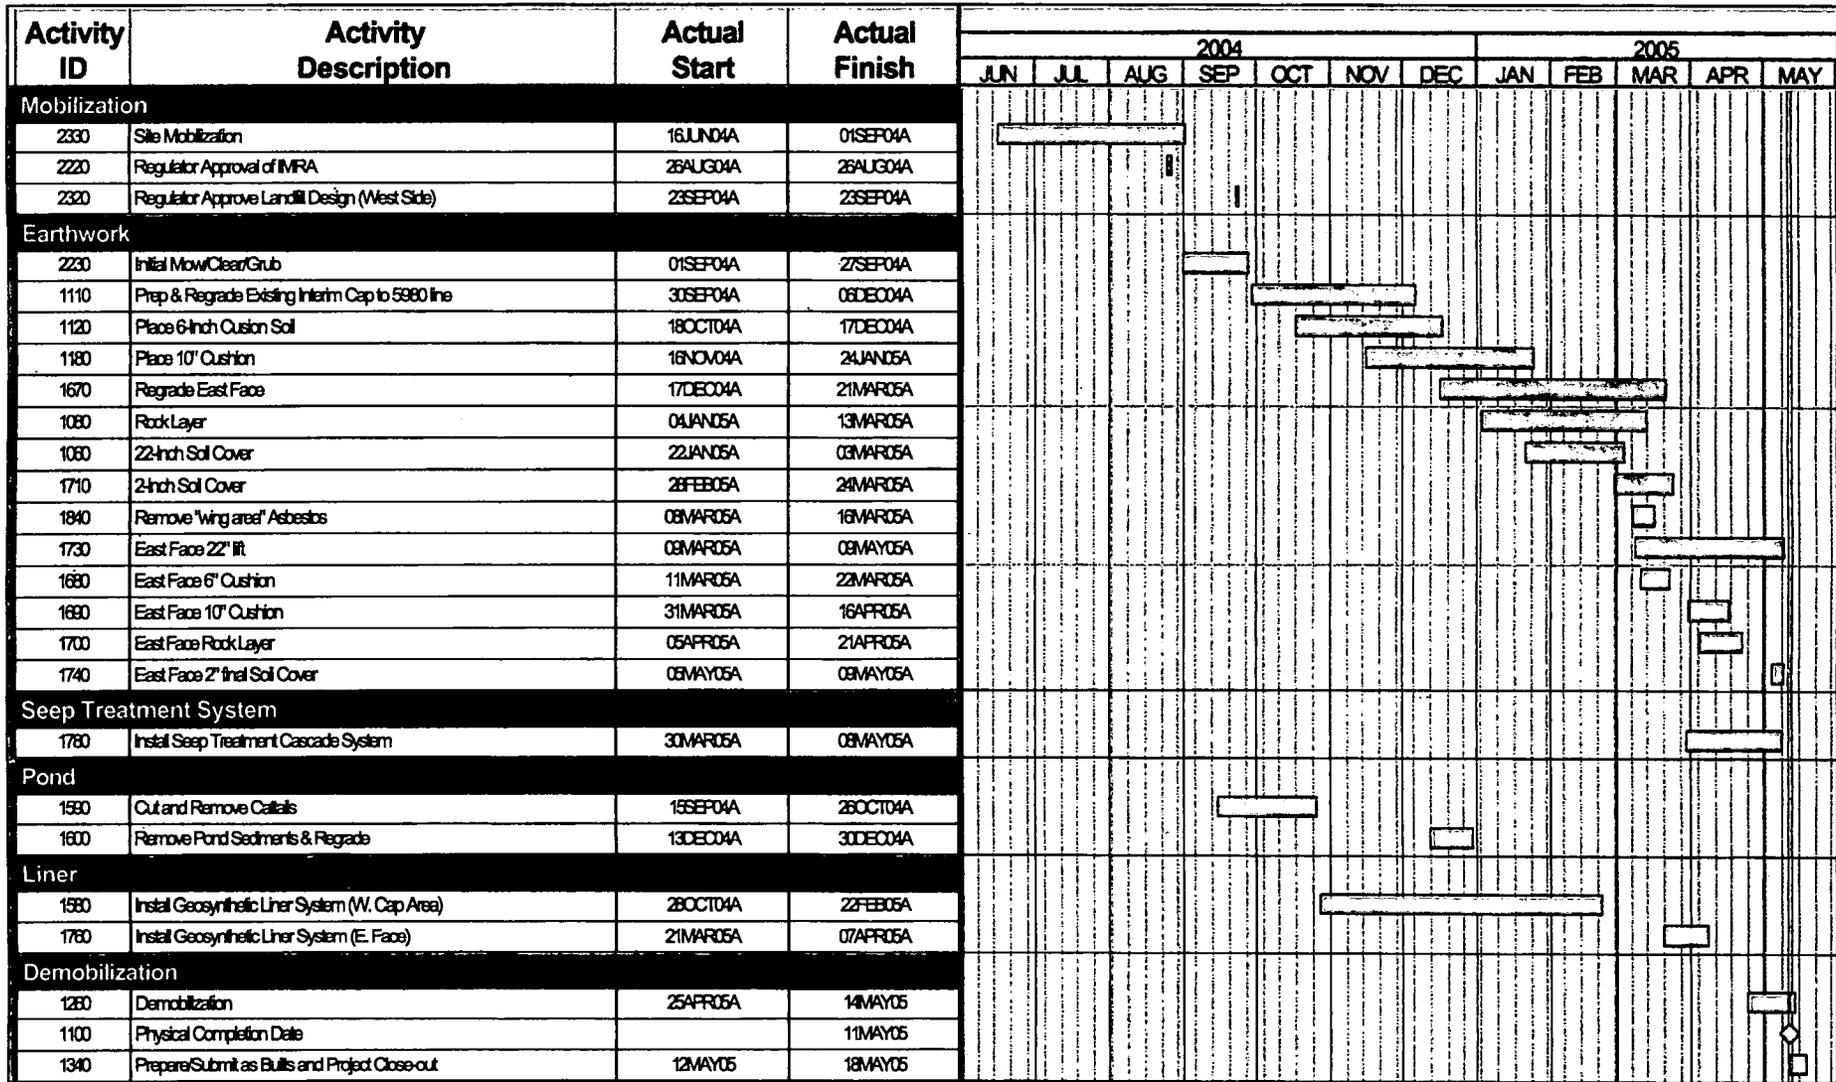
Start Date	17JUN04	0512	Sheet 1 of 1	Note: Seeding and Groundwater Monitoring Well Installation not Shown.	Figure 4
Finish Date	18MAY05	S.M. Stoller Corporation Construction of the Present Landfill Accelerated Action			
Data Date	12MAY05				
Run Date	23MAY05 11:05				
© Primavera Systems, Inc.		Actual Construction Schedule

Environmental Restoration (ER) accelerated action activities were conducted between August 2004 and May 2005. Starting and ending dates of significant activities are listed in the Final Detailed Schedule shown on Figure 4 of the CCR (Attachment A). Photographs of site activities are presented in Appendix C of the CCR (Attachment A).

This section presents the general construction sequence of the Present Landfill Accelerated Action from initiation of work in the summer of 2004 through the completion and closeout of the project in the spring of 2005. A detailed schedule for Stoller's construction activities through mid-May, 2005 is presented on Figure 4.

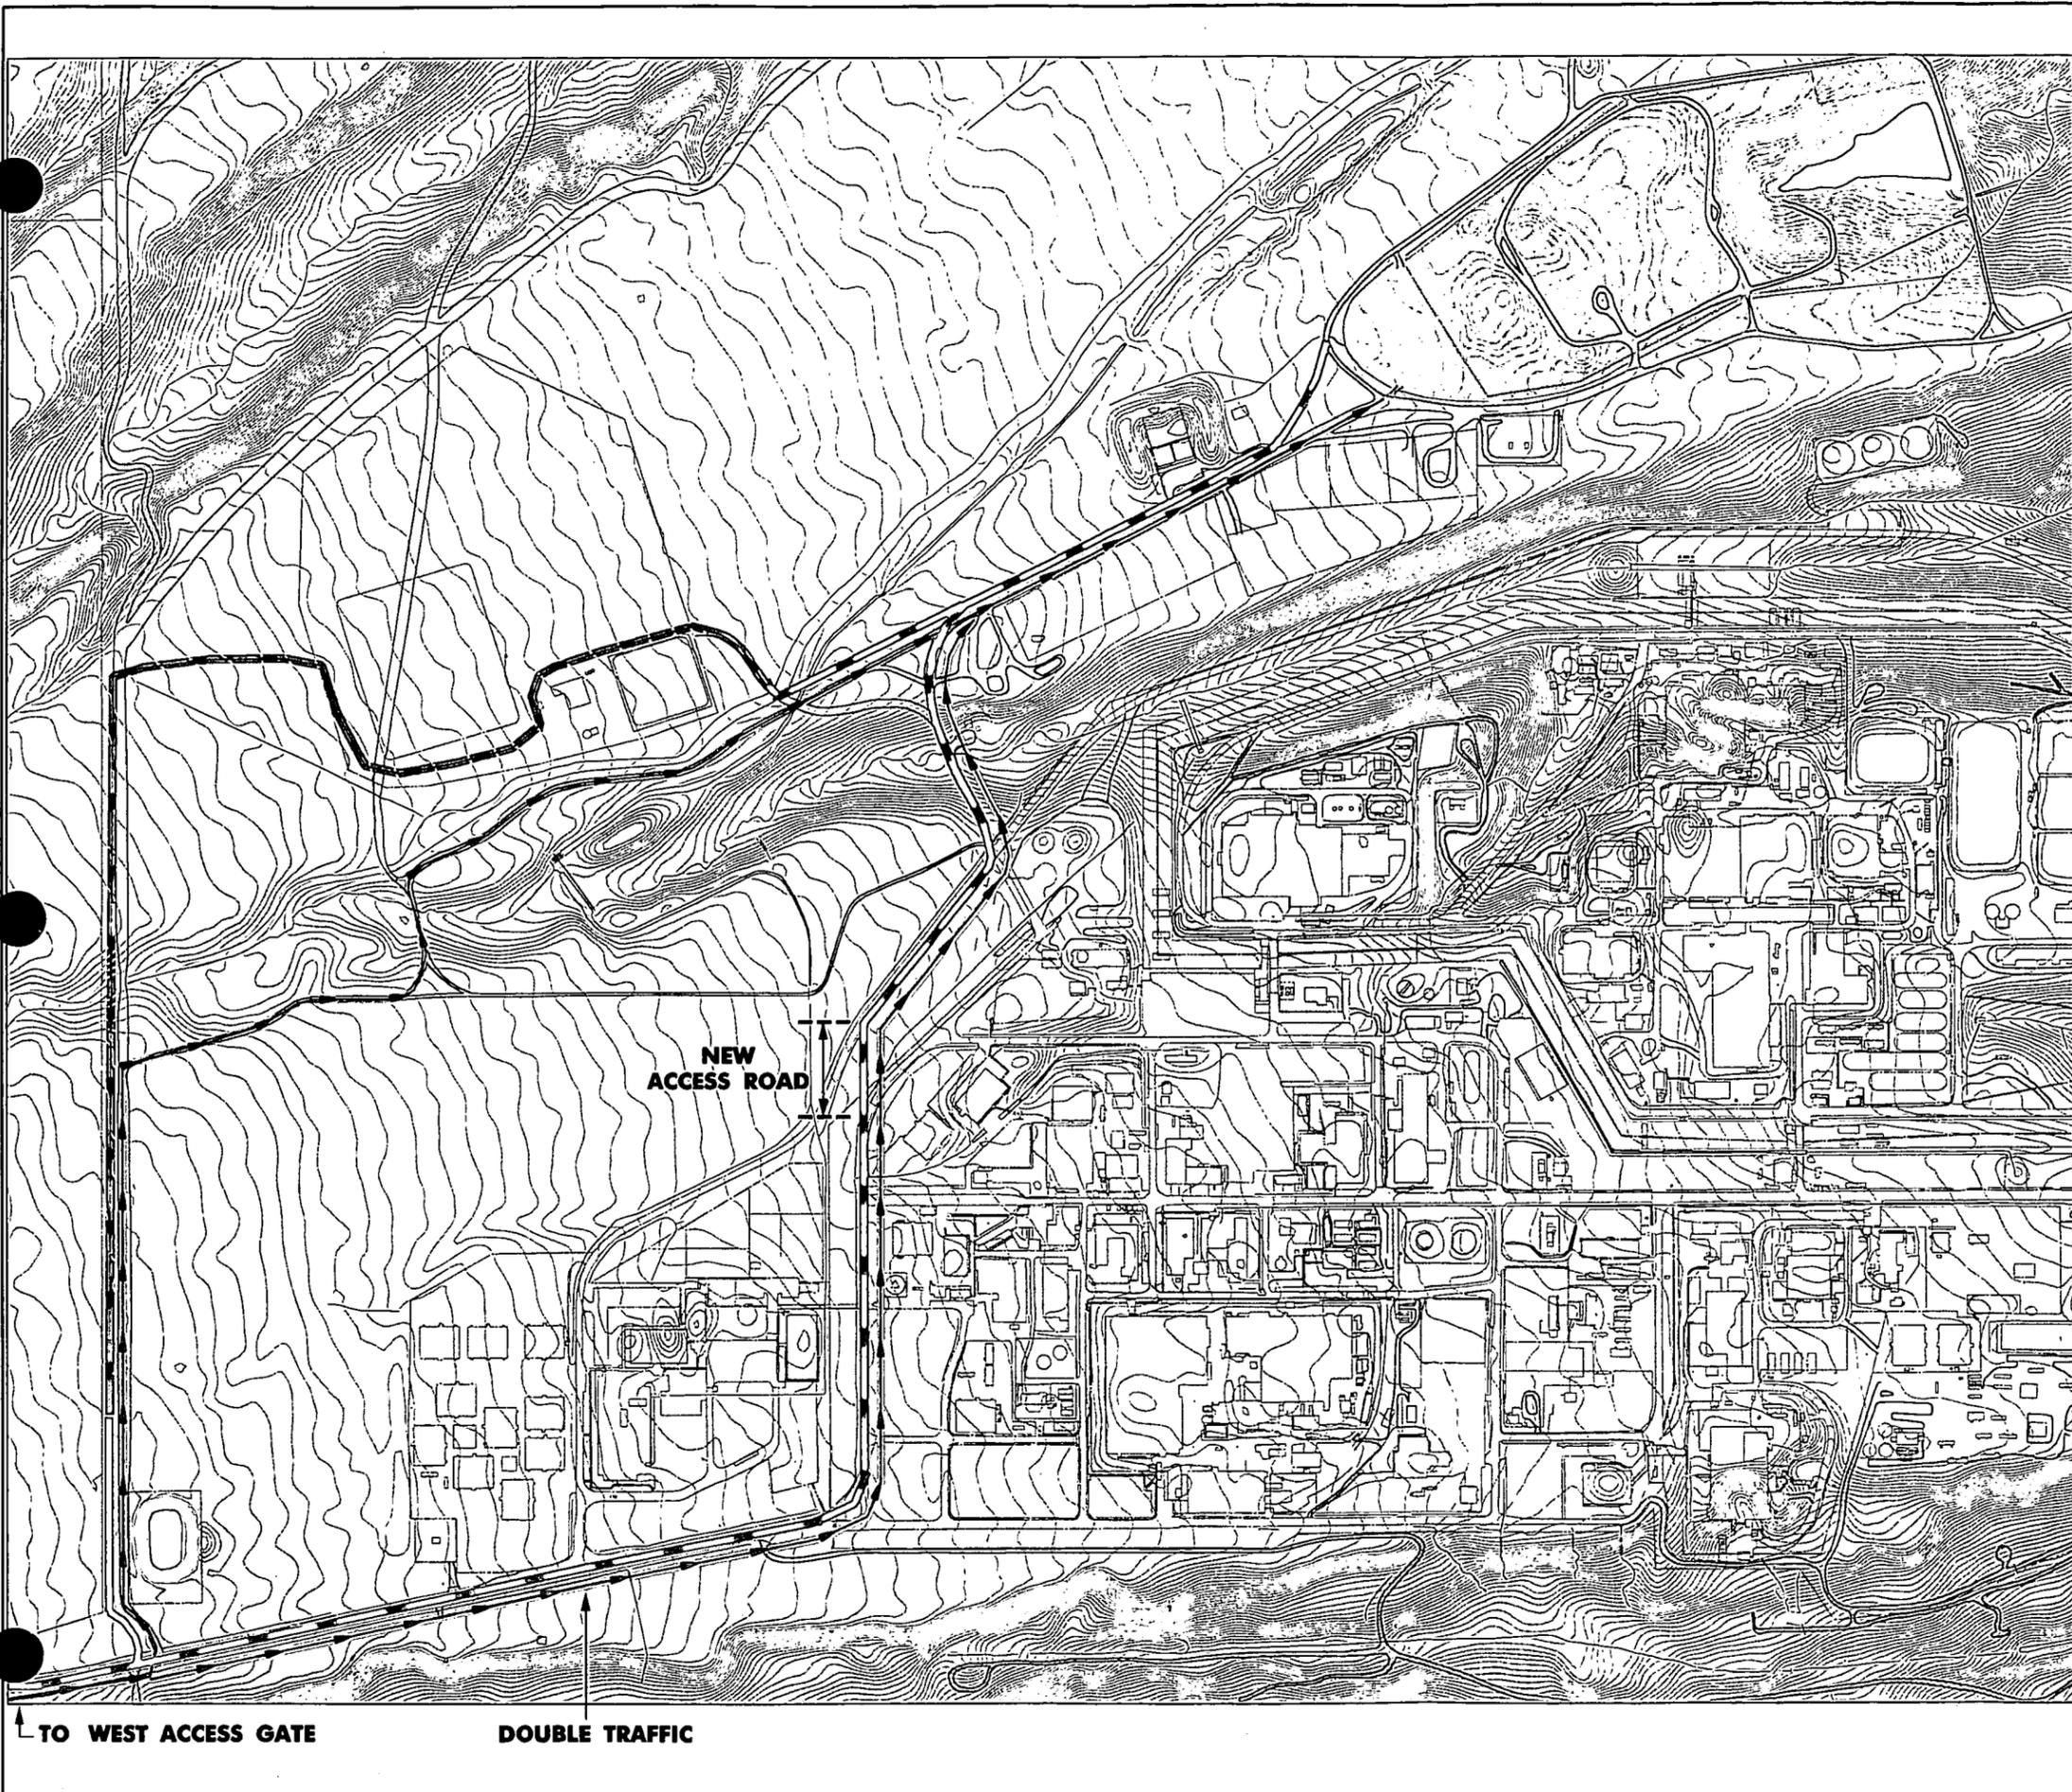
IN ROUTE
 OUT ROUTE

NOTE: ADDITIONAL TRAFFIC PATTERNS INCORPORATED INTO WORK PACKAGES.

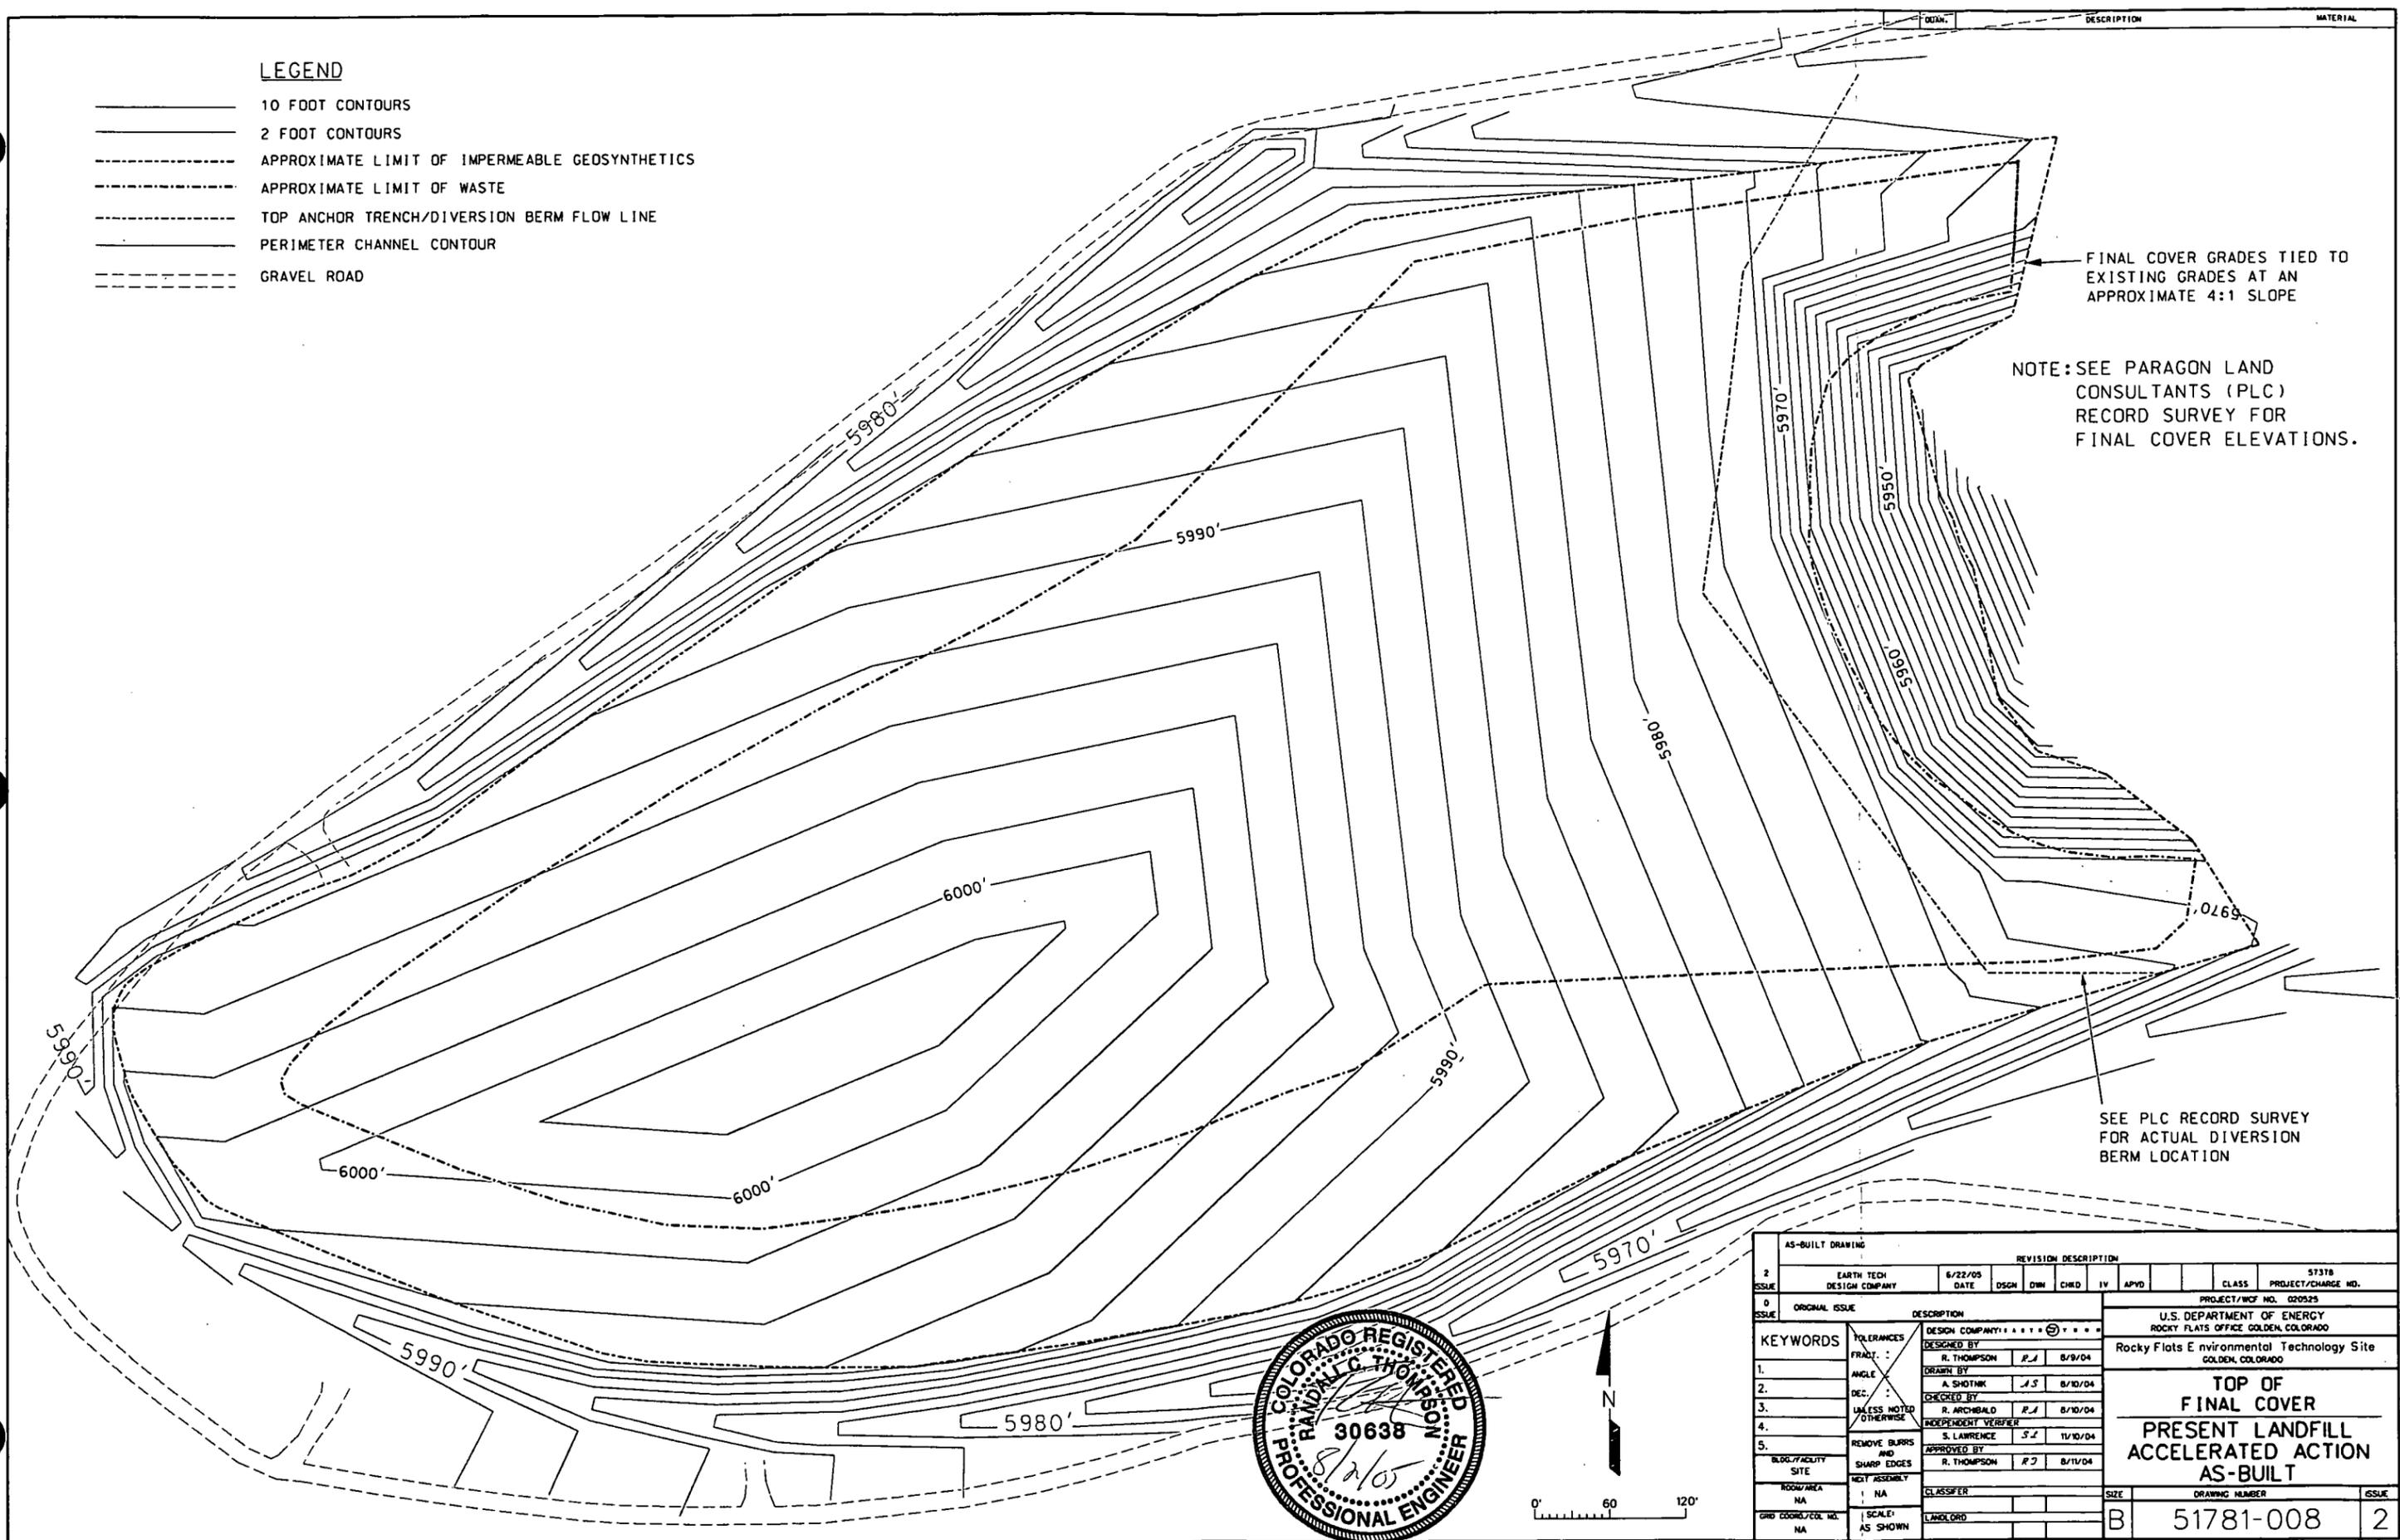
FINAL COVER GRADES TIED TO EXISTING GRADES AT AN APPROXIMATE 4:1 SLOPE

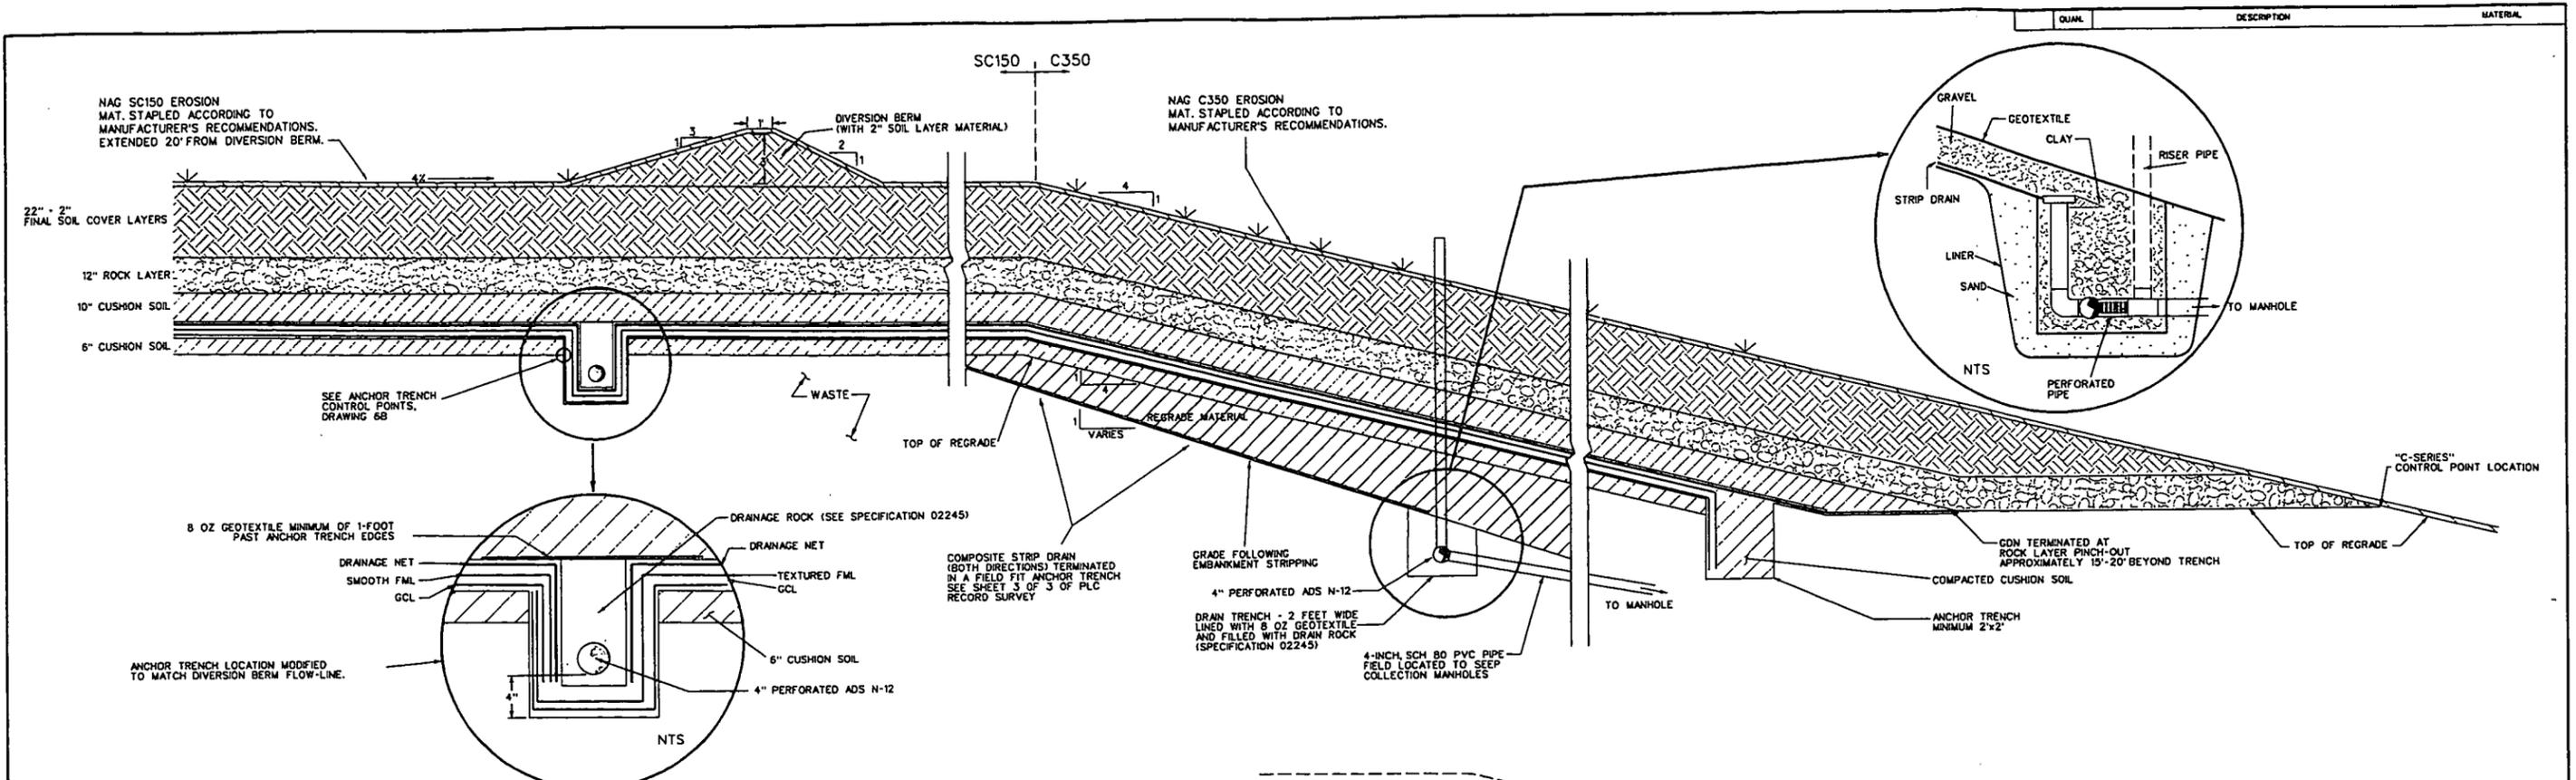
CROSS-SECTION A - A'

EAST SLOPE COVER BREAK AND DIVERSION BERM

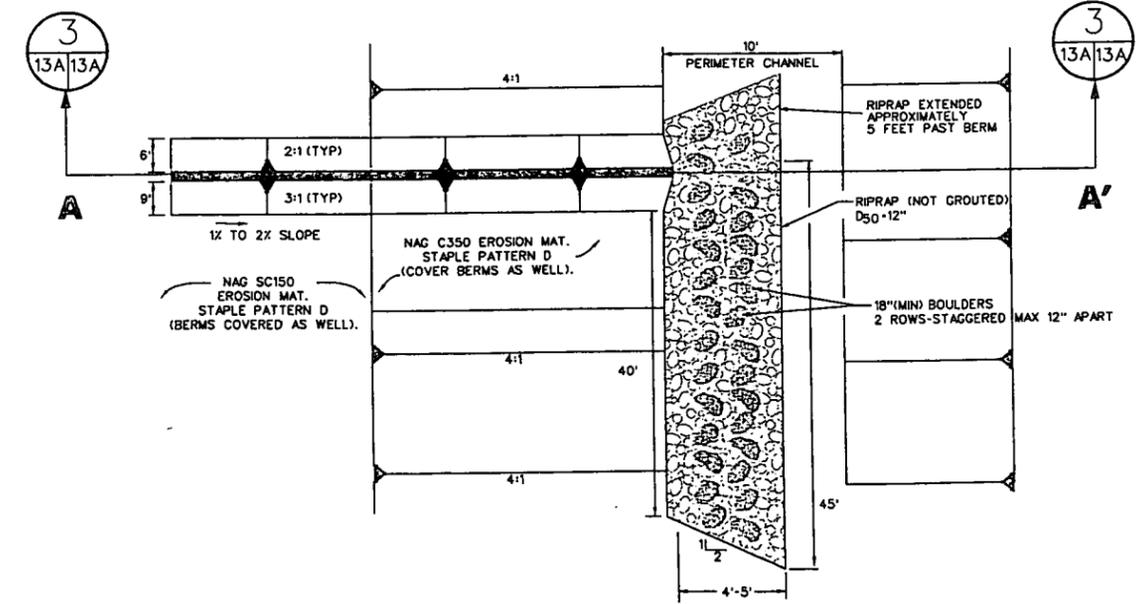
DOWNSLOPE CHANNEL TRANSITION FROM EAST SLOPE BERM TO PERIMETER CHANNEL

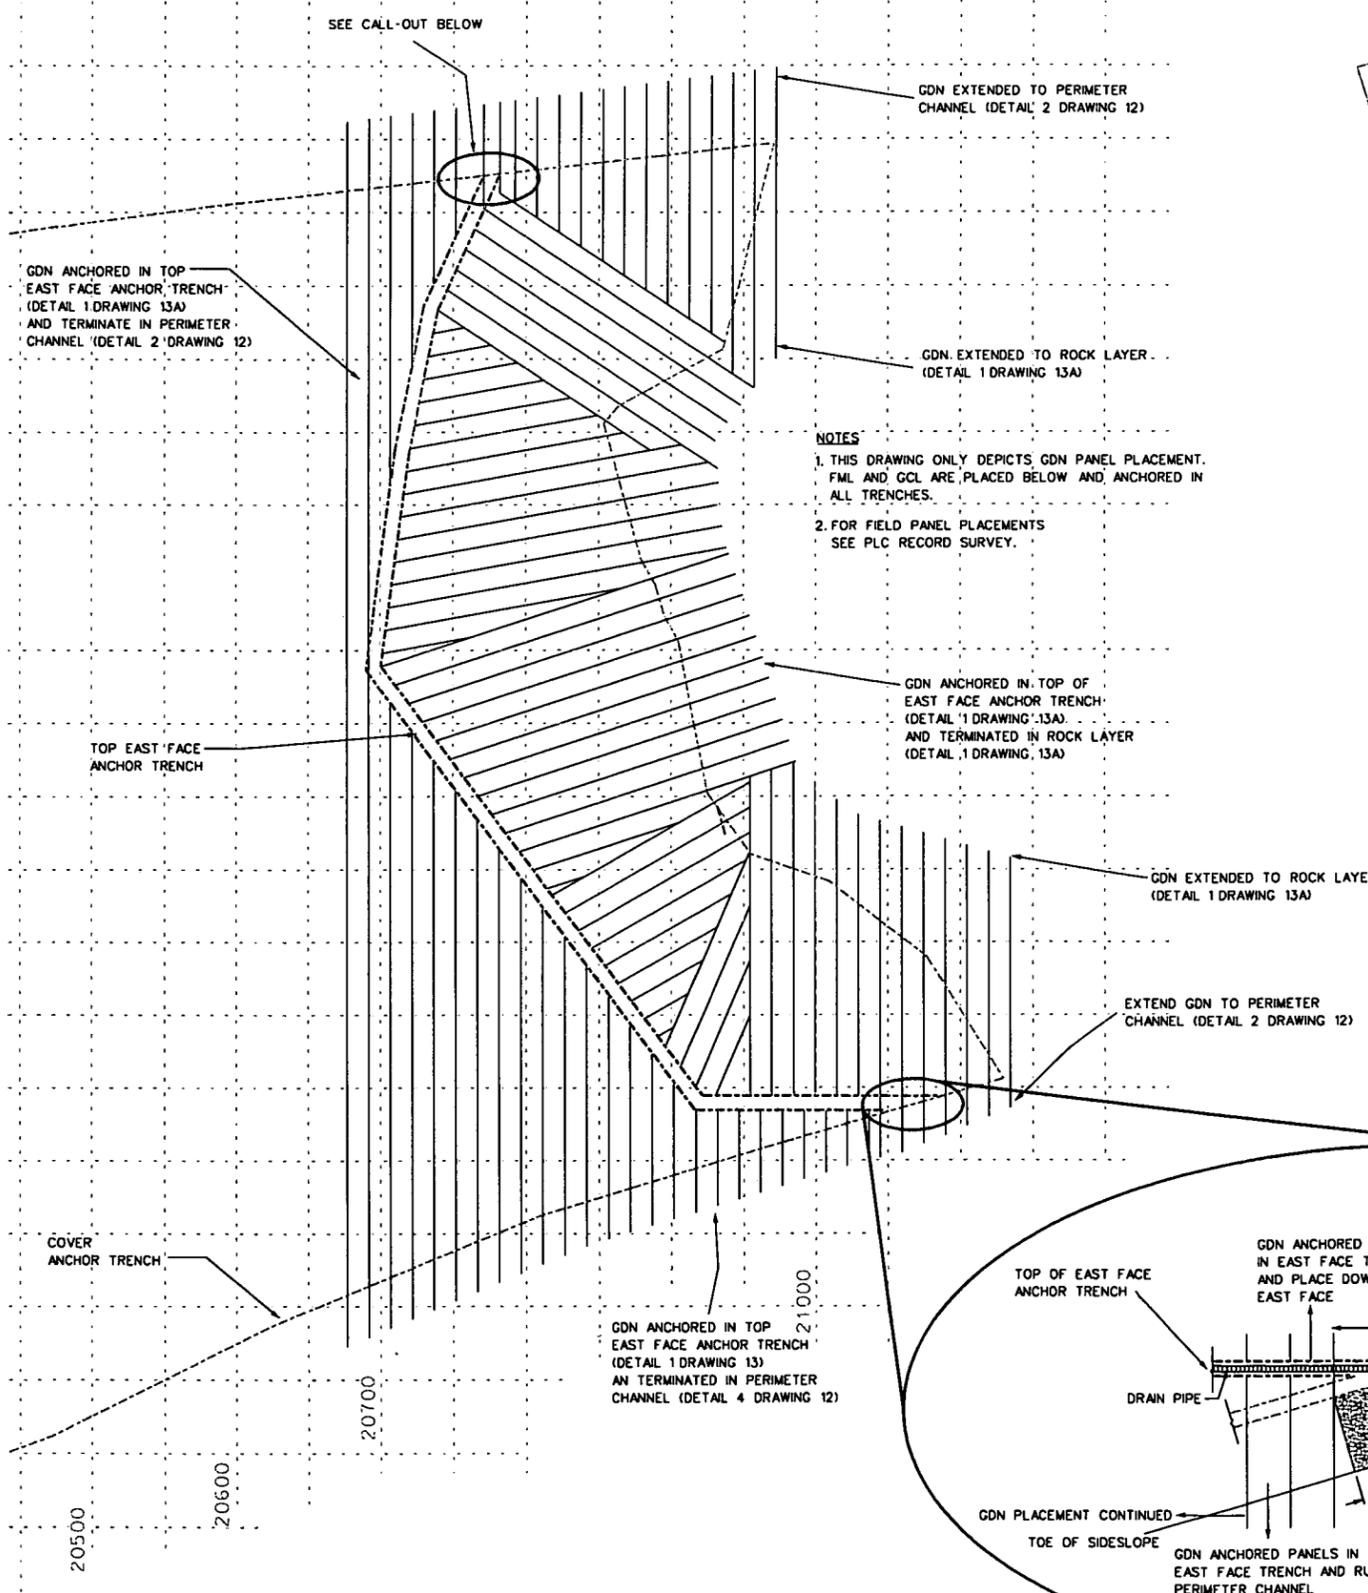
1. THIS DRAWING ONLY DEPICTS GDN PANEL PLACEMENT. FML AND GCL ARE PLACED BELOW AND ANCHORED IN ALL TRENCHES.
2. FOR FIELD PANEL PLACEMENTS SEE PLC RECORD SURVEY.

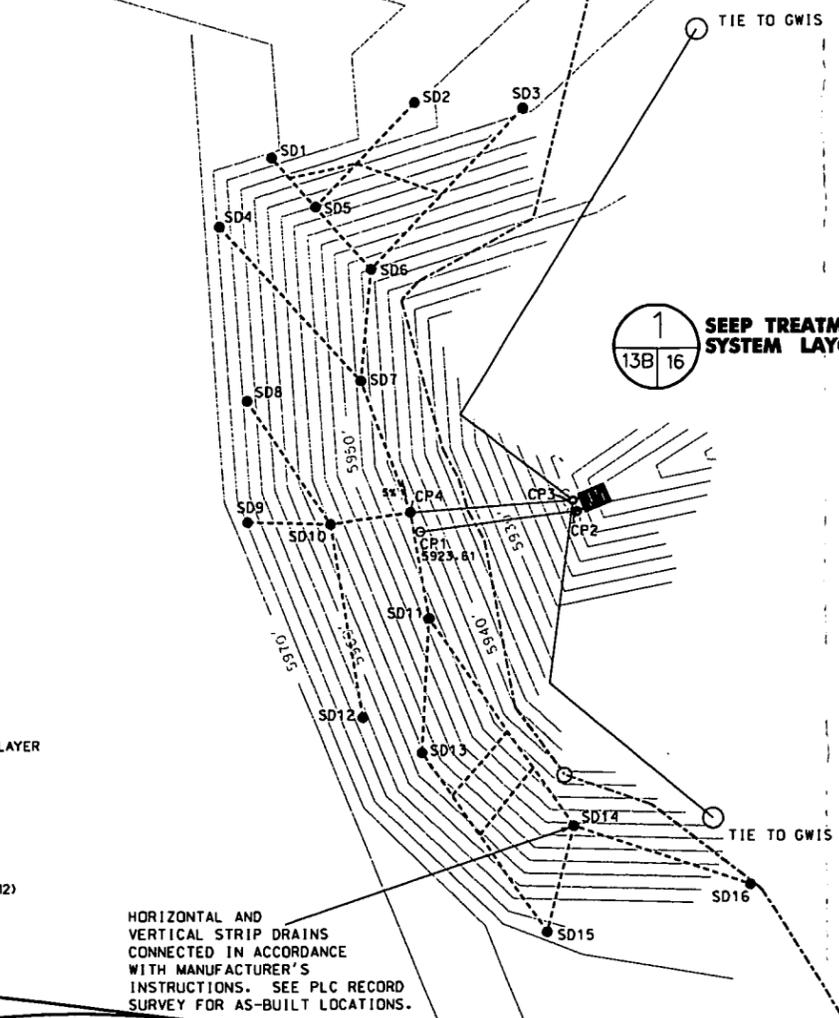
1
13B 16
SEEP TREATMENT SYSTEM LAYOUT

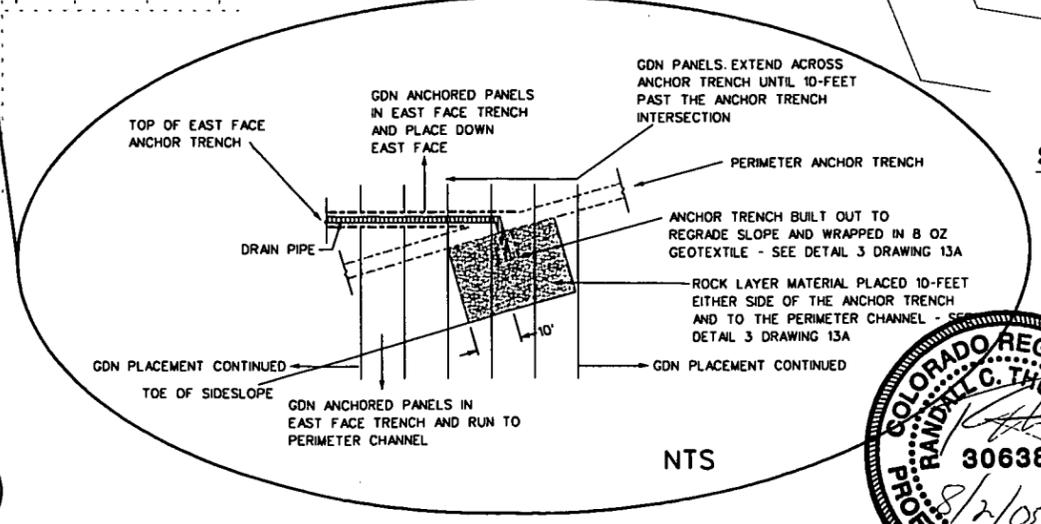
ANCHOR TRENCH - GDN PLACEMENT

AMERICAN WICK DRAIN CORPORATION'S 12-INCH AKWADRAIN SOIL STRIP DRAINS WERE INSTALLED. ANCHORED TO SOIL WITH EROSION MAT STAPLES OR NAILS AFFIXED WITH A WASHER TO PREVENT BREAKTHROUGH.

SEE PLC RECORD SURVEY FOR FINAL STRIP DRAIN AT SEEP SYSTEM LOCATIONS.

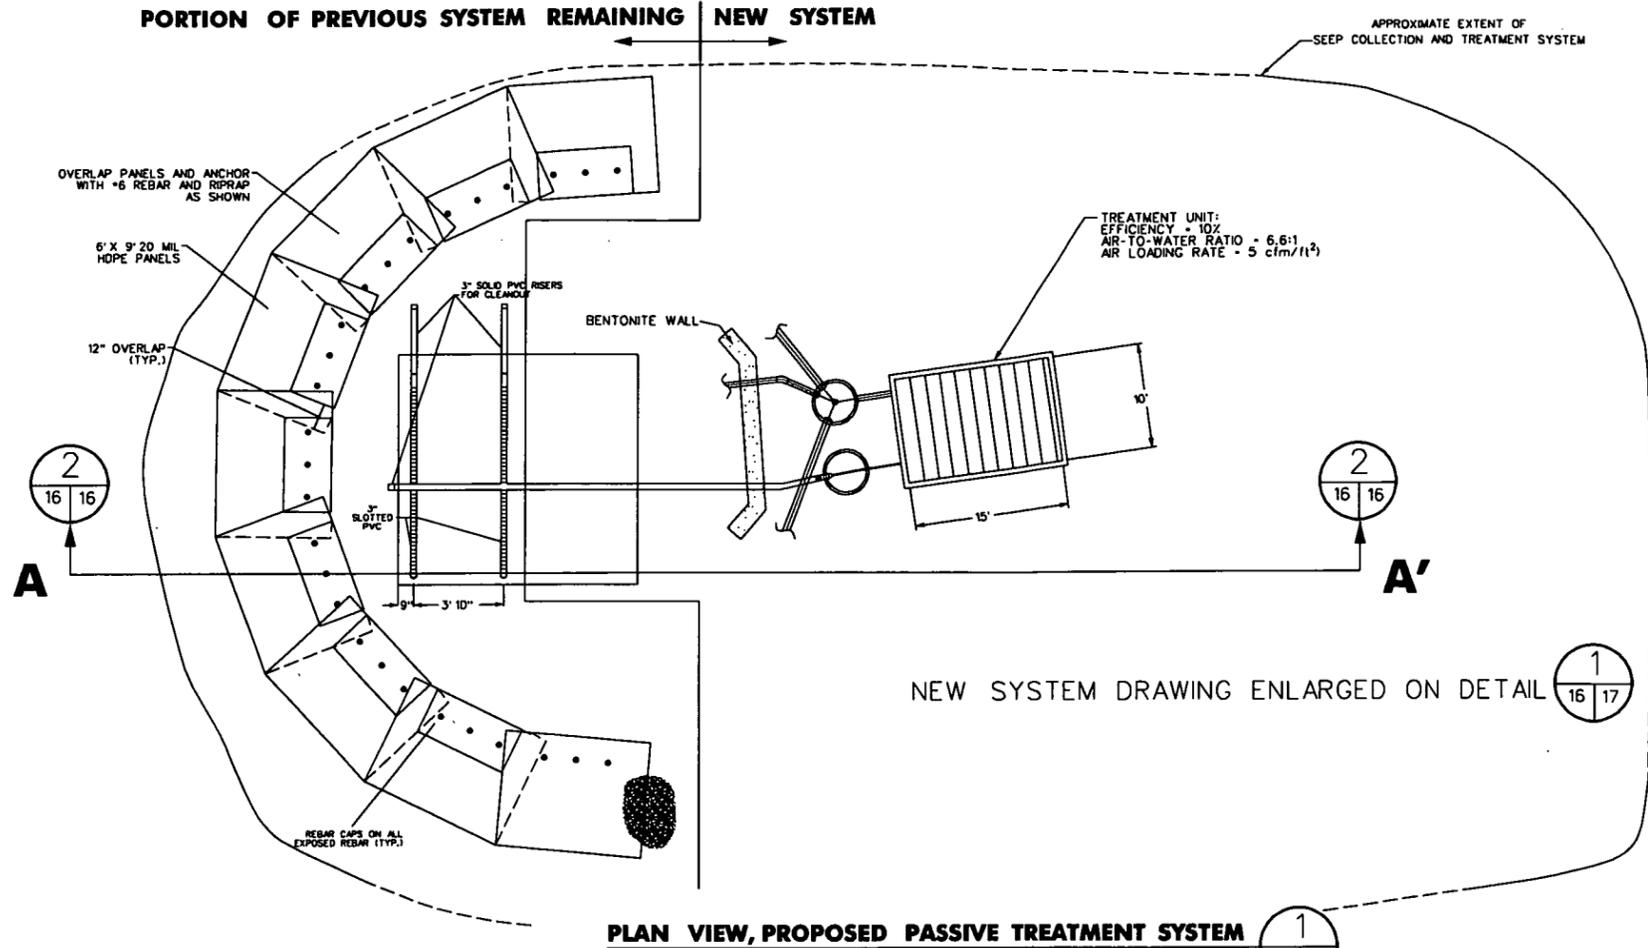
PLAN VIEW, PROPOSED PASSIVE TREATMENT SYSTEM

PORTION OF PREVIOUS SYSTEM REMAINING NEW SYSTEM

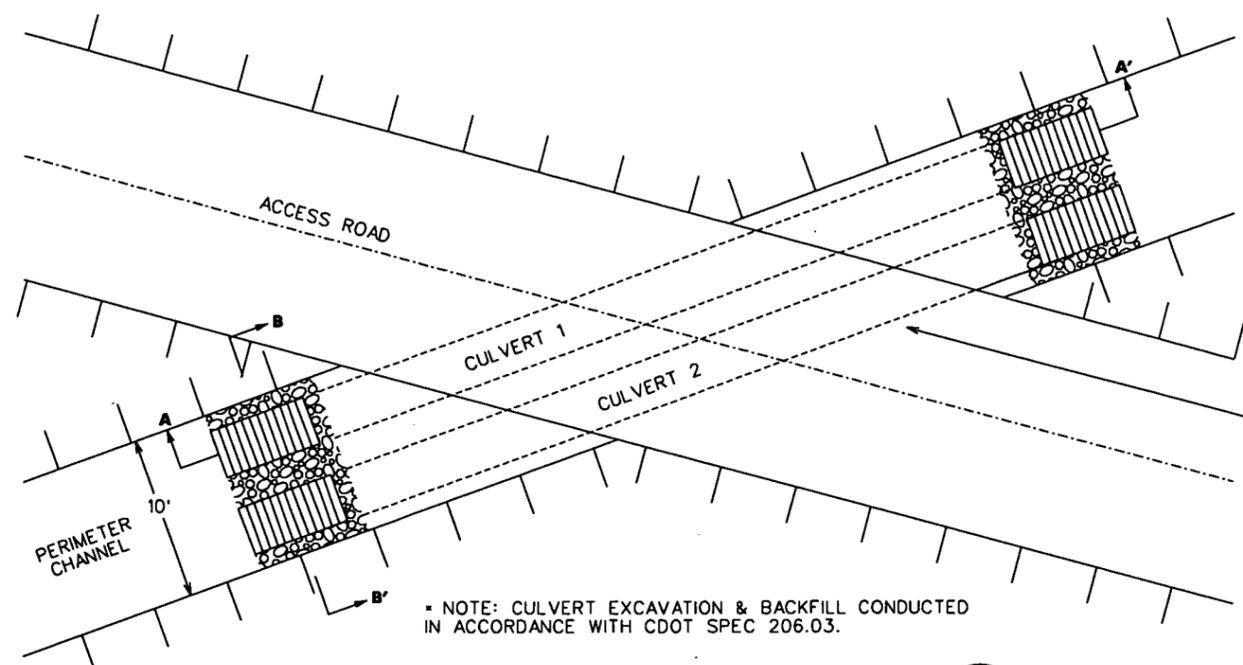
PERIMETER CHANNEL CULVERT DESIGN

NORTH CULVERTS SHOWN
(SOUTHEAST CULVERTS SIMILAR BUT
WITH SMALLER SKEW ANGLE)

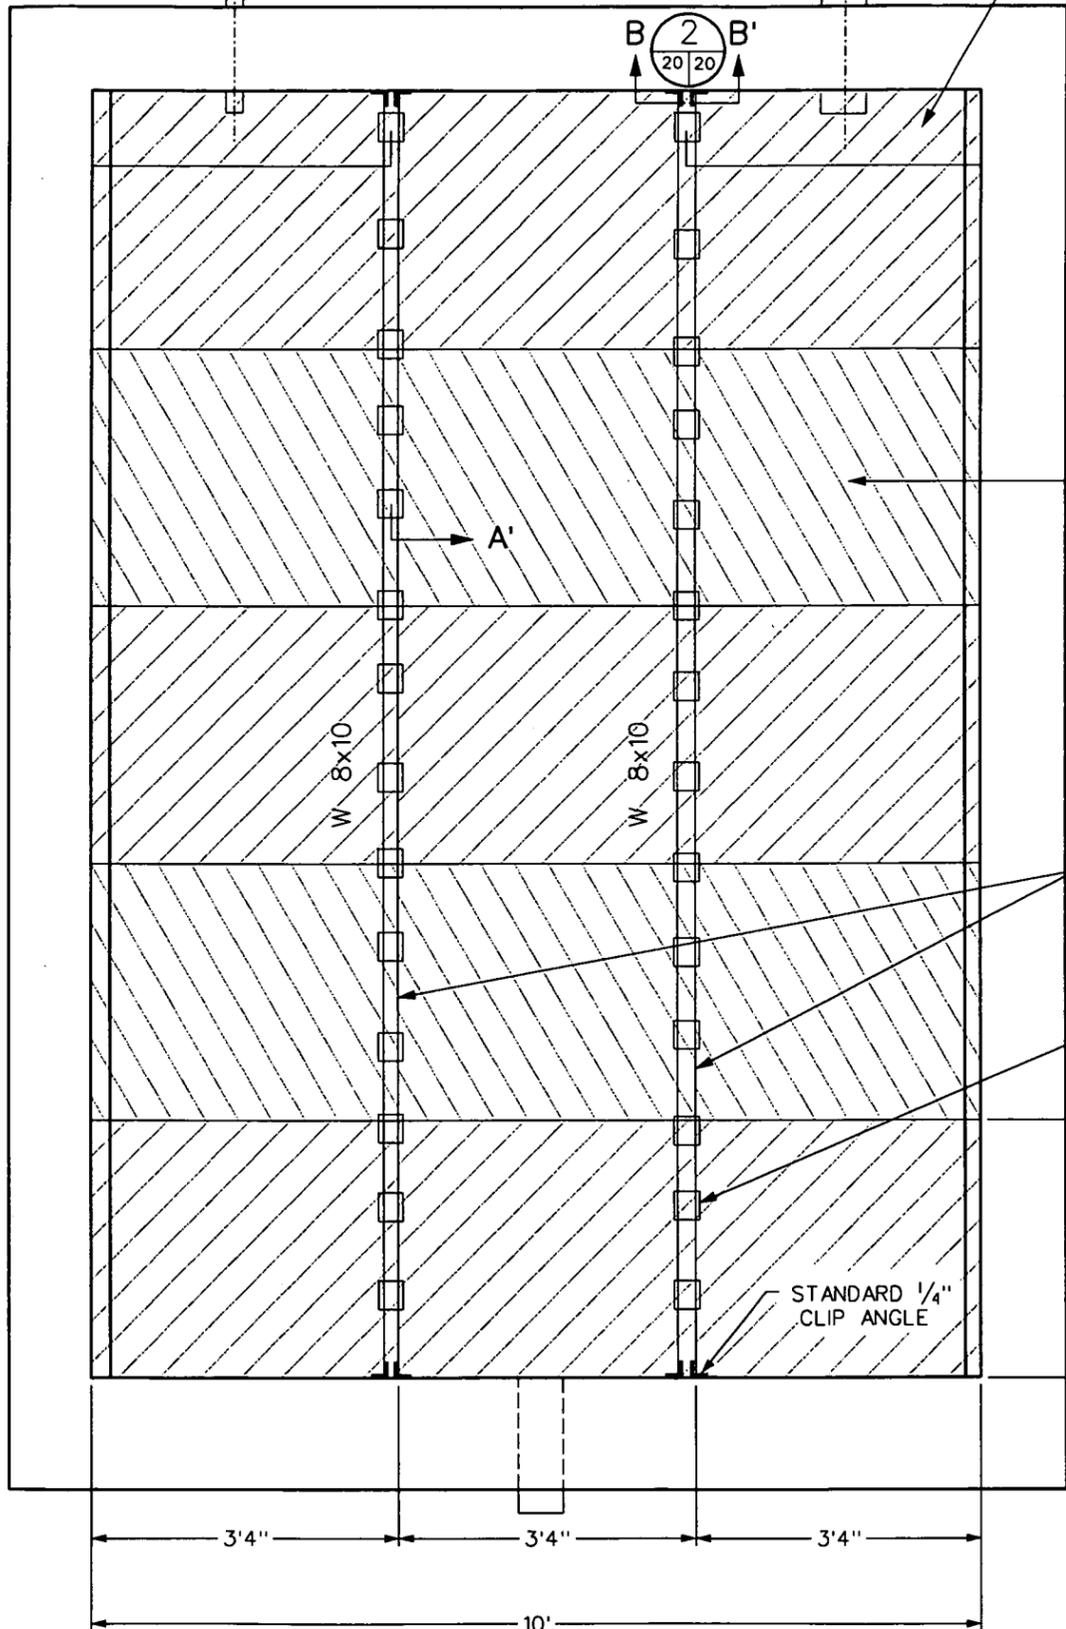
SEEP TREATMENT BOX
SCALE AS SHOWN

CUT 3'3"x10" PANELS ON EACH SIDE FOR SAMPLING ACCESS (NOT FOR HUMAN ENTRY) TYP - 2 PCS
