**Closeout Report
for IHSS Group 000-5
(Present Landfill [IHSS 114])**

**Final Closeout Report
for IHSS Group 000-5
Present Landfill (IHSS-114)**

**Environmental Restoration
Rocky Flats Environmental
Technology Site**

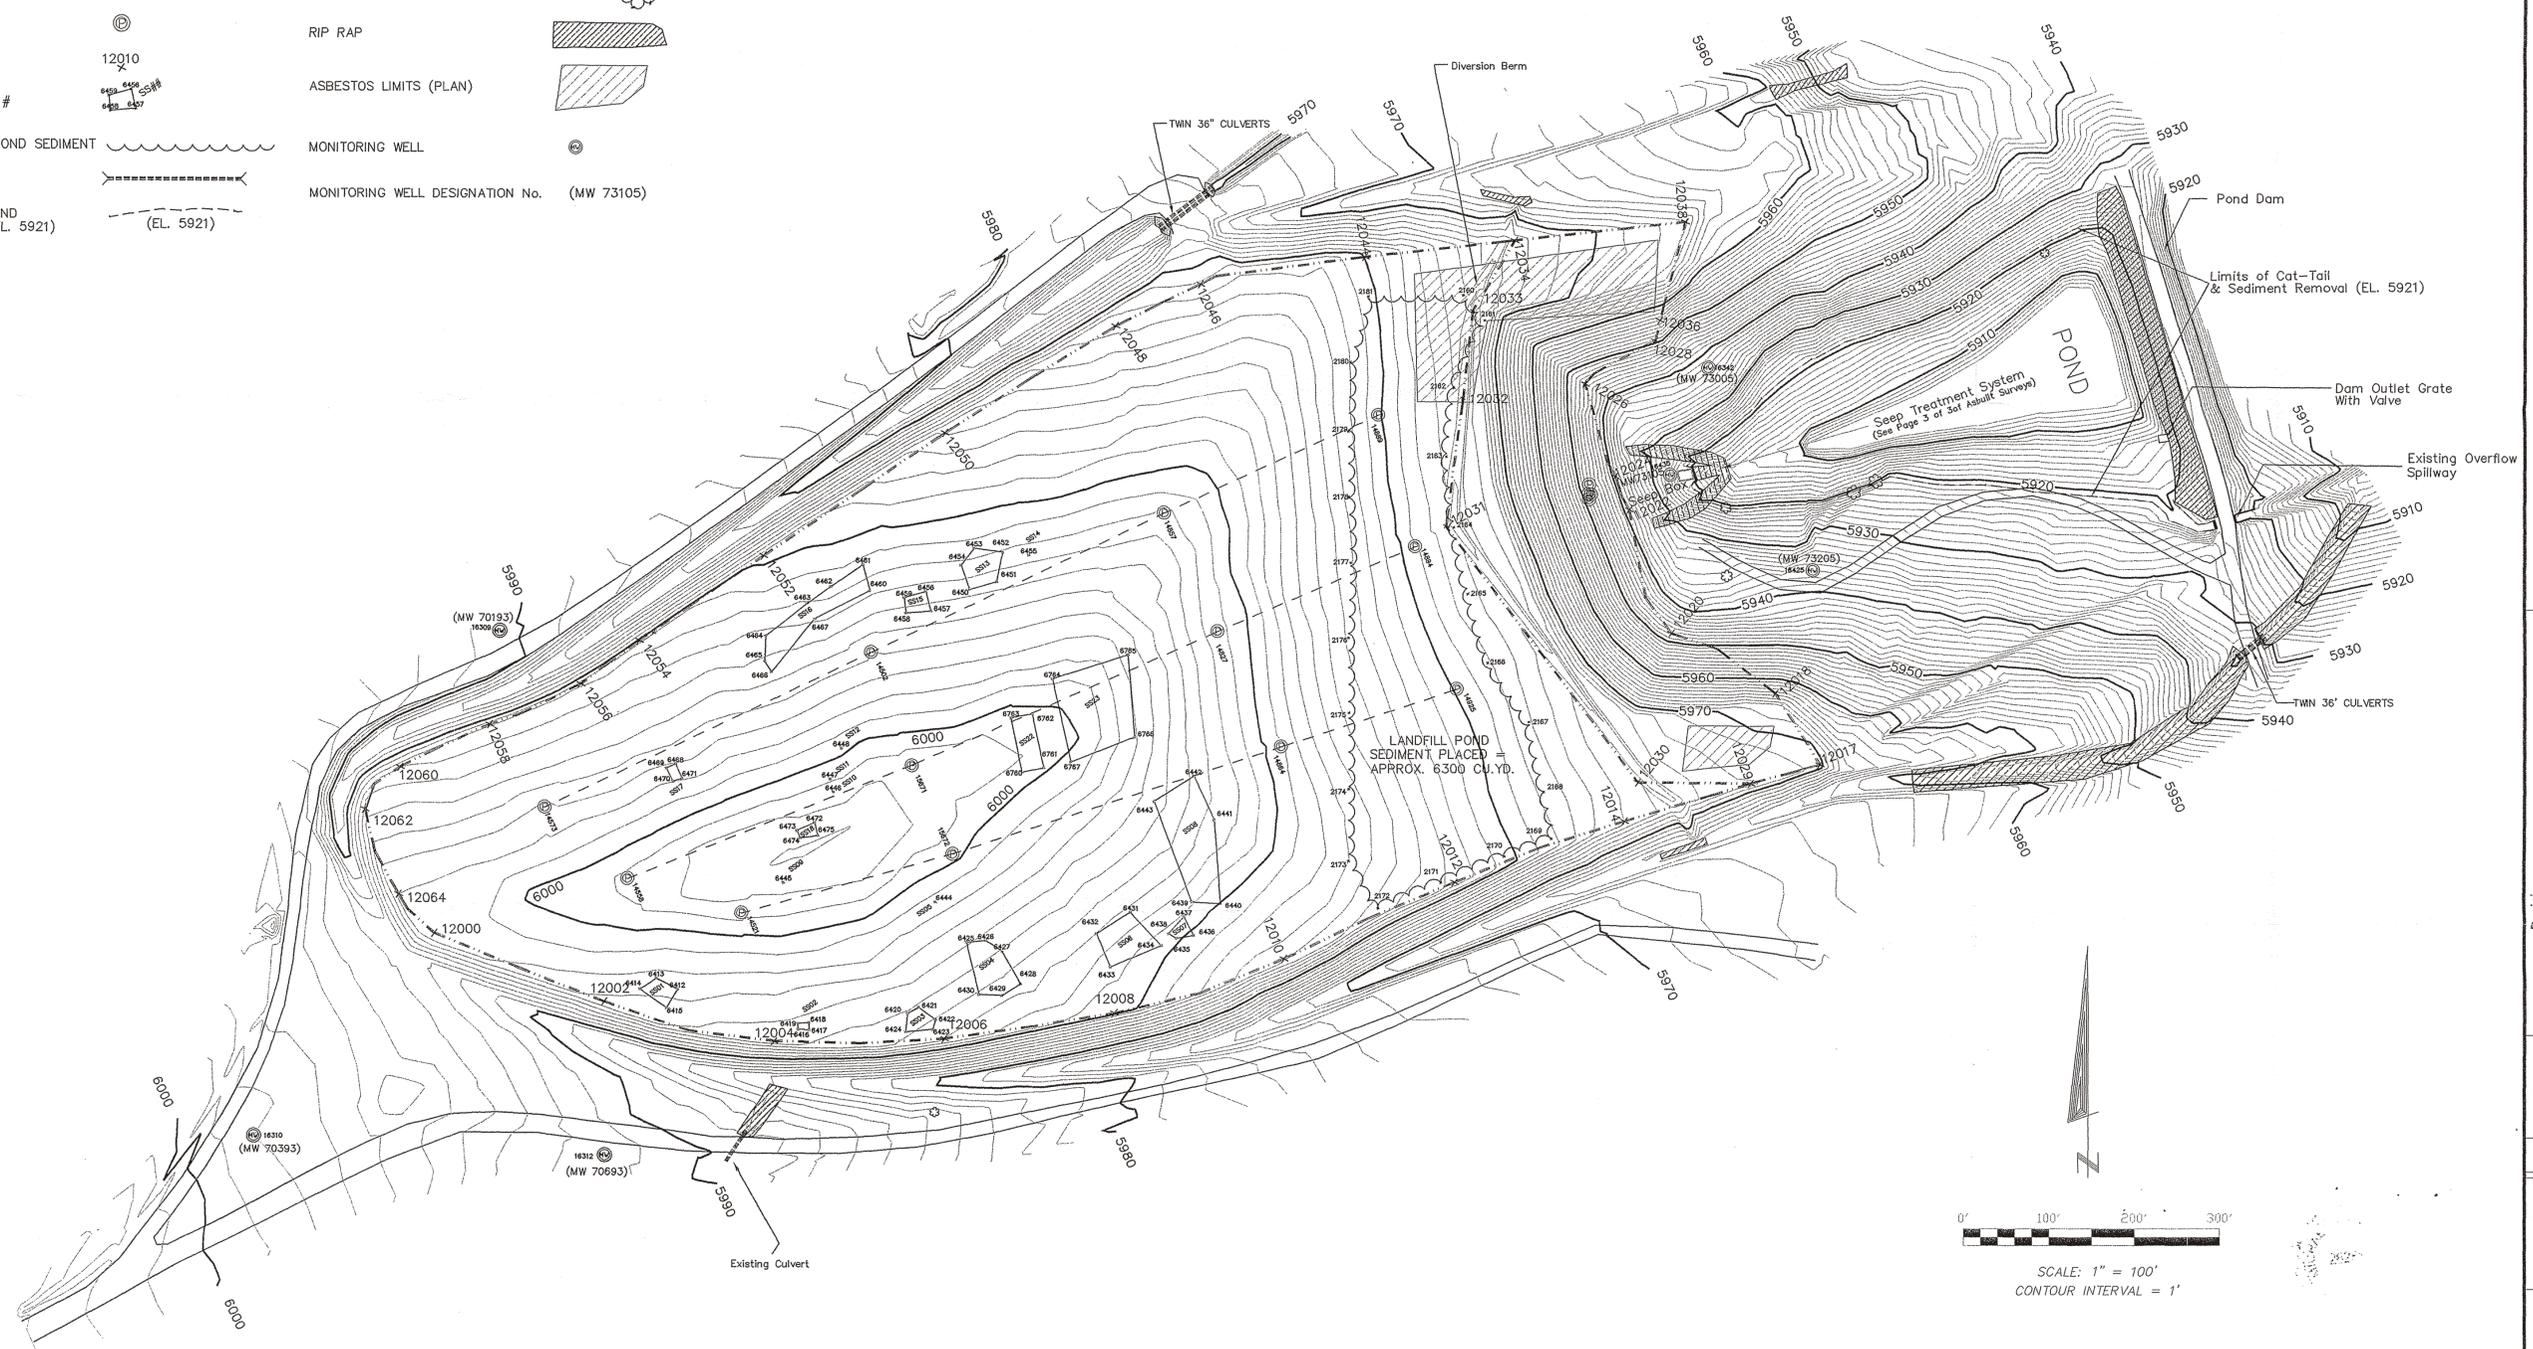
U.S. Department of Energy Rocky Flats Environmental Technology Site Golden, Colorado
ASBUILT SURVEY
 MAP OF PRESENT LANDFILL ACCELERATED ACTION

- SHEET 1 OF 4---COVER SHEET
- SHEET 2 OF 4---TOPOGRAPHIC ASBUILT (fullfills specifications sections 1.02a-3,6,9,10,11&12)
-INCLUDES ANCHOR TRENCH, POND SEDIMENT PLACEMENT,
SOFTSPOT LOCATION, VENT SYSTEM AND MONITORING WELLS
- SHEET 3 OF 4---ASBUILT OF NEW SEEP TREATMENT SYSTEM
- SHEET 4 OF 4---ASBUILT POINT TABLES
