Rocky Flats Environmental Technology Site

RECONNAISSANCE LEVEL CHARACTERIZATION REPORT (RLCR)

BUILDING 443 CLOSURE PROJECT

REVISION 0

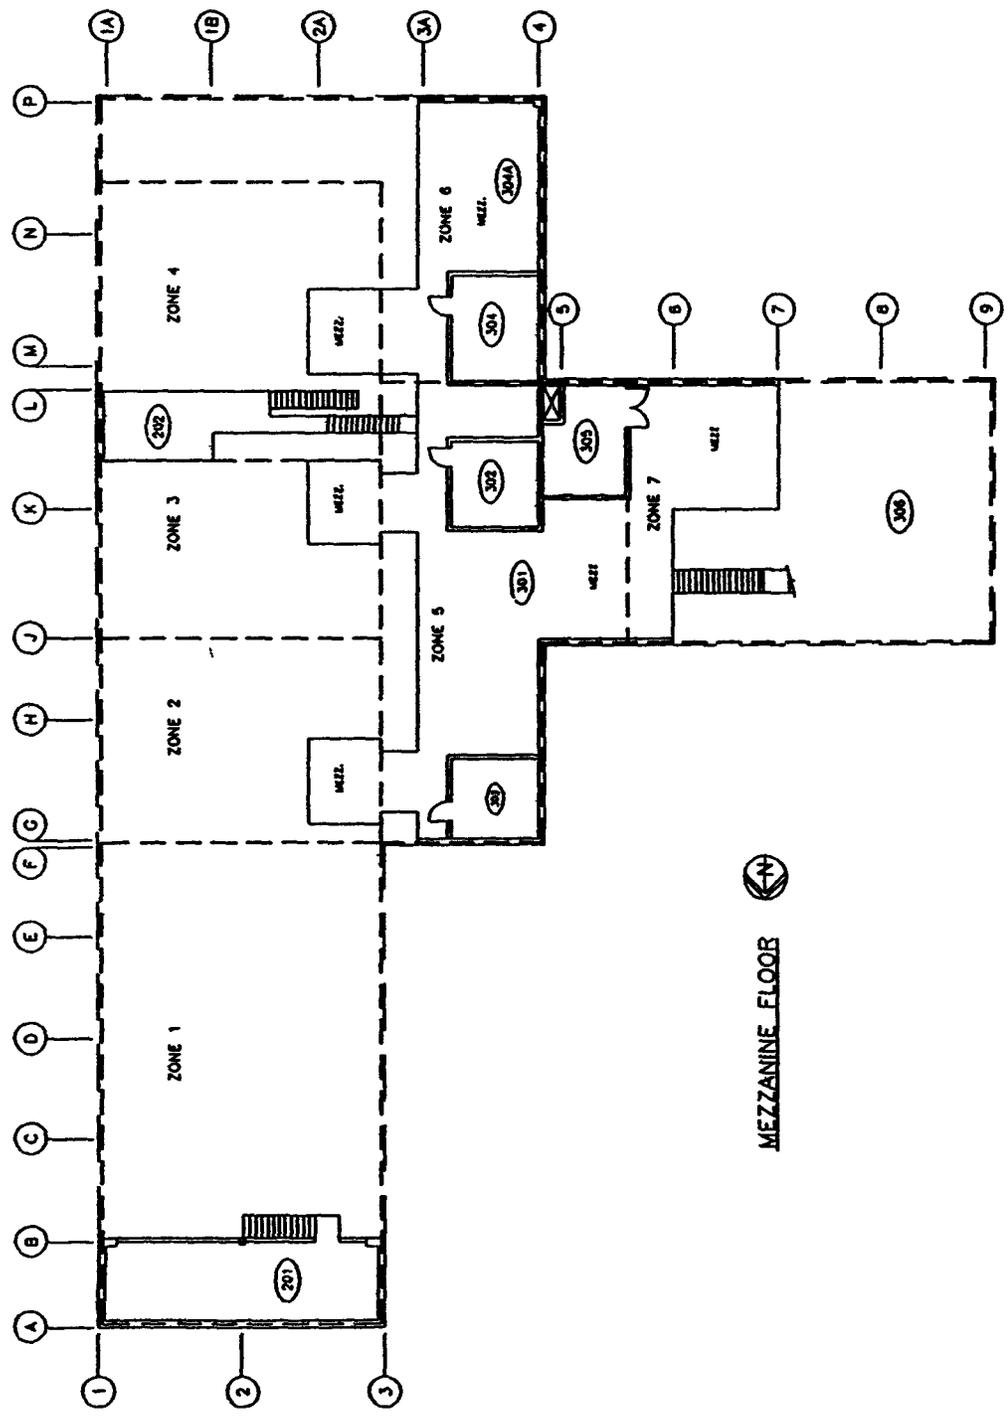
MEZZANINE FLOOR

- SPACE**
 ZONE 1 301
 ZONE 2 302
 ZONE 3 303
 ZONE 4 304
 ZONE 5 305
 ZONE 6 306
 ZONE 7 307
- ACCESSIBLE MATERIAL**
 EXPANSION TANK, AIR LINE
 STEAM 300, CONDENSATE
 STEAM, UNTEMPERED WATER
 EXPANSION TANK
 CONDENSATE STEAM
 STEAM 125, BOILER FEED WATER TANK
 TRANSDUCER WALL
 CONDENSATE STEAM
 PIPE ELBOWS/FITTINGS, BOILER FEED
 TANK
- ASBESTOS-CONTAINING BUILDING MATERIALS WERE NOT FOUND IN SPACES:**
 302
 304
 305
- LEGEND**
 ○ SPACE NUMBER
 — WALL
 - - - ZONE BOUNDARY

BUILDING 443

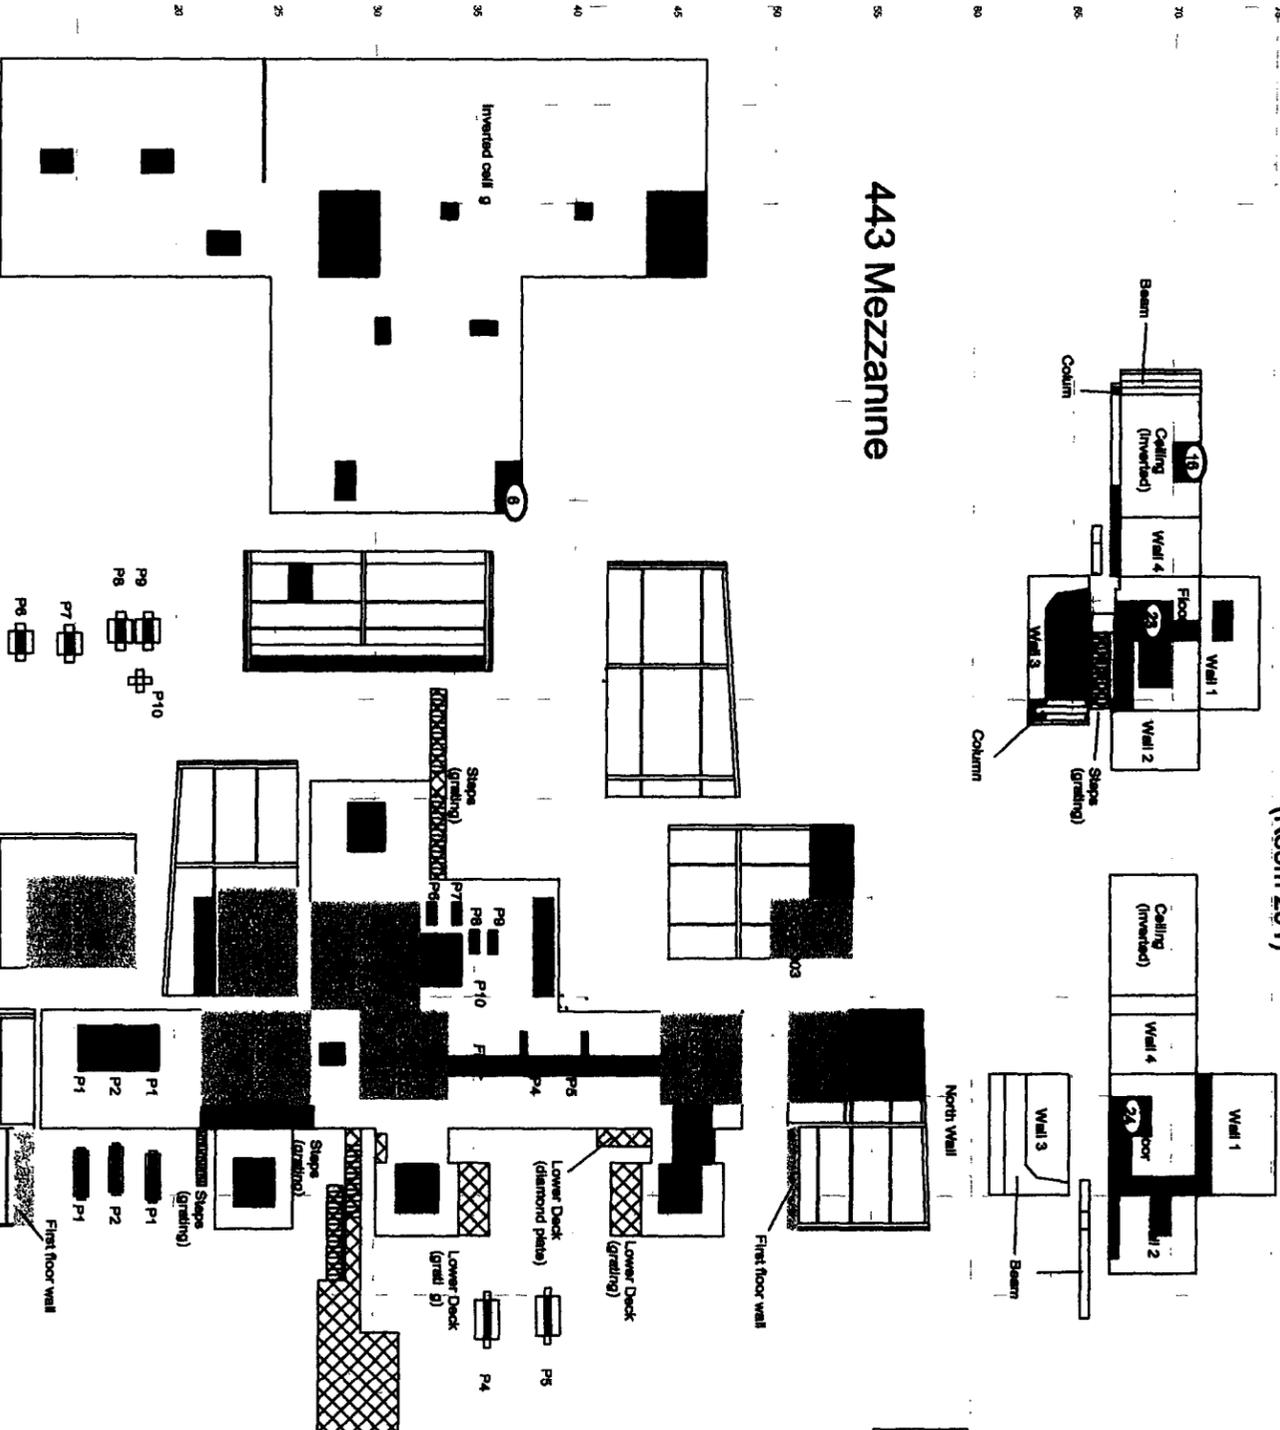
443 Mezzanine

**North end Mezzanine
(Room 201)**

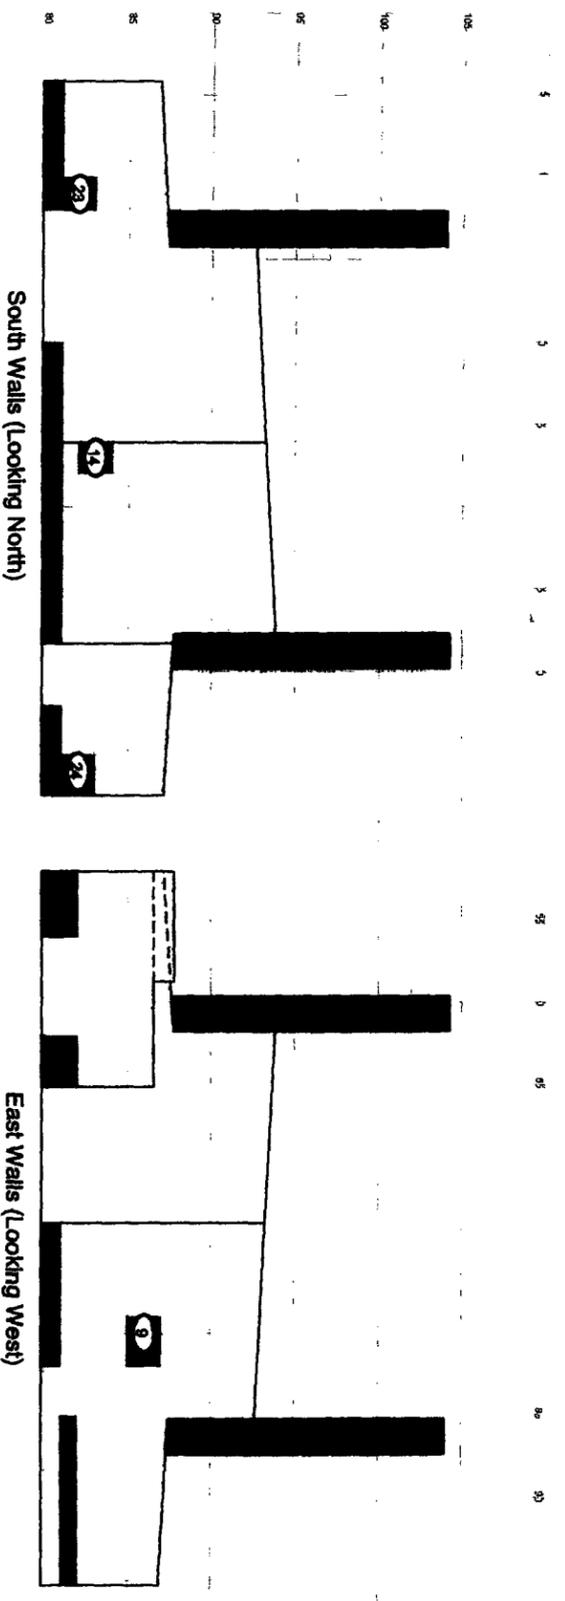
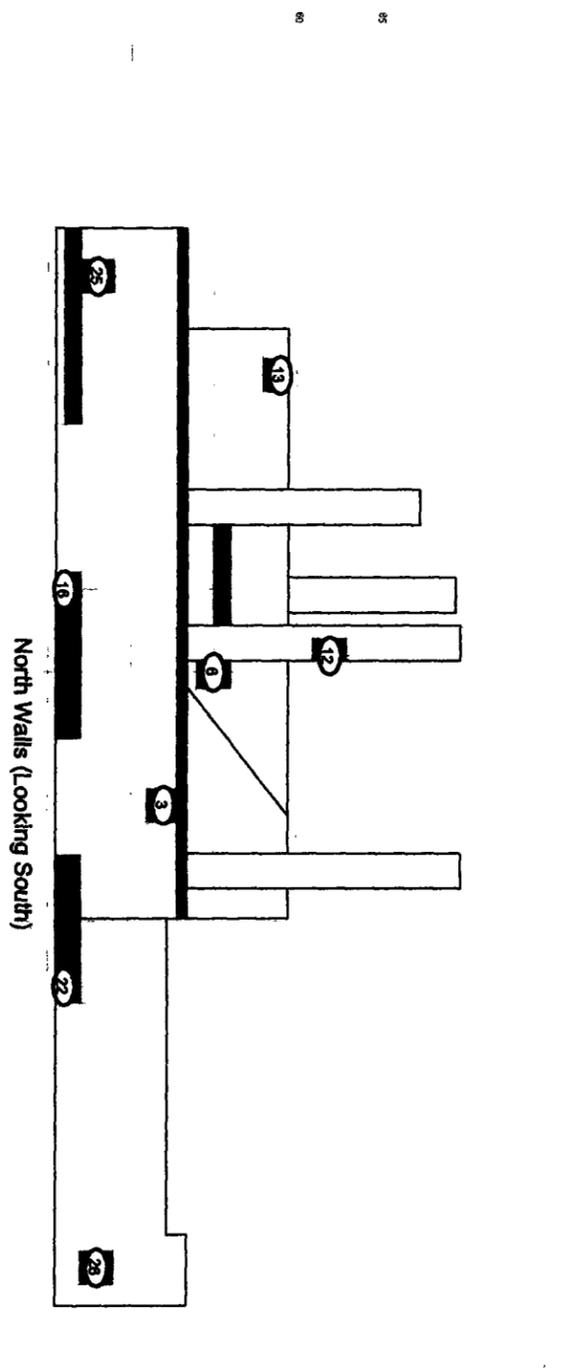
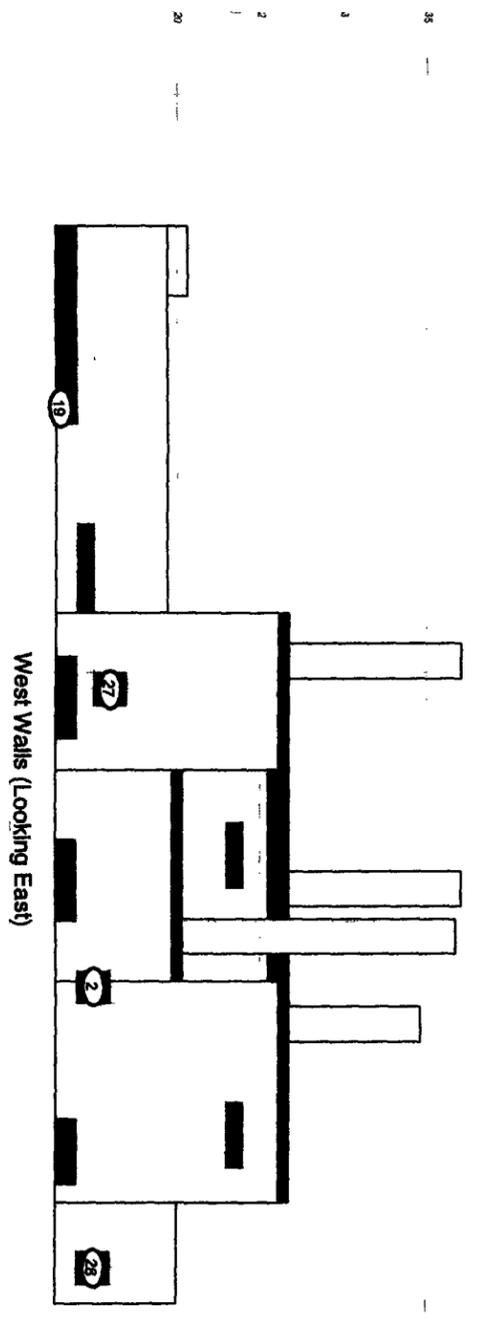
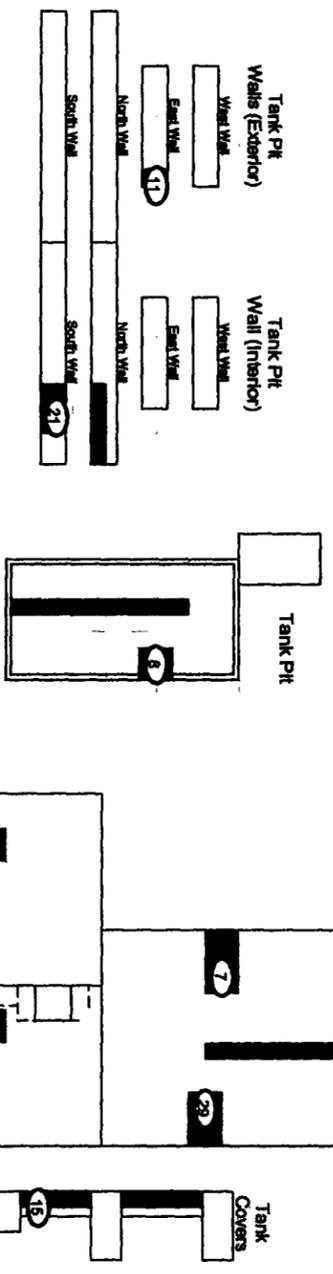
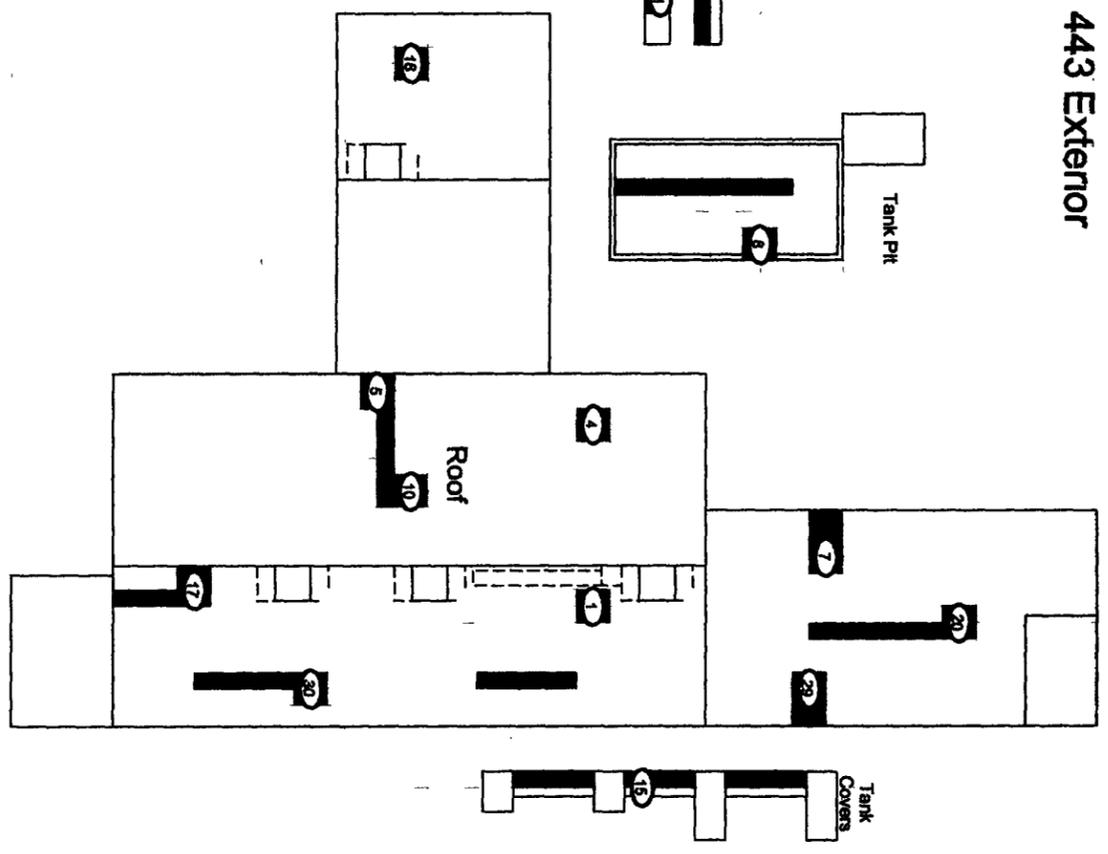
443 Exterior

Survey Area: A Survey Unit: 443-B-002 Classification: 3
 Building: 443 Survey Unit Description: Exterior
 Total Area: 4145 sq m Total Roof Area: 1405 sq m

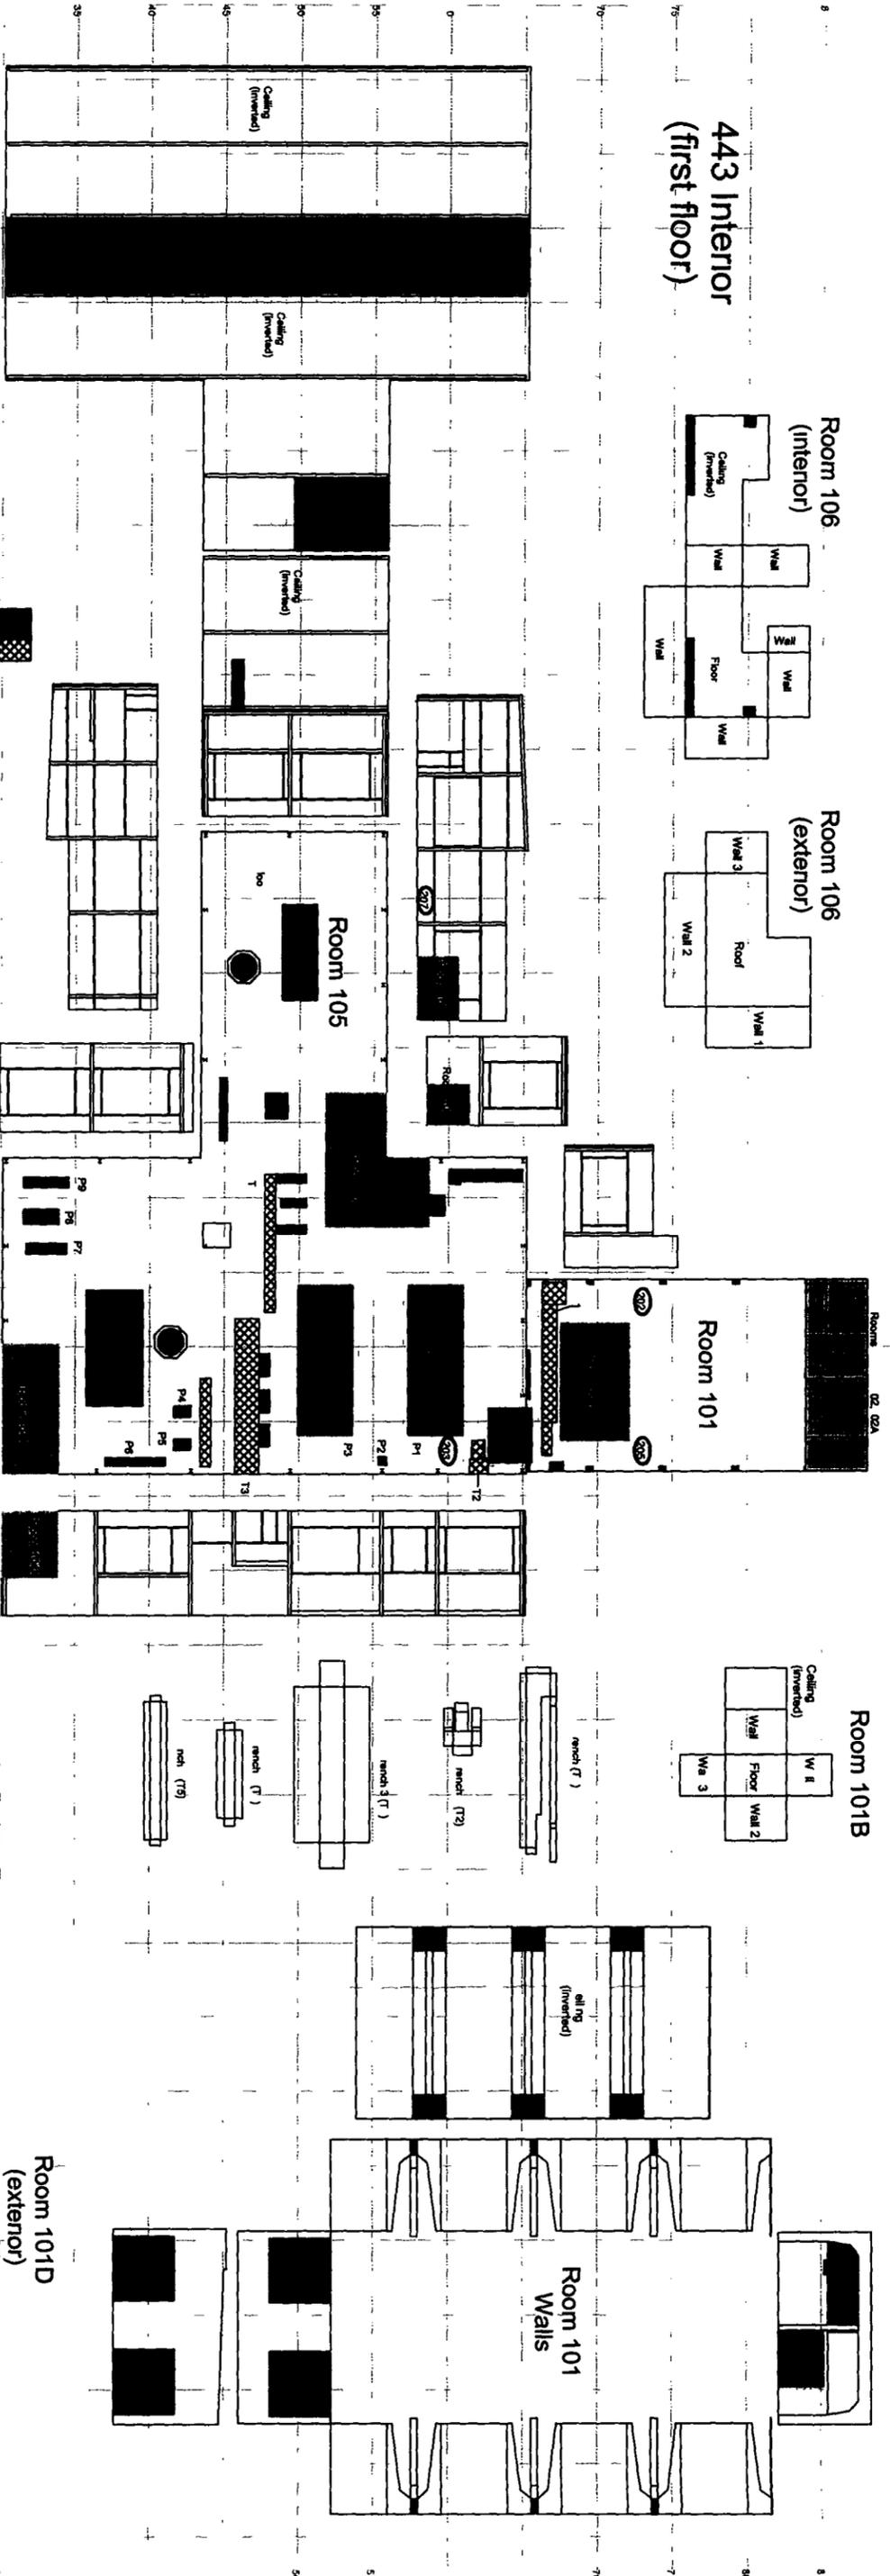
443 Interior
(first floor)

CHEMICAL SAMPLE MAP

Building 443 Interior

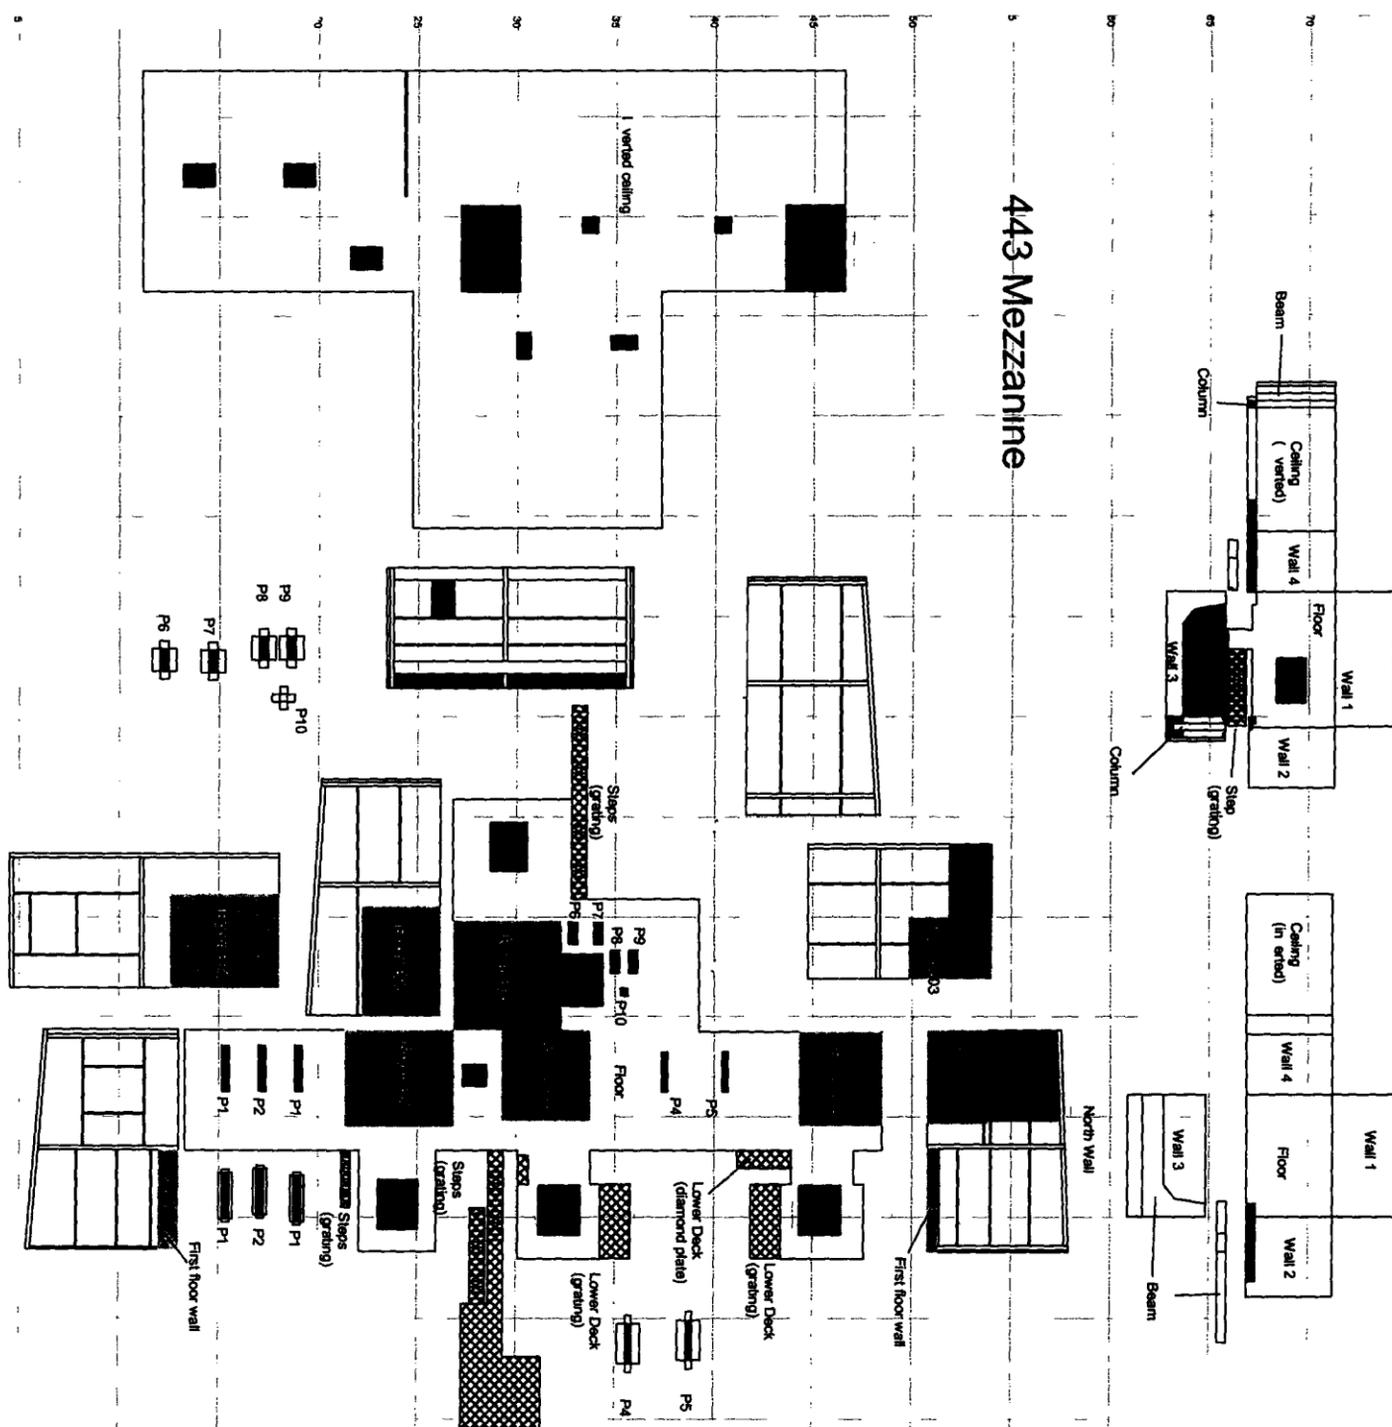
443 Mezzanine

North end Mezzanine
(Room 201)

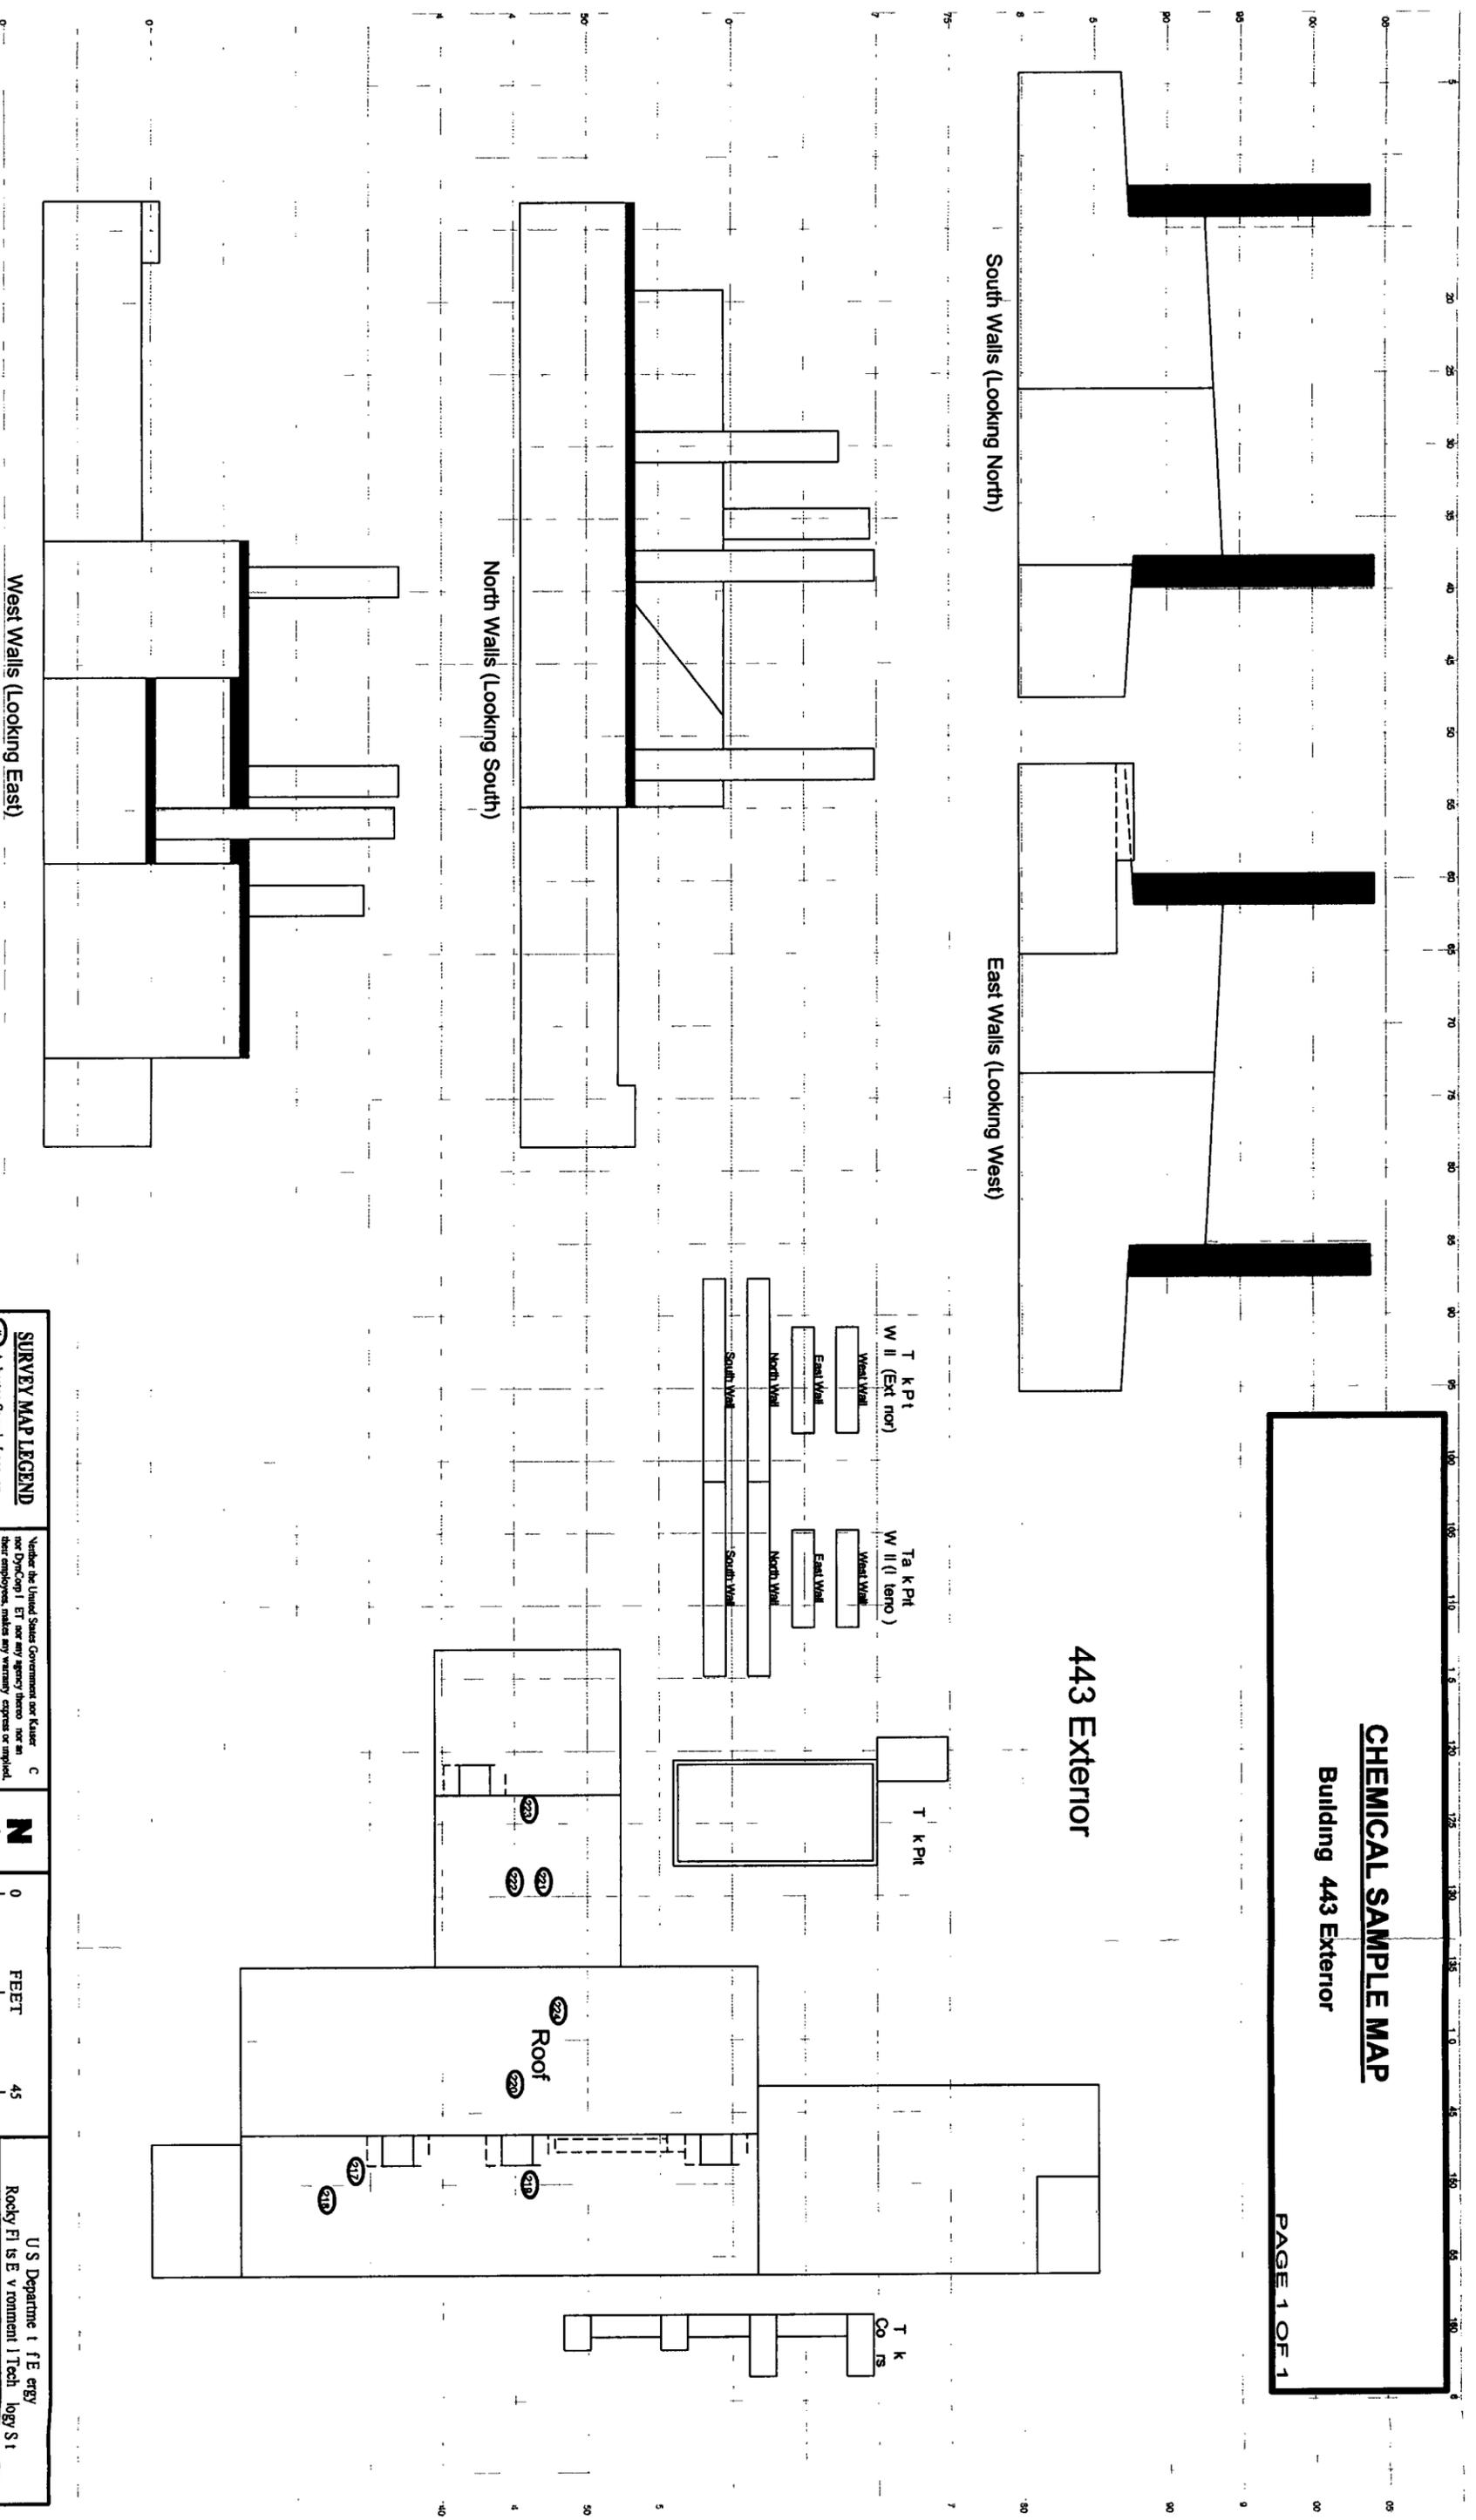
Building 443 Exterior

- A Beryllium Sample Location
- B Lead Sample Location
- RCRA/CERCLA Sample Location
- PCB Sample Location

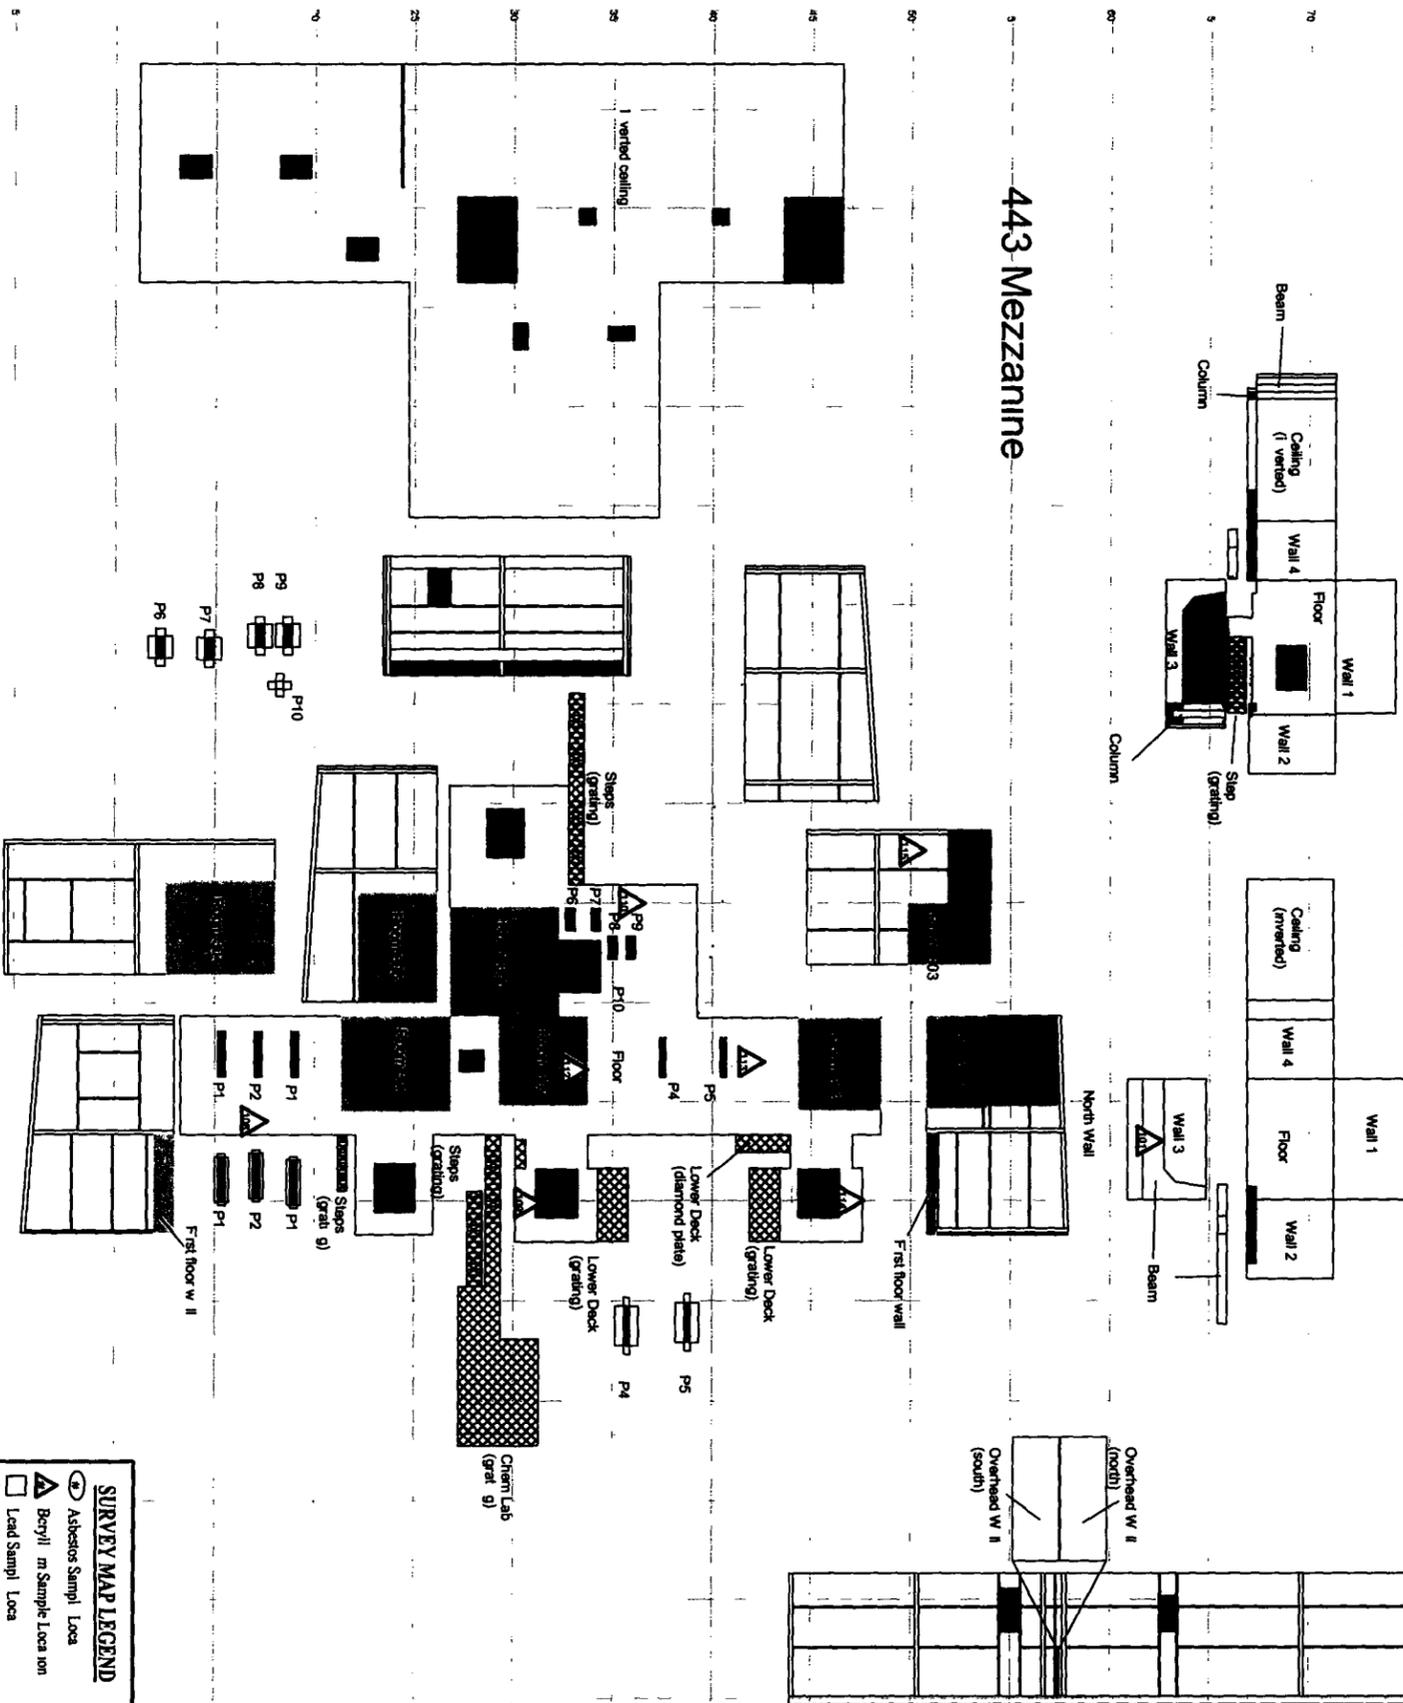
443 Mezzanine

North end Mezzanine
(Room 201)
