DOTY & ASSOCIATES

MEMORANDUM

Subject: Hydraulic Feasibility of 881 Hillside French Drain

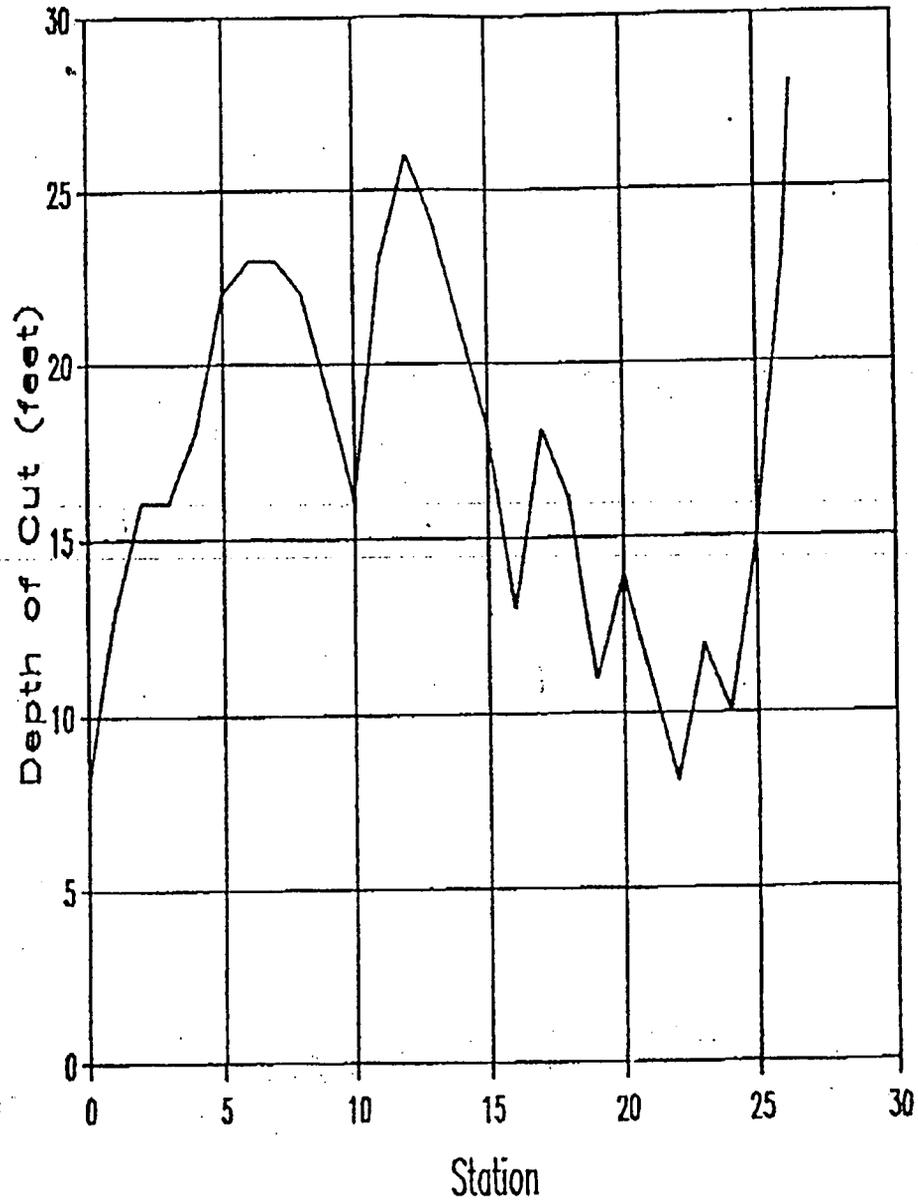
FIGURE 1

881 HILLSIDE DRAIN EXCAVATION DEPTHS

ASSUMING TWO FEET OF EXCAVATION BELOW PVC DRAIN LINE

- c. Some of the higher results (e.g., values in excess of 1×10^{-3} cm/s in B 3002 90) may result from accidental hydrofracture of the bedrock during the test.
6. The depth of cut shown on Plate 1 of EG&G (1990) never exceeds thirty feet. Engineering-Science (1991) shows the same alignment except west of the Building 881 footing drain discharge, where the alignment is farther south. The Engineering-Science (1991) cuts are never more than twenty-eight feet (Figure 1).
