# DURANGO

U.S. DEPARTMENT OF ENERGY GRAND JUNCTION OFFICE GRAND JUNCTION, COLORADO	
North-South Cross Section of Plate: 3 Bedrock Formations and Coal beds at the Raffinate Ponds Area	
DATE PREPARED: January 23, 2002	FILENAME: U0135600

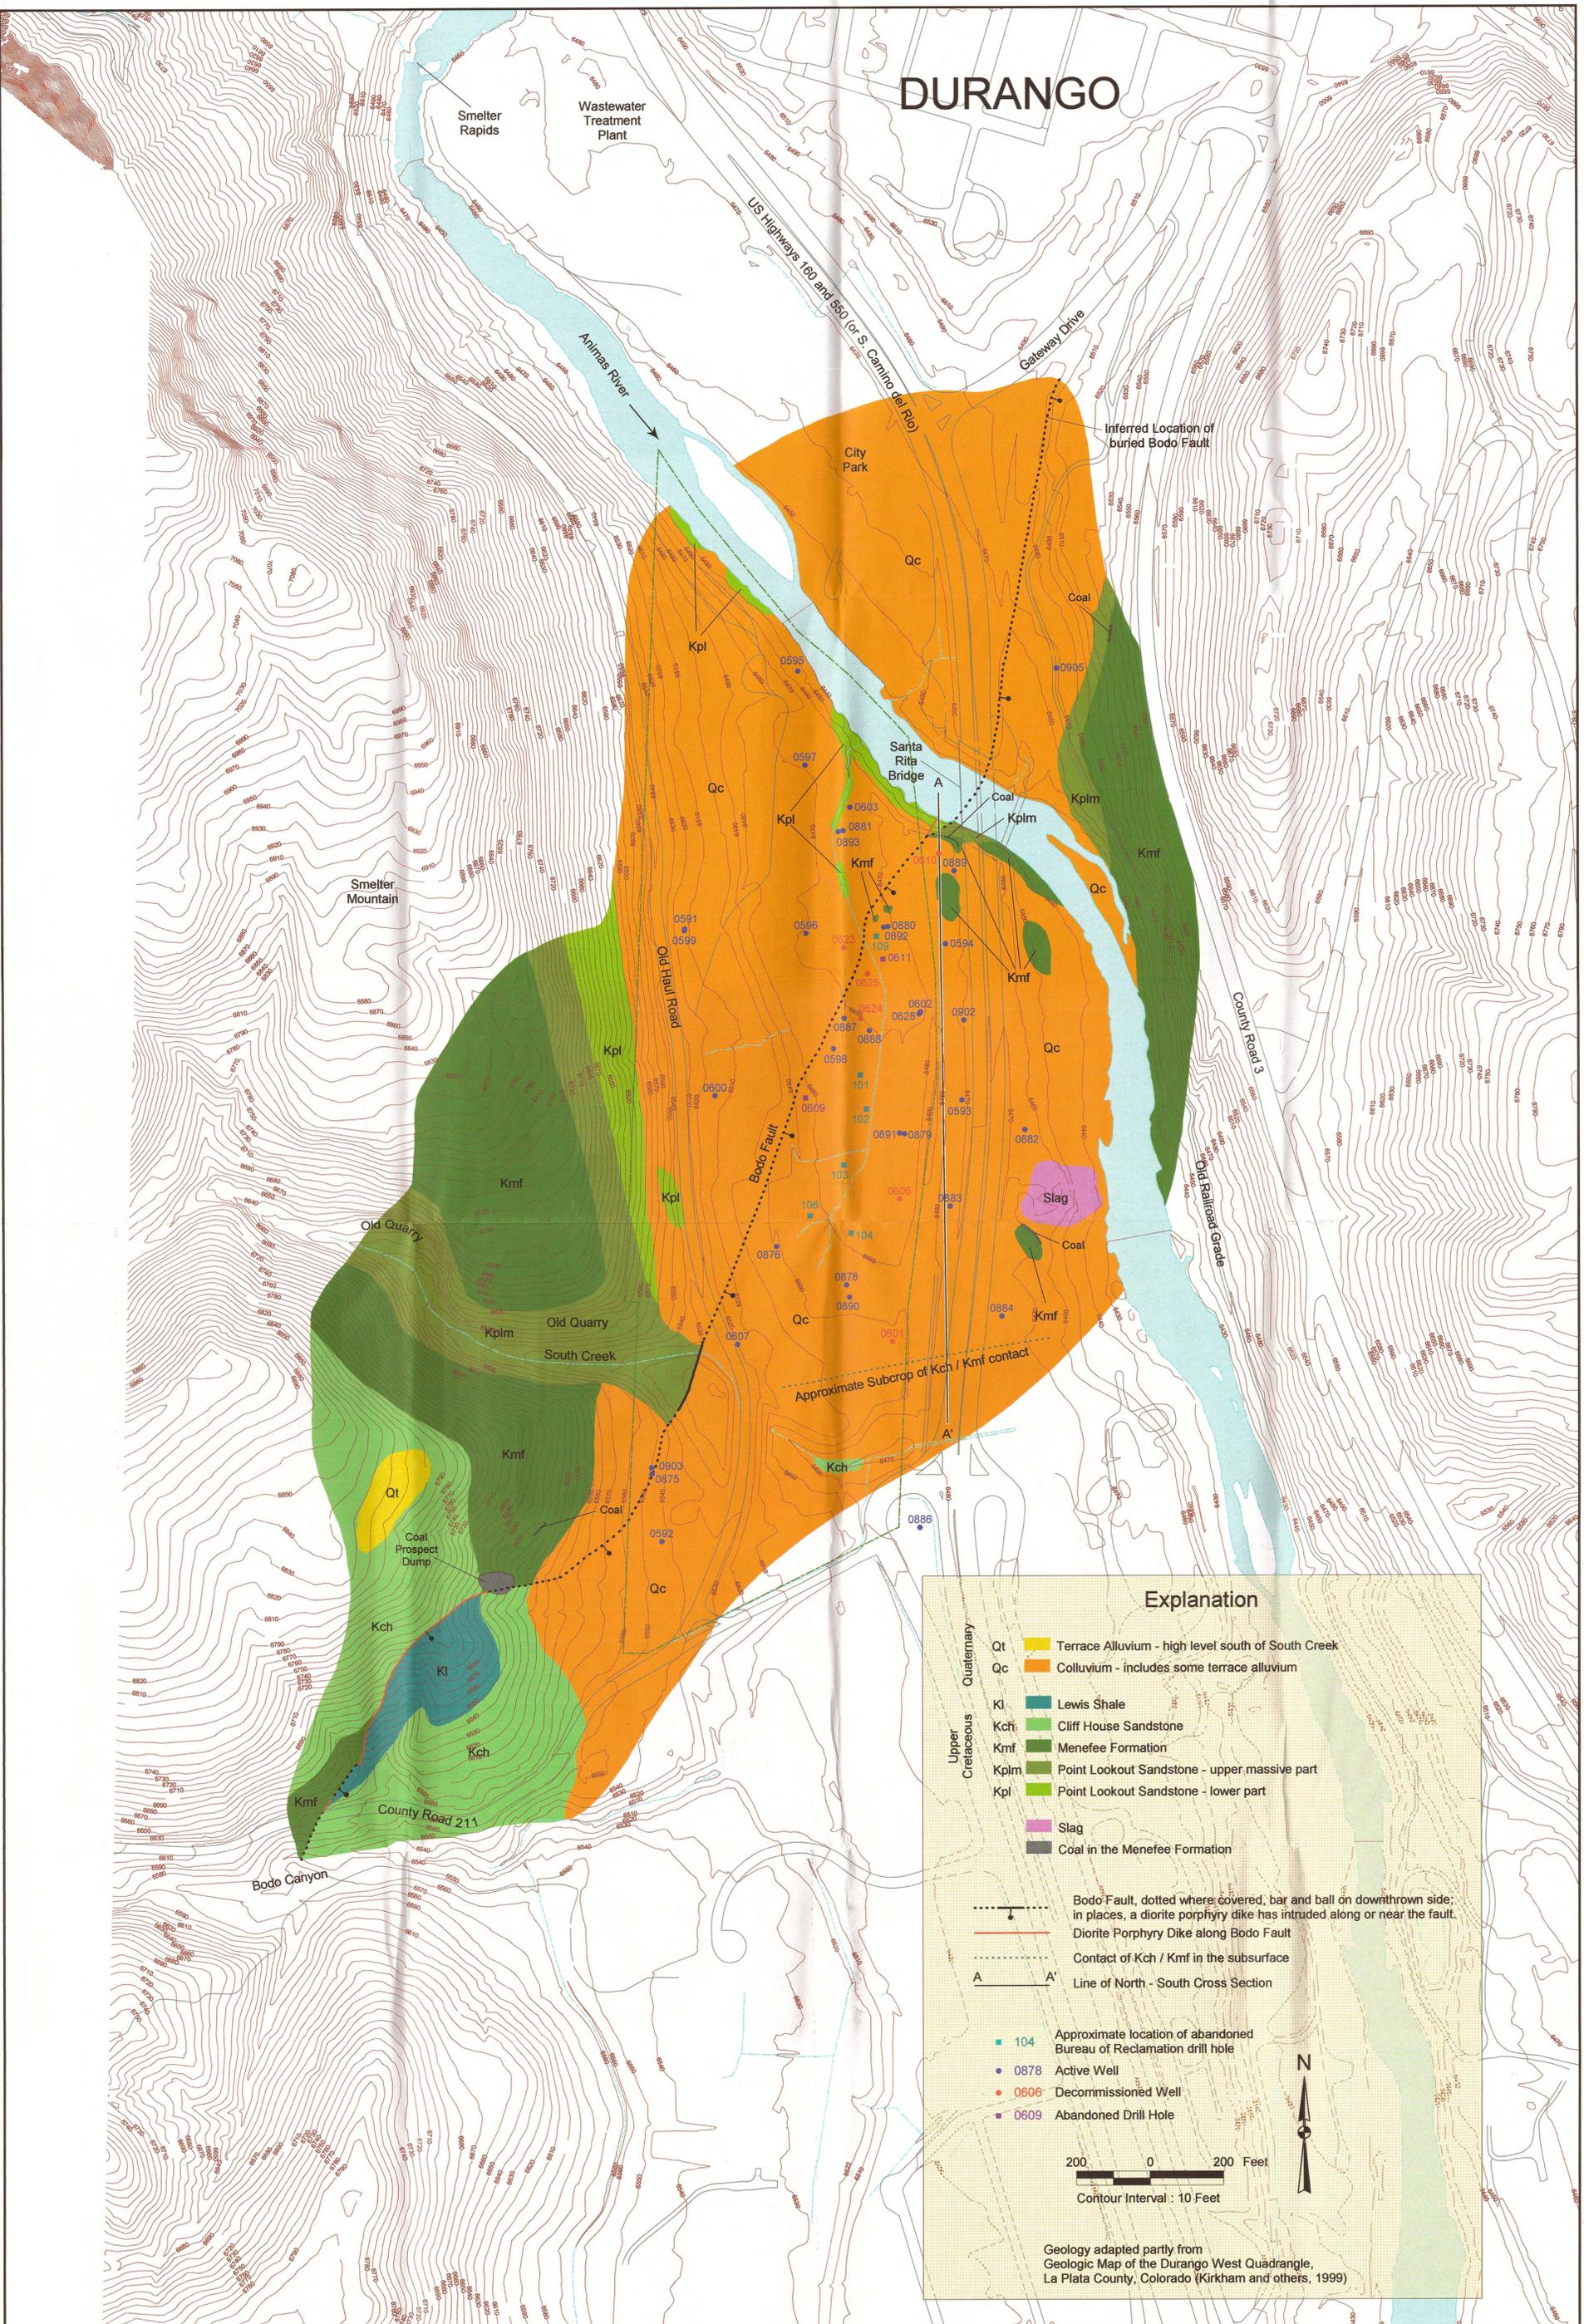
Quaternary	Qt	Terrace Alluvium - high level south of South Creek
	Qc	Colluvium - includes some terrace alluvium
Upper Cretaceous	Kl	Lewis Shale
	Kch	Cliff House Sandstone
	Kmf	Menefee Formation
	Kplm	Point Lookout Sandstone - upper massive part
	Kpl	Point Lookout Sandstone - lower part
	Slag	Slag
	Coal	Coal in the Menefee Formation

- - - - - Bodo Fault, dotted where covered; bar and ball on downthrown side; in places, a diorite porphyry dike has intruded along or near the fault.  
 ———— Diorite Porphyry Dike along Bodo Fault  
 - - - - - Contact of Kch / Kmf in the subsurface  
 A ———— A' Line of North - South Cross Section

■ 104 Approximate location of abandoned Bureau of Reclamation drill hole  
 ● 0878 Active Well  
 ● 0606 Decommissioned Well  
 ● 0609 Abandoned Drill Hole

Geology adapted partly from  
 Geologic Map of the Durango West Quadrangle,  
 La Plata County, Colorado (Kirkham and others, 1999)

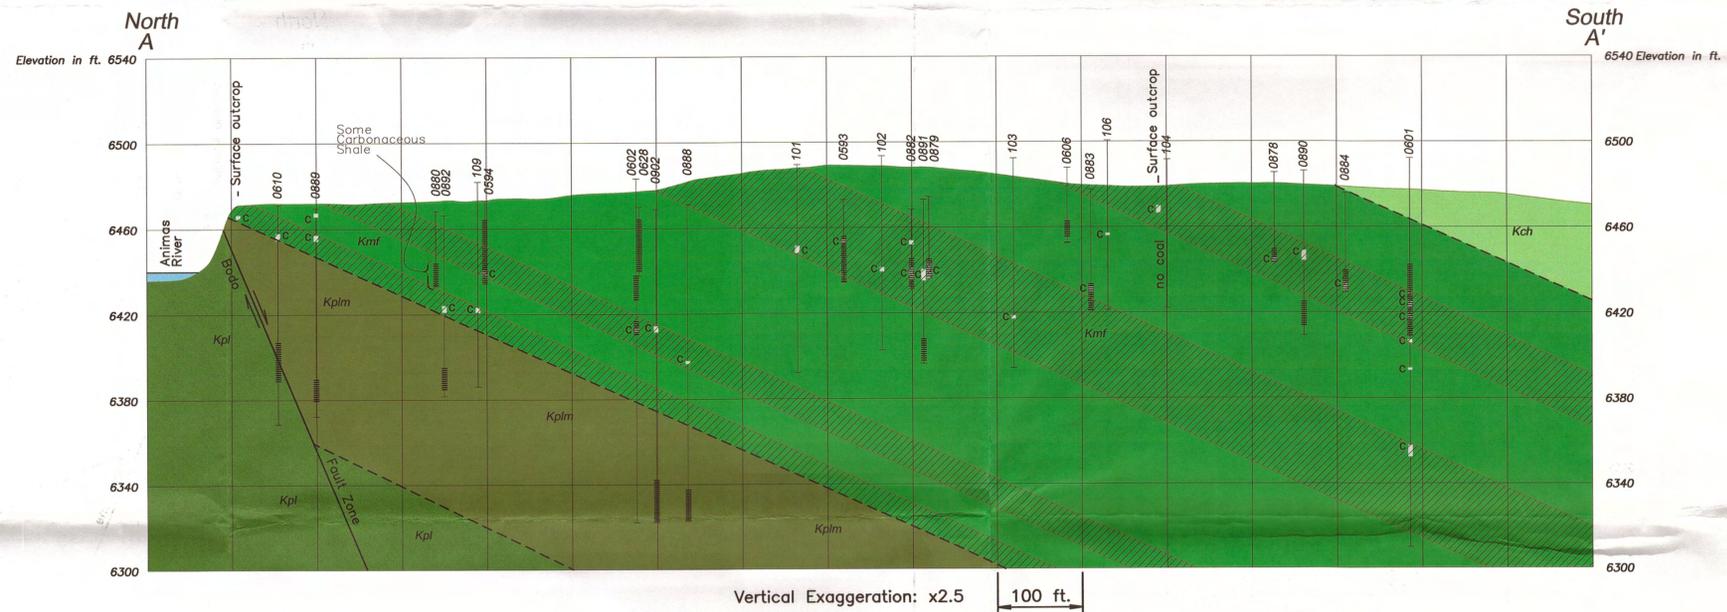
- CRETACEOUS
- Kch Cliff House Sandstone
  - Kmf Menefee Formation
  - Kplm Point Lookout Sandstone, upper massive part
  - Kpl Point Lookout Sandstone, lower part
  - Main Zones where coal beds occur

- 0593 ← Well or Drill Hole Number
- ← Surface elevation of well or drill hole
- ← Screened Interval
- c ← Coal Bed
- ← Bottom of well borehole or drill hole

- Ground surface along line of Cross Section
- - - - - Approximate Location of Formation Contact
- Approximate Location of Bodo Fault Zone showing direction of movement

Wells and drill holes were projected from various distances onto the cross section using the assumption that the formations strike due east (most strike measurements are within 5 degrees of due east).

Drill holes, shown in the cross section as the 100 series, were installed by the U. S. Bureau of Reclamation in 1989.
